## RECLAMATION CLOSURE REPORT

**RE:** RECLAMATION CLOSURE REPORT

**LOCATION:** Green Clean Water Treatment Facility

**NMOCD REF. NO.** NAPP2404355956

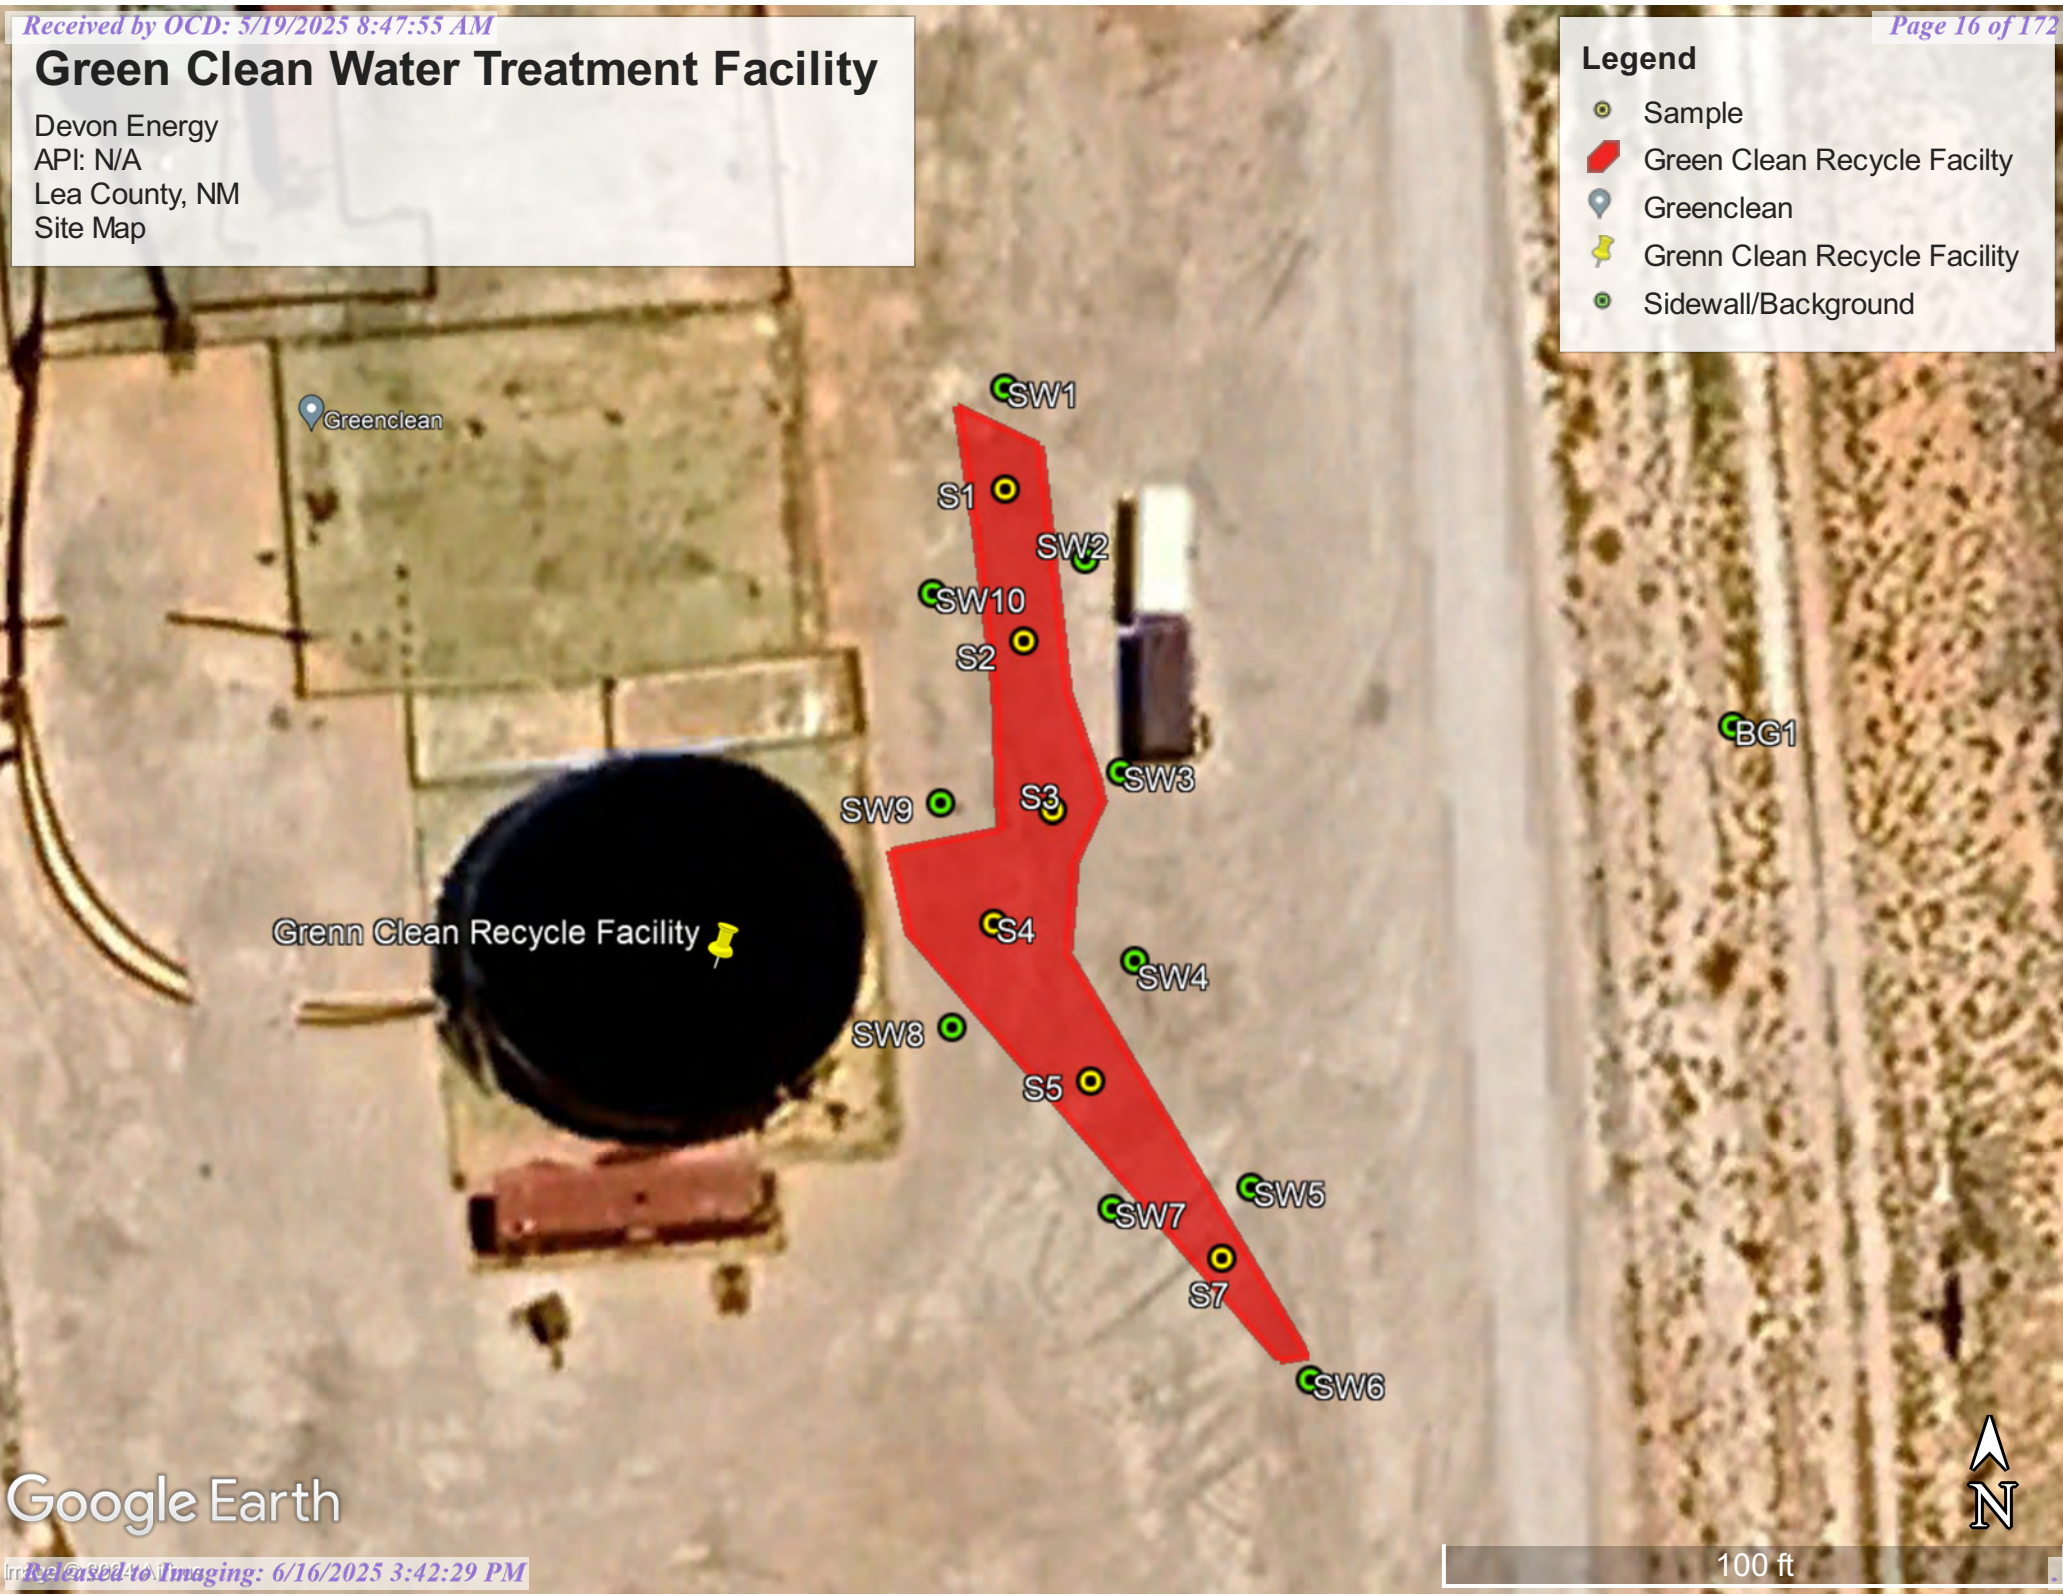
Devon Energy  
API: N/A  
Lea County, NM  
Site Map

- Sample
- Green Clean Recycle Facility
- Greenclean
- Green Clean Recycle Facility
- Sidewall/Background

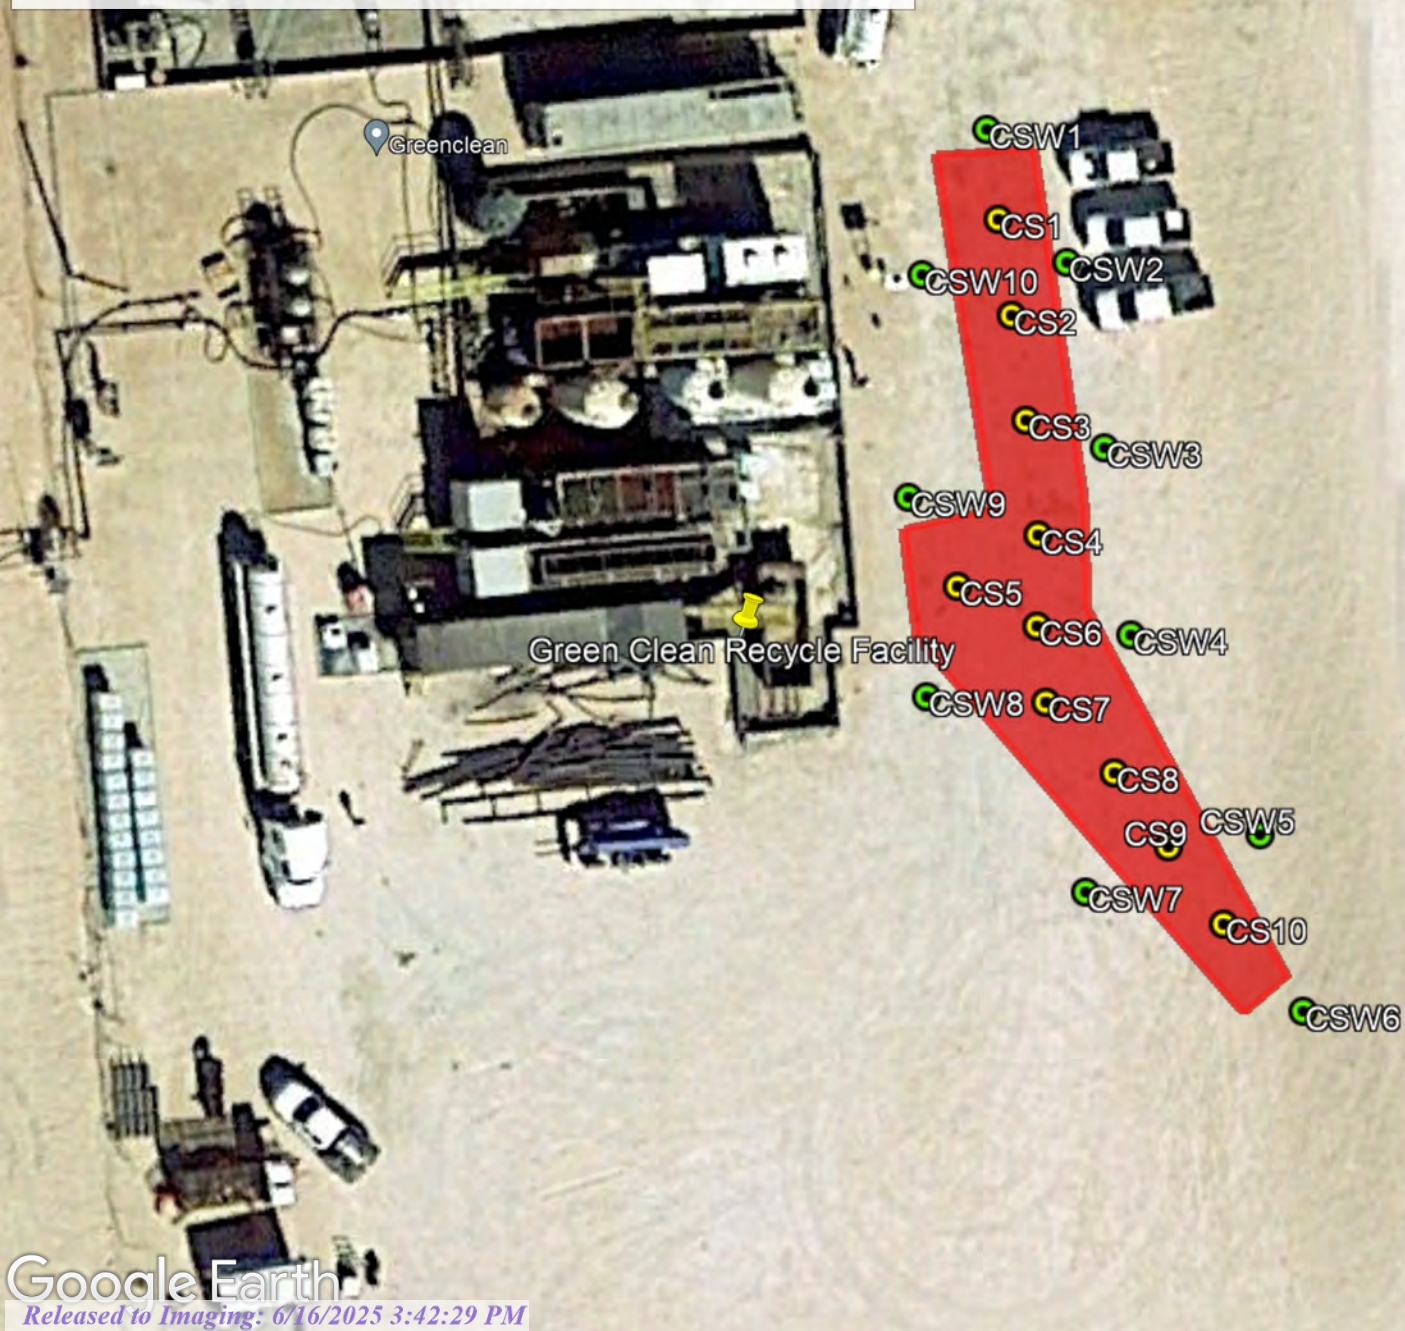
Devon Energy  
API: N/A  
Lea County, NM  
Confirmation Map

On April 23, 2024, after sending a 48-hour notification, application ID: 335346, Pima returned to the site to collect confirmation samples of the excavation. The results of this sampling event can be found in Figure 4. Analytical Laboratory Reports can be found in Appendix D. Photographic Documentation can be found in Appendix C.

- Confirmation Samples
- Confirmation Sidewall Samples
- Green Clean Recycle Facility
- Untitled Polygon

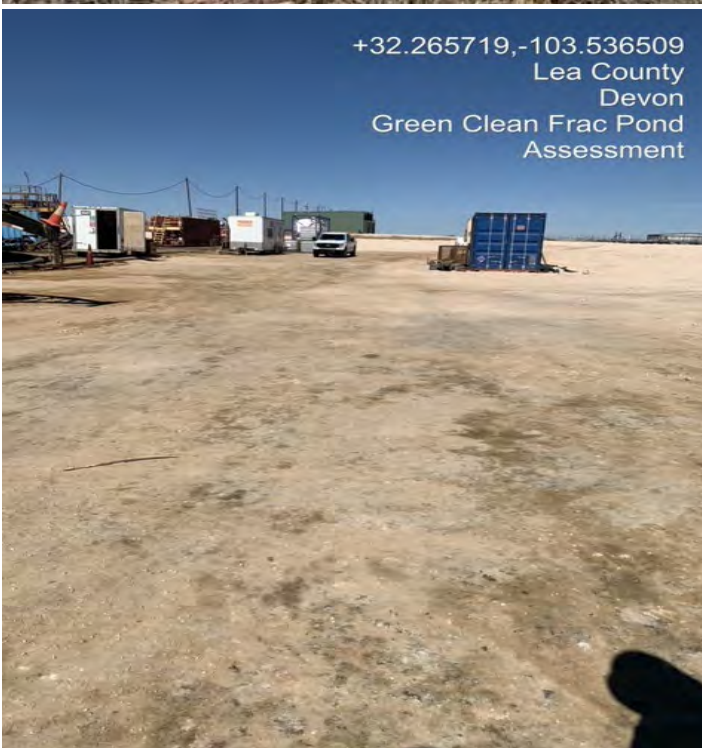
+32.265719,-103.536509  
Lea County  
Devon  
Green Clean Frac Pond  
Assessment

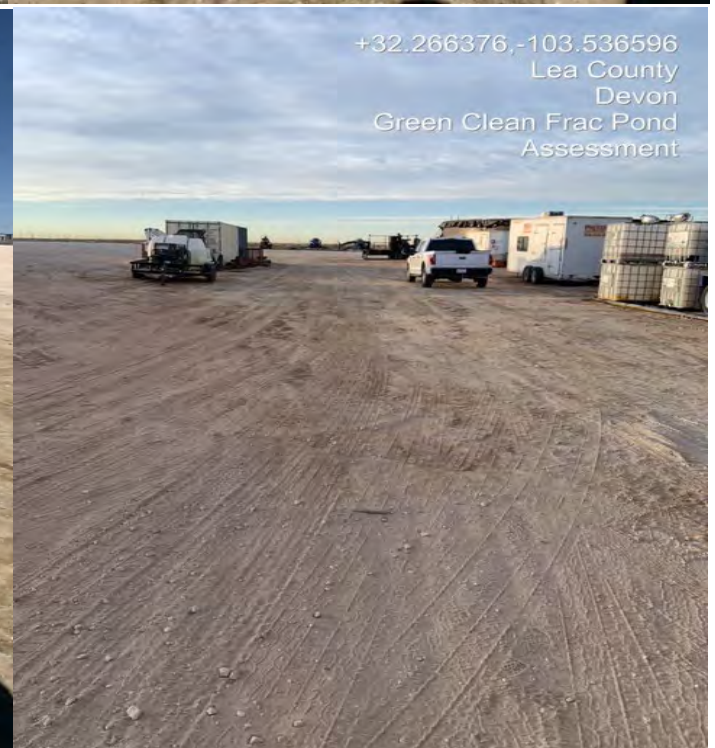
+32.265719,-103.536509  
Lea County  
Devon  
Green Clean Frac Pond  
Assessment

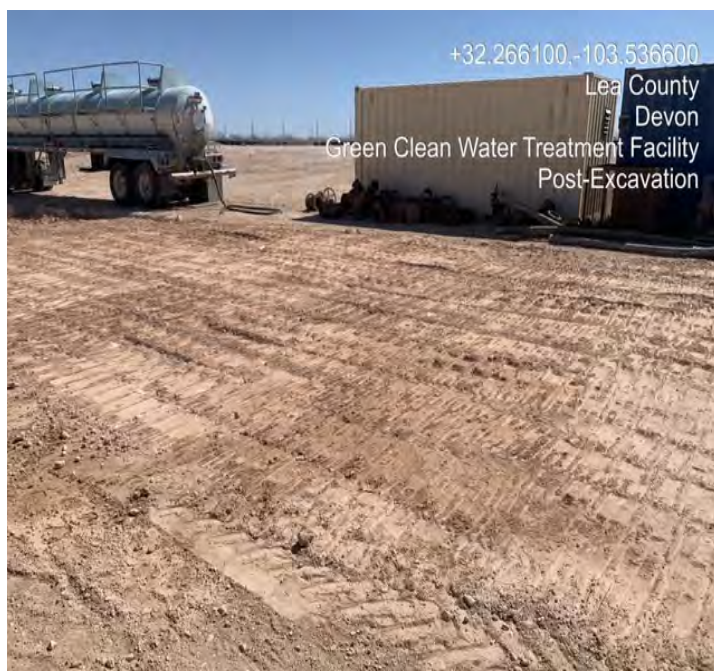
+32.266100,-103.536600  
Lea County  
Devon  
Green Clean Water Treatment Facility  
Post-Excavation

On April 17, 2024, the Devon Construction Department mobilized personnel and equipment to begin immediate remediation activities. They began by excavating the area to a depth of 4' BGS. The contaminated soil (154 cubic yards) was hauled to an approved, lined disposal facility and clean backfill material was brought in.

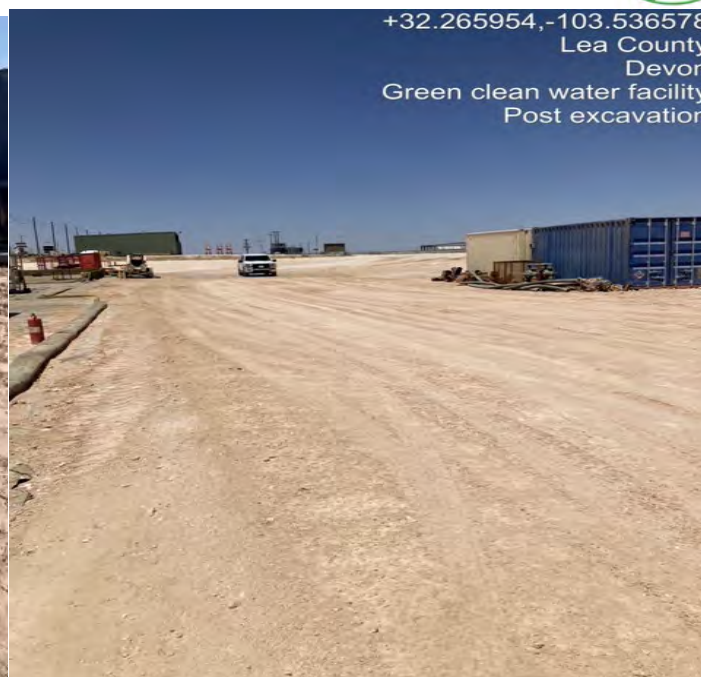
+32.265954,-103.536578  
Lea County  
Devon  
Green clean water facility  
Post excavation

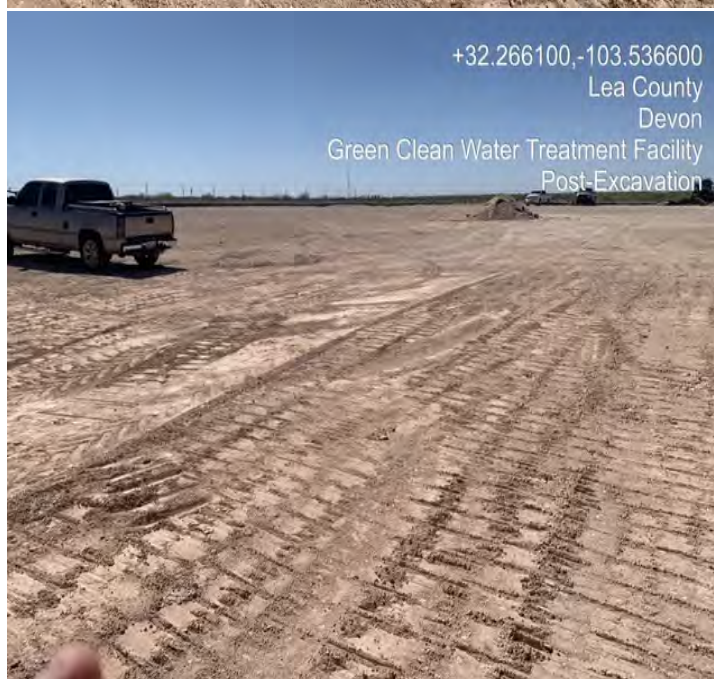
+32.266100,-103.536600  
Lea County  
Devon  
Green Clean Water Treatment Facility  
Post-Excavation

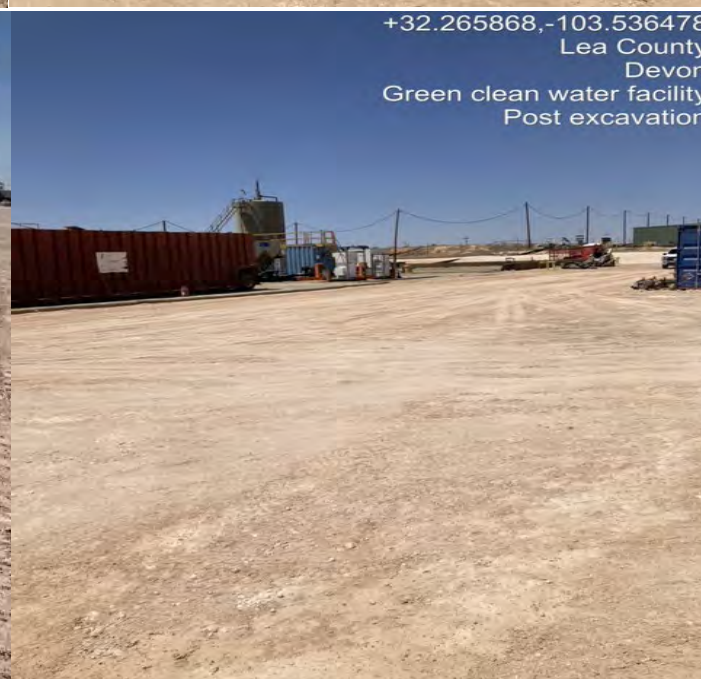
+32.265868,-103.536478  
Lea County  
Devon  
Green clean water facility  
Post excavation
