RE: **Seawolf 12 CTB 1 - Closure Request Report**
Incident Number: nAPP2500624157
GPS: 32.053553°, -103.52788°
Lea County, New Mexico
ESRR Project No. 2778/VP-21241

Earth Systems Response & Restoration (ESRR), on behalf of Devon Energy (Devon), presents the following Closure Request Report (CRR) detailing excavation activities and subsequent soil sampling events associated with an inadvertent release of produced water at Seawolf 12 CTB 1 (Site). Based on completed remedial actions and laboratory analytical results from recent soil sampling events, Devon is requesting No Further Action (NFA) at the Site.

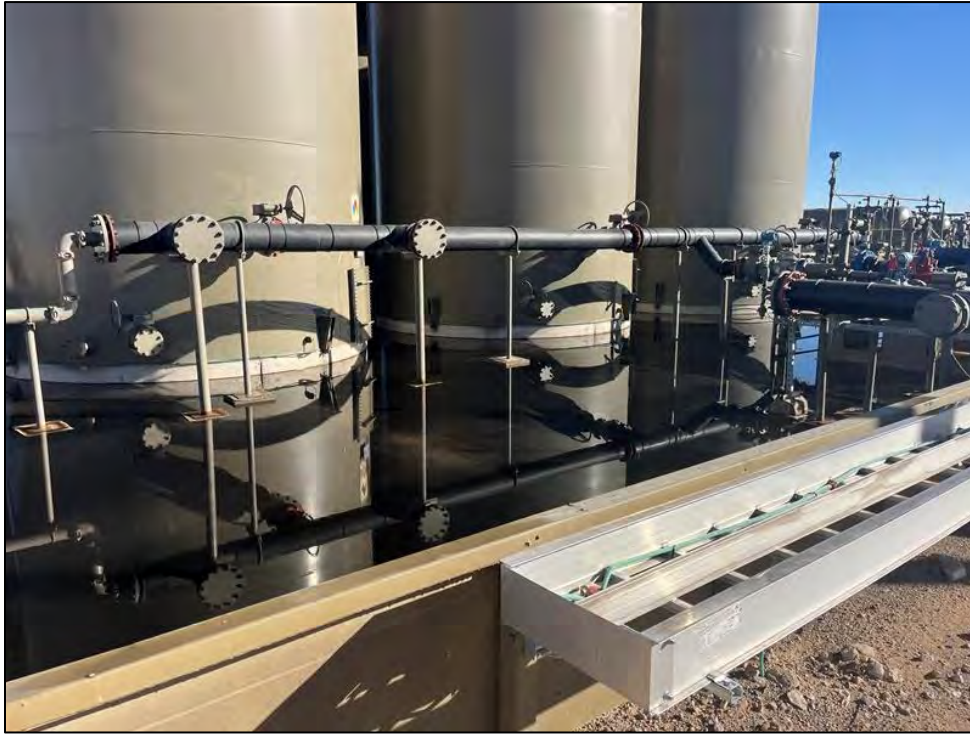
On December 31, 2024, threads on a piping connection failed, causing the release of approximately 43 barrels (bbl) of produced water within a lined secondary containment, where 1 bbl of produced water was blown out by wind onto the Devon operated production pad. A vacuum truck was immediately dispatched to the Site and recovered 42 bbl of fluids. ESRR conducted initial site assessment activities and mapped the observed release footprint on January 8, 2025, hereafter referred to as the Area of Concern (AOC) (**Figure 2**). Devon gave notice to the New Mexico Oil Conservation Division (NMOCD) on January 6, 2025, by Notification of Release (NOR) and was subsequently assigned Incident Number nAPP2500624157. A Corrective Action Form C-141 (Form C-141) was submitted on January 14, 2025.

PHOTO 1: Southeastern view during initial site assessment by Devon. 12/31/2024

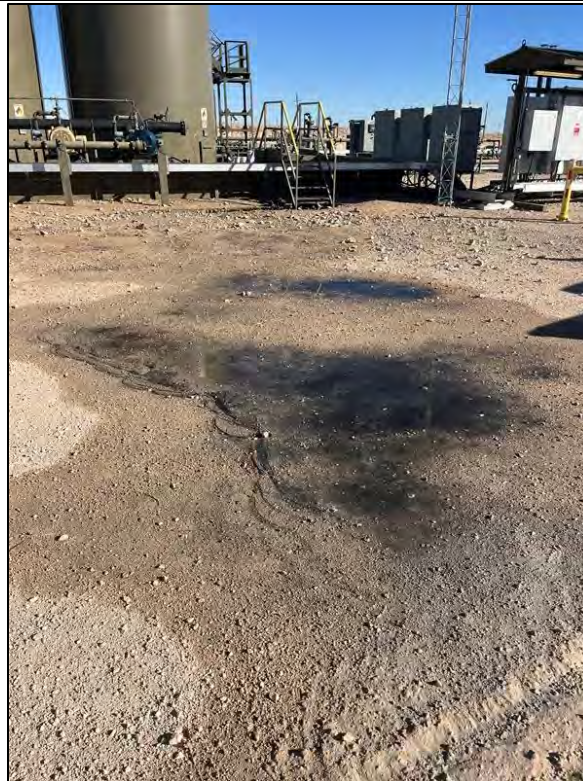
PHOTO 2: Southwestern view during initial site assessment by Devon. 12/31/2024

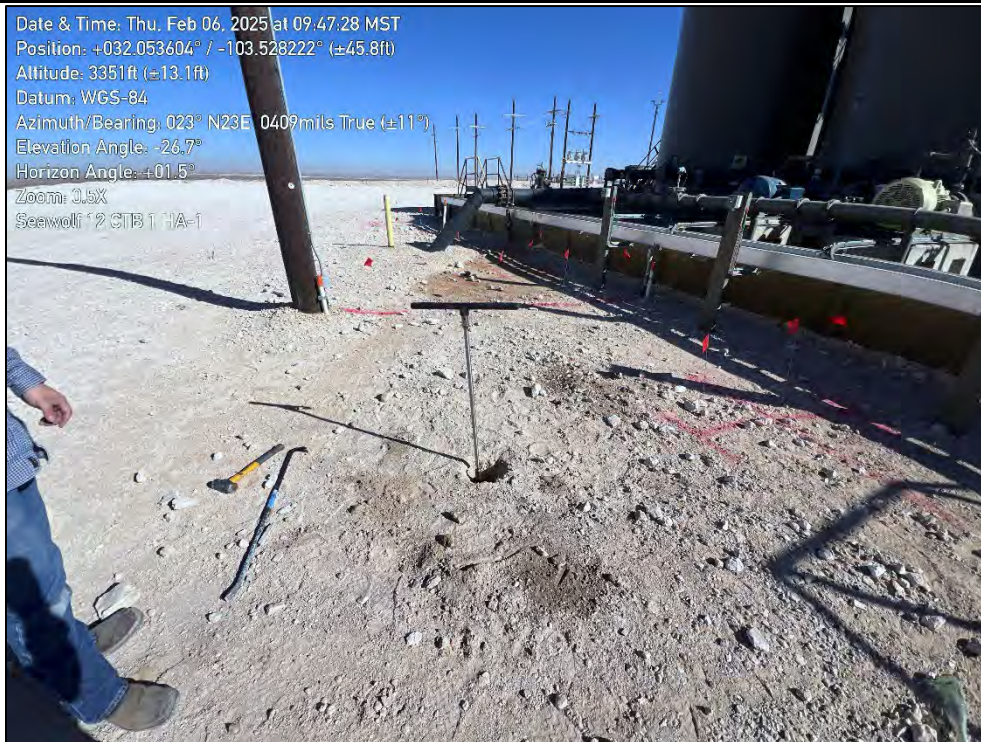
PHOTO 3: Northeastern view of delineation borehole during delineation sampling by ESRR. 2/6/2024

On February 6, 2025, ESRR conducted initial delineation activities to assess the presence or absence of residual soil impacts associated with the AOC. Six delineation boreholes (HA-1 through HA-6) were advanced to 1-foot below grade surface (bgs) via hand auger within and surrounding the AOC. Delineation activities were driven by field screening soil for chloride utilizing QuanTab® test strips. A minimum of two soil samples were collected from each delineation borehole, representing the highest observed field screening concentrations and the greatest depth. Delineation soil samples were placed directly into pre-cleaned jars, packed with minimal void space, labeled, and placed on ice. The delineation soil samples were transported under strict chain-of-custody procedures, to Eurofins in Carlsbad, New Mexico, for analysis of the COCs. **Photographic Documentation** of all activities are attached.

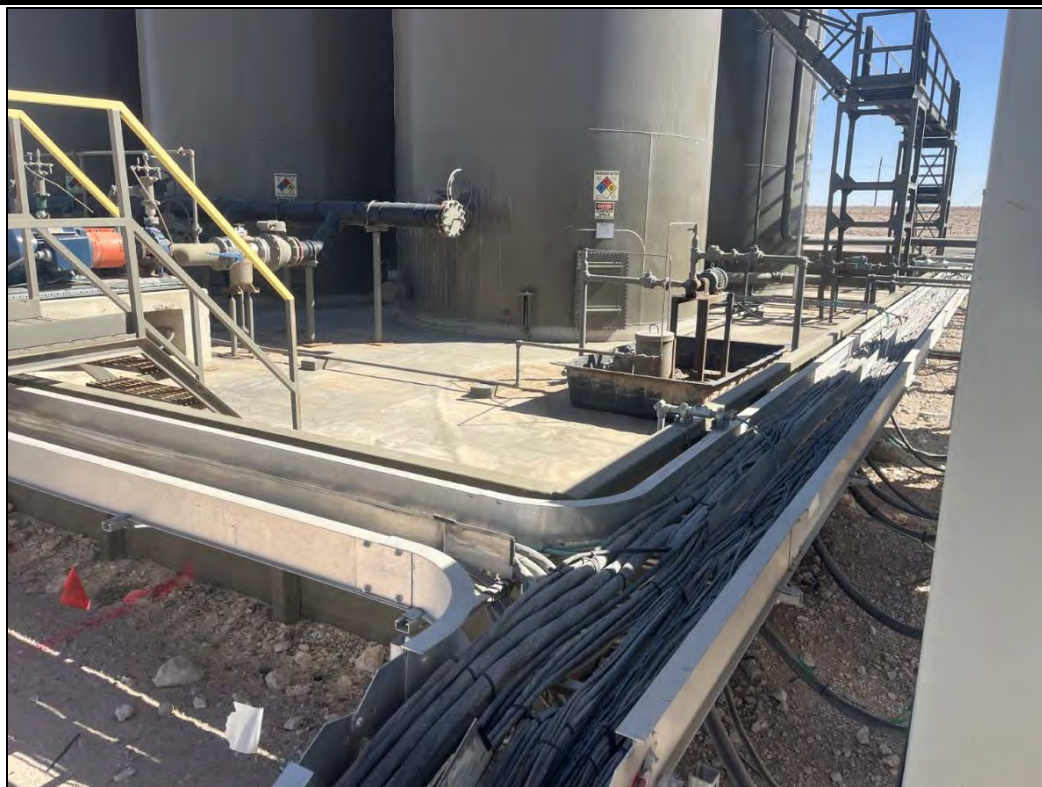
On March 5, 2025, ESRR conducted a thorough visual inspection of the LSC and found no tears, cracks, cuts, breaks, or other signs of damage within the LSC (**Figure 2**), confirming no evidence of a breach of the LSC. As a result, impacts to the production pad appear to have occurred due to windblown overspray of fluids from the LSC. **Photographic Documentation** of liner inspection activities is attached.

PHOTO 8: Northeastern view outside of containment during liner inspection activities. 3/5/2025

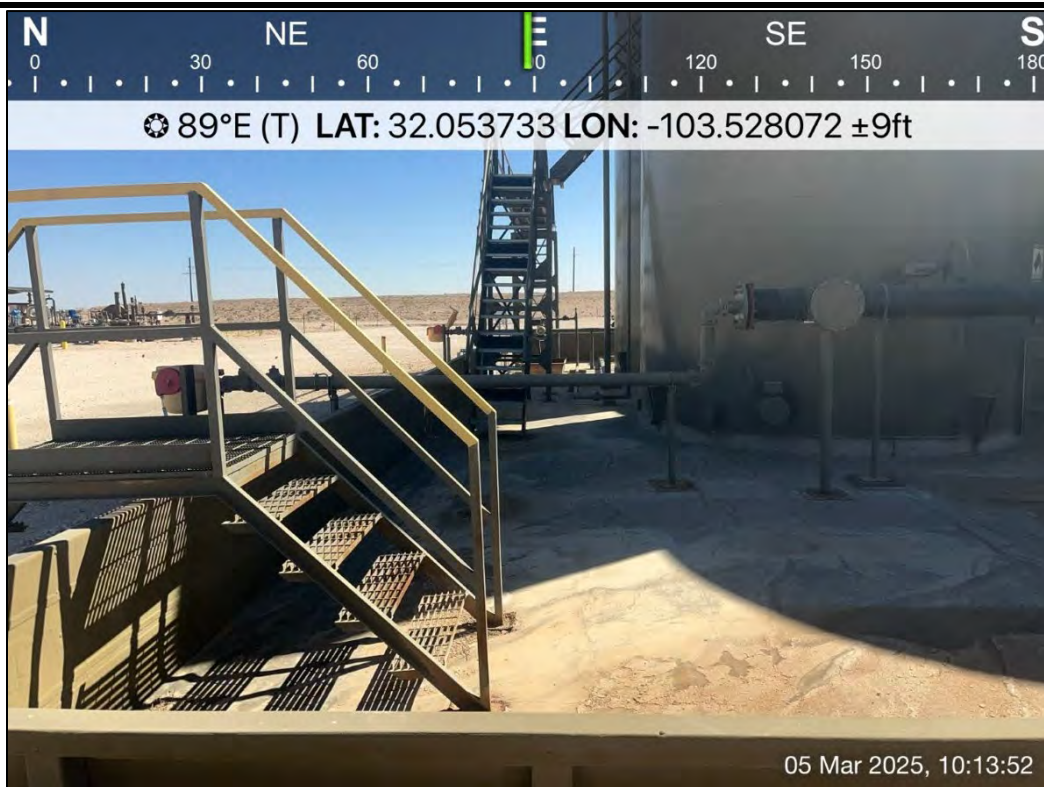
PHOTO 15: Eastern view during liner inspection activities. 3/5/2025

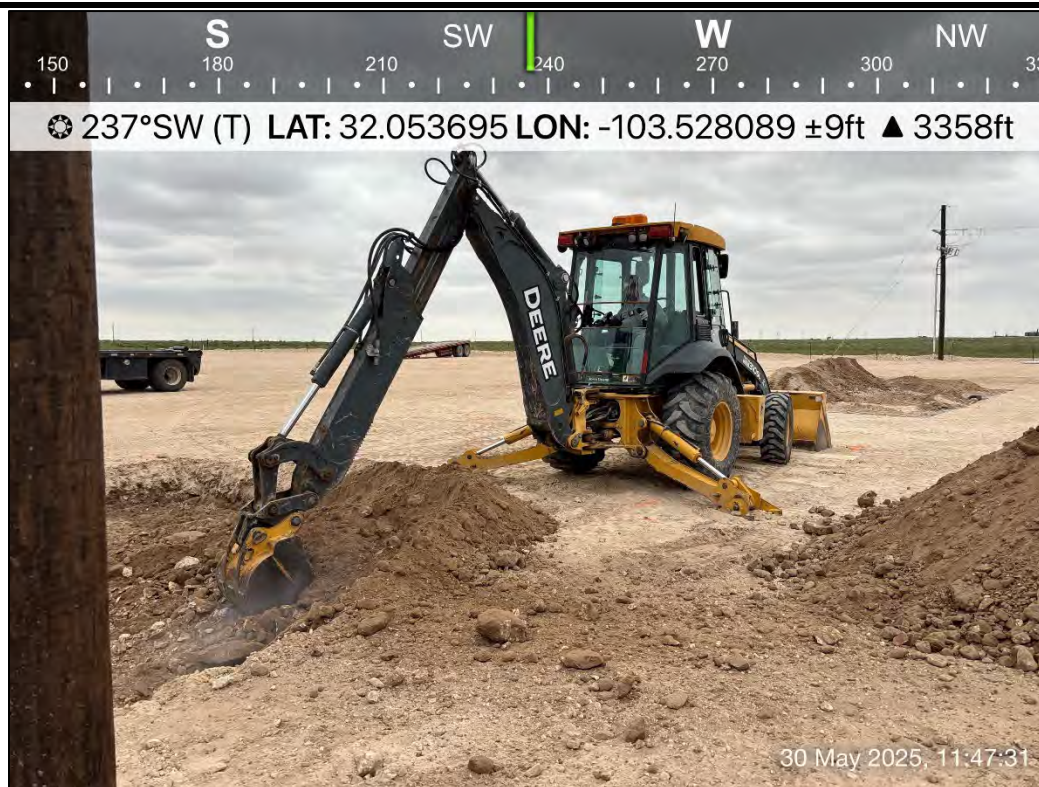
PHOTO 25: Southwestern view during excavation activities. 5/30/2025

During May 30, 2025, ESRR oversaw excavation activities of identified soil impacts performed via mechanical equipment based on laboratory analytical results associated with delineation soil sampling activities and visual observation. The excavation was vertically advanced to a depth of approximately 2-feet bgs.

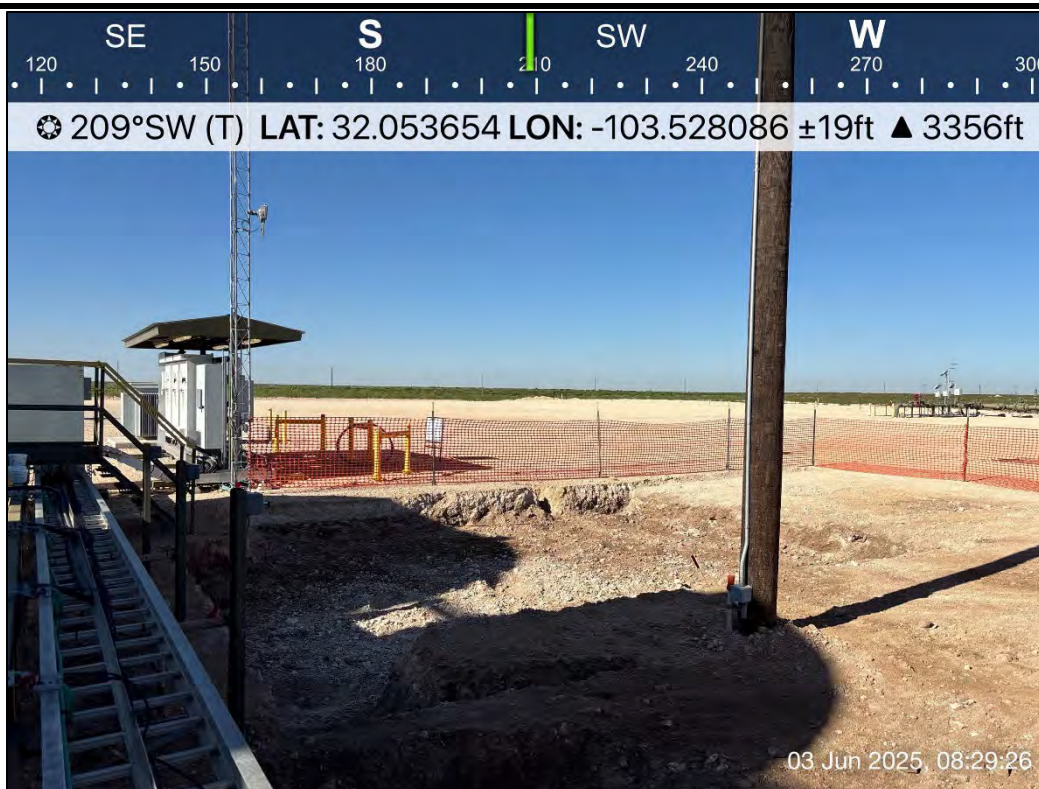
PHOTO 26: Southwestern view of excavation extent. 6/3/2025

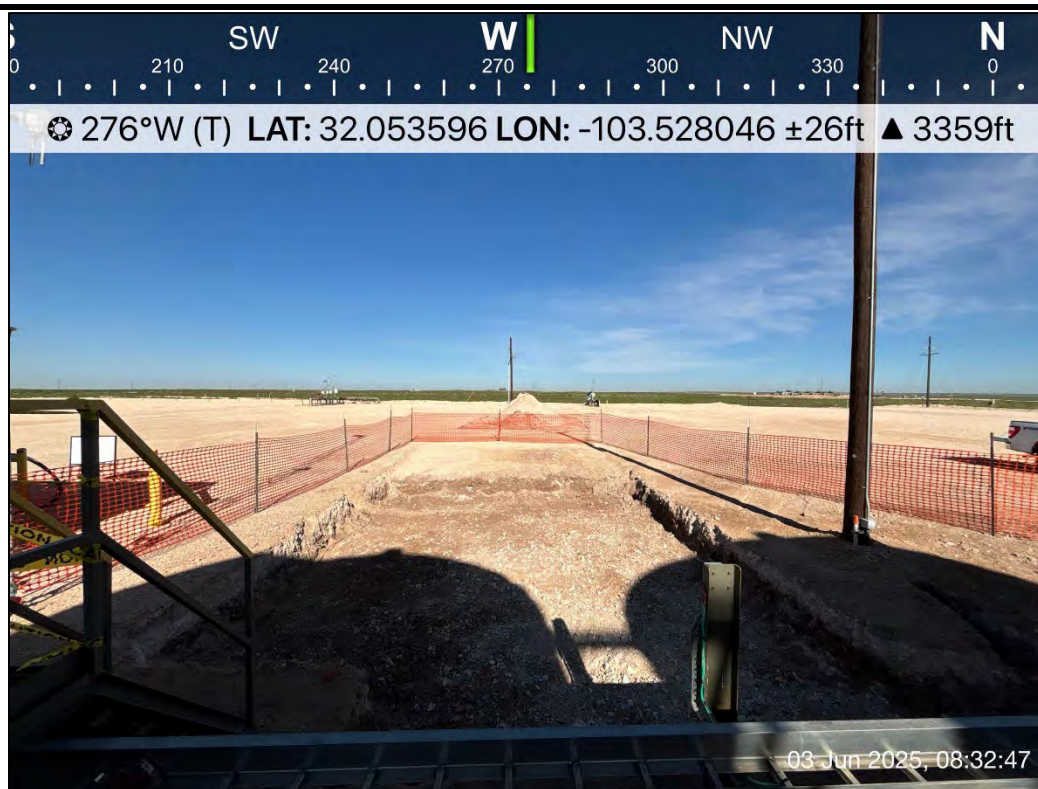
PHOTO 27: Northwestern view of excavation extent. 6/3/2025

Laboratory analytical results indicated that the concentration of COCs for all final confirmation soil samples were below the applicable Site Closure Criteria and/or reclamation standard. Laboratory results are summarized in **Table 1**, included in the attachments. The locations of all final confirmation soil samples are shown in **Figure 3**.
