**Re: 2025 Closure Request Addendum
James Ranch Unit #017
Incident Number NAB1627451198
Eddy County, New Mexico**

XTO Energy, Inc.
Closure Request Addendum
James Ranch Unit 17

XTO Energy, Inc.
James Ranch Unit 17 Battery
Incident Number: NAB1627451198
Unit F, Section 6, Township 23 South, Range 31 East
Eddy County, New Mexico

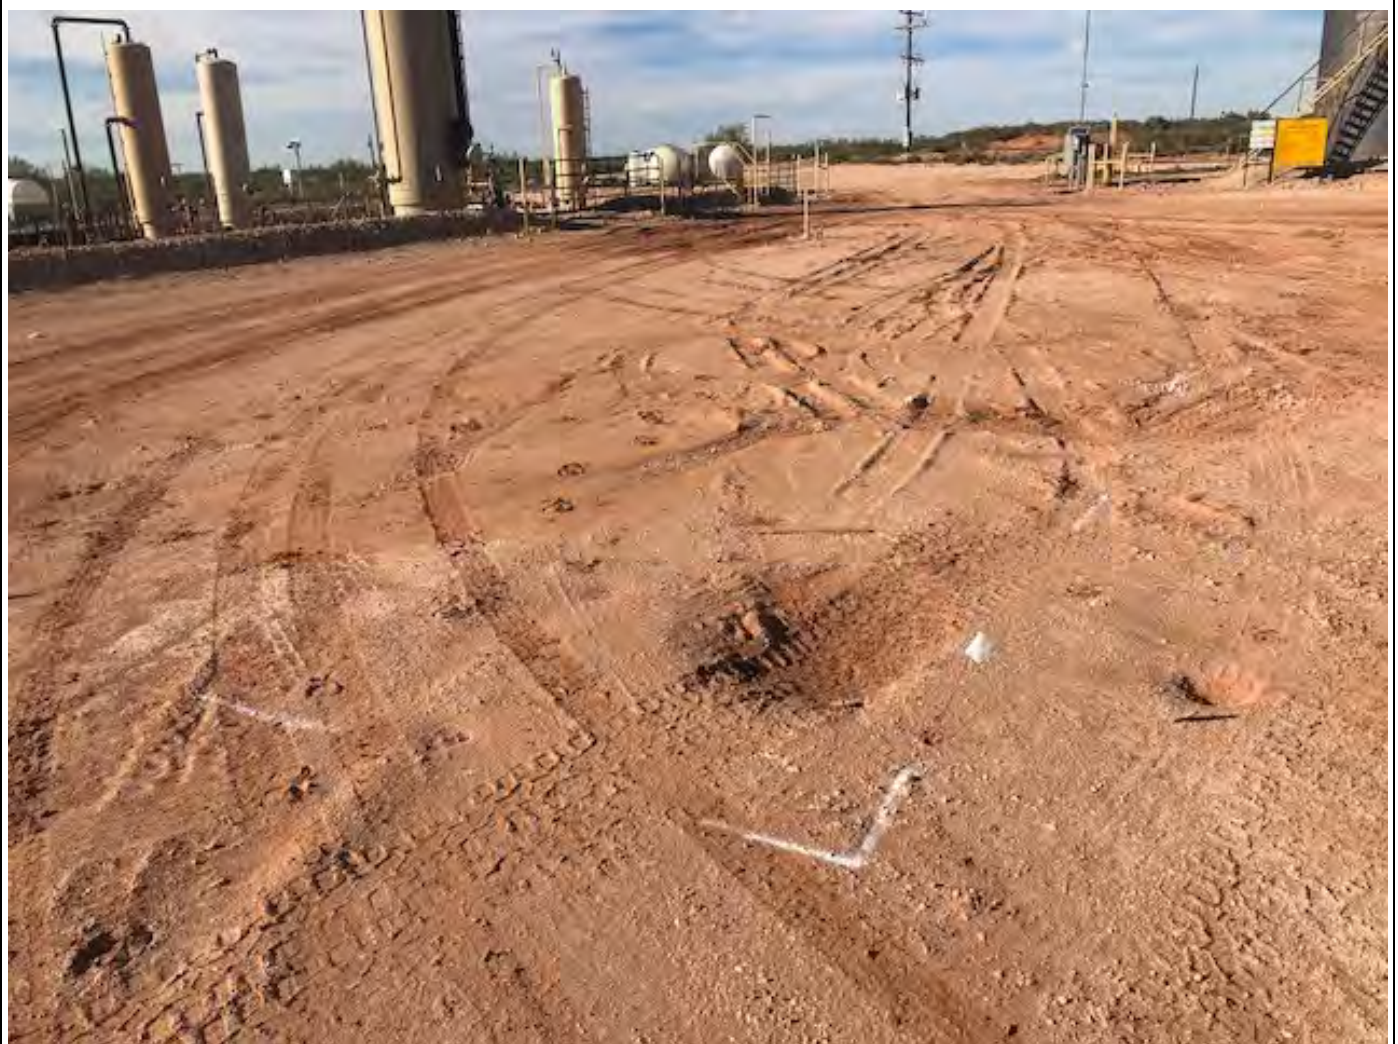
View northwest of release area and processing equipment.

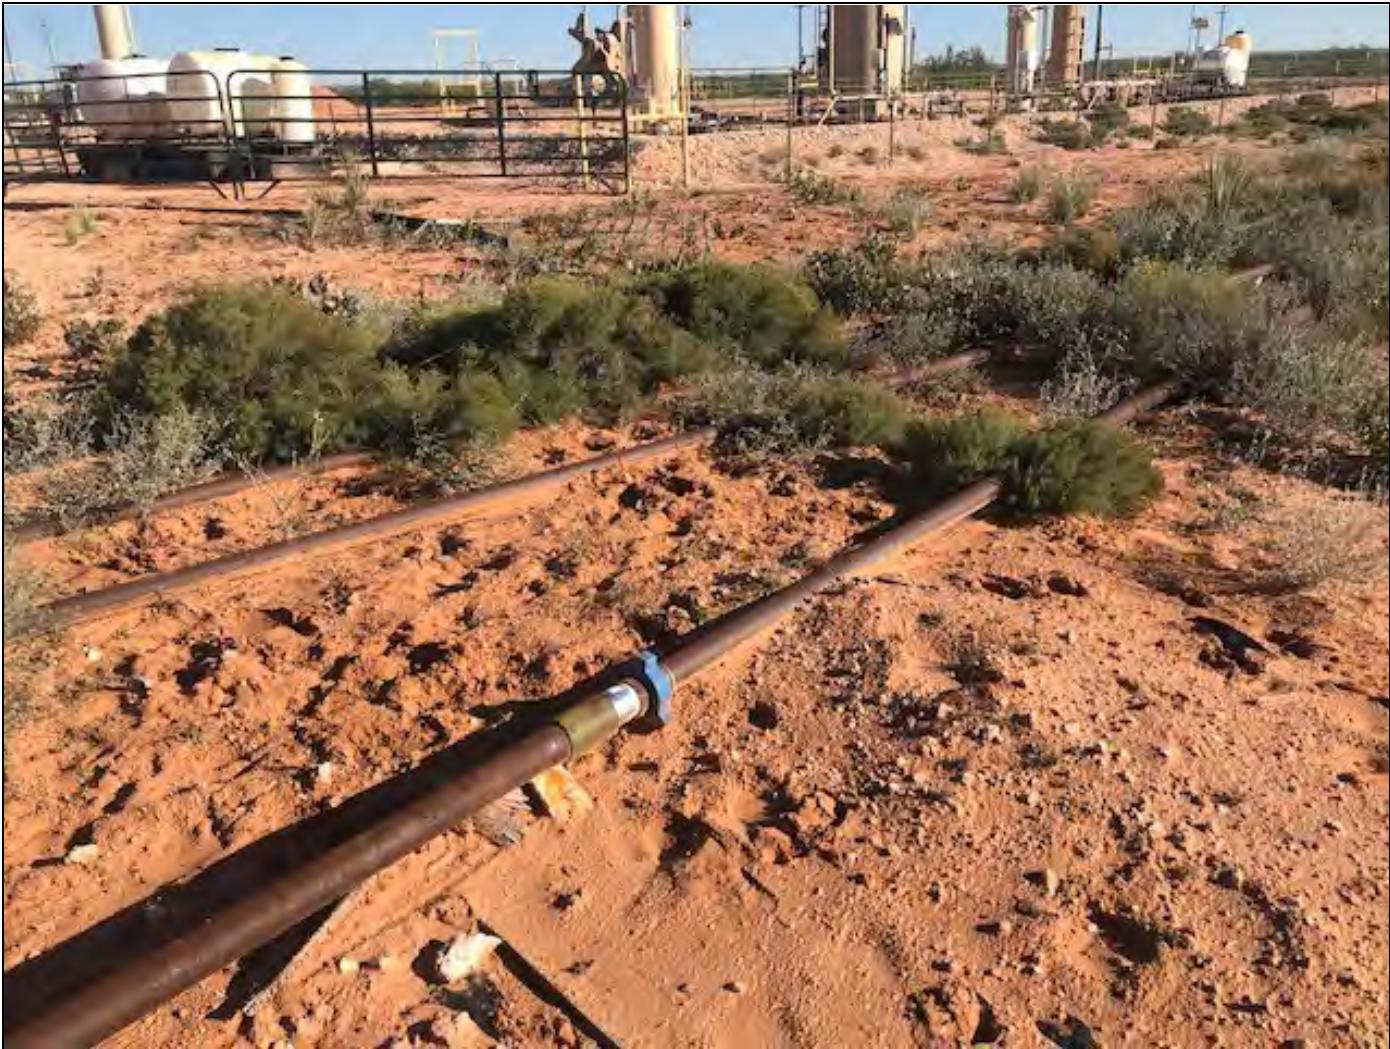
View southeast from the pasture of flow lines and processing equipment.

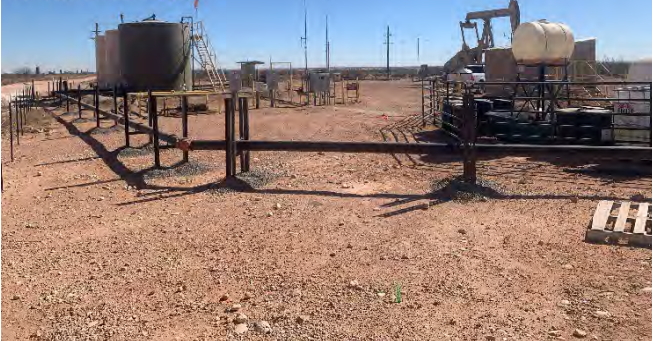
Photograph 1 Date: 01/22/2024
Description: SS05 sampling area and new piping
View: Southeast

Date & Time: Mon, Jan 22, 2024 at 11:42:39 MST
Position: +032.335477° / -103.818901° (±14.0ft)
Altitude: 3319ft (±10.4ft)
Datum: WGS-84
Azimuth/Bearing: 139° S43E 2236mils True (±14°)
Elevation Angle: -02.6°
Horizon Angle: -01.3°
Zoom: 1.0X
JRU 17, SS05 area and new piping.

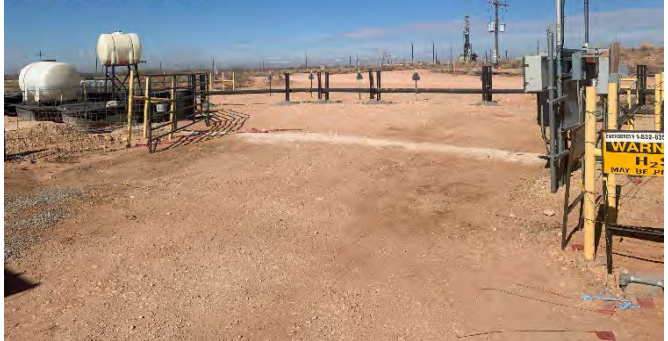
Photograph 2 Date: 01/22/2024
Description: SS05 sampling area and new piping
View: Northwest

Date & Time: Mon, Jan 22, 2024 at 11:41:33 MST
Position: +032.335547° / -103.818901° (±1400.9ft)
Altitude: 3333ft (±6.1ft)
Datum: WGS-84
Azimuth/Bearing: 323° N37W 5742mils True (±14°)
Elevation Angle: -01.6°
Horizon Angle: -01.8°
Zoom: 1.0X
JRU 17, SS05 area and new piping.

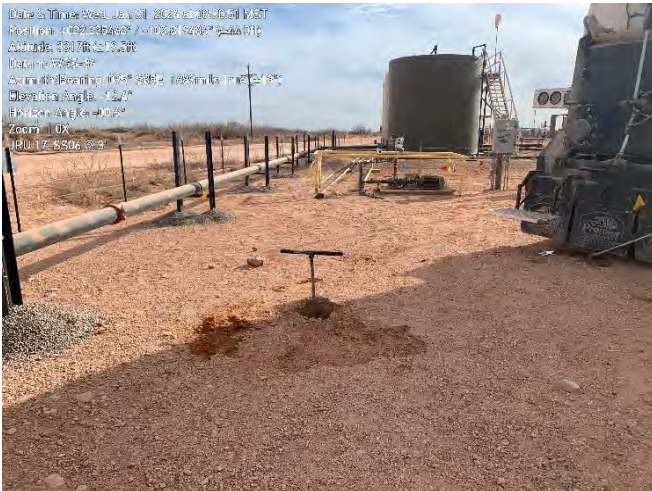
Photograph 3 Date: 01/31/2024
Description: SS06 sampling location
View: East

Date & Time: Wed, Jan 31, 2024 at 08:26:51 MST
Position: +032.335455° / -103.818659° (±1151.6ft)
Altitude: 3301ft (±10.4ft)
Datum: WGS-84
Azimuth/Bearing: 162° S88E 1250mils True (±14°)
Elevation Angle: -02.6°
Horizon Angle: -02.6°
Zoom: 1.0X
JRU 17, SS06 area.

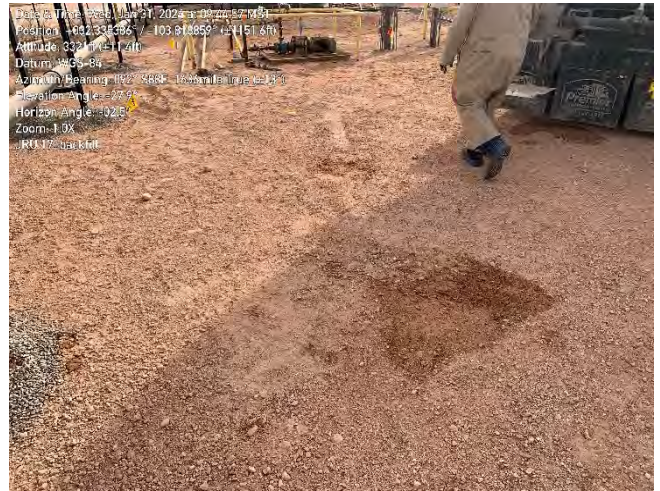
Photograph 4 Date: 01/31/2024
Description: Backfilled SS06 sampling location
View: East

Date & Time: Wed, Jan 31, 2024 at 08:26:57 MST
Position: +032.335455° / -103.818659° (±1151.6ft)
Altitude: 3301ft (±10.4ft)
Datum: WGS-84
Azimuth/Bearing: 162° S88E 1250mils True (±14°)
Elevation Angle: -02.6°
Horizon Angle: -02.6°
Zoom: 1.0X
JRU 17, SS06 area.
