CLOSURE REQUEST REPORT

Flagler 8 CTB 1

Incident Number nAPP2328556508

*Unit M, Section 8, Township 25 South, Range 33 East
Lea County, New Mexico
(32.13873°, -103.59416°)*

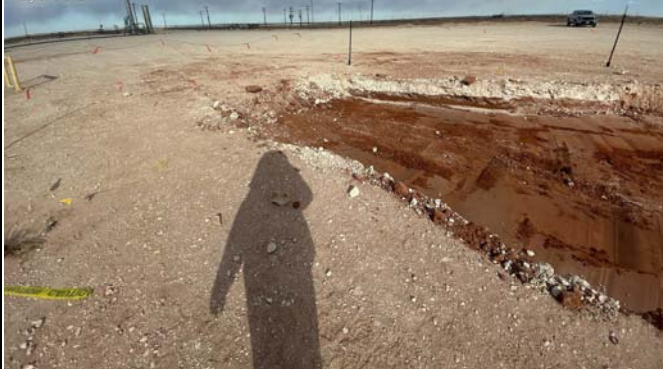
**Photograph 1****Date: 01/23/2025**

Description: Northeastern view of excavation activities.

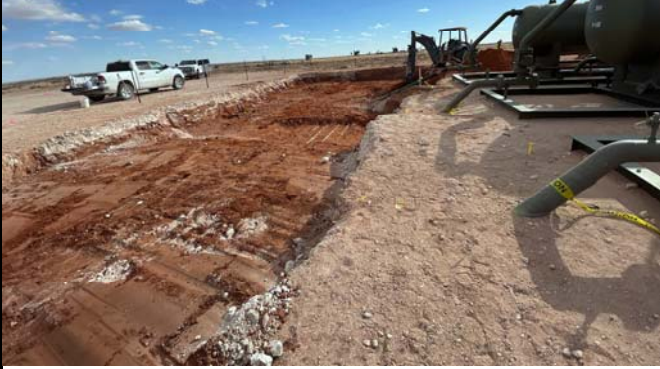
**Photograph 2****Date: 01/23/2025**

Description: Southeastern view of excavation activities.

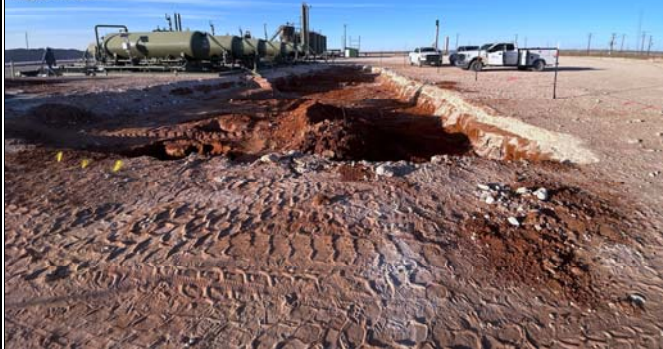
**Photograph 3****Date: 01/23/2025**

Description: Northern view of excavation activities.

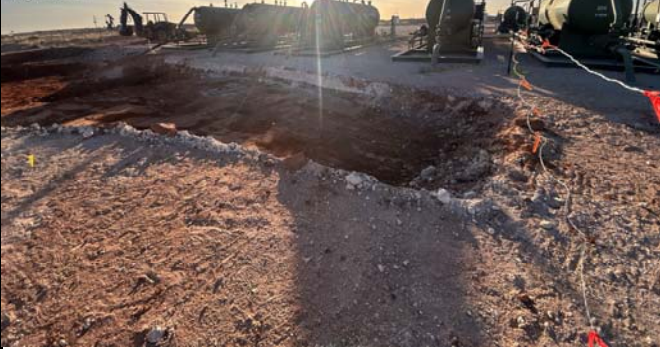
**Photograph 4****Date: 01/23/2025**

Description: Southwestern view of excavation activities.

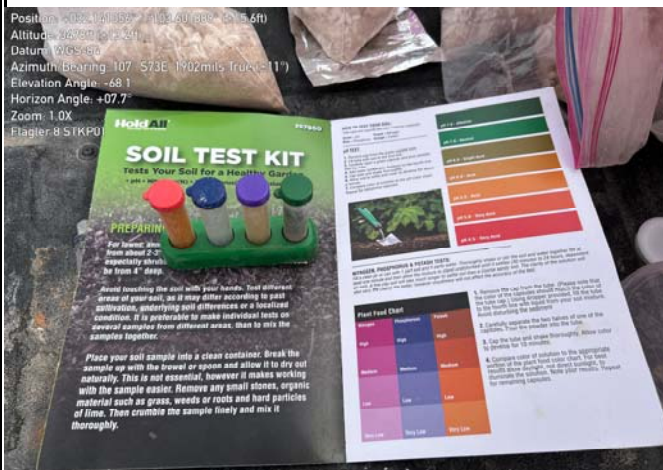
Photograph 5

Description: Results of the nutrient soil test for backfill STKP01 material.

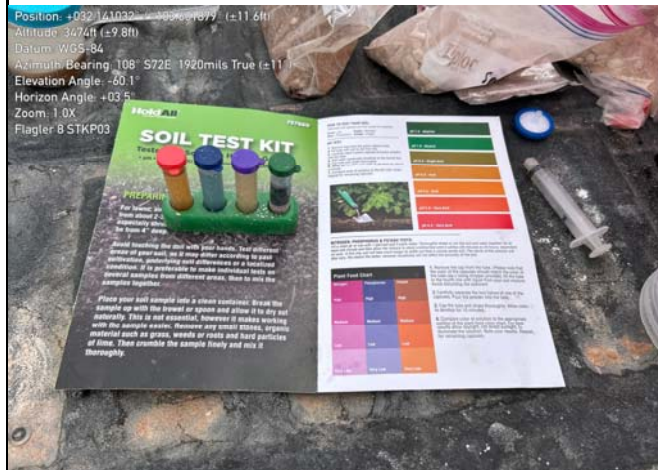
Photograph 6

Description: Results of the nutrient soil test for backfill STKP03 material.

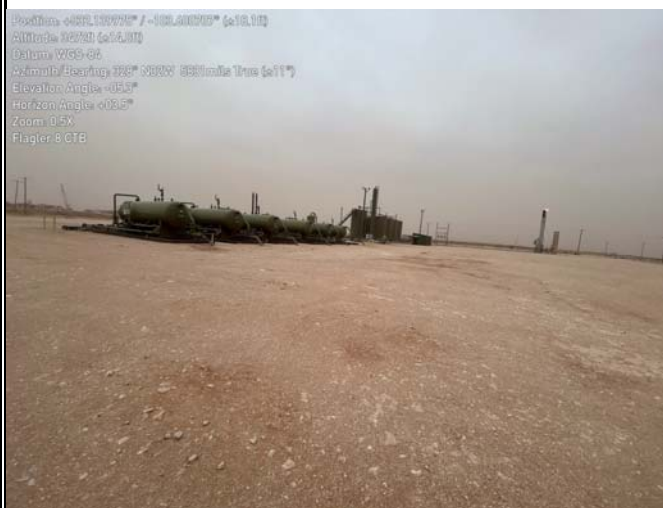
Photograph 7

Description: Northwestern view of completed restoration.
