CLOSURE REQUEST REPORT

Flagler 8 CTB 1

Incident Number nRM2014360340

Lea County, New Mexico

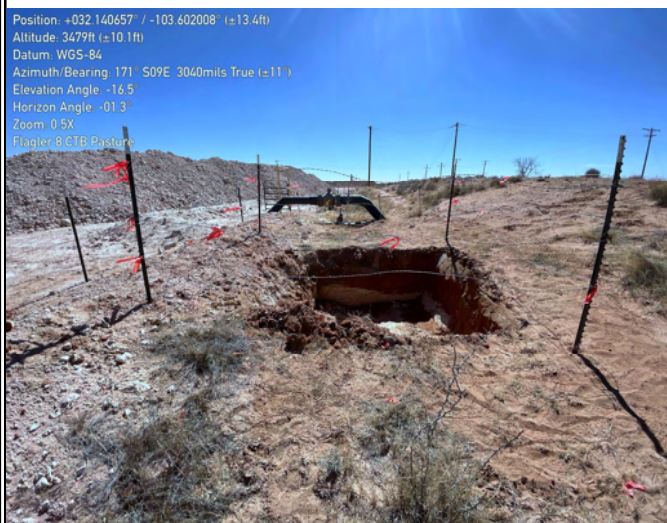
Photograph 1

Description: Southern view of excavation activities.

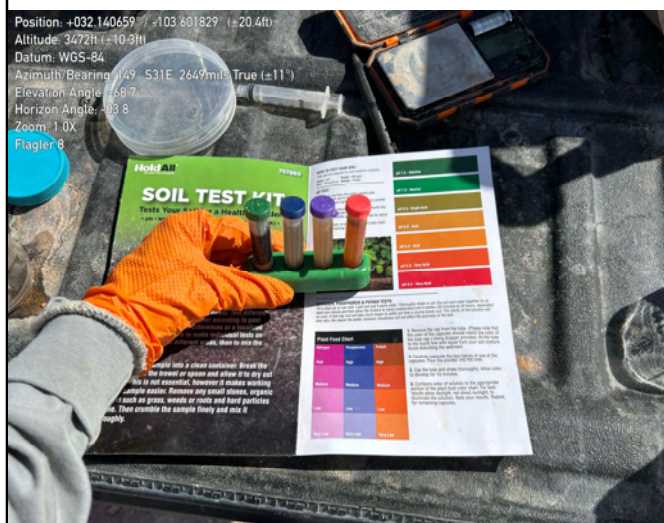
Photograph 2

Description: Southeastern view of backfill stockpile soil sample nutrient test results.

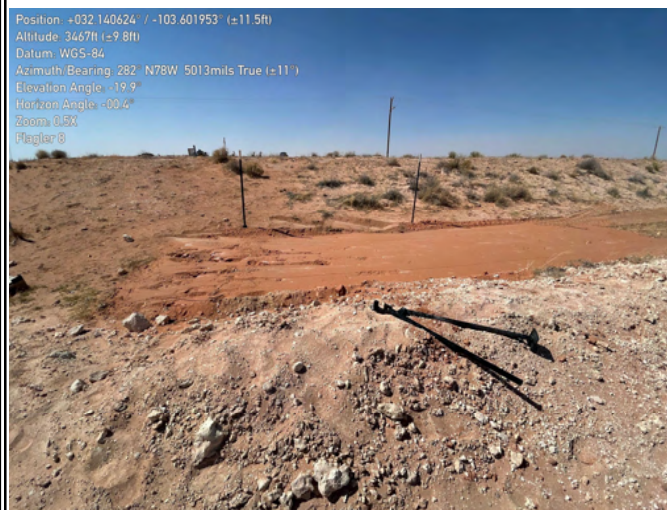
Photograph 3

Description: Description: Western view of completed restoration activities.

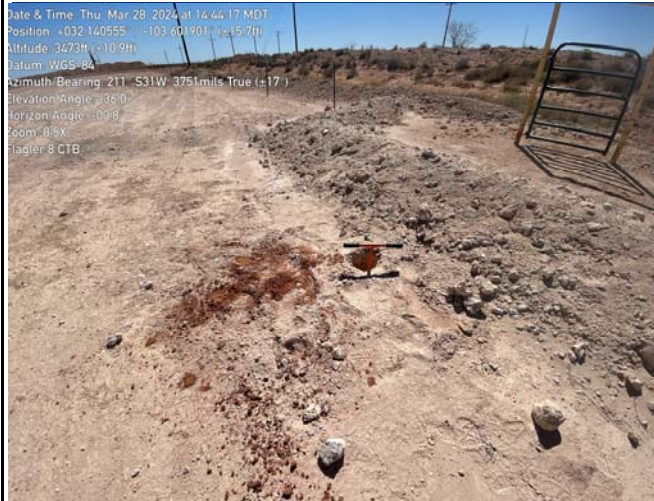
**Photograph 1****Date: 03/28/2024**

Description: Northeastern view of delineation activities.

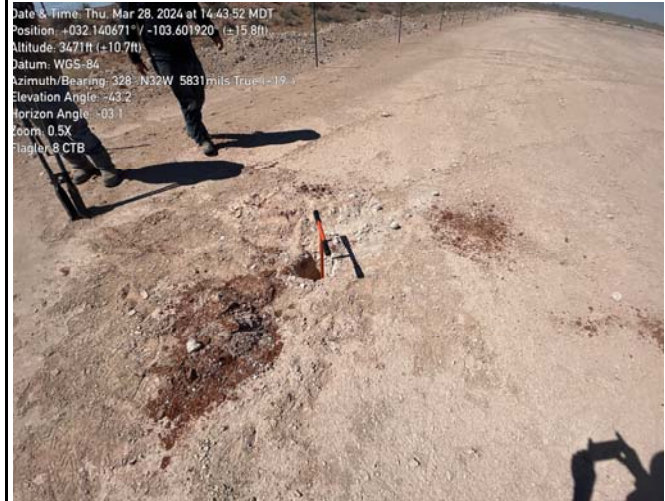
**Photograph 2****Date: 03/28/2024**

Description: Northwestern view of delineation activities.

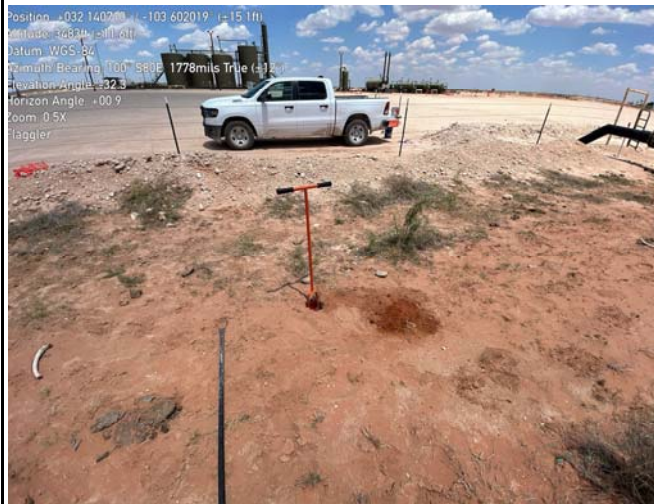
**Photograph 3****Date: 07/09/2024**

Description: Southeastern view of delineation activities.

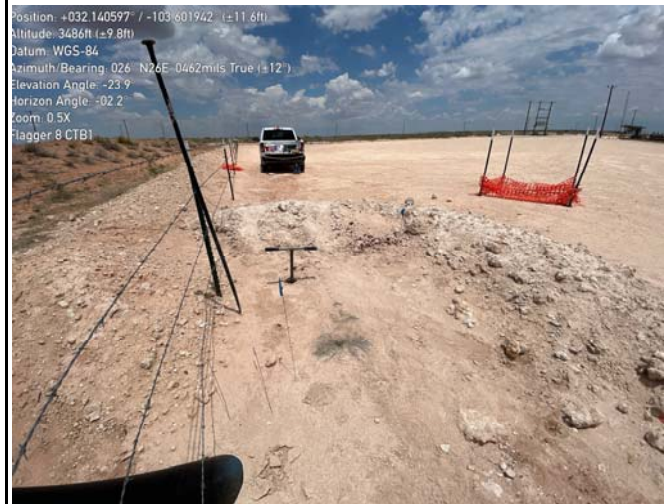
**Photograph 4****Date: 07/09/2024**

Description: Northeastern view of delineation activities.
