Soil Assessment and Closure Report

Gadwall 18 Federal Com #003
Incident# nJMW1234241521
Eddy County, New Mexico

Subject: **Soil Assessment and Closure Report**
Gadwall 18 Federal Com #003
Eddy County, NM

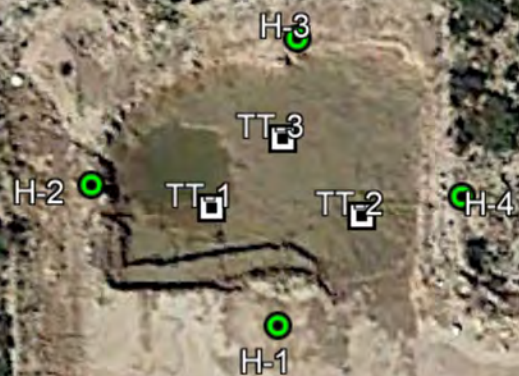
Cimarex Energy Co. of Colorado
Incident# nJMW1234241521
Eddy County, NM
Karst Potential Map

According to the soil survey provided by the United States Department of Agriculture Natural Resources Conservation Service, the soil in this area is made up of Reagan-Upton association, 0 to 9 percent slopes. The referenced soil data is attached in [Appendix II](#). Drainage courses in this area are typically dry. The project site is in a high Karst potential area (Karst Map, [Appendix I](#)).

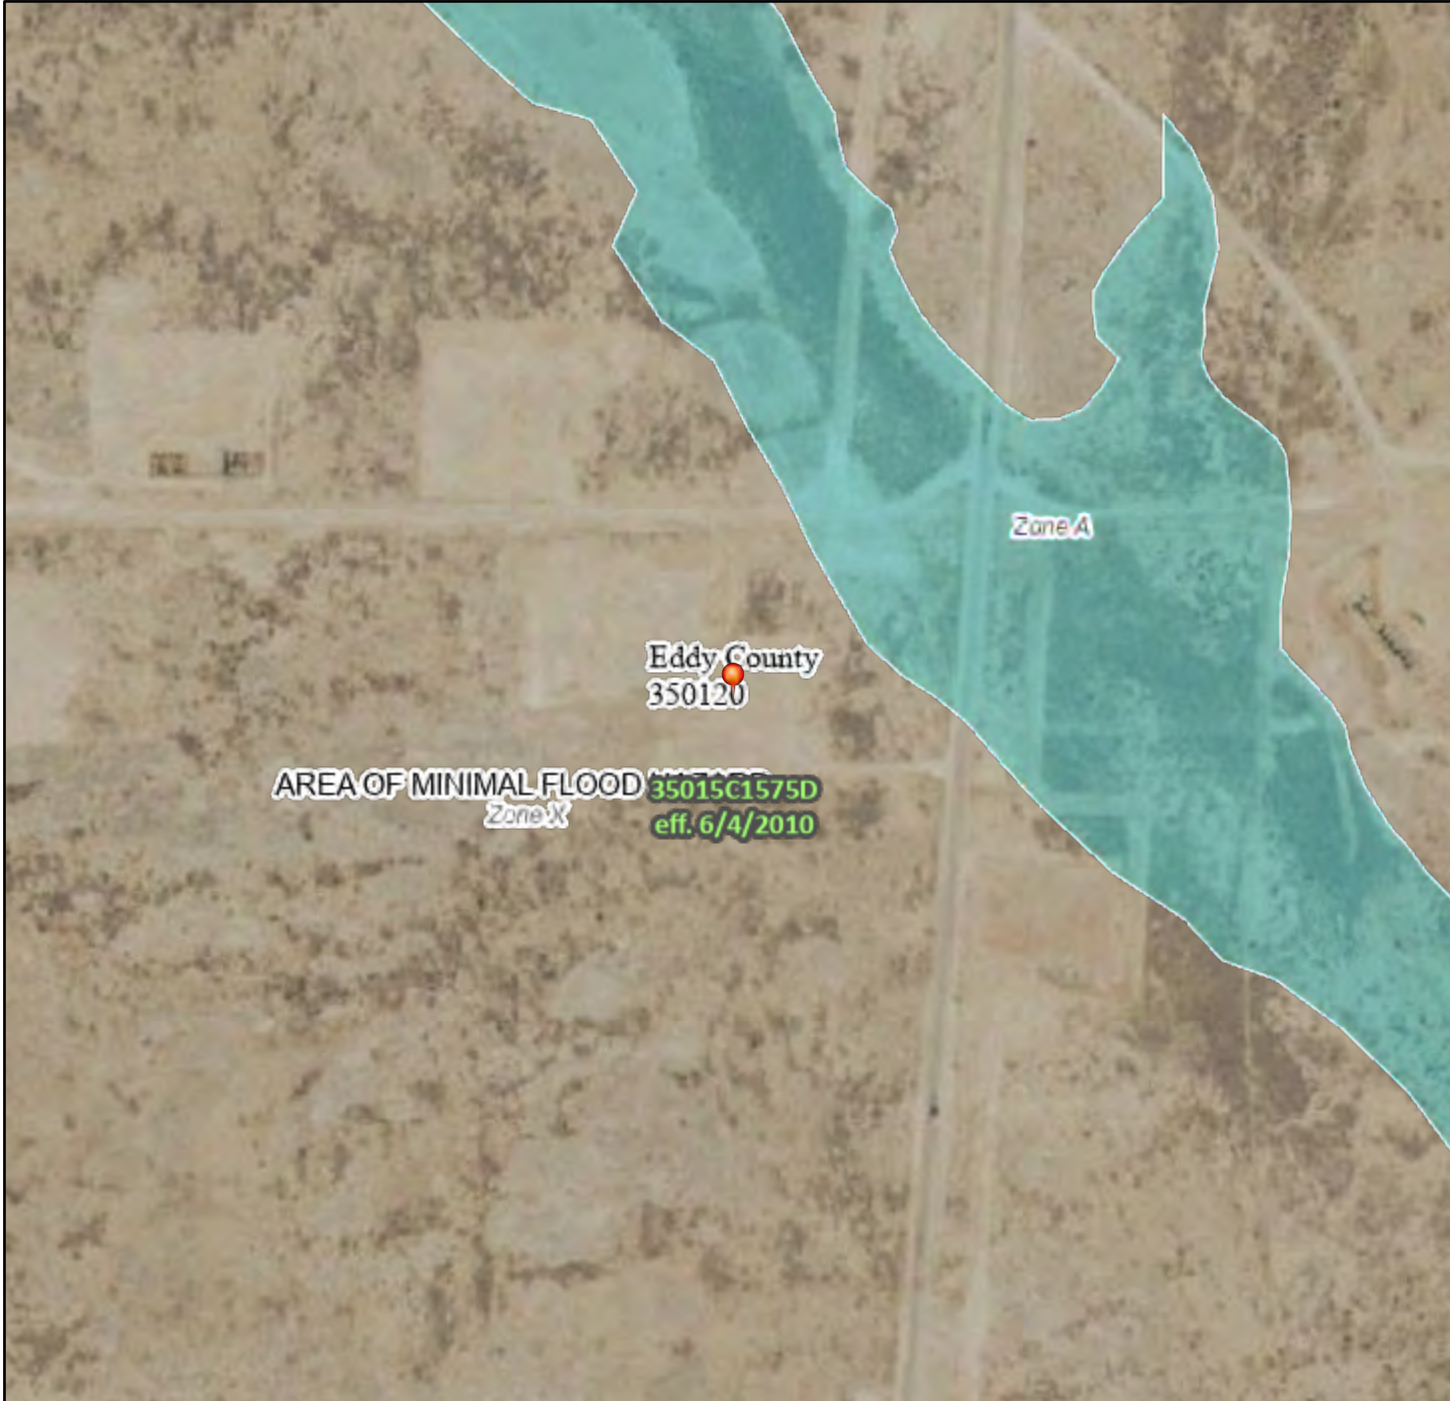
National Flood Hazard Layer FIRMette

The flood hazard information is derived directly from the authoritative NFHL web services provided by FEMA. This map was exported on 3/17/2025 at 7:36 PM and does not reflect changes or amendments subsequent to this date and time. The NFHL and effective information may change or become superseded by new data over time.

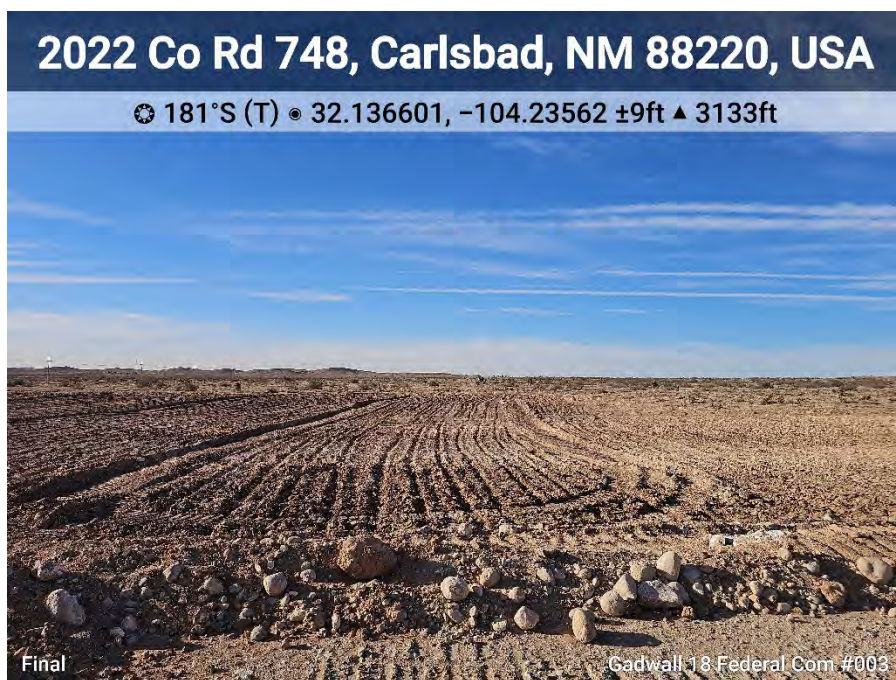
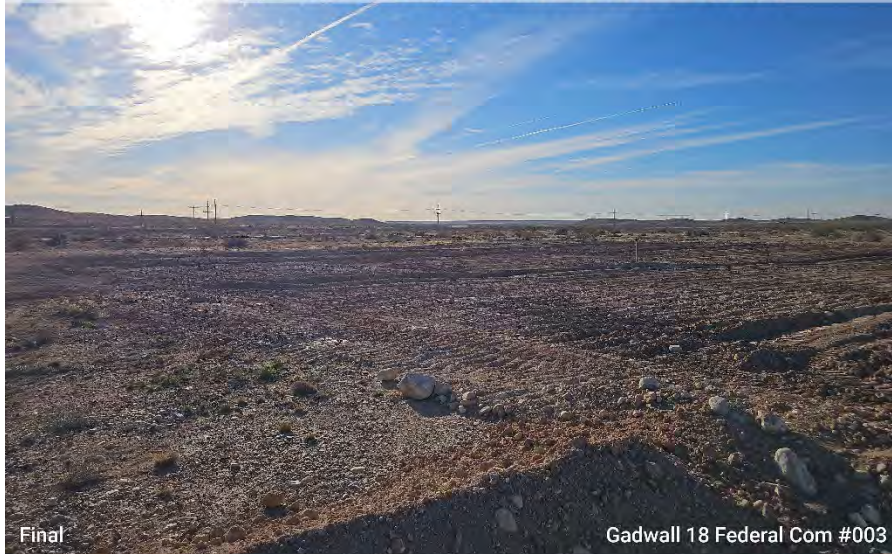
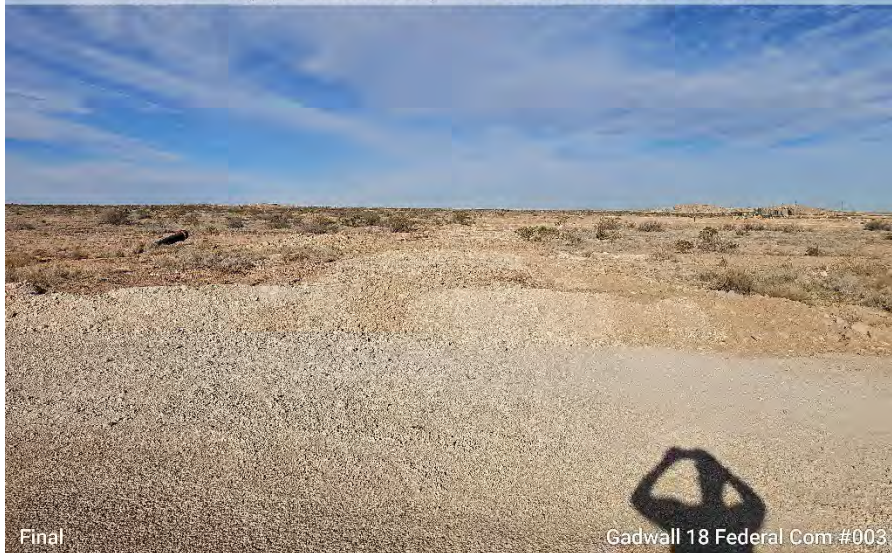
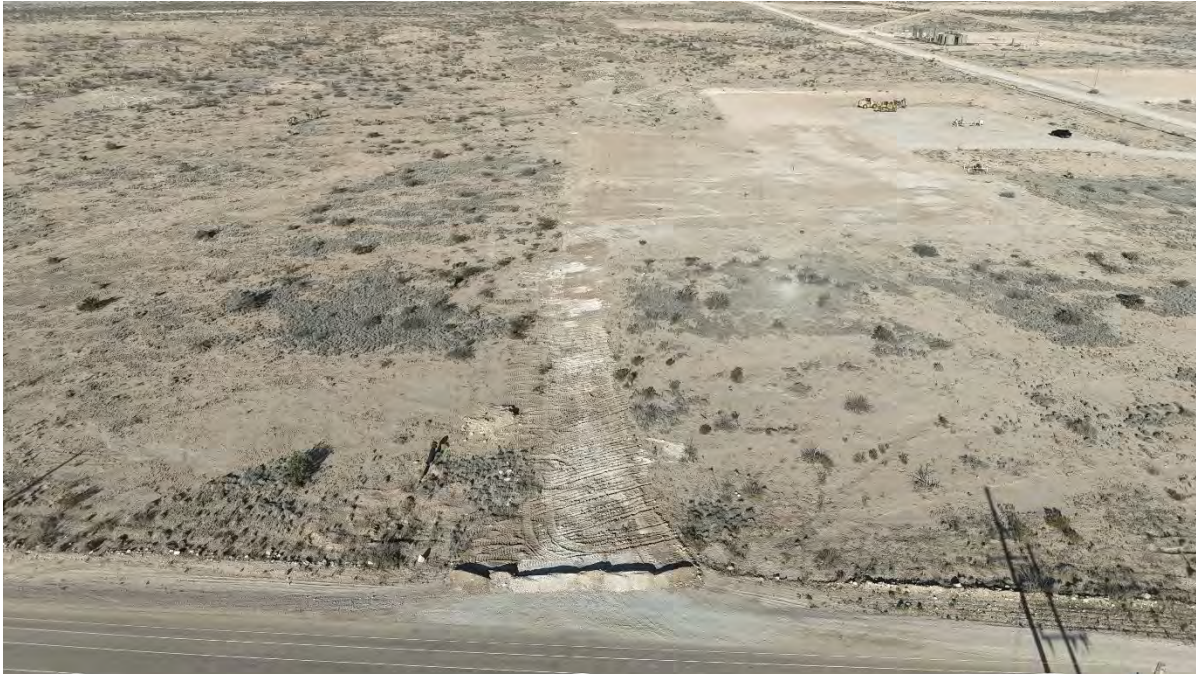
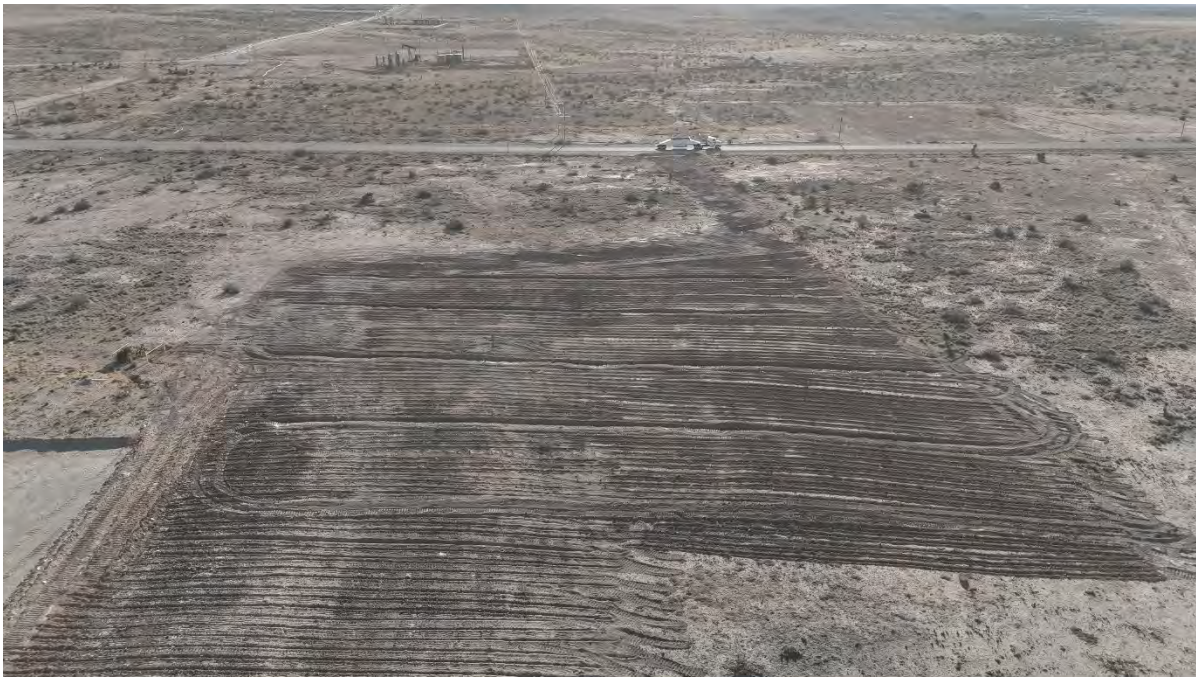
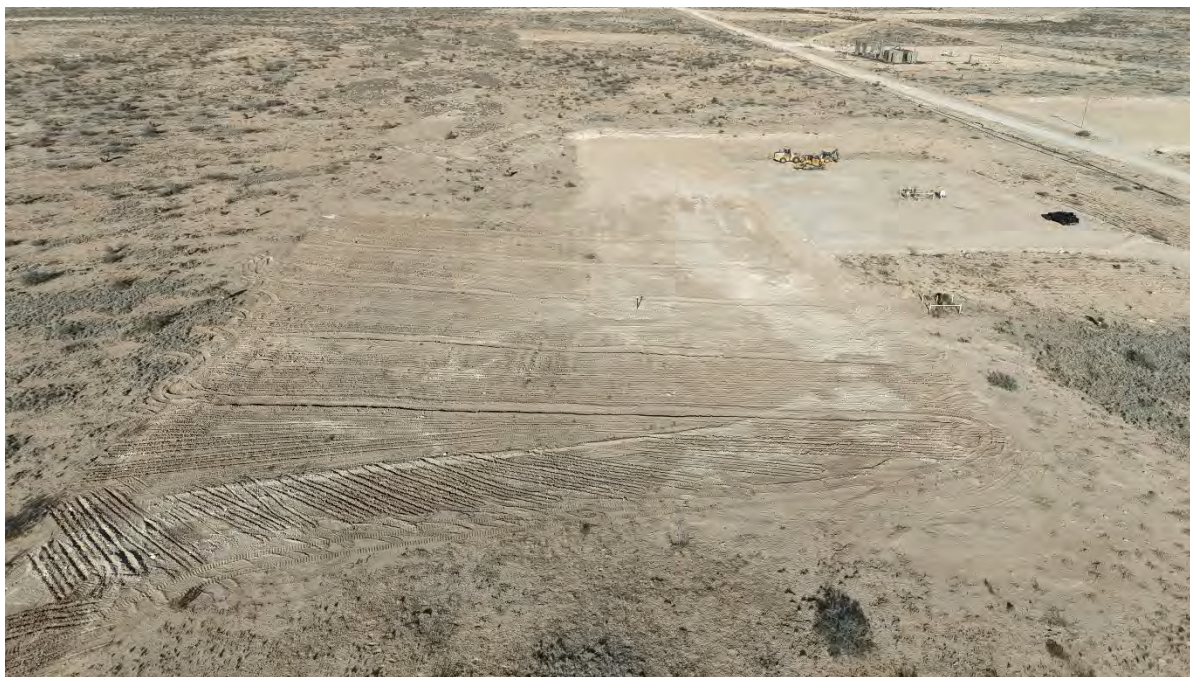
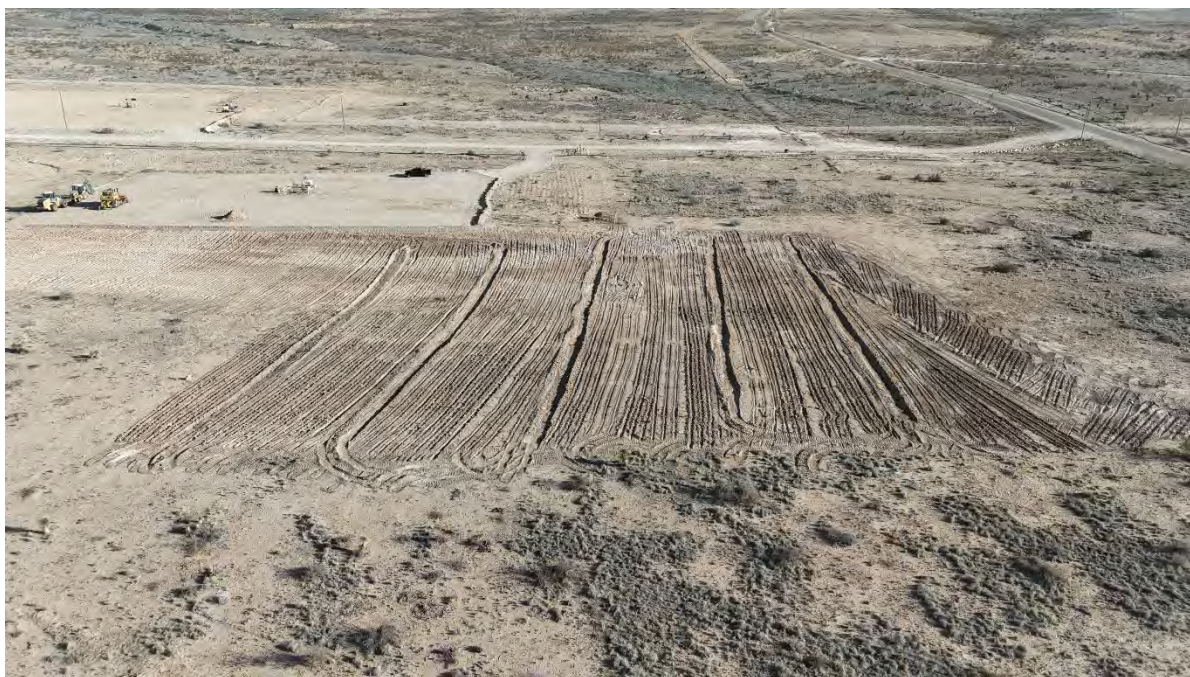
RECLAMATION PHOTOGRAPHS

This pad was reclaimed prior to remediation efforts beginning on the open incident but, it was not reclaimed to industry standards. Once the remediation efforts were completed, the entire pad as well as the access road were reclaimed and brought up to industry standards. Photographic documentation of the final reclamation are attached in [Appendix IV](#).
