Site Characterization Report and Remediation Workplan

April 28, 2025

**State BT N #001
Historical Release
API # 30-025-01012
Incident #nAPP2427382332
Lease No. E0-0026-13**

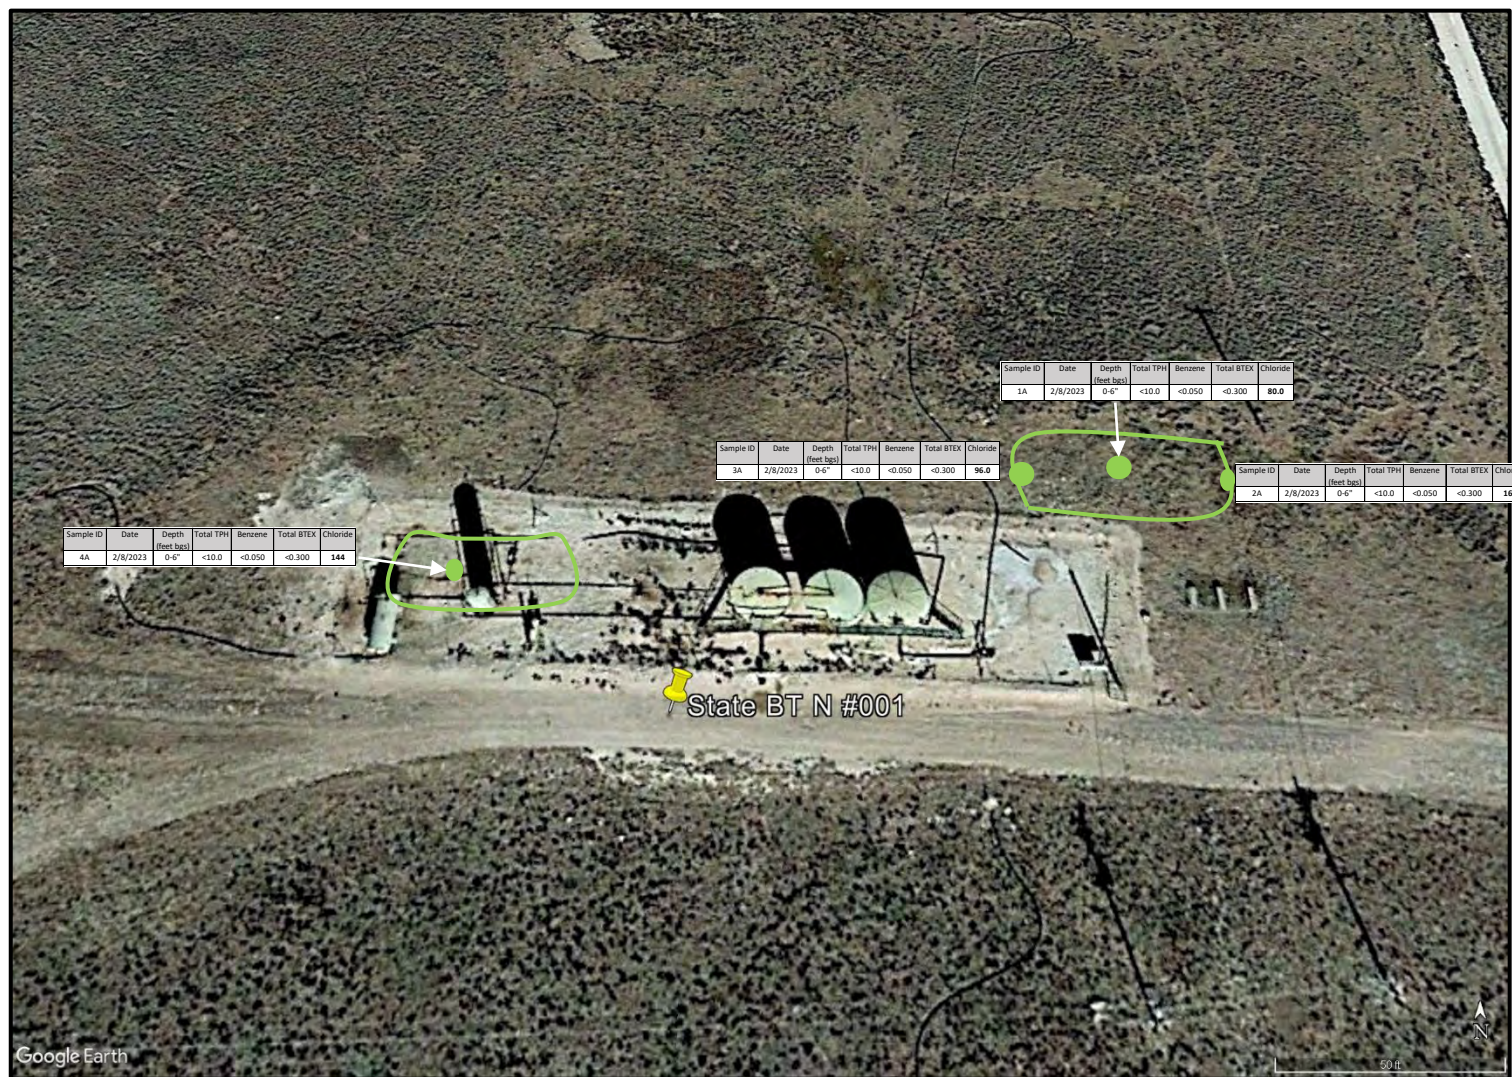
LEGEND:		Figure 2 Sample Location Map BXP Operating, LLC State BT N #001 Lea County, New Mexico

Treatment Boundary		Drafted by: CC Checked by: CC

Sample Location With Concentrations (mg/kg) and Depth (bgs)		Draft: April 28, 2025	
bgs:	Below ground surface		GPS: 33.316781° -103.594265°

As required by 19.15.29.11 NMAC, a scaled diagram showing significant Site infrastructure, sample point locations, and known subsurface features such as utilities is provided as Figure 2.

Table 1 provides a summary of the laboratory results, and sample locations with concentrations are provided on Figure 2. Appendix B provides a copy of the laboratory report and chain-of-custody documentation. Photographic documentation is provided in Appendix C.

BXP proposes to remove all treated soil from the 50' x 30' area north of the battery, and from the 40' x 17' area around the heater treater and collect five-point composite confirmation samples from the bottom (at a depth of 2' bgs) and sidewalls of the excavations at a rate of one sample per 200 square feet.

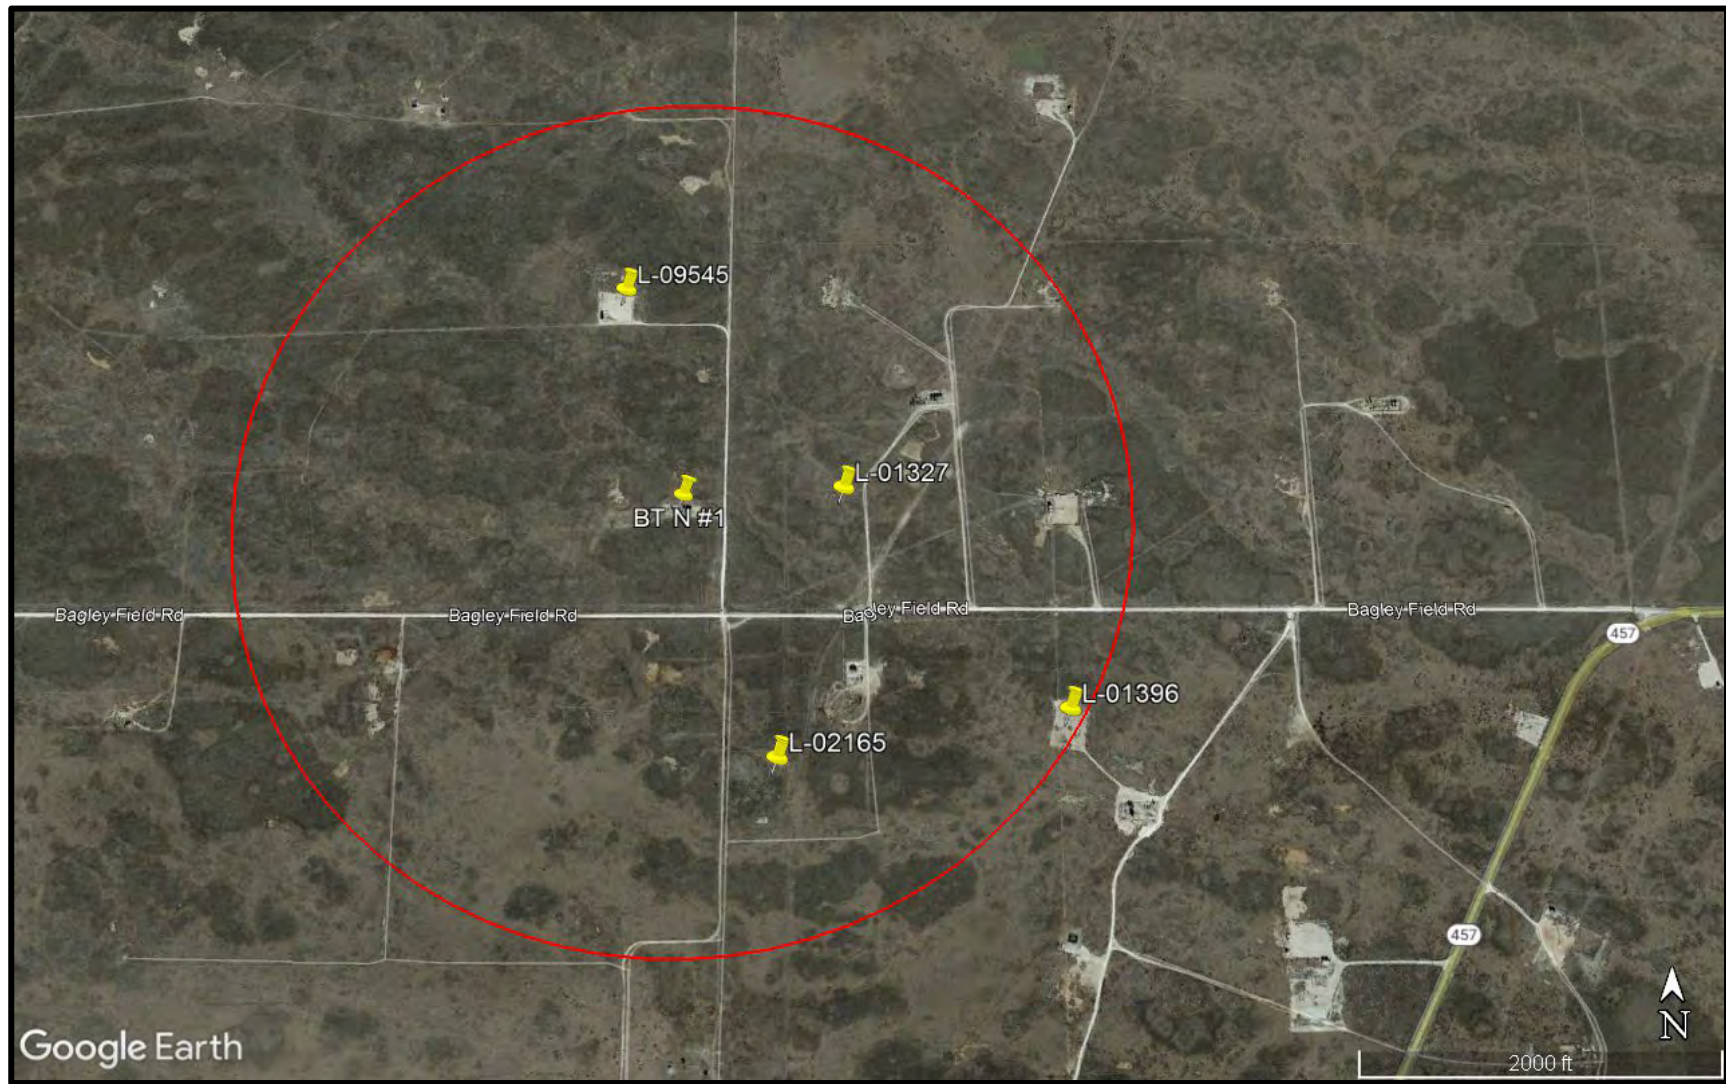
Figure 3

The 0.5-mile wellhead protection area is shown on Figure 3. As listed in the NMOSE database, there are four water wells within a 0.5-mile radius of the Site. There were no water sources, springs, or other sources of freshwater extraction identified within 0.5-mile of the Site.

Wellhead Protection Area Map
BXP Operating, LLC
State BT N #001
Lea County, New Mexico

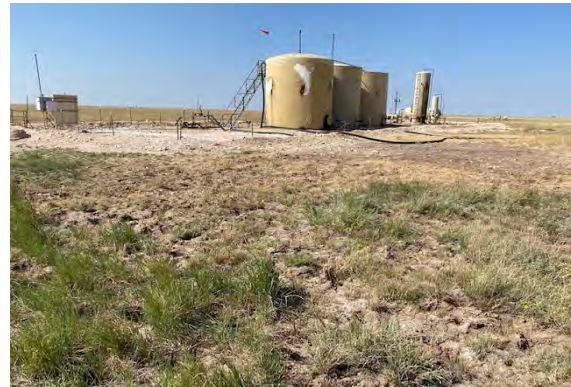
On September 2, 2021, BXP received a letter from the New Mexico State Land Office (SLO) that identified bare ground indicating a potential past spill, and that the fence around the battery was down. The fence was repaired in September of 2021. On February 3, 2023, a barren area was observed north of the battery that measured approximately 50' x 30' and covered a total area of approximately 1,500 square feet (ft²). An area of stained soil was also observed around the heater treater (40' x 17') within the battery. The areas of remediation are shown on Figure 2.

View of barren areas N and E of Tank Battery (9/2/21).

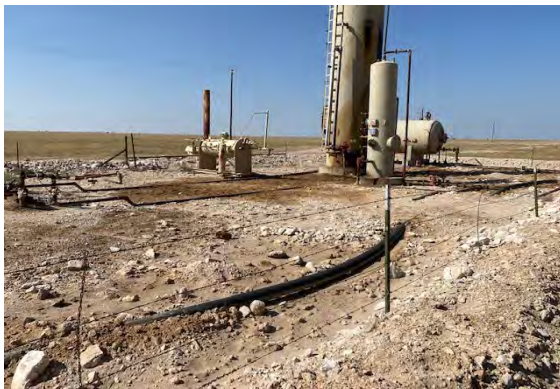
Soil staining around equipment (9/2/21).

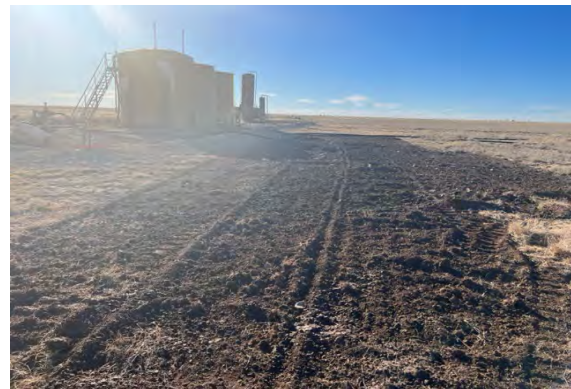
View to W of area N and E of TB following treatment (2/8/23).

To promote porosity of the soil, the areas north of the tank battery and around the heater treater were tilled with a high-speed tiller to depths between 6 and 10 inches and a 10 percent solution of hydrogen peroxide (H_2O_2) was applied. Following application of H_2O_2 the soil was tilled again, a reagent called Bio-Regen SA1000 was applied, and the soils were tilled again to ensure that all soil particles were introduced to the H_2O_2 and Bio-Regen SA 1000 products.

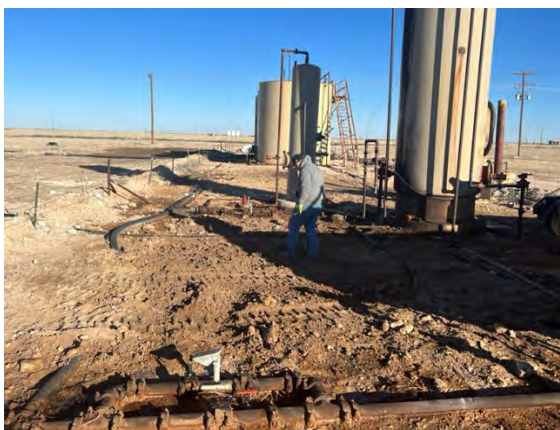
View of area around equipment following treatment (2/8/23).

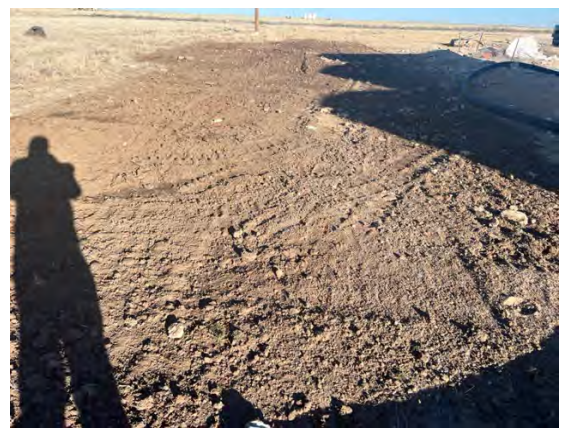
View to E of area N and E of TB following treatment (2/8/23).
