## CLOSURE REPORT

**Lateral 2C-39 (12/04/24)**  
Unit Letter G, S08 T25N R03W  
Rio Arriba County, New Mexico

**New Mexico EMNRD OCD Incident ID No. NAPP2433944047**

**March 31, 2025**

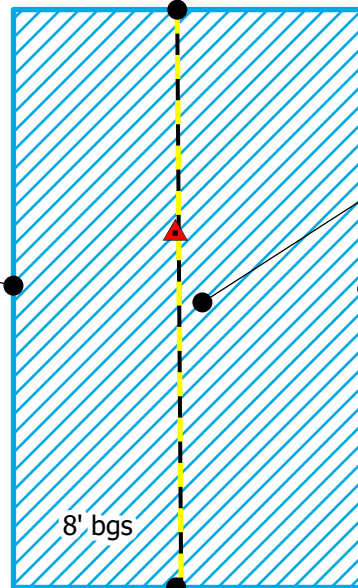
**Site Map with Soil Analytical Results**

**Figure 3** is a map that identifies approximate soil sample locations and depicts the approximate dimensions of the excavation with respect to the pipeline (**Appendix A**). Photographic documentation of the field activities is included in **Appendix D**.

S-5	
12.05.24	
W (0' - 8')	
Benzene...	<0.019
Toluene...	0.053
Ethylbenzene...	<0.039
Xylenes...	0.17
Total BTEX...	0.22
TPH GRO...	<3.9
TPH DRO...	<9.9
TPH MRO...	<50
Total Combined TPH	
GRO/DRO/MRO...	ND
Chlorides...	87

S-2	
12.05.24	
W (0' - 8')	
Benzene...	<0.024
Toluene...	<0.048
Ethylbenzene...	<0.048
Xylenes...	0.11
Total BTEX...	0.11
TPH GRO...	<4.8
TPH DRO...	<9.9
TPH MRO...	<50
Total Combined TPH	
GRO/DRO/MRO...	ND
Chlorides...	87

S-1	
12.05.24	
F (8')	
Benzene...	<0.018
Toluene...	<0.037
Ethylbenzene...	<0.037
Xylenes...	0.088
Total BTEX...	0.088
TPH GRO...	<3.7
TPH DRO...	<9.6
TPH MRO...	<48
Total Combined TPH	
GRO/DRO/MRO...	ND
Chlorides...	72

S-3	
12.05.24	
W (0' - 8')	
Benzene...	<0.020
Toluene...	<0.039
Ethylbenzene...	<0.039
Xylenes...	0.14
Total BTEX...	0.14
TPH GRO...	<3.9
TPH DRO...	<9.4
TPH MRO...	<47
Total Combined TPH	
GRO/DRO/MRO...	ND
Chlorides...	<60

S-4	
12.05.24	
W (0' - 8')	
Benzene...	<0.022
Toluene...	<0.043
Ethylbenzene...	<0.043
Xylenes...	0.094
Total BTEX...	0.094
TPH GRO...	<4.3
TPH DRO...	<9.5
TPH MRO...	<48
Total Combined TPH	
GRO/DRO/MRO...	ND
Chlorides...	87

The excavation measured approximately 15 feet long and 9 feet wide at the maximum extents, with an approximate 135 ft<sup>2</sup> footprint. The maximum depth of the excavation measured approximately 8 feet bgs. The lithology encountered during the completion of remediation activities consisted primarily of unconsolidated silty sandy clay.

- The laboratory analytical results for composite soil samples S-1 through S-5 indicate total BTEX concentrations ranging from 0.088 mg/kg (S-1) to 0.22 mg/kg (S-5) which are less than the NM EMNRD OCD closure criteria of 50 mg/kg. Total BTEX was not detected in composite soil sample BF-1 at a concentration greater than the laboratory PQLs/RLs, which are less than the NM EMNRD OCD closure criteria of 50 mg/kg.

- The laboratory analytical results for composite soil samples S-1, S-2 and S-4 indicate chloride concentrations ranging from 72 mg/kg (S-1) to 87 mg/kg (S-2 and S-4), which are less than the NM EMNRD OCD closure criteria of 600 mg/kg. The analytical results for the other composite soil samples collected from soils remaining at the Site indicate that chloride concentrations are less than the laboratory PQLs / RLs, which are less than the NM EMNRD OCD closure criteria of 600 mg/kg.

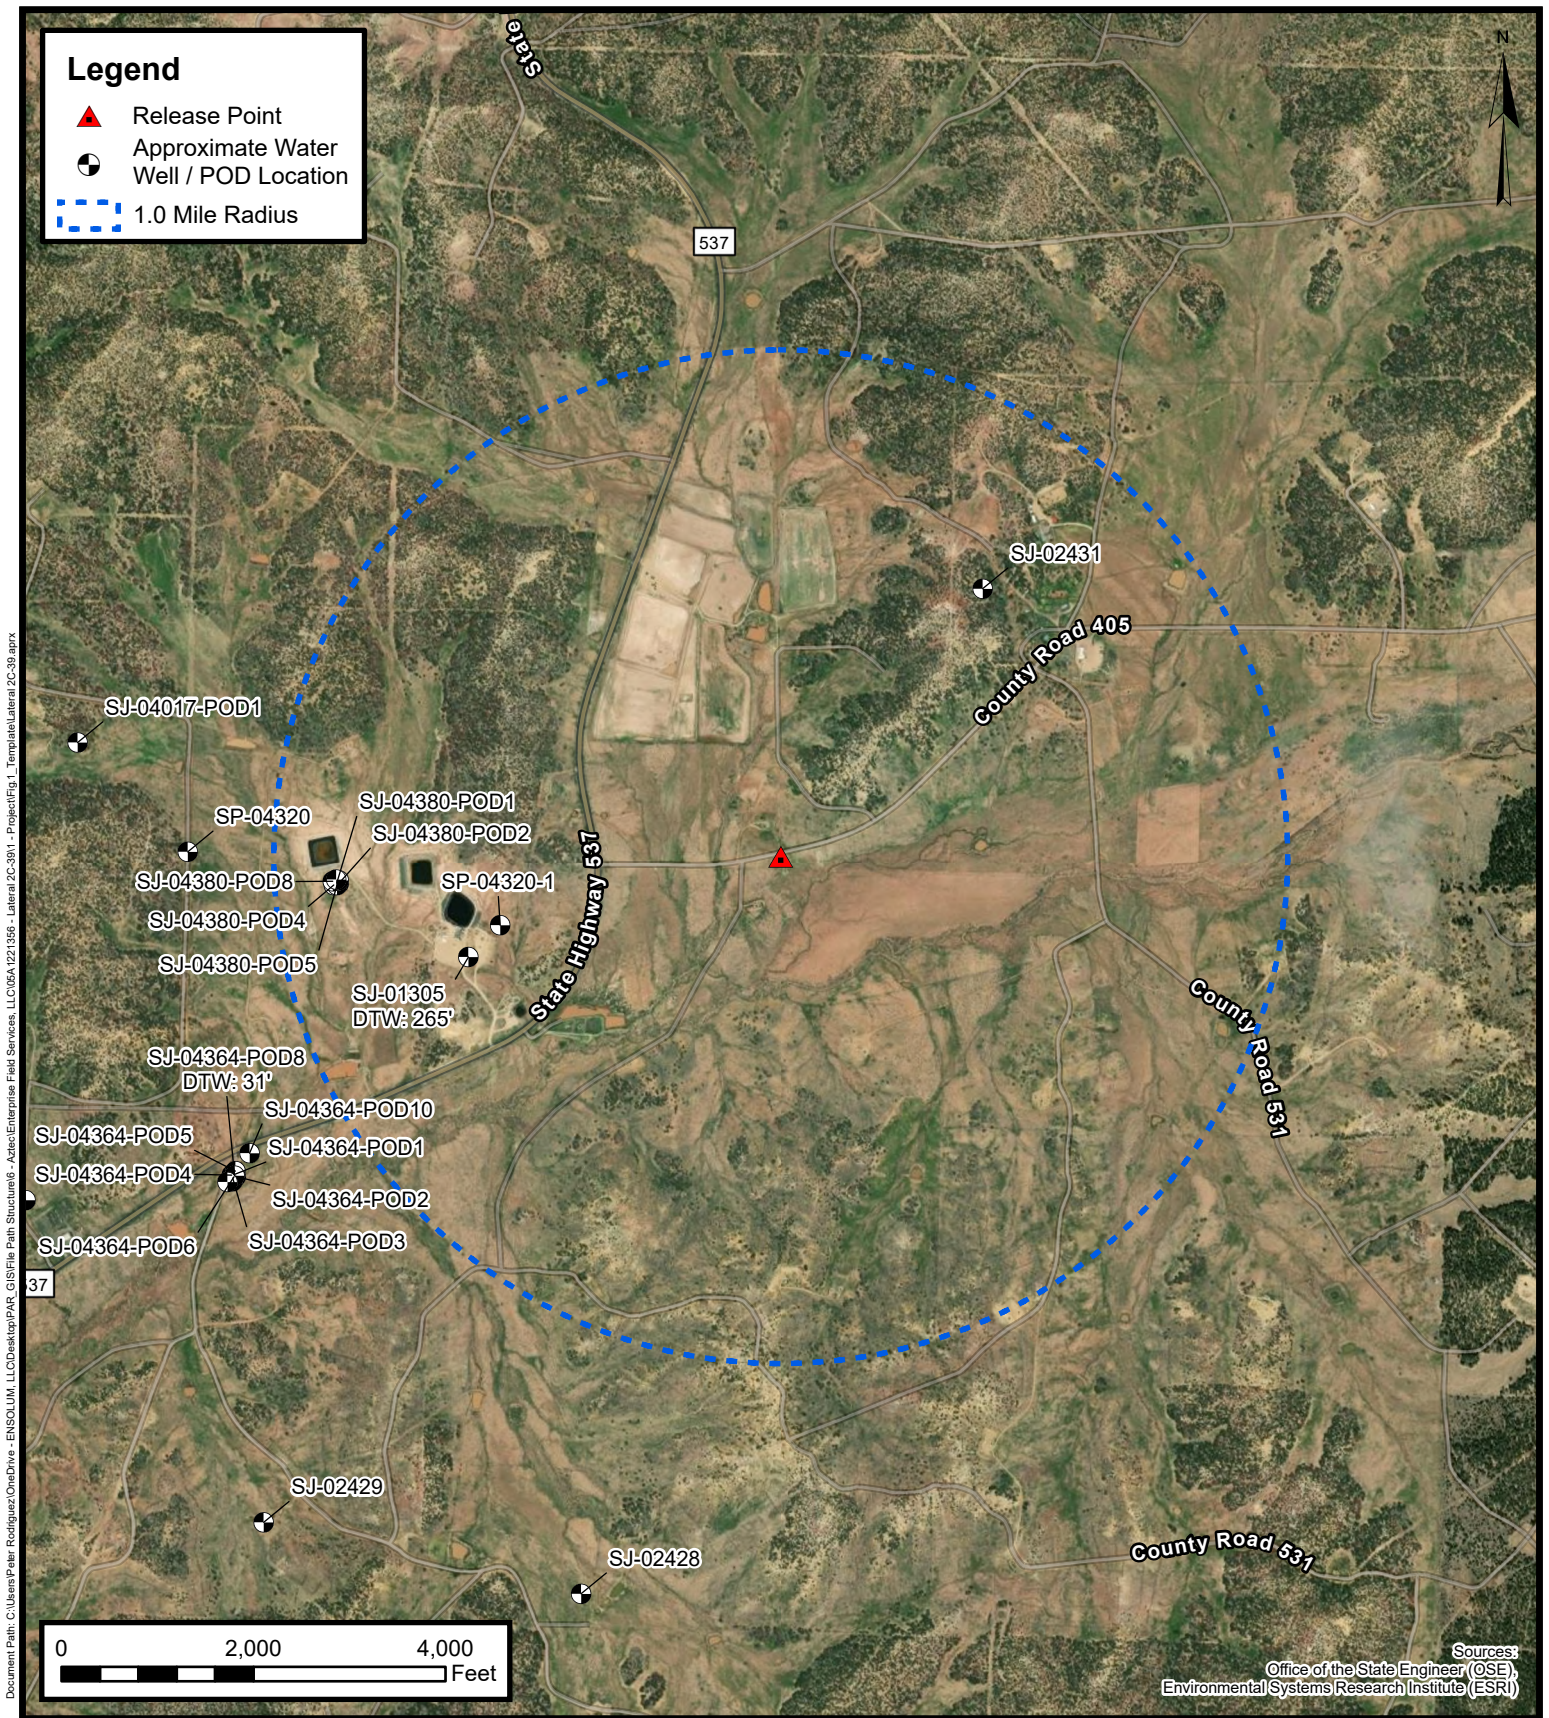
### 1.0 Mile Radius Water Well / POD Location Map

- The NM Office of the State Engineer (OSE) tracks the usage and assignment of water rights and water well installations and records this information in the Water Rights Reporting System (WRRS) database. Water wells and other points of diversion (PODs) are each assigned POD numbers in the database (which is searchable and includes an interactive map). One POD was identified in the same Public Land Survey System (PLSS) section and two PODs were identified in adjacent PLSS sections (**Figure A, Appendix B**). The closest POD with a recorded depth to water (SJ-01305) is approximately 0.65 miles southwest of the site and approximately 20 feet higher in elevation than the Site. The recorded depth to water (DTW) for this POD is 265 feet below grade surface (bgs). POD SJ-04364 POD 8 is approximately 1.26 miles southwest of the site and approximately 58 feet higher in elevation than the Site. The recorded DTW for this POD is 31 feet below grade surface (bgs).

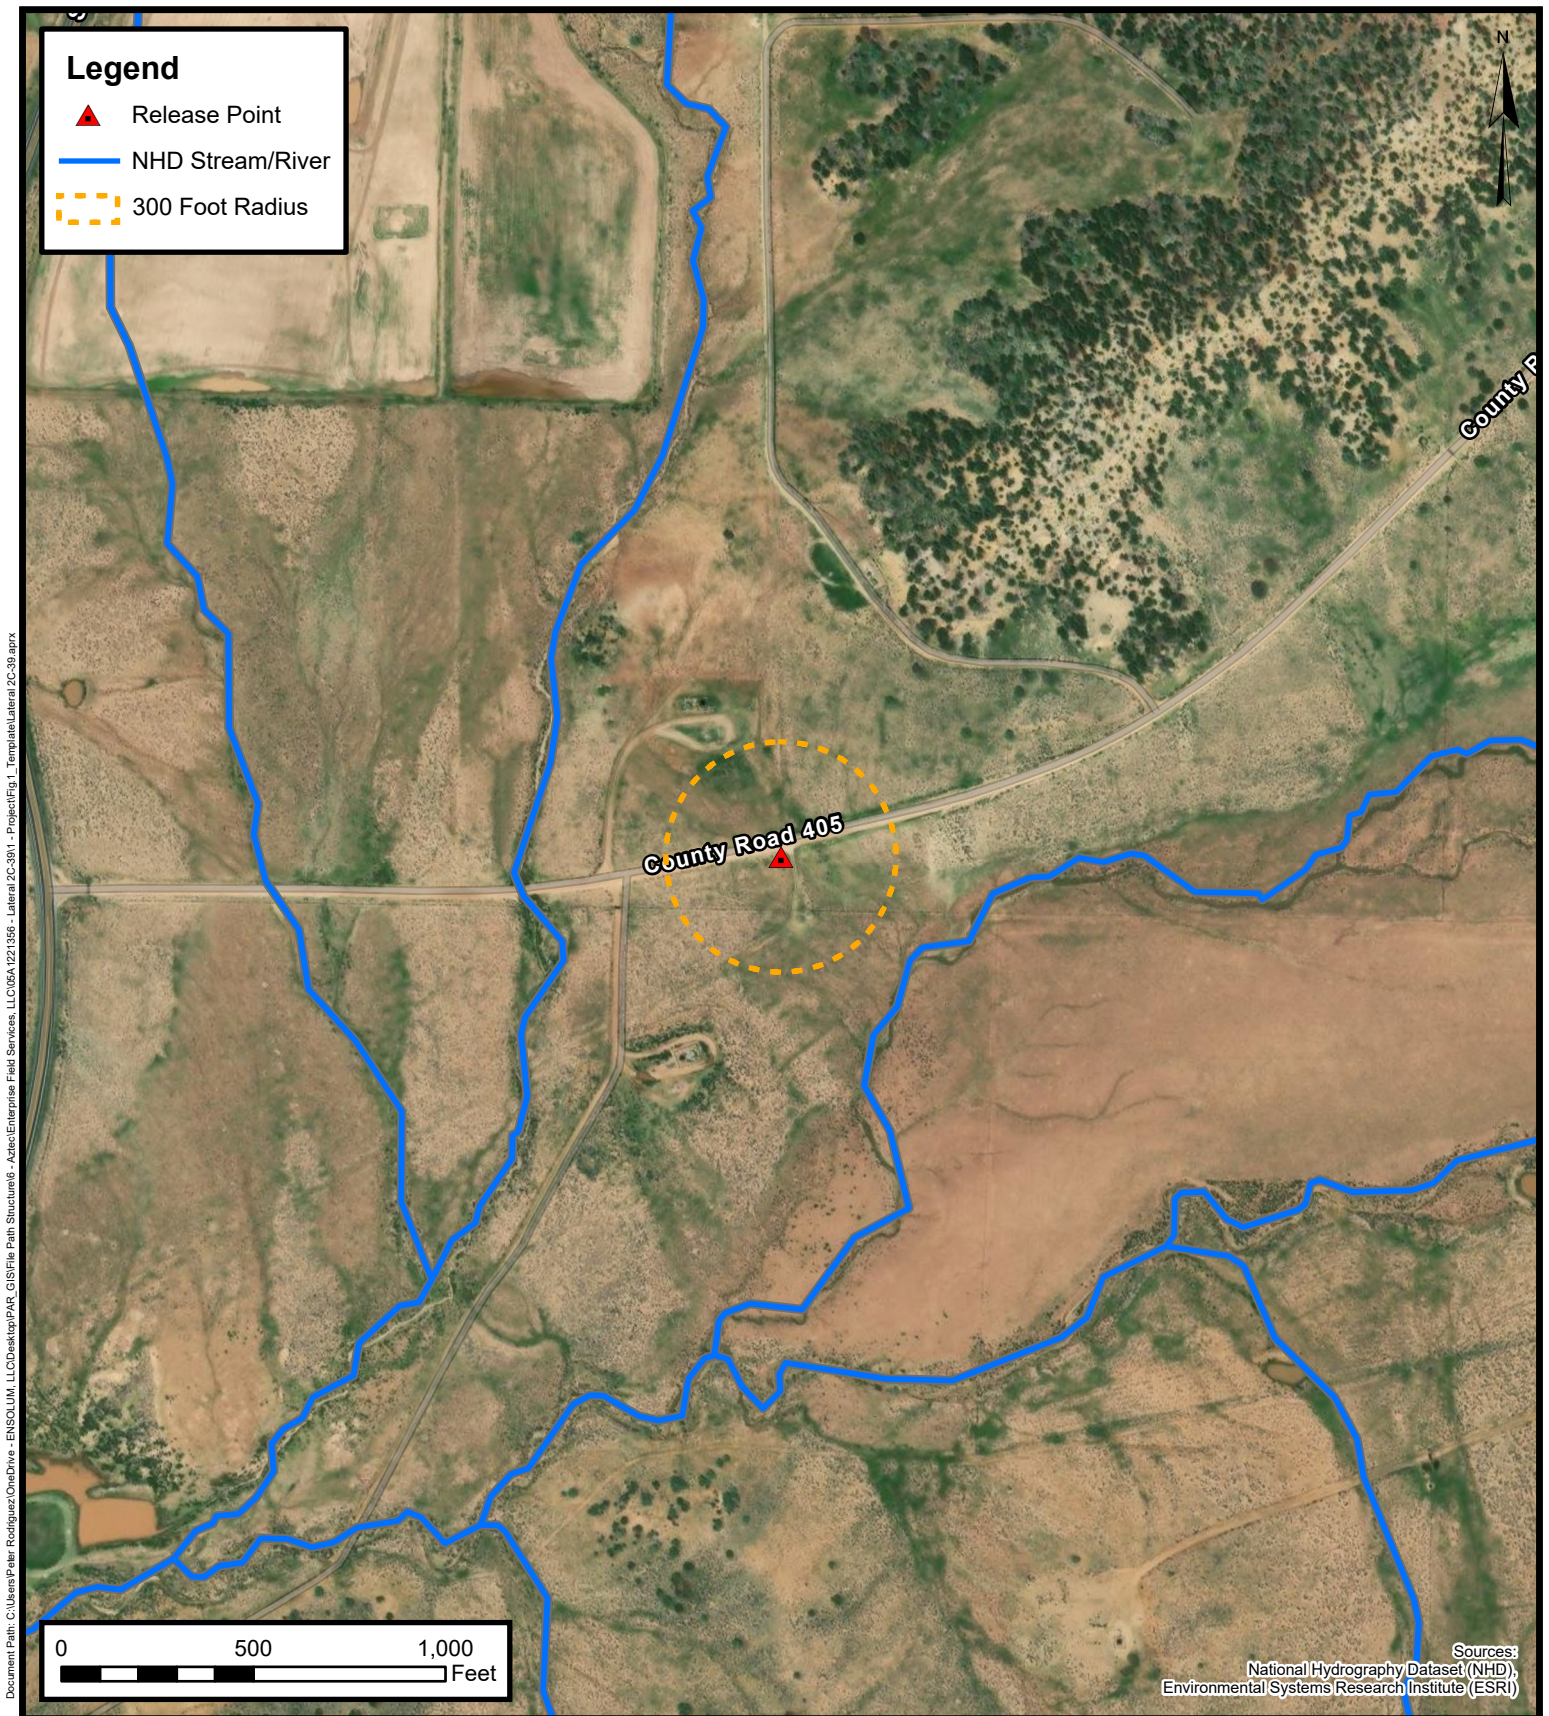
### 300 Foot Radius Watercourse and Drainage Identification

- The Site is located within 300 feet of a NM EMNRD OCD-defined continuously flowing watercourse or significant watercourse (**Figure C, Appendix B**). As defined by the NM EMNRD OCD in their training seminar, a first order drainage to a “blue line” ephemeral wash is considered a significant watercourse. Such a drainage is located approximately 114 feet east of the Site.

The Site is located within 300 feet of a NM EMNRD OCD-defined continuously flowing watercourse or significant watercourse, resulting in a Tier I ranking. The closure criteria for soils remaining in place at the Site include:

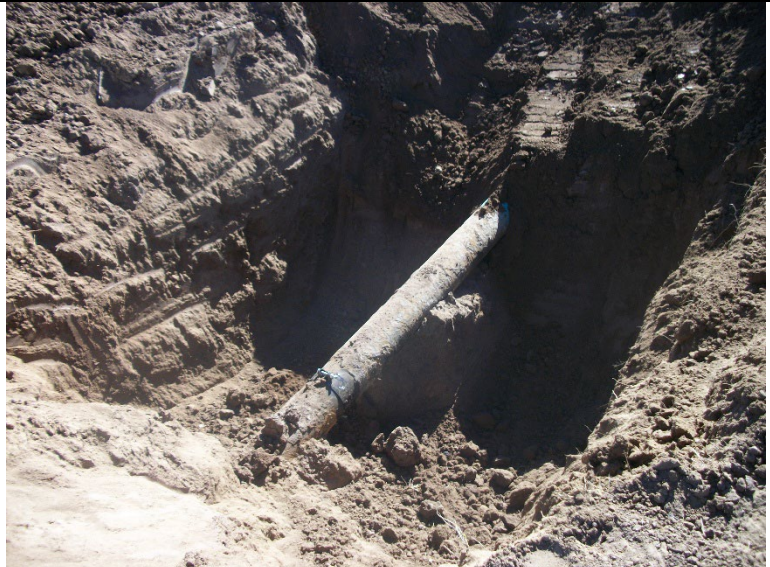
**Photograph 1**

Photograph Description: View of the in-process excavation activities.

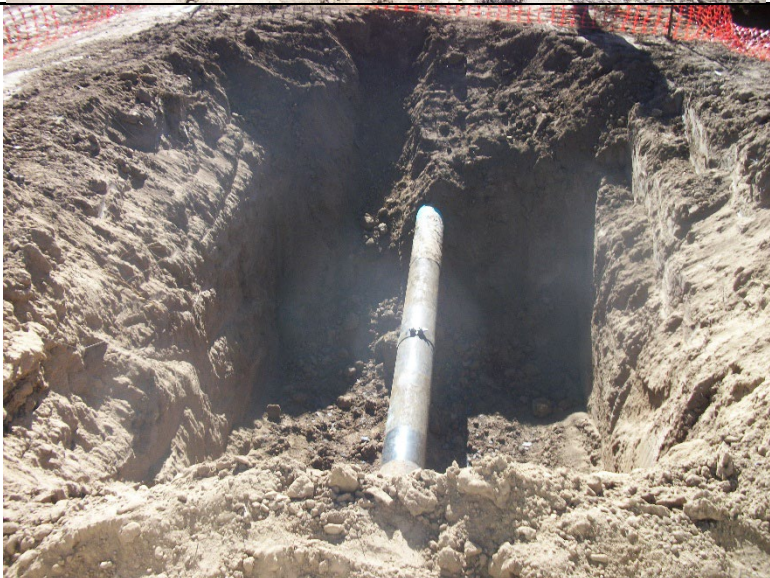
**Photograph 2**

Photograph Description: View of the final excavation.

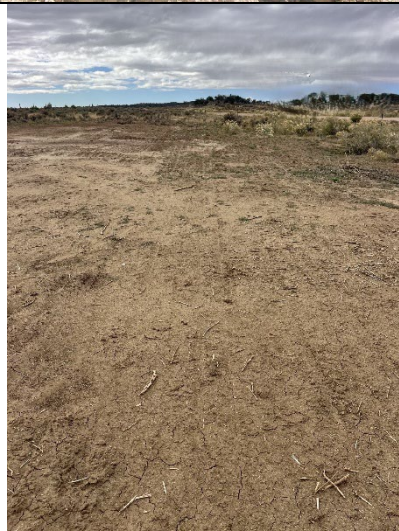
**Photograph 3**

Photograph Description: View of the final excavation after initial restoration.

The excavation was backfilled with imported fill and then contoured to the surrounding grade. The backfill and the upper four feet of the excavation have been analytically verified to be below the Tier I soil standards of 50 mg/kg BTEX, 10 mg/kg benzene, 100 mg/kg total combined TPH, and 600 mg/kg Chloride. See **APPENDIX D** and **APPENDIX F** for further documentation.
