Remediation Report and Closure Request
San Juan 31-6 #39M
Section: 28 Township: 31N Range: 6W
Lat: 36.875168 Long: -107.459927
Rio Arriba County, New Mexico

Photo Page
San Juan 31-6 #39M Pipeline Release
Lat: 36.875168 Long: -107.459927

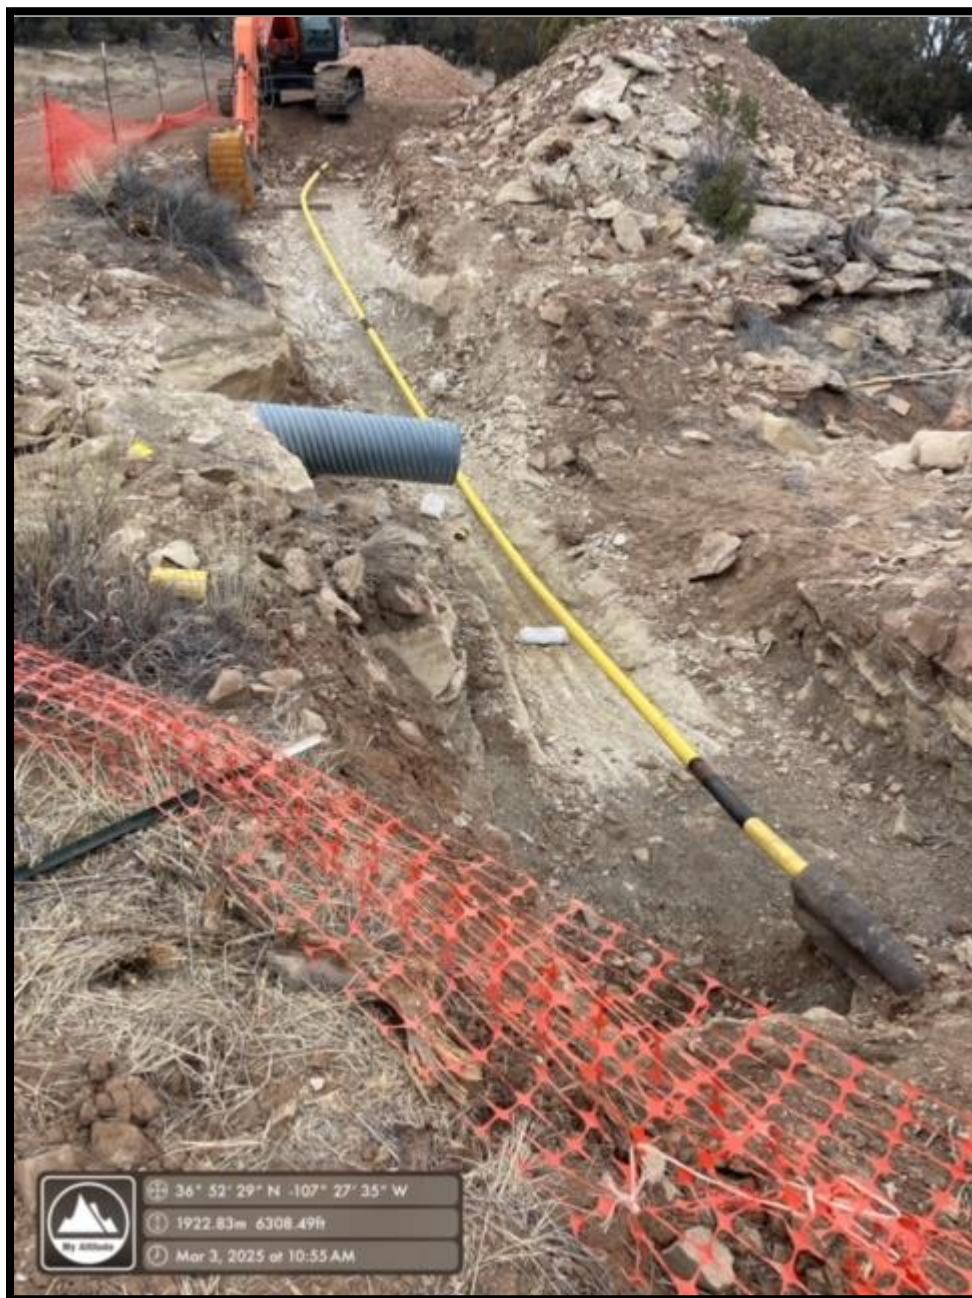
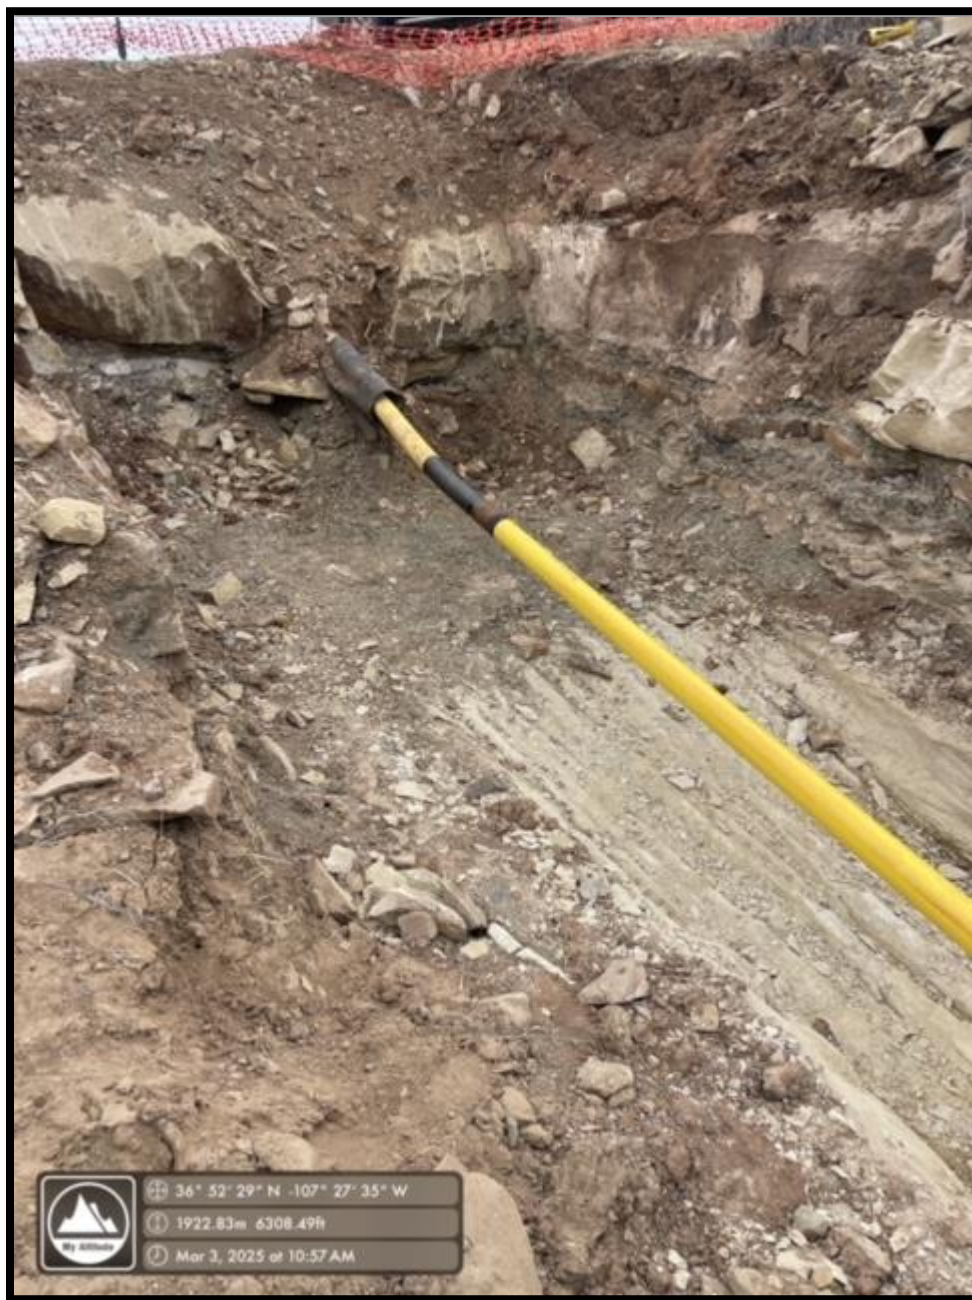
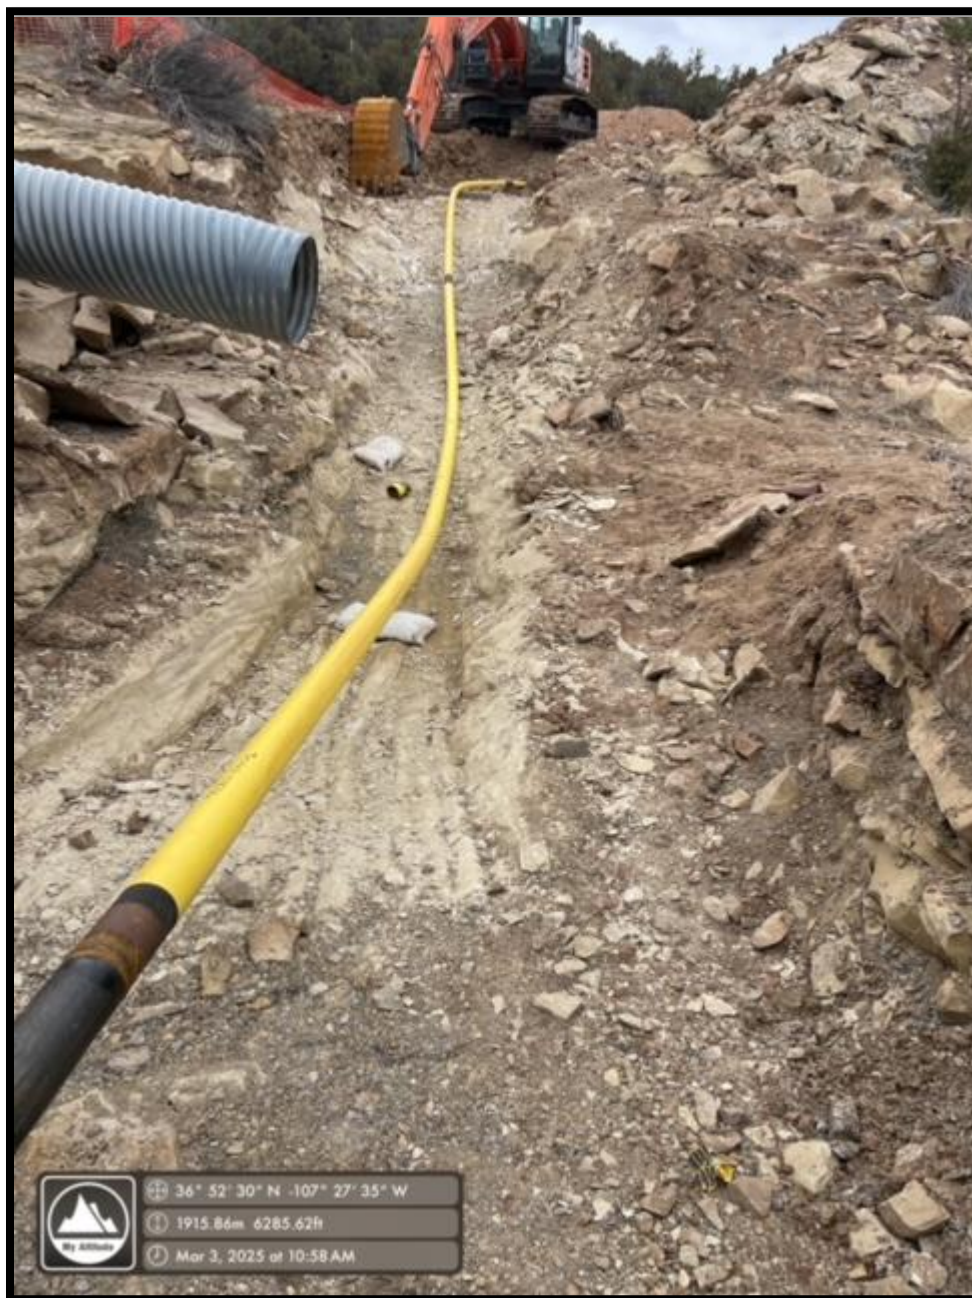
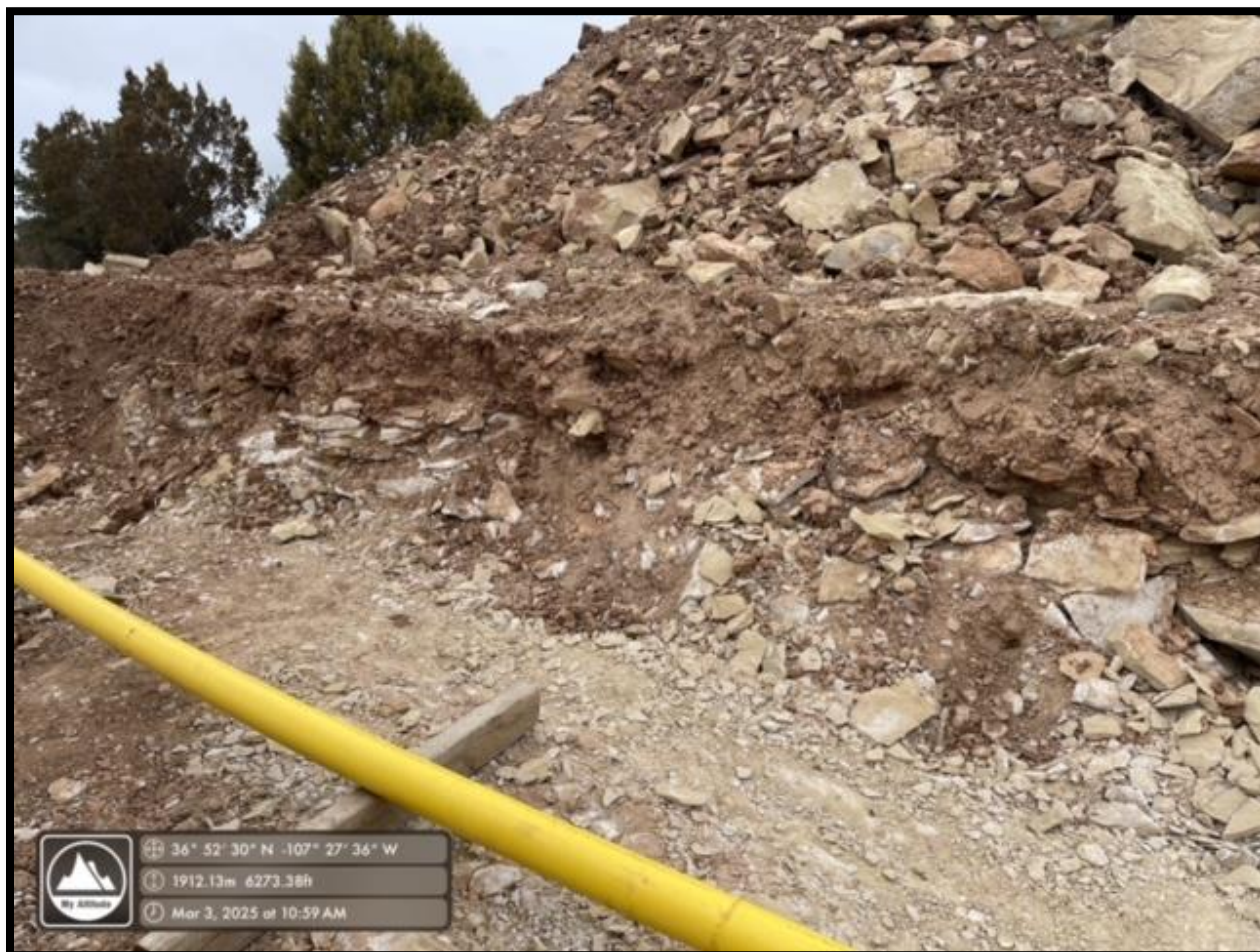
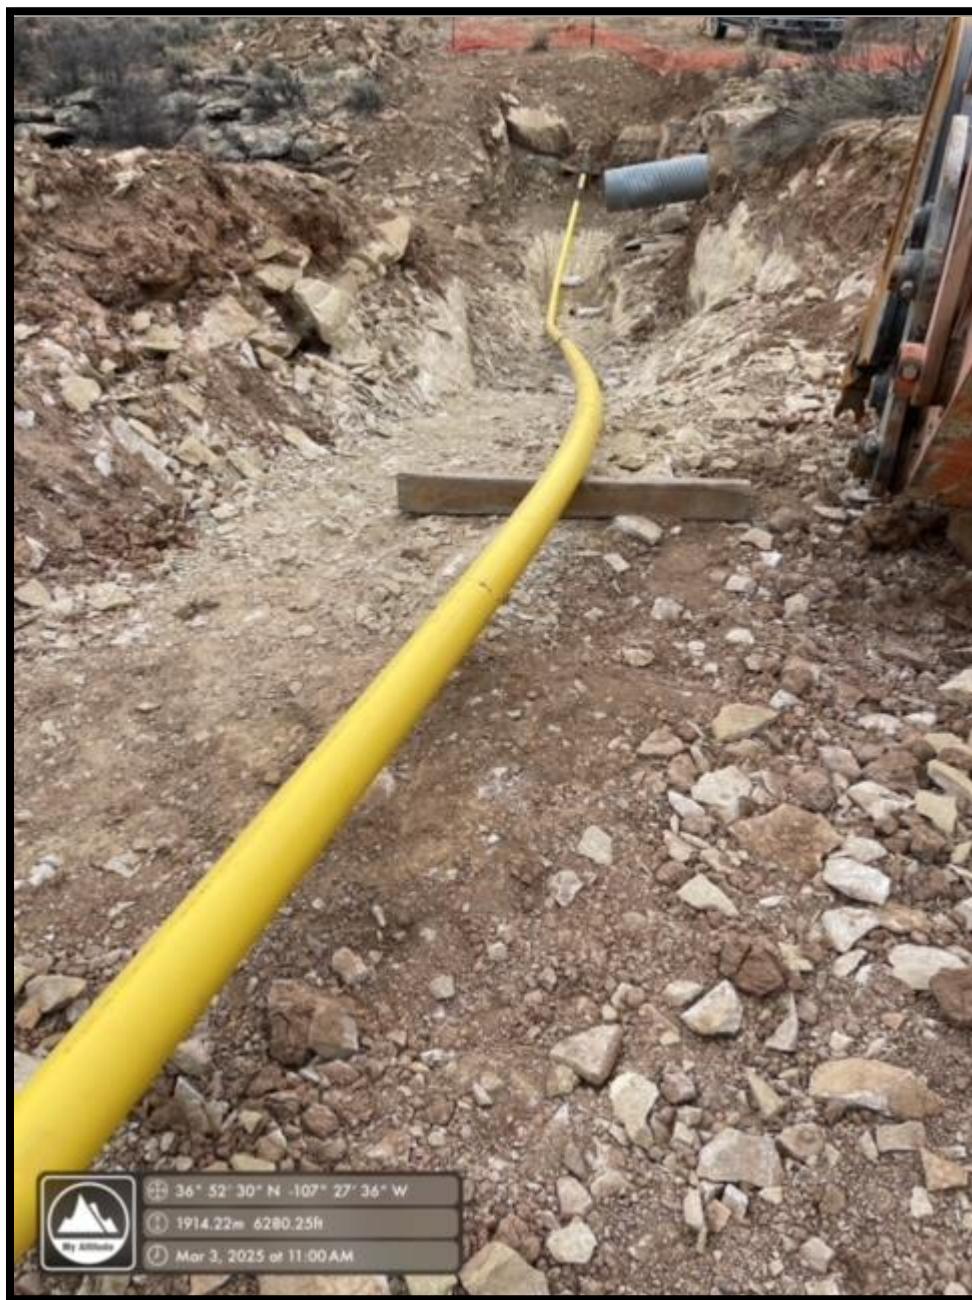
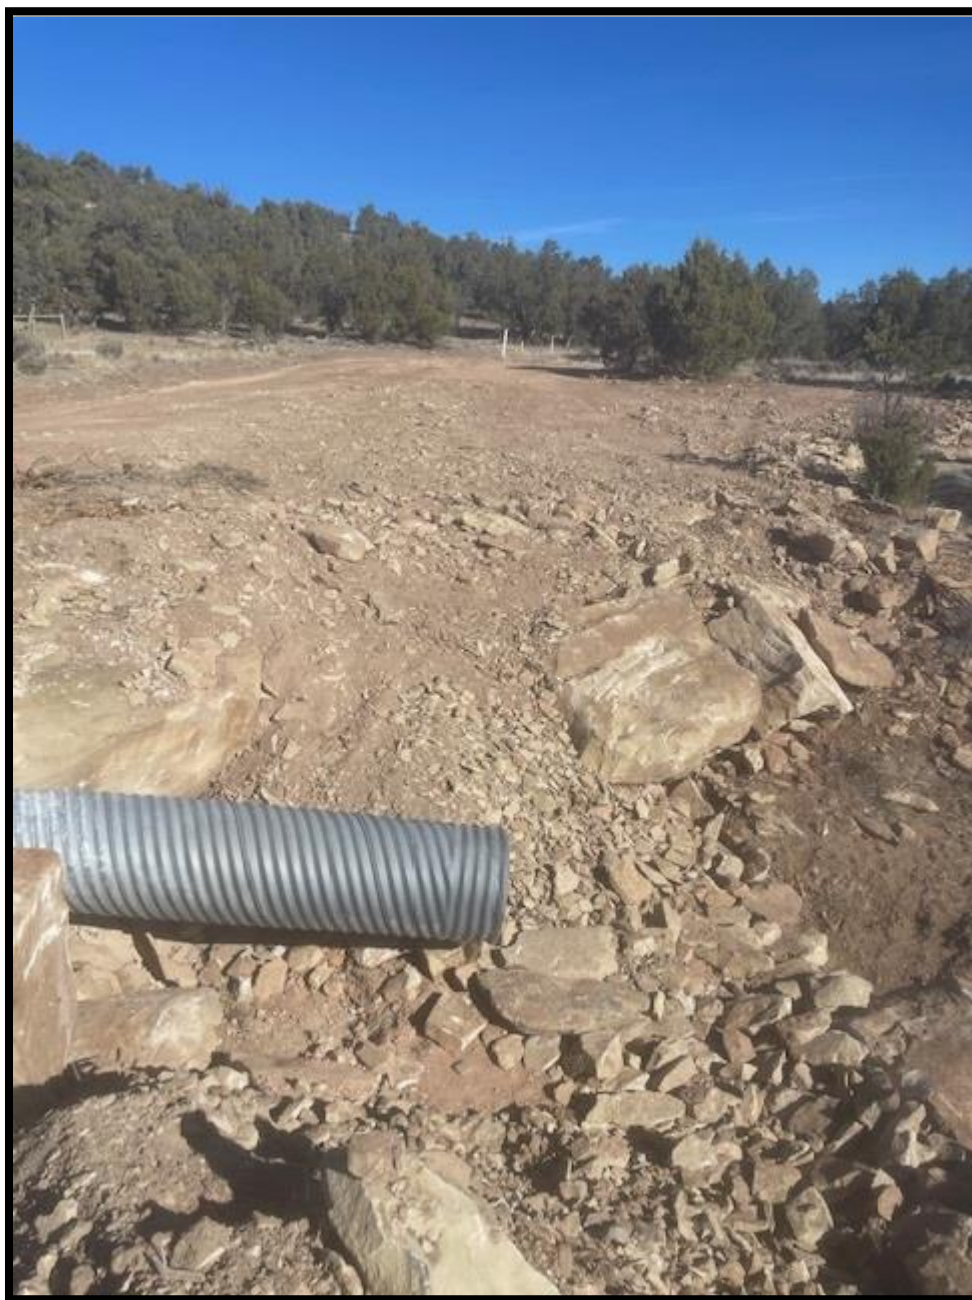
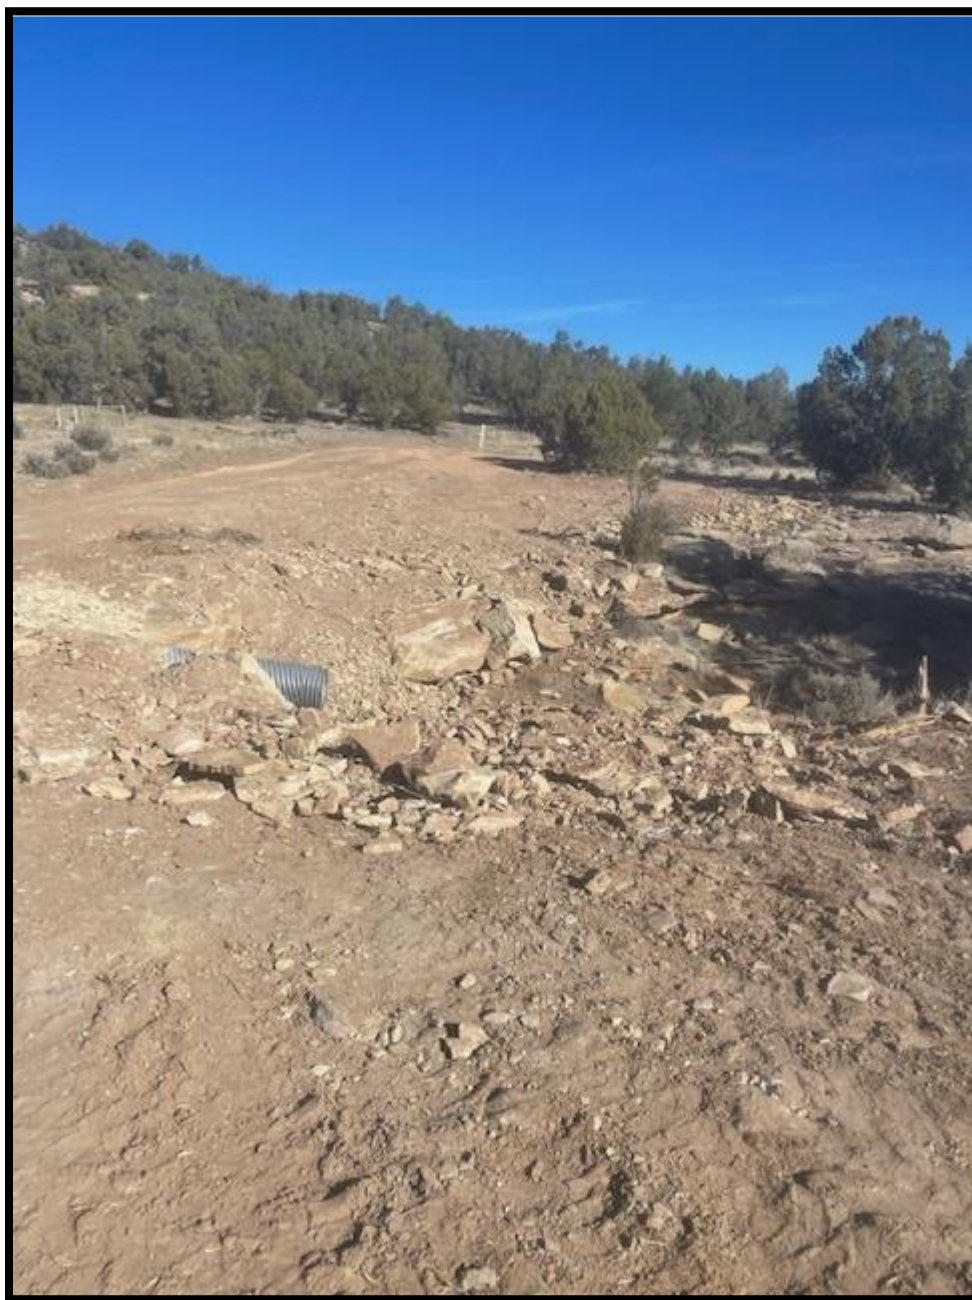
A crew was onsite to excavate and repair pipeline. The hole that formed in the pipeline causing the leak was discovered to be caused by internal corrosion. Failed piping was replaced along with 82 ft of new pipe and returned to service. 24 cubic yards of contaminated soil was removed. Volume of gas loss was calculated 5.339 Mcf.

The excavation was backfilled, and no further action is required at this time.

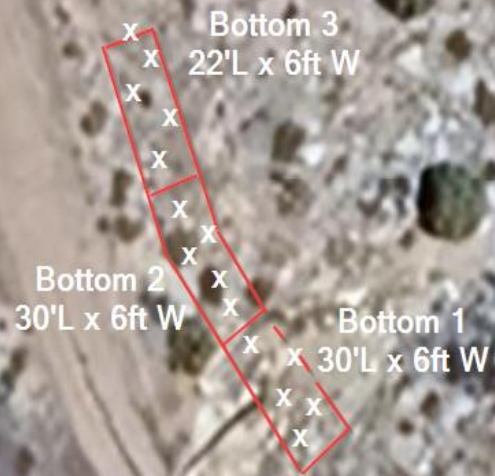
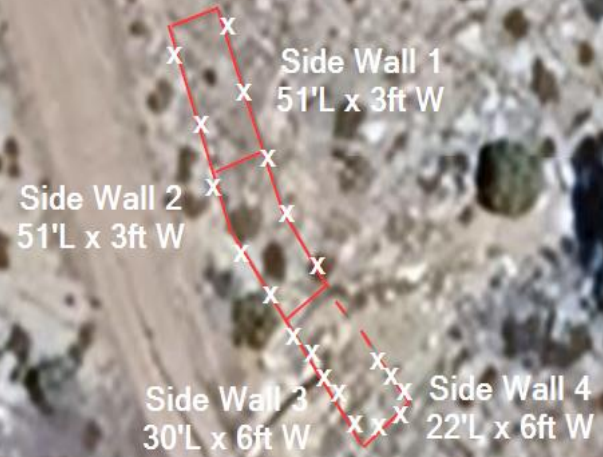
Sample Map
3-3-2025

A Harvest representative was on site to perform sampling activities. Seven, five-point composite samples were collected from the excavated area. "Bottom 1" which measured 30ft long x 6 ft wide, "Bottom 2" which measured 30ft long x 6 ft wide, "Bottom 3" which measured 22ft long x 6 ft wide, "Side Wall 1" which was to the northwest of the excavation measured 51 ft long x 3 ft wide. "Side Wall 2" Southwest of excavation measured 51 ft long by 3ft wide. "Side Wall 3" Southeast of excavation measured 30ft long by 6 ft wide. "Side Wall 4" which is the east wall and northeast wall of excavation measured 22ft by 6ft. Samples were sent in for analysis of BTEX, TPH (GRO/DRO/ORO) and Chlorides. See "Sample Map" for reference".
