A-2-3-7 EXT LINE LEAK

Remediation Summary & Closure Report Addendum

NMOCD Incident No. nAPP2331222132

May 7, 2025

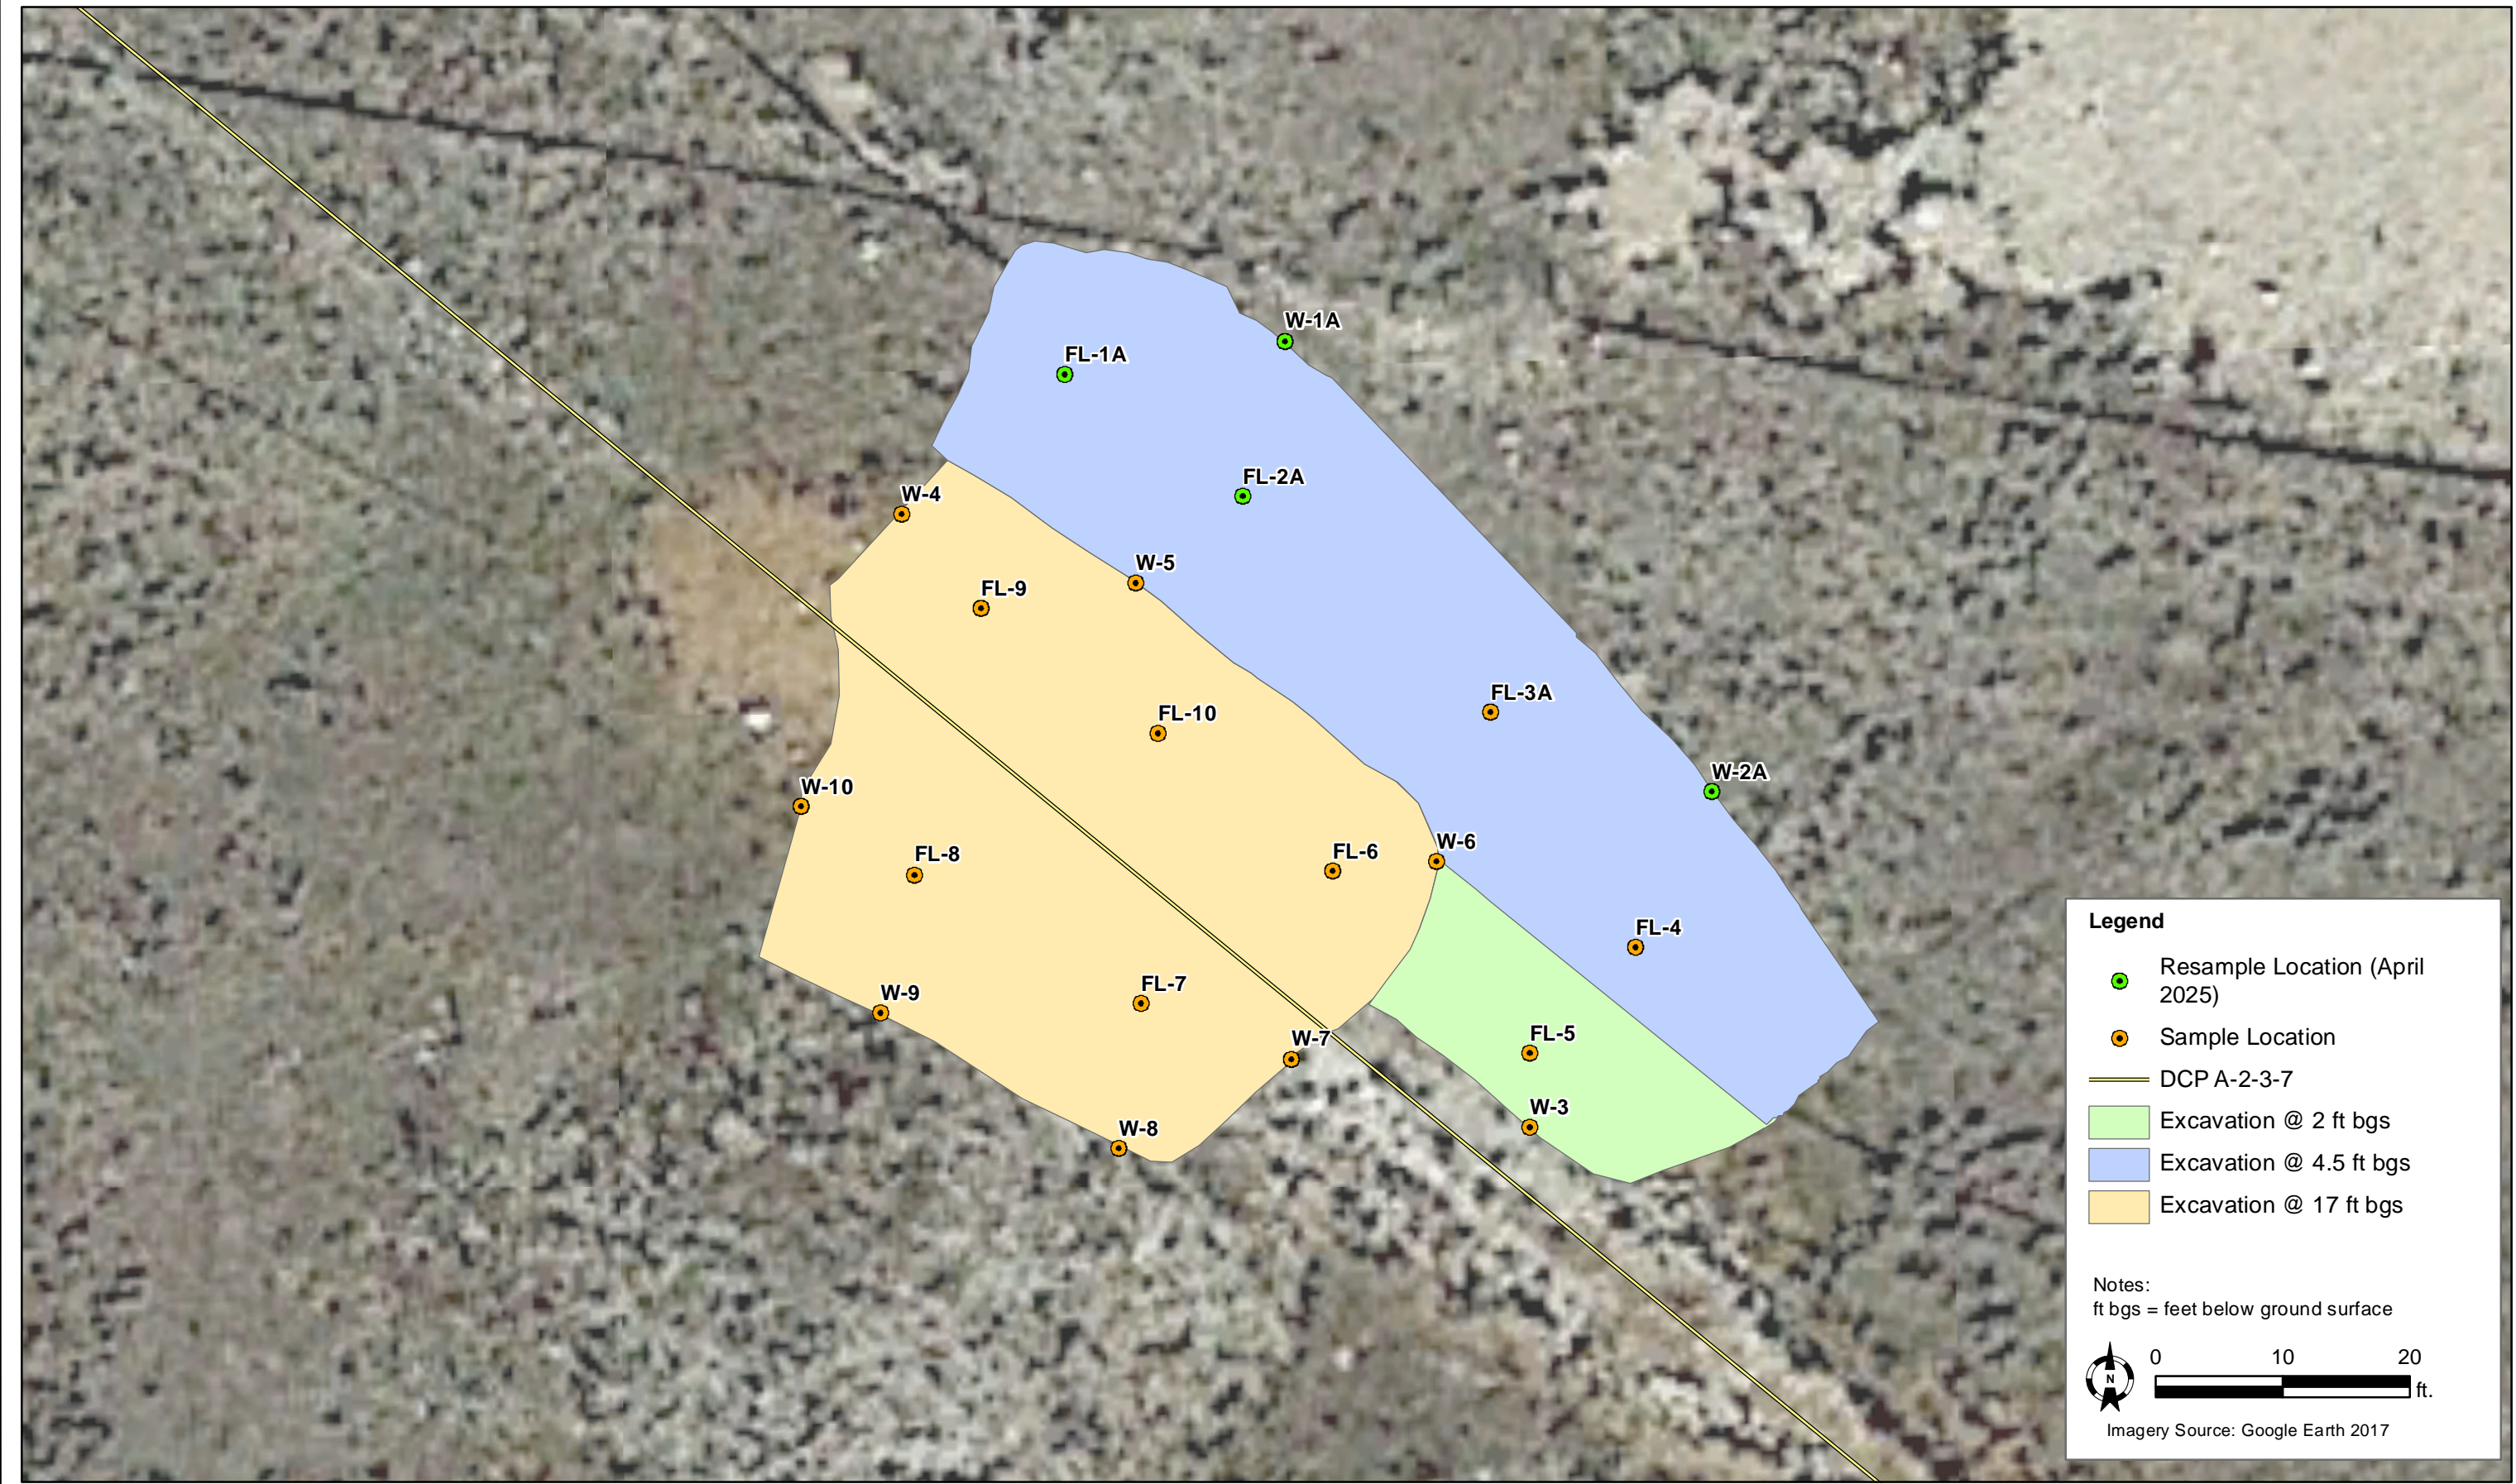
Excavation Overview Map

Tasman returned to the site on April 22, 2025, to excavate backfilled material using a backhoe and collect confirmation soil samples from the base of the excavation. Tasman collected a total of 2 confirmation soil samples from the base of the excavation and samples were collected as a five-point composite representing no more than 400 ft².

A summary of soil analytical results is provided as Table 1 and certified laboratory analytical reports are provided in Appendix C. The attached Figure 2 illustrates excavation extents and confirmation sample locations.
