**Re: Closure Request
Ross Draw 25 #31 Battery
Incident Number nAPP2504152469
Eddy County, New Mexico**

Ensolum, LLC (Ensolum) on behalf of XTO Energy, Inc. (XTO), has prepared this *Closure Request* to document the findings of a liner integrity inspection and excavation and soil sampling activities conducted at the Ross Draw 25 #31 Battery (Site) following a release of produced water. Based on the liner integrity inspection, excavation, and soil sampling activities completed, XTO is submitting this *Closure Request*, describing all remediation activities that have occurred and requesting closure for Incident Number nAPP2504152469.

XTO Energy, Inc.
Closure Request
Ross Draw 25 #31 Battery

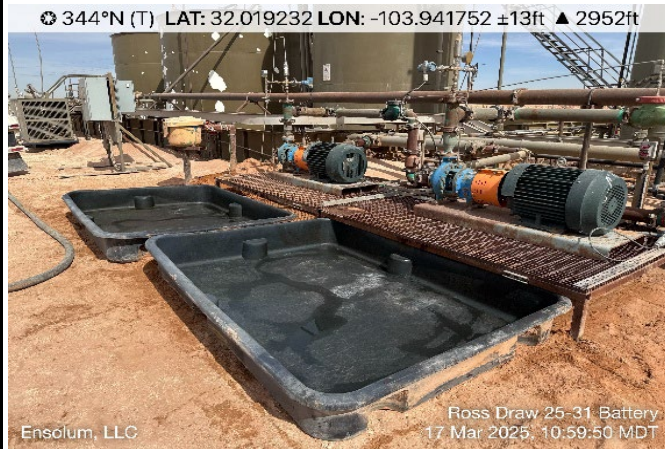
Photograph: 1 Date: 3/17/2025
Description: Liner inspection activities
View: North

After a review of the C-141 and release photographs it was confirmed the release occurred within a lined containment. The lined containment was cleaned of all debris, power washed, and a 48-hour advance notice of the liner inspection was submitted on March 12, 2025. On March 17, 2025, the lined containment was inspected by Ensolum personnel and was determined to be operating as designed. Upon inspection, no rips, tears, holes, or damage were observed and the liner was determined to be sufficient. Photographic documentation of the inspection is included in Appendix B.

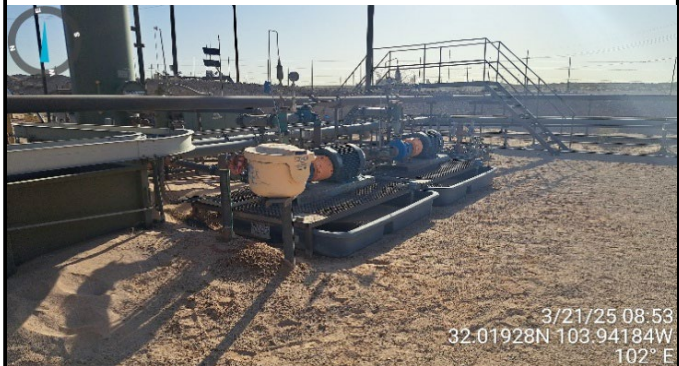
Photograph: 2 Date: 3/21/2025
Description: Delineation Sampling
View: East

On March 21, 2025, Ensolum personnel returned to the Site to complete delineation soil sampling activities. Four delineation soil samples, SS01 through SS04, were collected from a depth of approximately 0.5 feet bgs around the release extent area to define the lateral extent of the release. On April 3, 2025, Ensolum personnel oversaw excavation activities utilizing a backhoe and transport vehicles. The entire release extent area was excavated to approximately 2 feet bgs. Ensolum personnel collected 5-point composite soil samples representing no more than 200 square feet from the floor and sidewall of the excavated area. The 5-point composite soil samples were collected by placing five equivalent aliquots of soil into a 1-gallon, resealable plastic bag and homogenizing the samples by thoroughly mixing. Confirmation soil sample FS01 was collected from the floor of the excavation from a depth of 2 feet bgs. Confirmation soil sample SW01 was collected from the sidewall of the excavation at depths ranging from ground surface to 2 feet bgs. All soil samples collected were field screened for volatile organic compounds (VOCs) utilizing a calibrated photoionization detector (PID) and chloride utilizing Hach® chloride QuanTab® test strips. Photographic documentation of all Site activities are included in Appendix B. The release extent, excavation extent, delineation and confirmation soil sample locations are depicted in Figure 2.

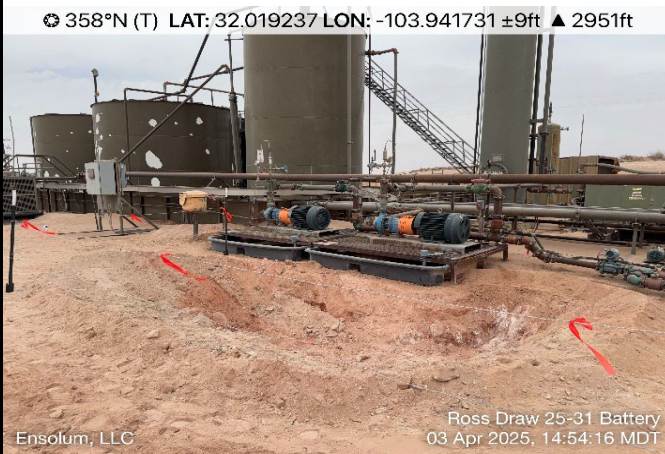
Photograph: 3 Date: 4/3/2025
Description: Excavation activities
View: North

The final excavation extent measured an estimated 184 square feet. A total of 13 cubic yards of impacted soil was removed during the excavation activities. The impacted soil was transported and properly disposed of at the R360 Facility in Hobbs, New Mexico.
