Incident Number: NAPP2509233514

## Closure Report

Outrider 28 Federal CVB

Section 28, Township 24 South, Range 32 East  
32.18629, -103.67561

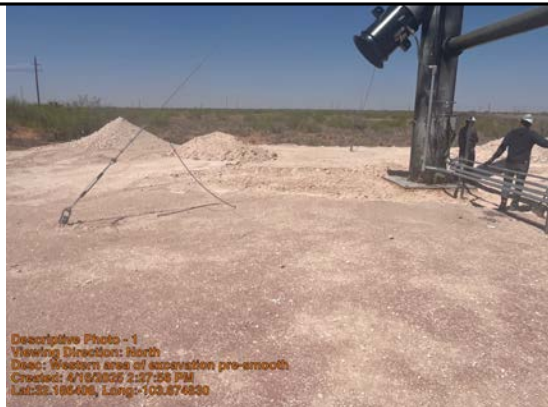
Viewing Direction: North

Western area of excavation pre-smooth

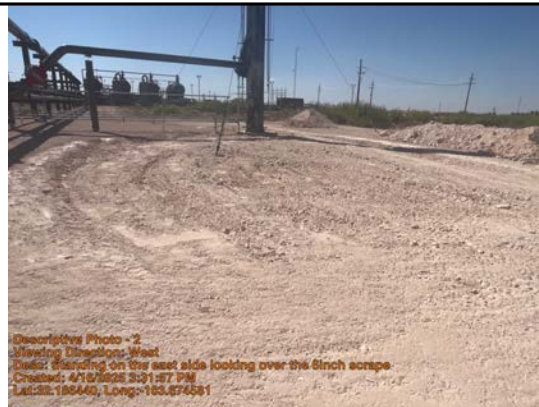
Viewing Direction: West

Standing on the east side looking over the 6inch scrape

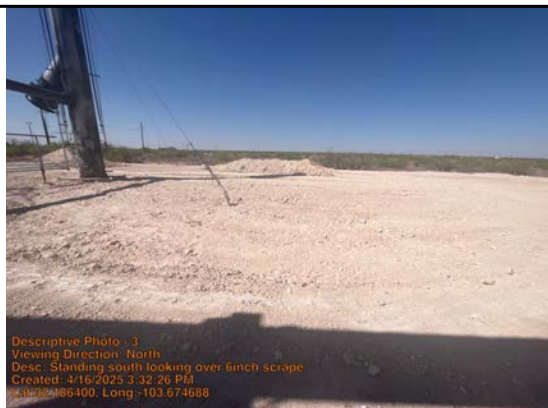
Viewing Direction: North

Standing south looking over 6inch scrape

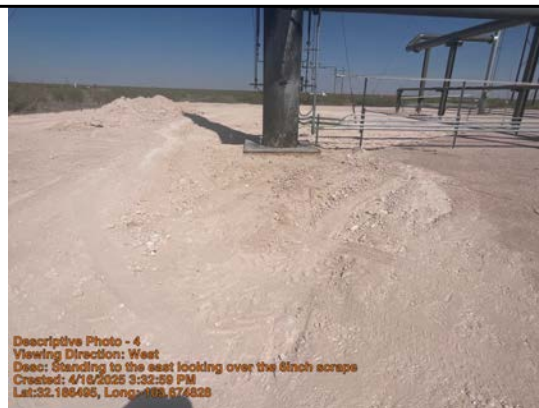
Viewing Direction: West

Standing to the east looking over the 6inch scrape

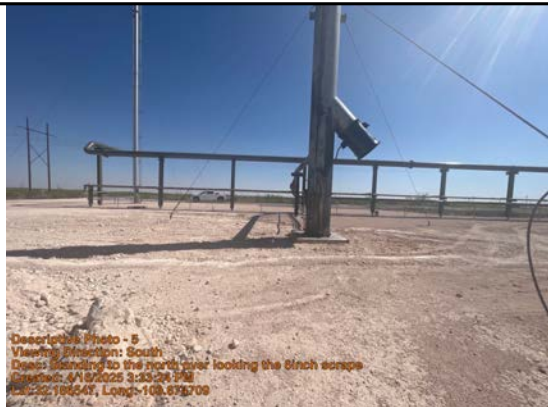
Viewing Direction: South

Standing to the north over looking the 6inch scrape

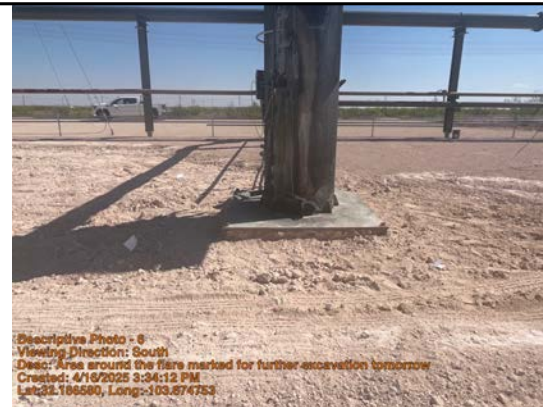
Viewing Direction: South

Area around the flare marked for further excavation tomorrow

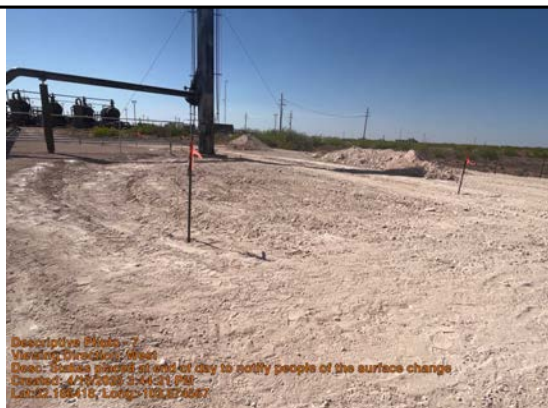
Viewing Direction: West

Stakes placed at end of day to notify people of the surface change

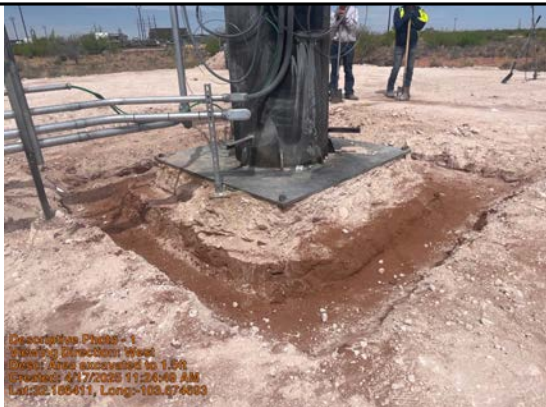
Viewing Direction: Northwest

Area excavated to 1.5ft

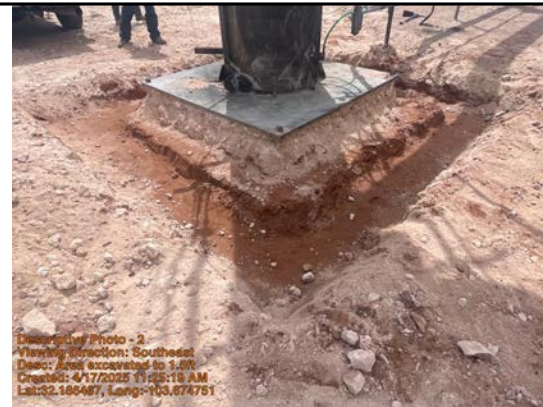
Viewing Direction: Southeast

Area excavated to 1.5ft

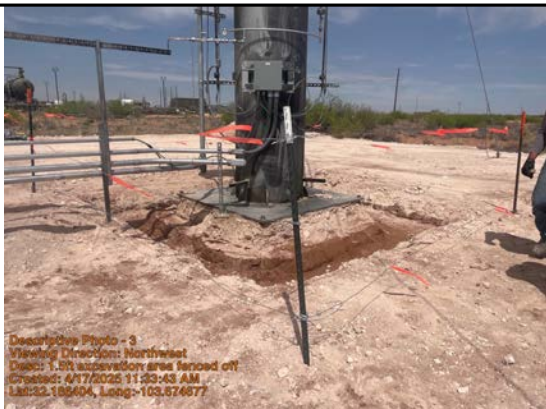
Viewing Direction: Northwest

1.5ft excavation area fenced off

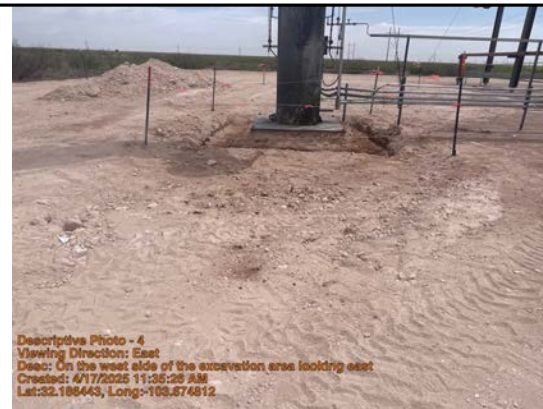
Viewing Direction: East

On the west side of the excavation area looking east

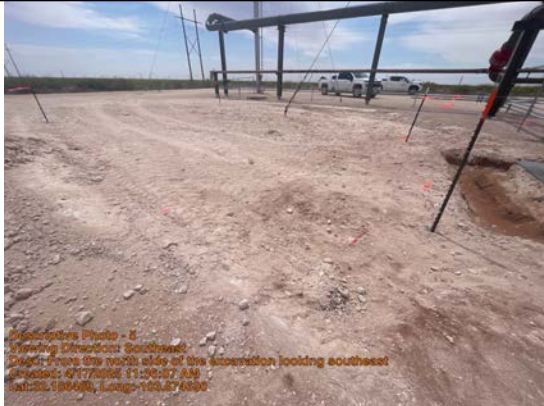
**Viewing Direction: Southeast**

From the north side of the excavation looking southeast

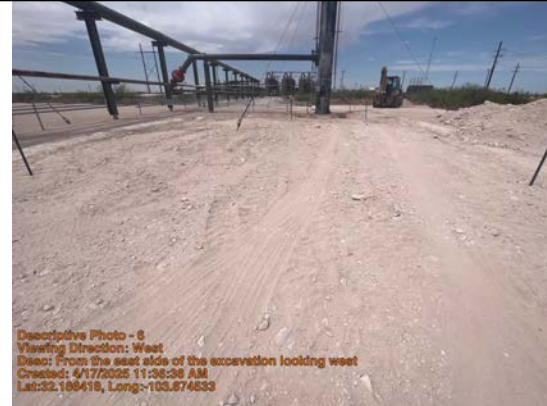
**Viewing Direction: West**

From the east side of the excavation looking west

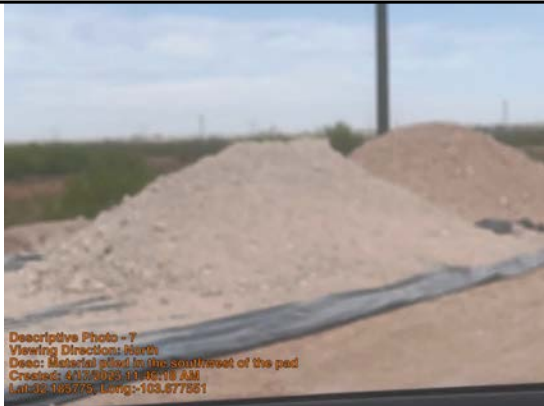
**Viewing Direction: North**

Material piled in the southwest of the pad

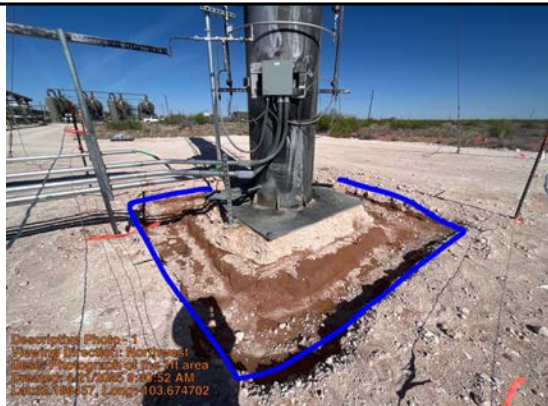
Viewing Direction: Northwest

Wall sample 01 from 0.5 to 1.5 around the whole wall of the 1.5ft area

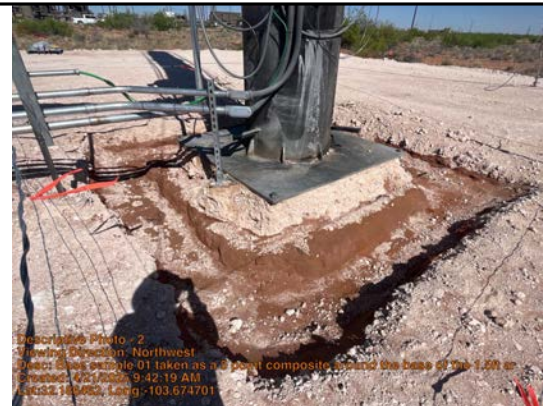
Viewing Direction: Northwest

Base sample 01 taken as a 5 point composite around the base of the 1.5ft area

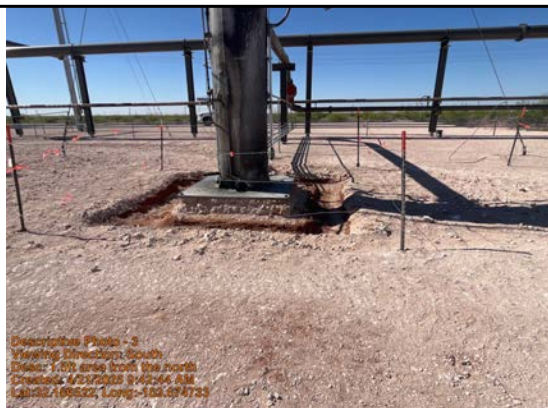
Viewing Direction: South

1.5ft area from the north
