Location of spill: Poseidon LGL Station

Date of Spill: 1/19/2025

**SITE CHARACTERIZATION, ASSESSMENT,
AND PROPOSED REMEDIATION PLAN**

**POSEIDON LGL STATION
32.255874, -103.670635
UNIT N, SECTION 34 T23S-R32E
LEA COUNTY, NEW MEXICO**

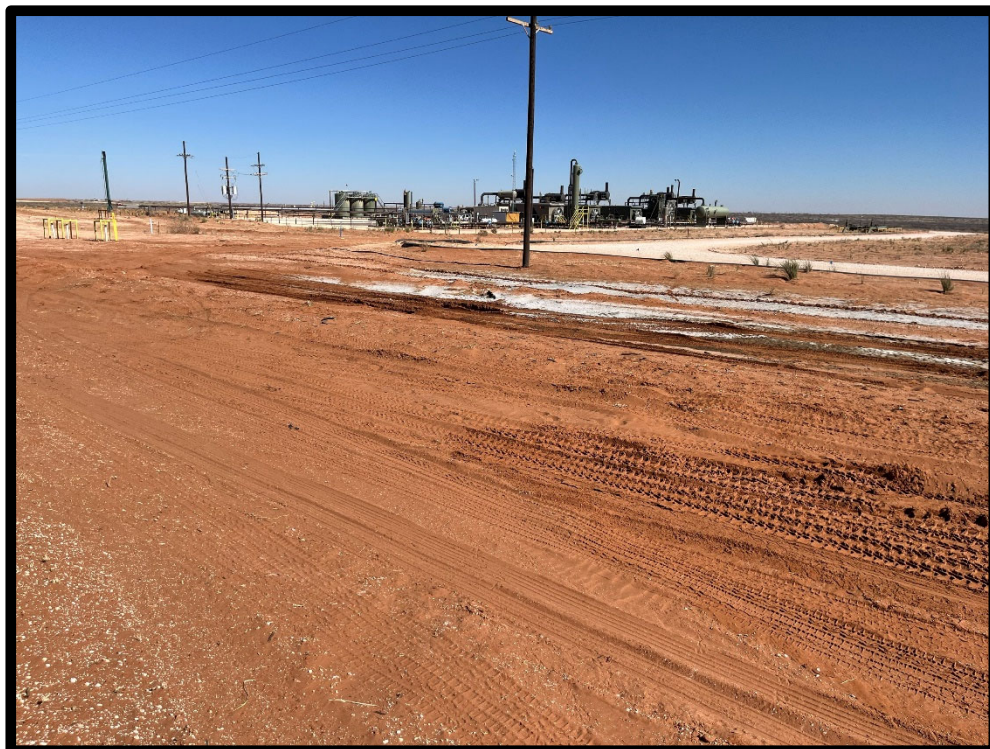
PHOTOGRAPH NO. 1 – A view of the Site during the initial response activities from the vicinity of the release location. The view is towards the northeast
(Approximate GPS Coordinates 32.255687, -103.670830)

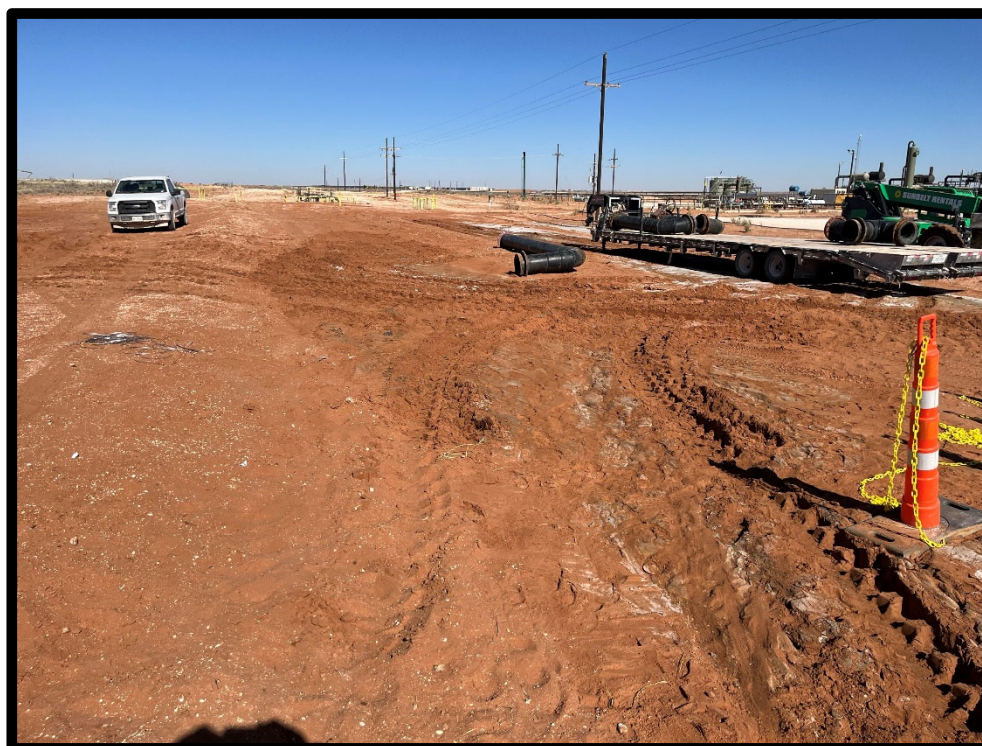
PHOTOGRAPH NO. 2 – An additional view of the Site during the initial response activities. The view is towards the north.
(Approximate GPS Coordinates 32.255630, -103.670813)

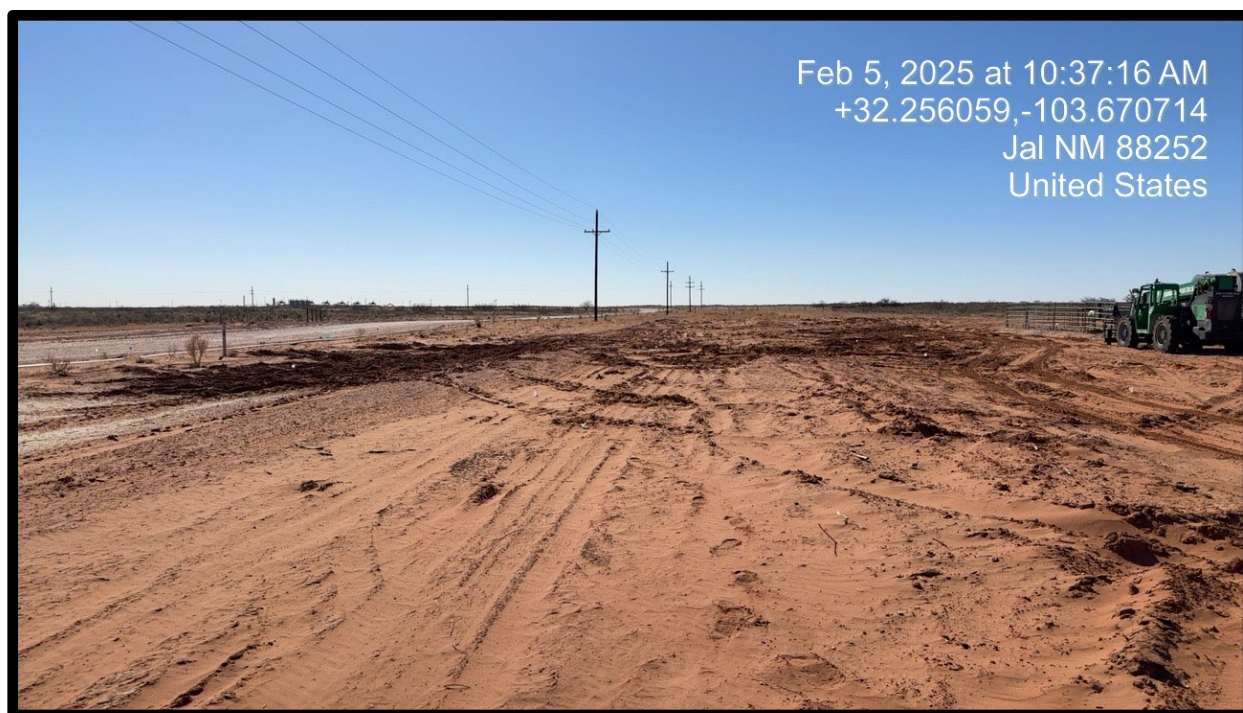
PHOTOGRAPH NO. 3 – A view of the impact area during the February 5, 2025 assessment activities. The view is towards the south.

Ranger recommends soil removal operations to address the elevated chloride concentrations in the soil. Due the presence of multiple underground lines in the impacted area, line spotting via hydrovac soil removal will be necessary for safety purposes within the proposed remediation area. Once all underground lines are identified, excavation activities utilizing earth moving equipment will be completed approximately two feet from the subject utility or a distance as dictated by the lines operator. The remaining material along the lines will be removed by hand excavation. According to available data, the lines are located approximately four feet bgs. Based on the preliminary assessment activities performed by Ranger in February 2025, the estimated size of the excavation area will be approximately 180 feet by 100 feet. The proposed soil removal operations will be completed to a depth of approximately four feet bgs to bring the site into compliance with the proposed site Table 1 Criteria.

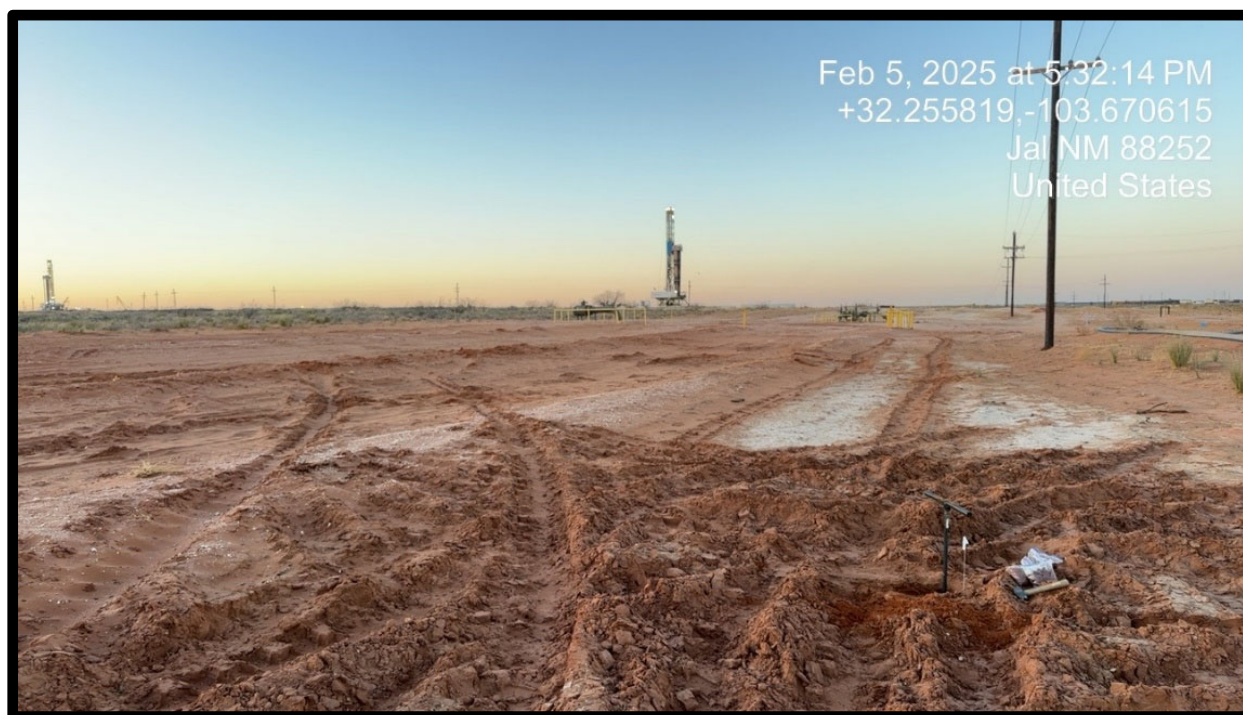
PHOTOGRAPH NO. 4 – An additional view of the Site during the February 5, 2025 assessment activities. The view is towards the northwest.
