Deferral Report
Yukon Gold 31 CTB 2
Incident ID: NAPP2504240482
Unit H Sec 31 T23S R30E
Eddy County, New Mexico
32.26299°, -103.91305°

Produced Water Release
Point of Release: Pinhole developed on a 3" ball valve on water dump line
Release Date: 02.09.2025
Volume Released: 5.706 Barrels of Produced Water
Volume Recovered: 0 Barrels of Produced Water

**Re: Deferral Report
Yukon Gold 31 CTB 2
Devon Energy
Incident ID: NAPP2504240482
Site Location: Unit H, S31, T23S, R30E
(Lat 32.26299°, Long -103.91305°)
Eddy County, New Mexico**

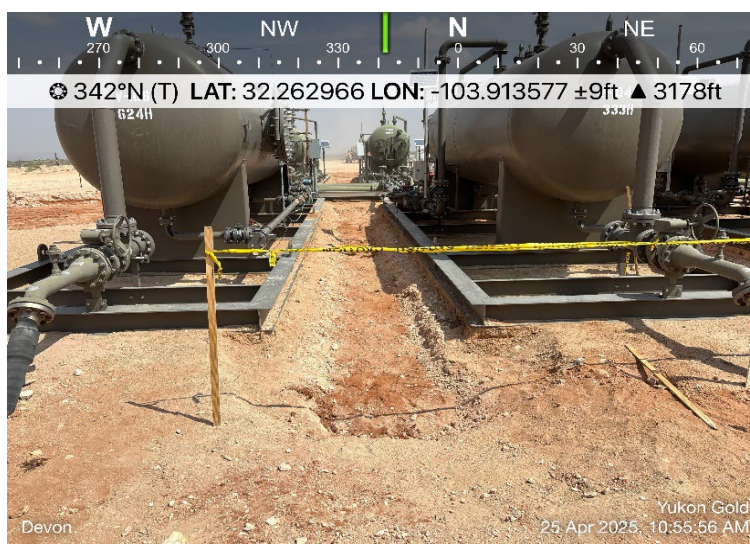
View North, area of CS-1.

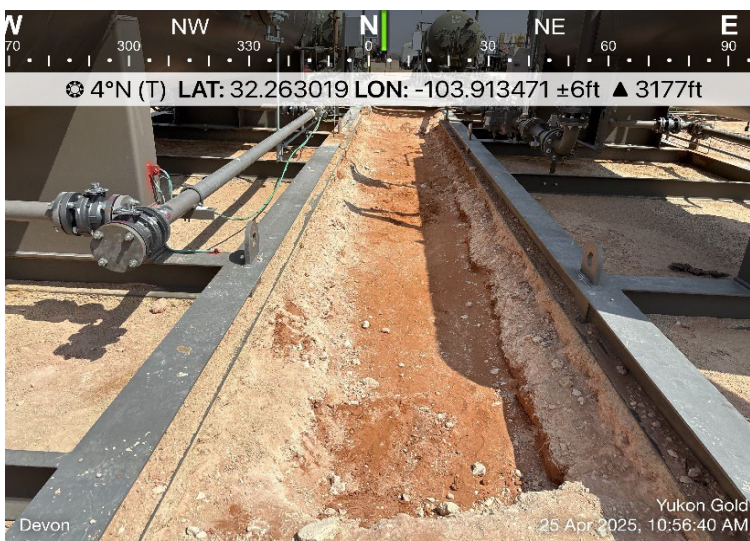
Photograph No. 2

View North, area of CS-2.

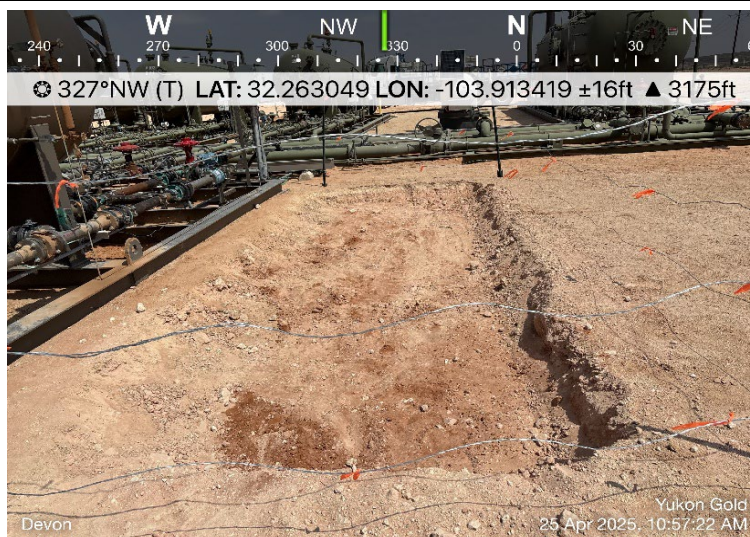
Photograph No. 3

View Northwest, area of CS-3.

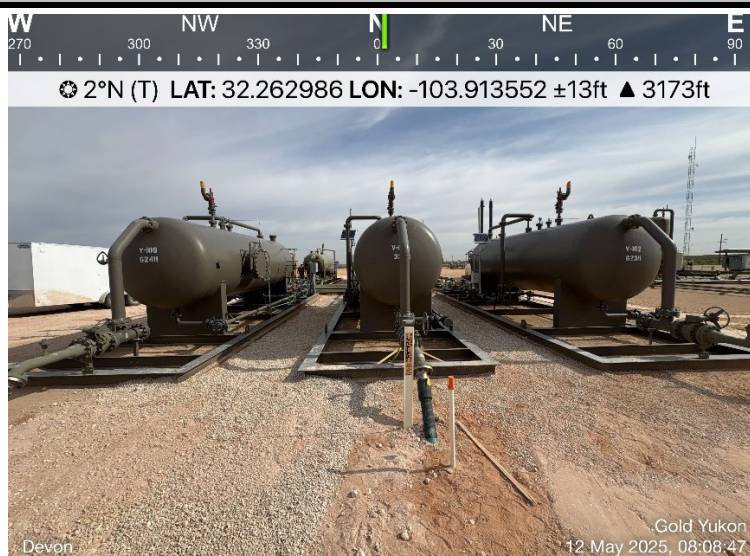
View North of backfilled area.

Once the remediation activities were completed, the excavated areas were backfilled with clean material to surface grade. Approximately 316 square feet of contamination was remediated, resulting in 12 cubic yards of material excavated and transported offsite for proper disposal. Backfill operations were completed on May 12, 2025. The backfill material was sourced from Northern Delaware Basin Landfill and was collected for laboratory analysis on April 25, 2025, before being utilized. Laboratory data can be found in Table 1.

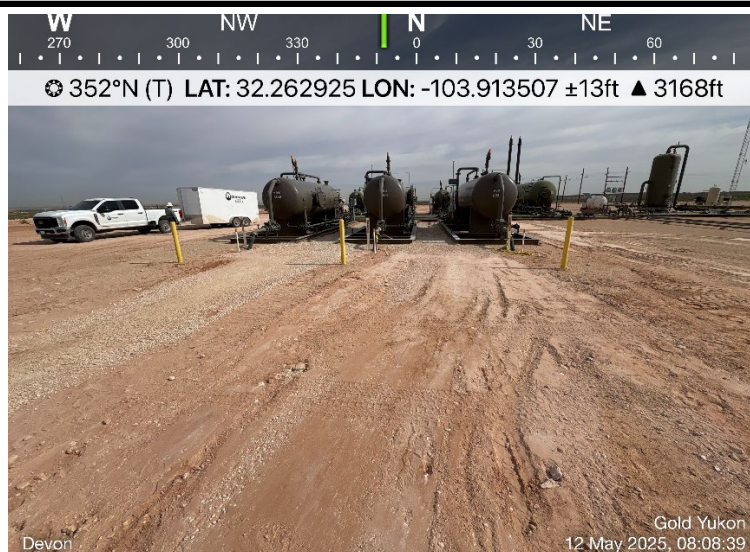
Photograph No. 5

View North of backfilled area.

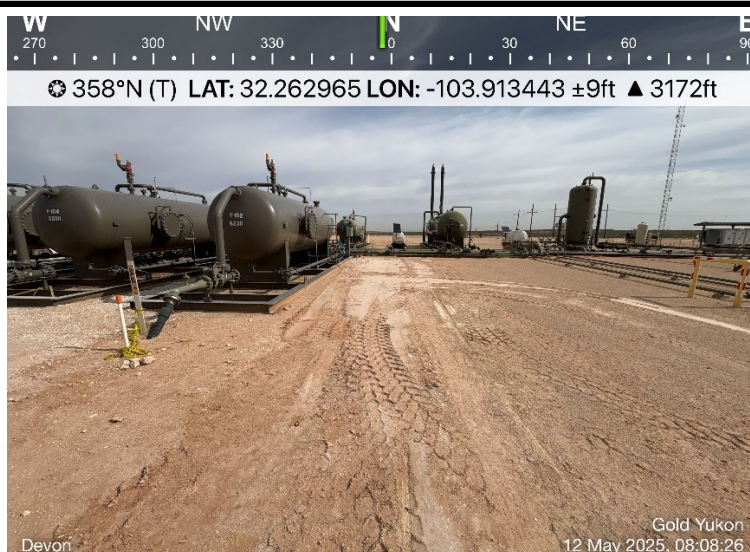
Photograph No. 6

View North of backfilled area.

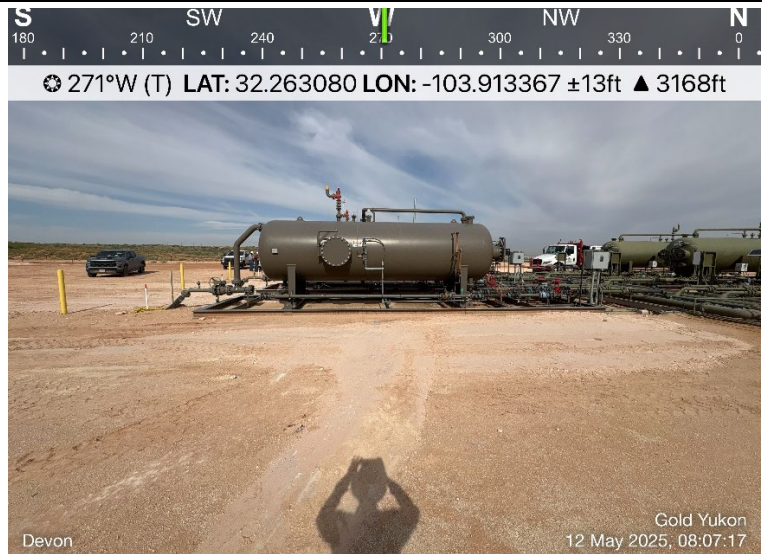
View West of backfilled area.

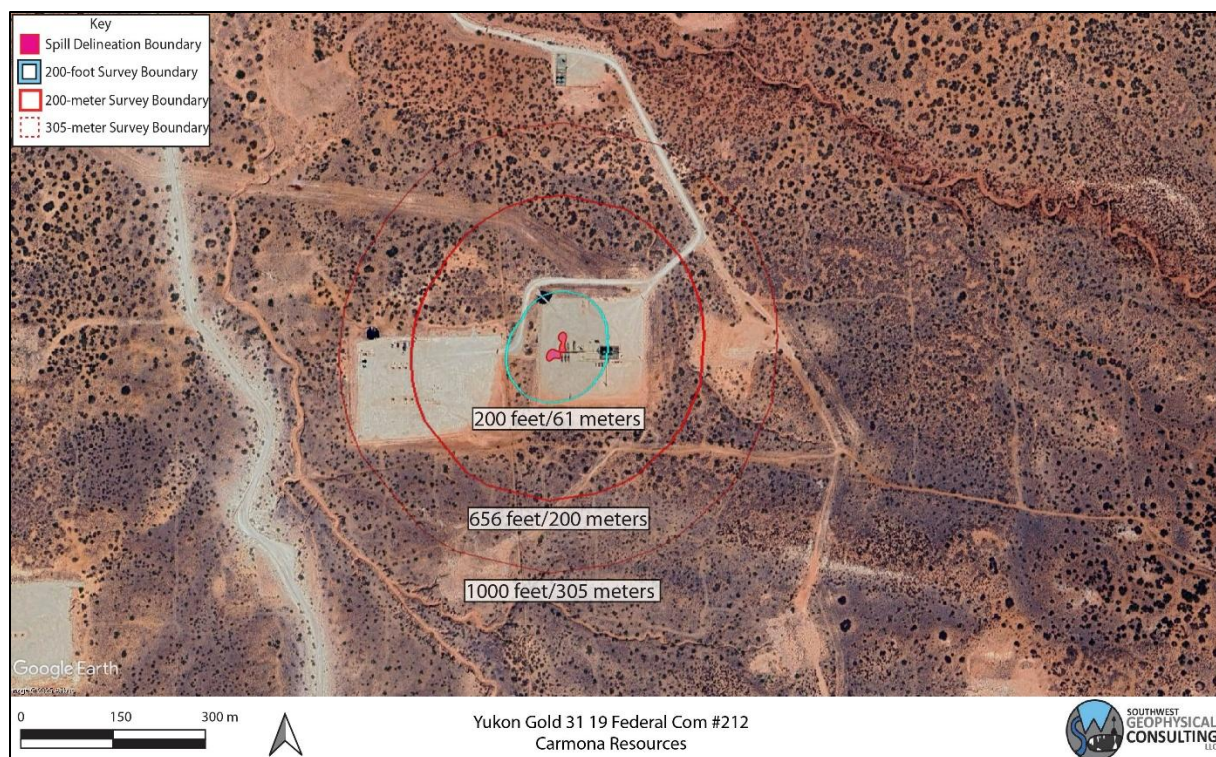
Figure 4: Surface survey overview. Background image credit: Google Earth. Image date: August 21, 2024. Datum: WGS-84.

Aerial karst surveys are conducted at low elevation within 200 meters of the spill delineation boundary^[4] (**Figure 4**) following a preplanned raster pattern flightpath designed for the purpose of generating at least 75% imagery overlap. The collected high-resolution, georeferenced imagery is stitched together to develop orthomosaic imagery which is further developed into a digital elevation model (DEM); the DEM is then processed into a local relief model (LRM) (**Figure 6**). This LRM is color coded to enhance differences in elevation of as little as five centimeters. The orthoimagery, DEM, and LRM are uploaded to a server where they are analyzed by an experienced karst geologist. Finally, the data is reviewed by a senior karst geologist for quality assurance and downloaded into a table for inclusion in a written report^[16].

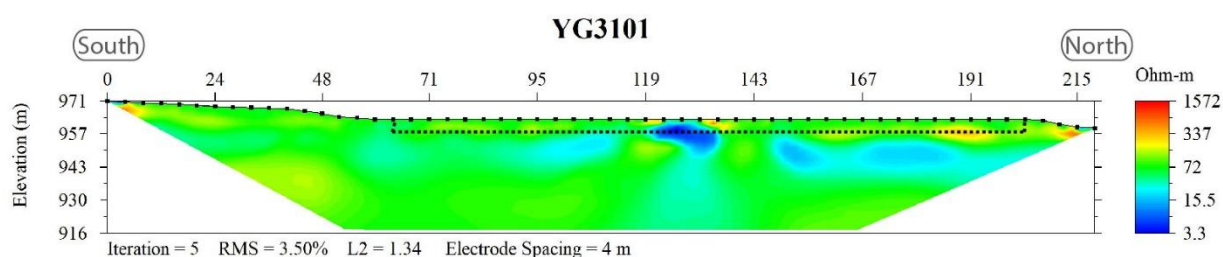
The results of this study indicate a moderately well-layered geologic system with resistivities between 3.3 and 1,572 Ohm-m (**Figure 7**). Please keep in mind when viewing the 2D inverted resistivity sections that color maps can be widely different for each view. Always check the color map located on the right side of the image when viewing the 2D images to ensure you understand the range of resistivities presented. Distances along the top and depths along the left side are in meters. The color map along the right side is in Ohm-m. Due to the nature of the survey, shallower zones have higher resolution between electrodes than deeper zones; therefore, small features at depth will not be visible.

Figure 7: 2D inverted resistivity sections. Reds and oranges indicate higher resistivity values. Yellows and greens are medium-resistivity values. Blues are low-resistivity values. Please note that the color scale is relative. The dashed black line indicates the location of the well pad.

No anomalies consistent with air-filled subsurface voids are found within the YG31 survey area. However, small solutionally enlarged voids or fractures at or near the resolution limit of the survey (1.5 – 2.0 meters) may be present. Slightly higher-than-average resistivity areas less than 10 meters beneath the surface are interpreted as dry caliche or gypsite soils. Due to their low resistivity values when compared with significant subsurface voids, these features should not be a concern during remediation efforts. Areas of moderate resistivity (yellows, and greens) near the surface are interpreted as dry gypsite soils and gypsum bedrock of the Rustler Formation^[17] (**Figure 7** and **Figure 8**).

The low-resistivity area between 3.3 – 15 Ohm-m is interpreted to represent fluid from the brine release. Other low resistivity areas between 15 and 50 may represent surface-to-subsurface hydrologic pathways, or a layer of either clays and halite lenses or moist or saturated layers within the Rustler Formation. (**Figure 7**).

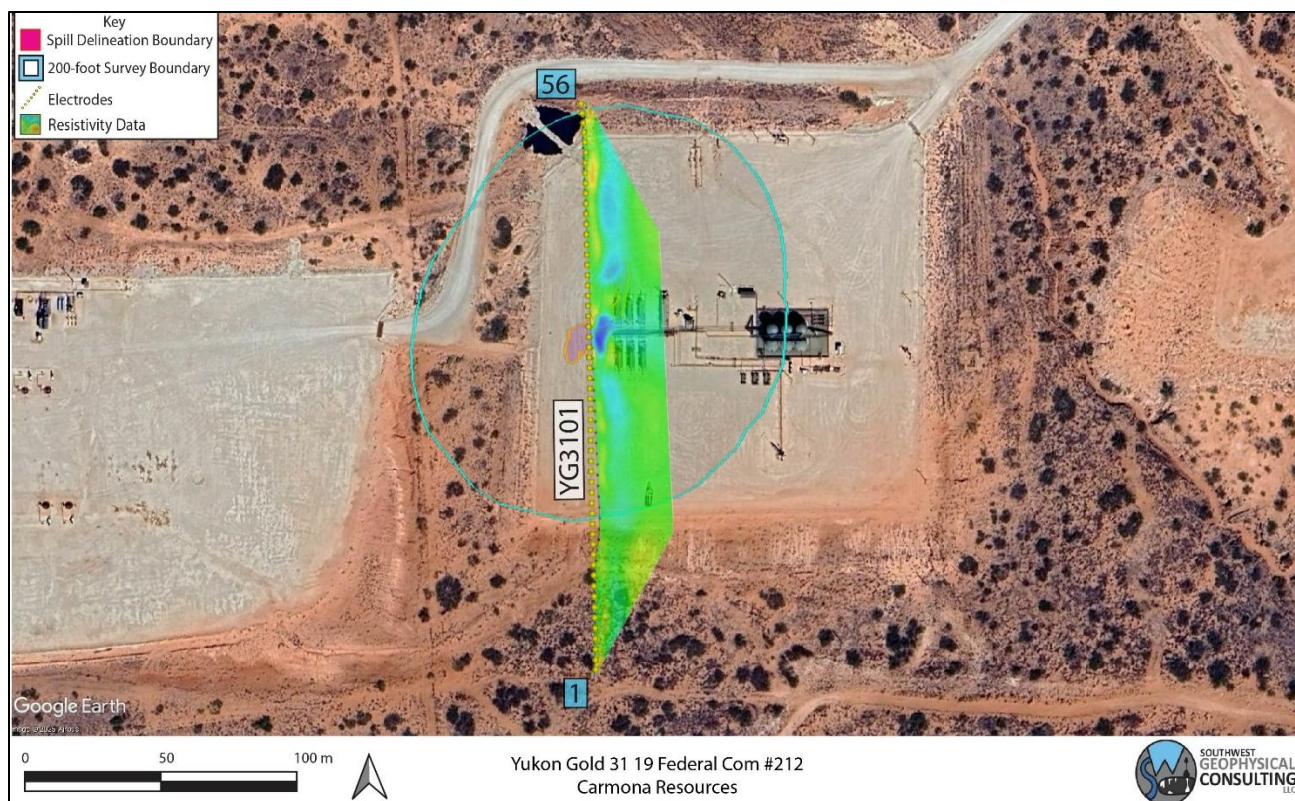
Figure 8: Data overlay. Colored trapezoid is the 2D inverted resistivity line. Background image credit: Google Earth. Image date: March 20, 2023.

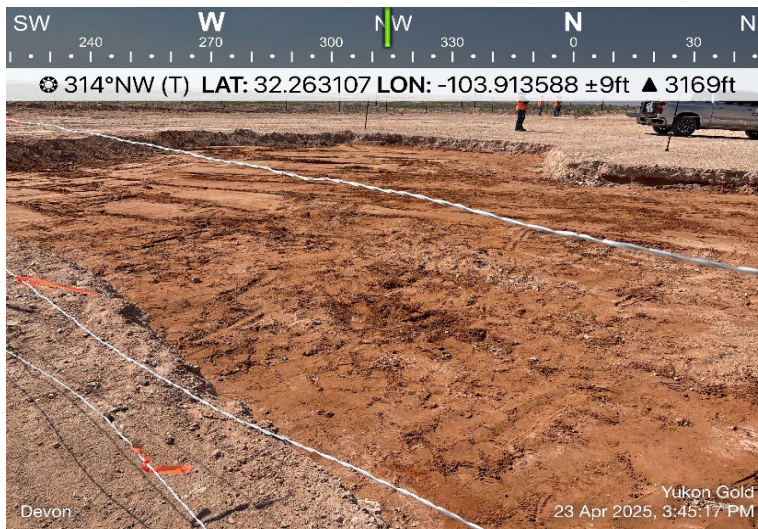
Photograph No. 2

View Northwest, area of CS-1 through CS-12.

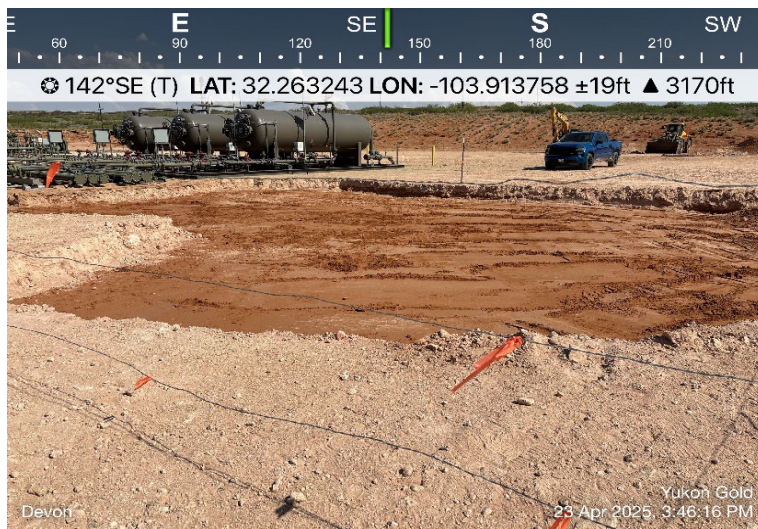
Photograph No. 3

View Southeast, area of CS-1 through CS-12.

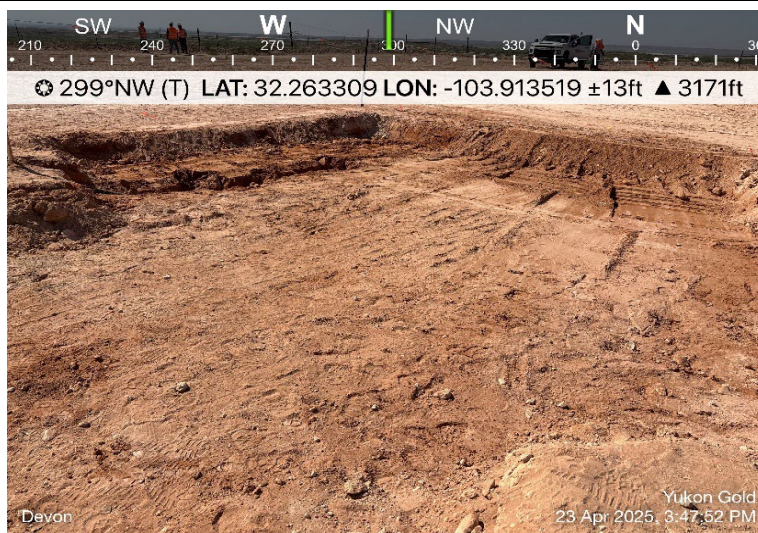
View Northwest, area of CS-13.

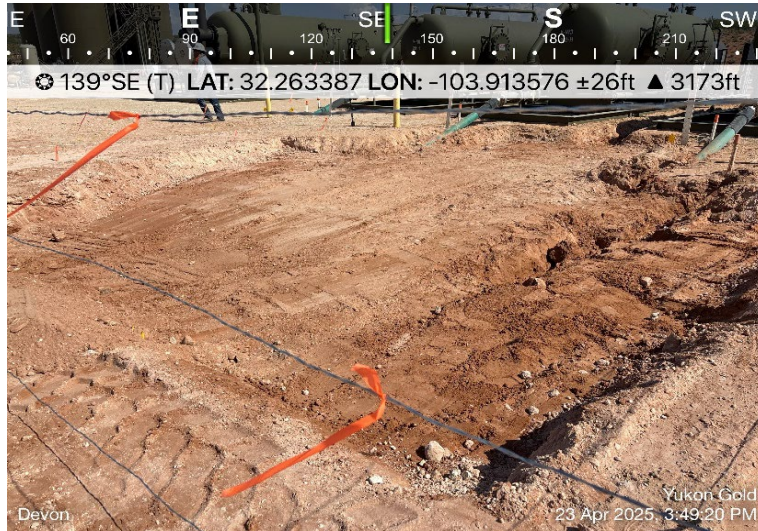
Photograph No. 5

View Southeast, area of CS-13.

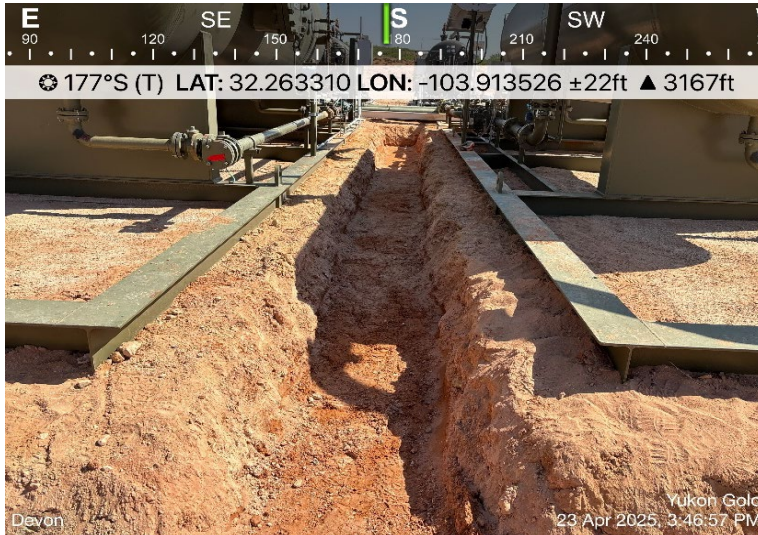
Photograph No. 6

View South, area of CS-14.

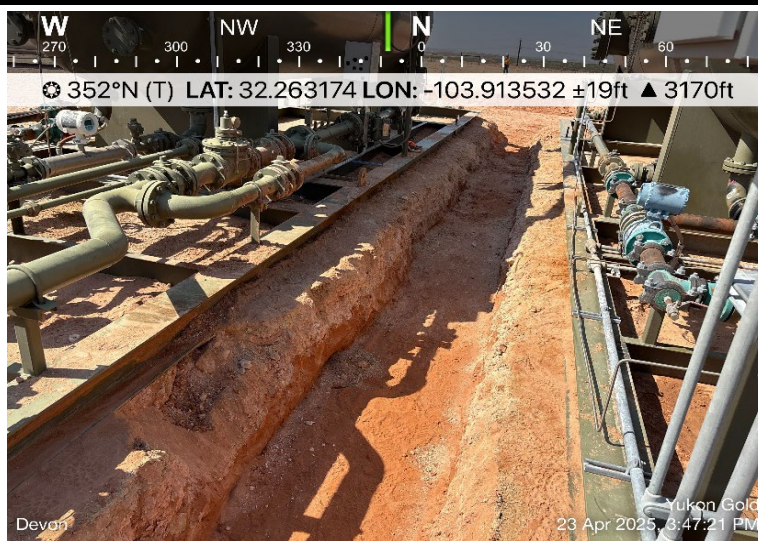
View North, area of CS-14.

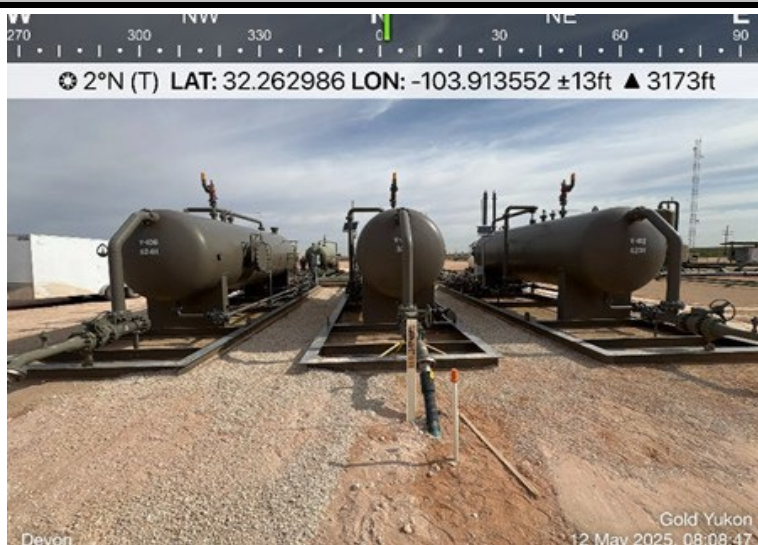
Photograph No. 8

View North of backfilled area of CS-14

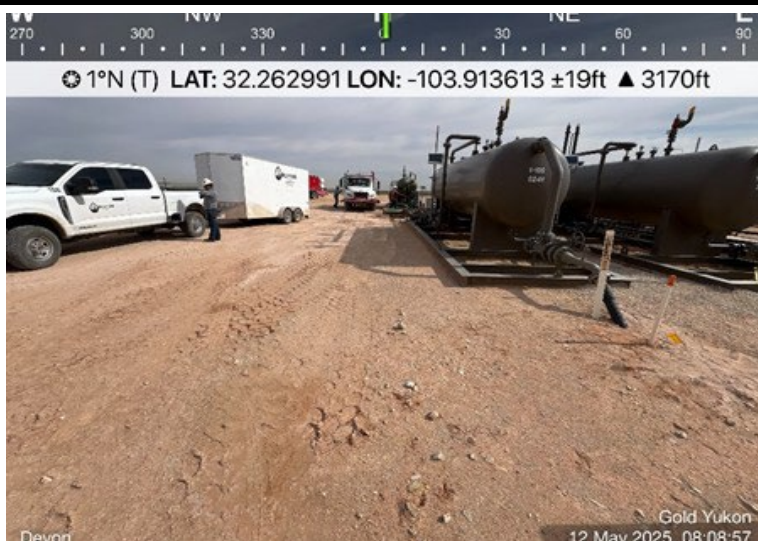
Photograph No. 9

View North of backfilled areas of CS-1 through CS-12

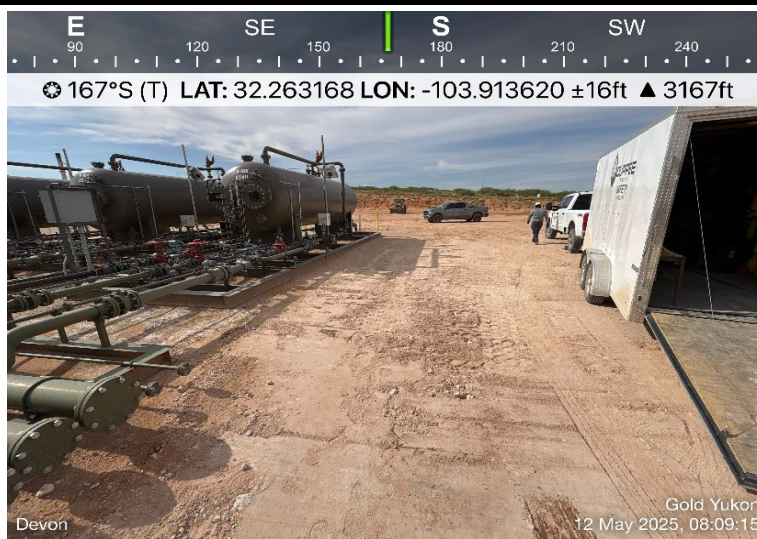
View South of backfilled areas of CS-1 through CS-12

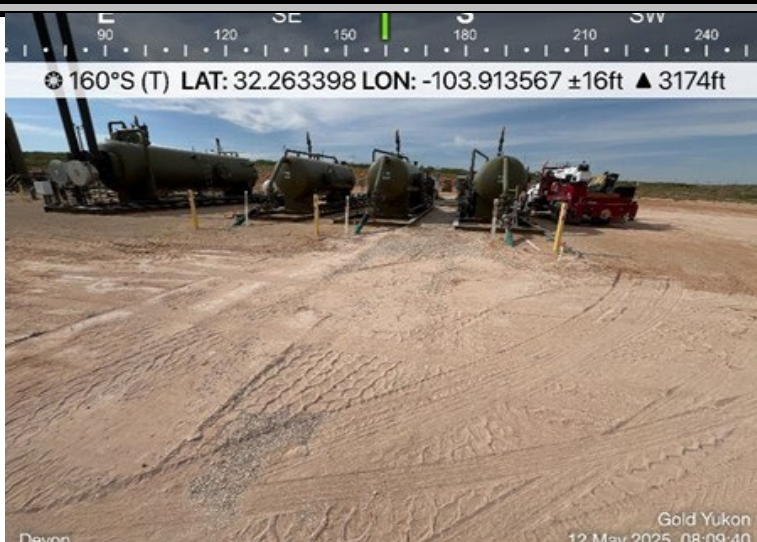
Photograph No. 11

View South of backfilled area of CS-13

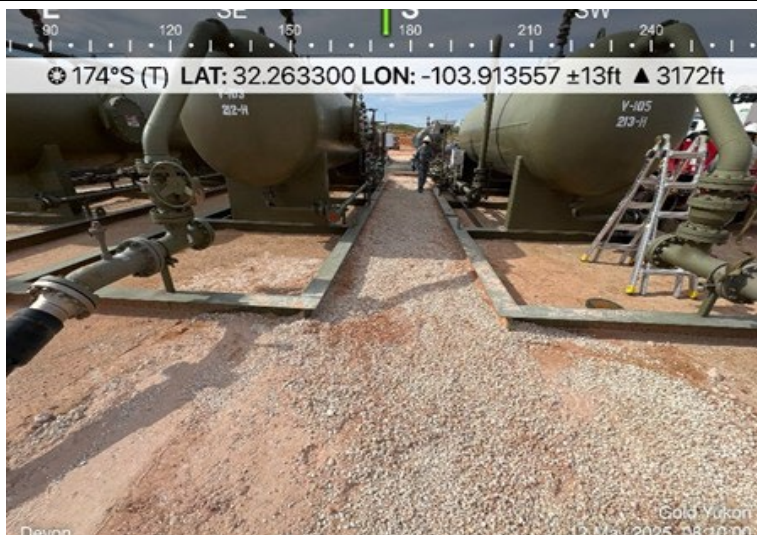
Photograph No. 12

View South of backfilled area CS-14.

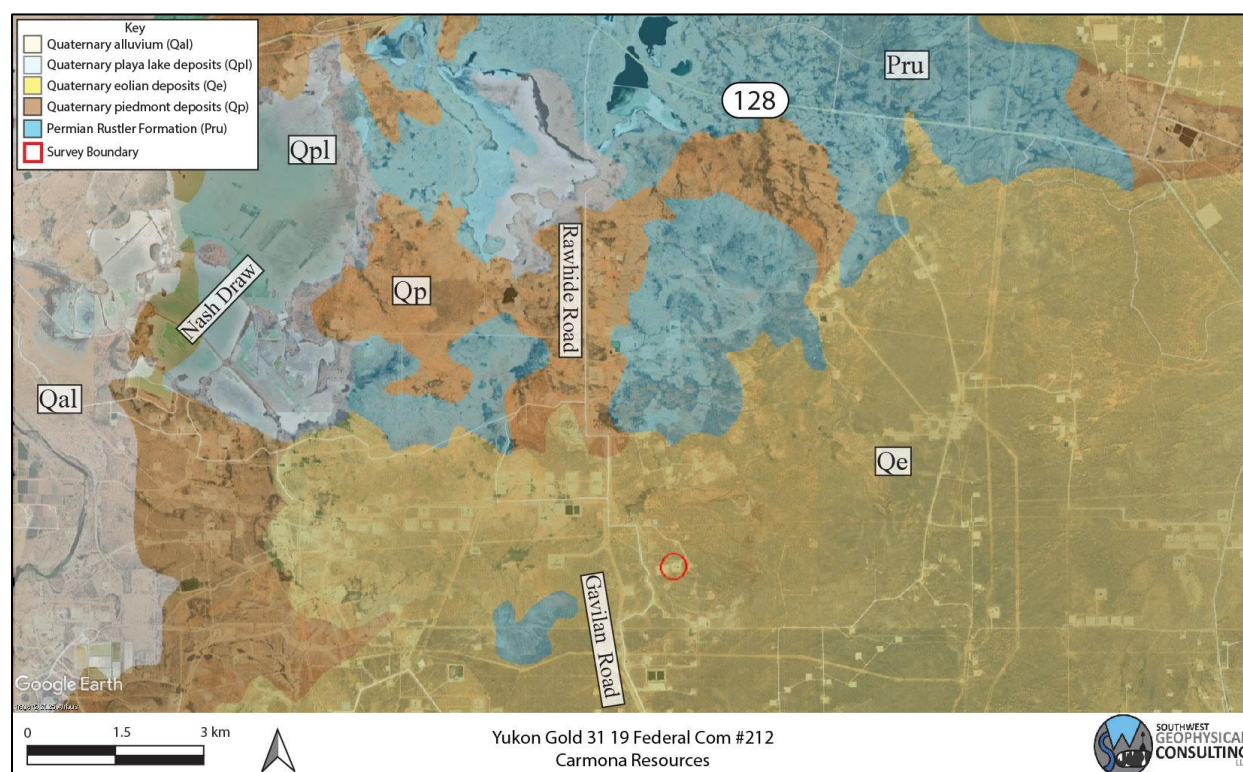
Figure 3: Geology overview. Geology map credit: The Digital Geologic Map of New Mexico in ARC/INFO Format. Background image credit: Google Earth. Image date: August 21, 2024. Image datum: WGS-84.

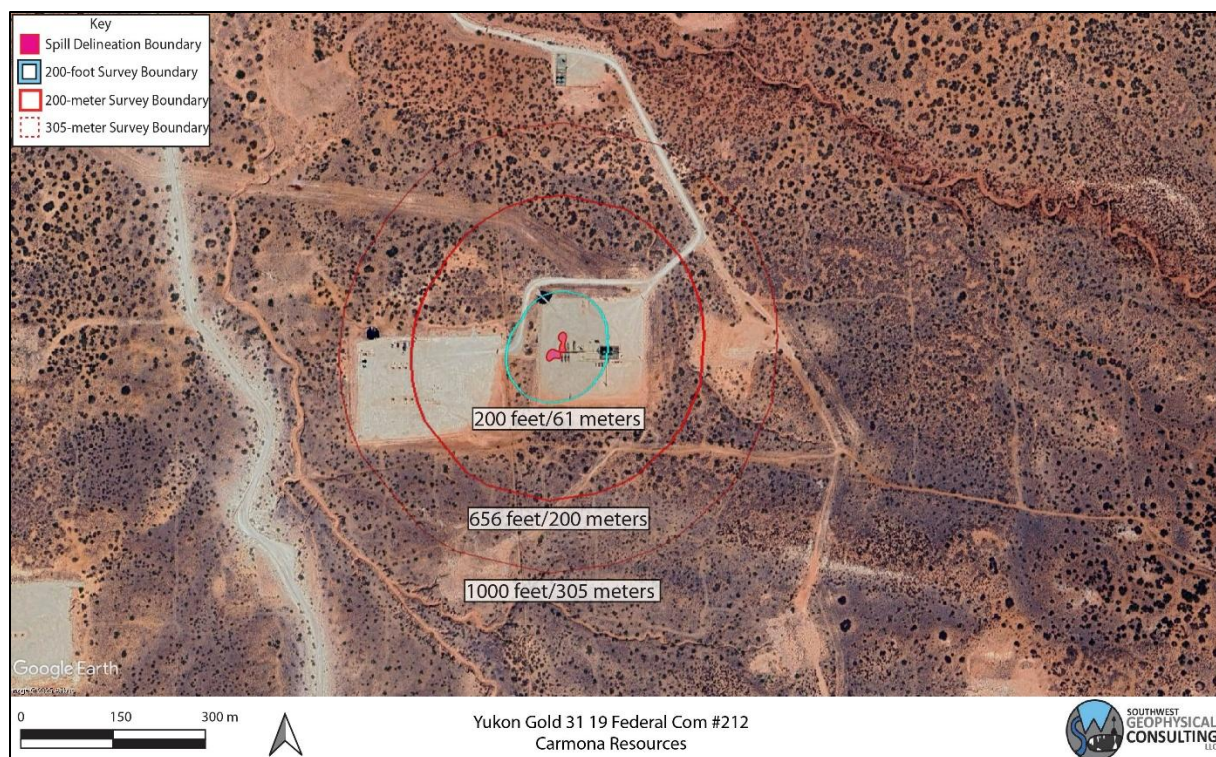
Figure 4: Surface survey overview. Background image credit: Google Earth. Image date: August 21, 2024. Datum: WGS-84.

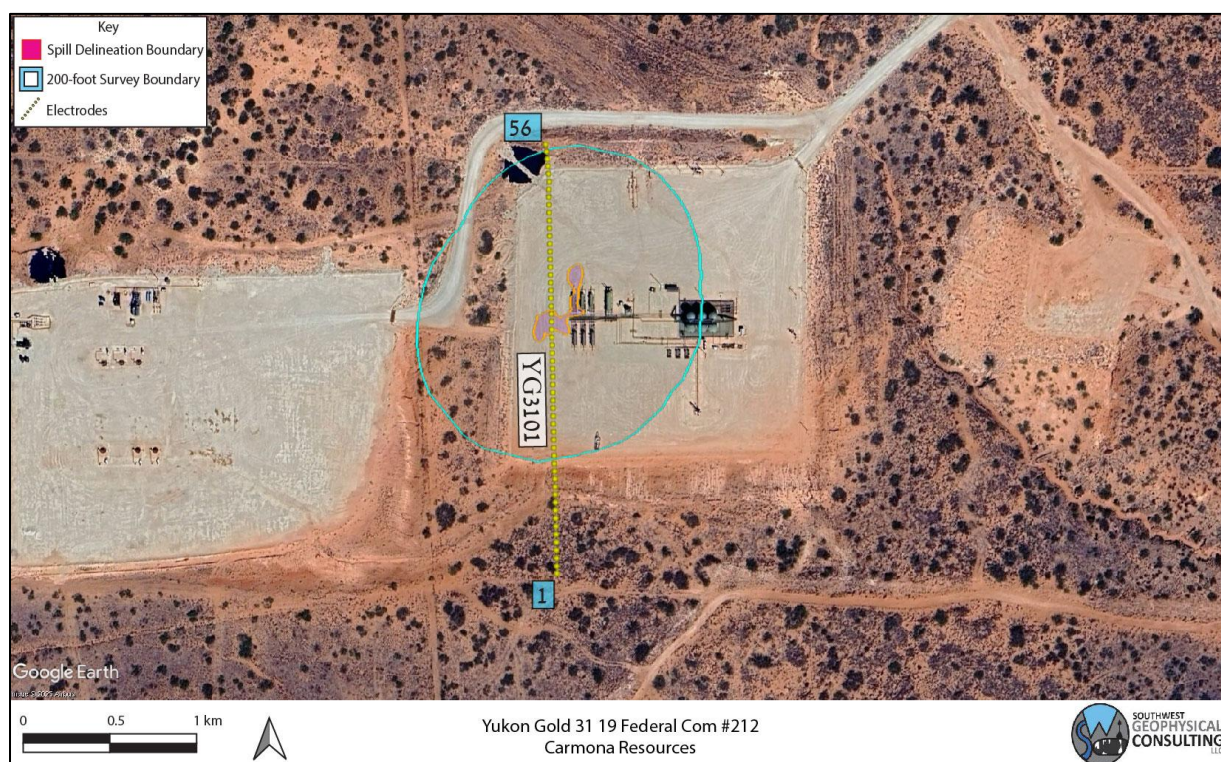
For this survey, an Advanced Geosciences Inc. (AGI) SuperSting™ Wifi R8 with a multi-electrode switchbox, a 56-electrode array of 40-centimeter-long electrodes, and a tablet controller were used to image the subsurface. This survey consisted of one resistivity line in a dipole-dipole strong-gradient configuration laid out south to north. The single line consisted of 56 electrodes at 4-meter spacing, resulting in a 220-meter-long array (**Figure 5, Table 1**). A preconfigured command file was used to run the data collection (DDSG56). This electrode configuration provided a depth of investigation of 44 meters (144 feet) and a resolution of 2.0 to 2.5 meters (6.6 to 8.2 feet) within the first 5 to 8 meters (16 to 26 feet) from the surface. A Leica GS18 GPS was used to record electrode locations and elevations.

Figure 5: Geophysical survey overview. One survey line was conducted with 56 electrodes each at 4-meter spacing (yellow dots denoted with blue numbers). Background image credit: Google Earth. Image date: August 21, 2024. Image datum: WGS-84.

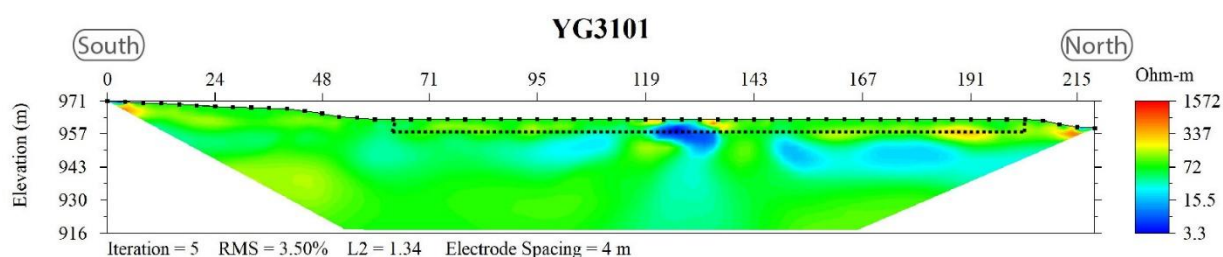
The results of this study indicate a moderately well-layered geologic system with resistivities between 3.3 and 1,572 Ohm-m (**Figure 7**). Please keep in mind when viewing the 2D inverted resistivity sections that color maps can be widely different for each view. Always check the color map located on the right side of the image when viewing the 2D images to ensure you understand the range of resistivities presented. Distances along the top and depths along the left side are in meters. The color map along the right side is in Ohm-m. Due to the nature of the survey, shallower zones have higher resolution between electrodes than deeper zones; therefore, small features at depth will not be visible.

Figure 7: 2D inverted resistivity sections. Reds and oranges indicate higher resistivity values. Yellows and greens are medium-resistivity values. Blues are low-resistivity values. Please note that the color scale is relative. The dashed black line indicates the location of the well pad.

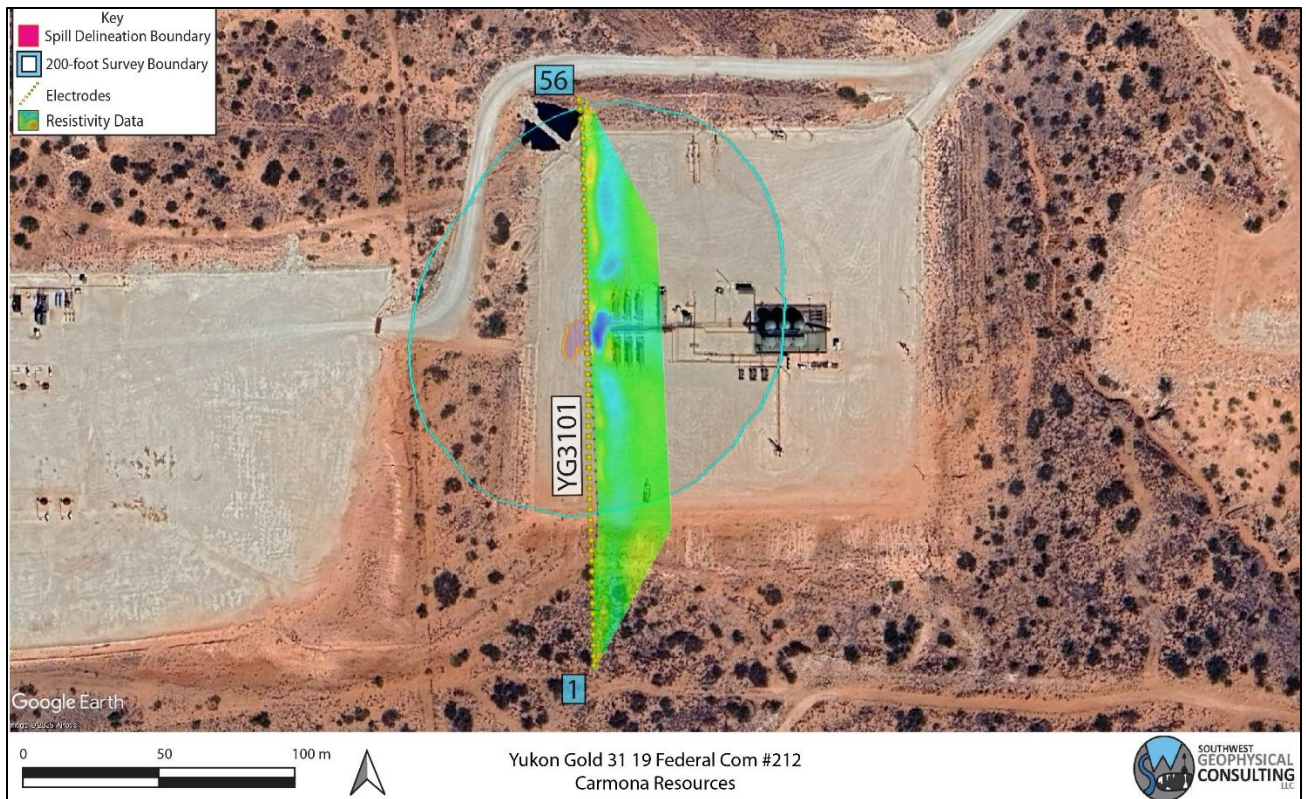
Figure 8: Data overlay. Colored trapezoid is the 2D inverted resistivity line. Background image credit: Google Earth. Image date: March 20, 2023.
