## Closure Report

PLU 23 DTD CVB

API/Facility ID: fAPP2325847913

ExxonMobil Upstream Company

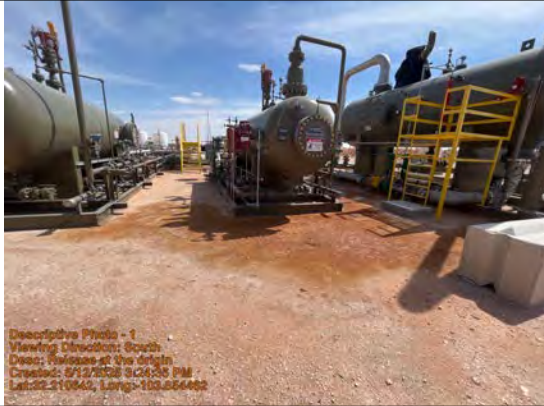
Release at the origin

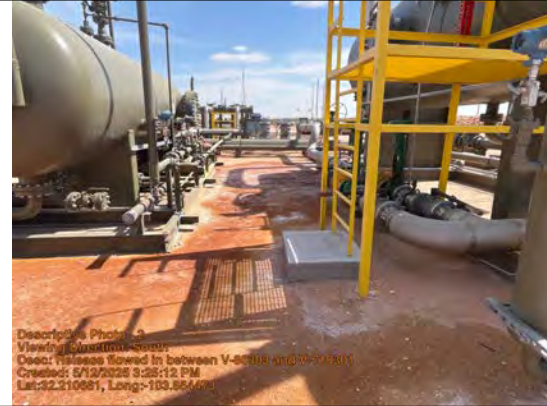
Release flowed in between V-80303 and V-710301

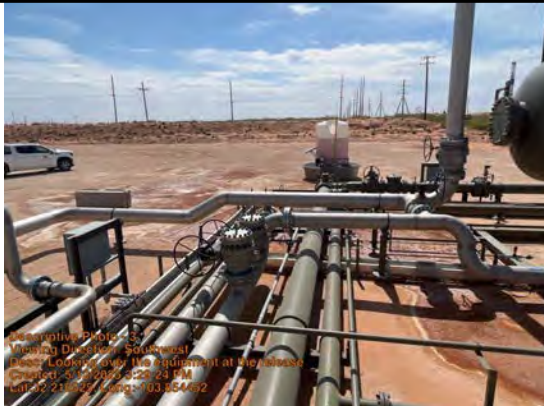
Looking over the equipment at the southwest area of the release

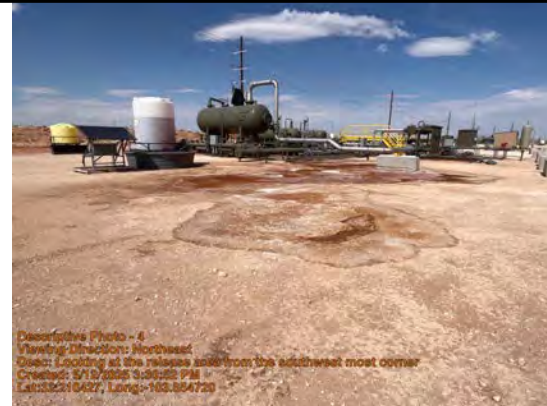
Looking at the release area from the southwest most corner

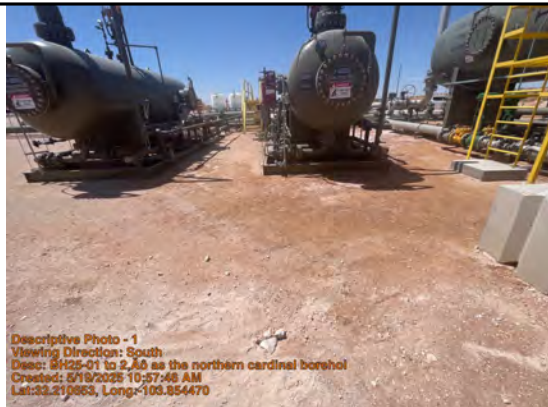
BH25-01 to 2' as the northern cardinal borehole

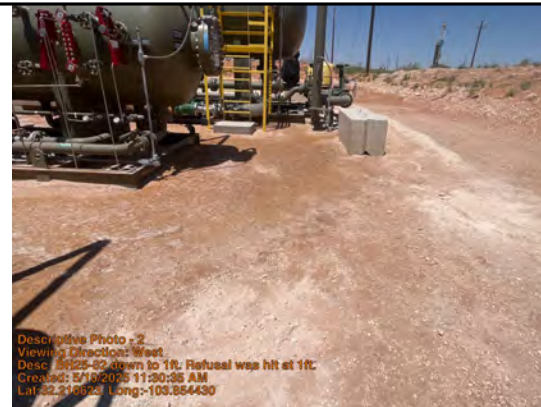
BH25-02 down to 1ft. Refusal was hit at 1ft. At the eastern extent of the visible release

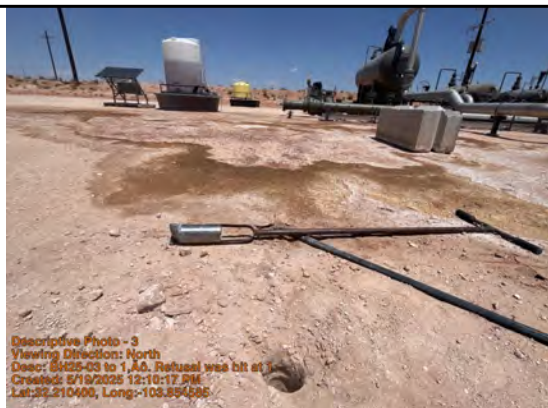
BH25-03 to 1'. Refusal was hit at 1'. This borehole is the southern extent

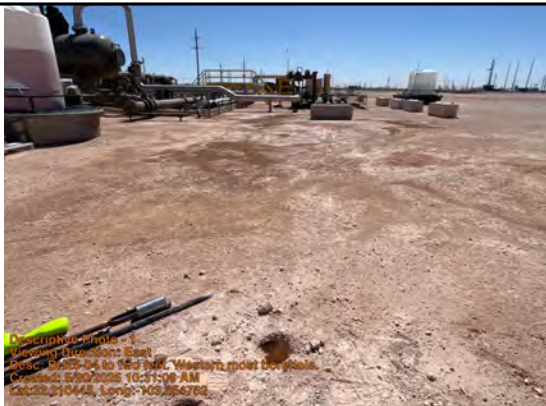
BH25-04 to two feet. Western most borehole.  
Hit refusal at 2ft

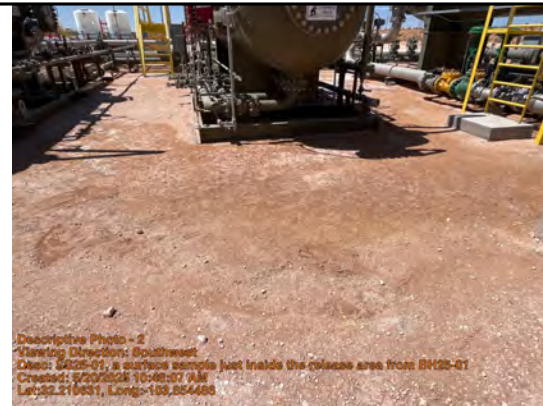
SS25-01, a surface sample just inside the  
release area from BH25-01

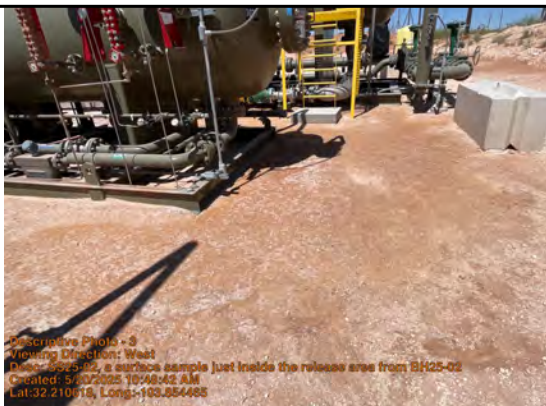
SS25-02, a surface sample just inside the  
release area from BH25-02

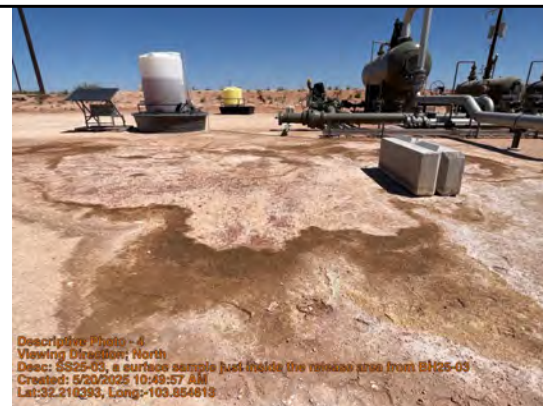
SS25-03, a surface sample just inside the  
release area from BH25-03

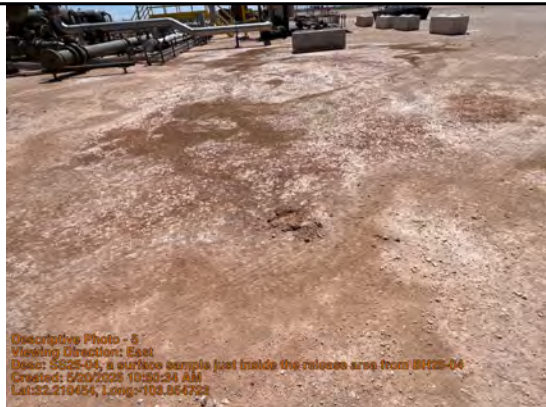
SS25-04, a surface sample just inside the release area from BH25-04

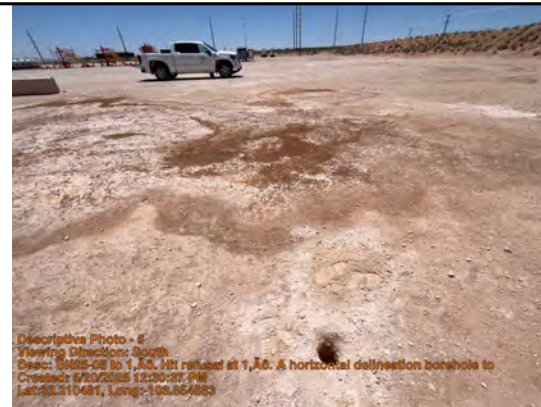
BH25-05 to 1'. Hit refusal at 1'. A horizontal delineation borehole to the north of the southern section of the release

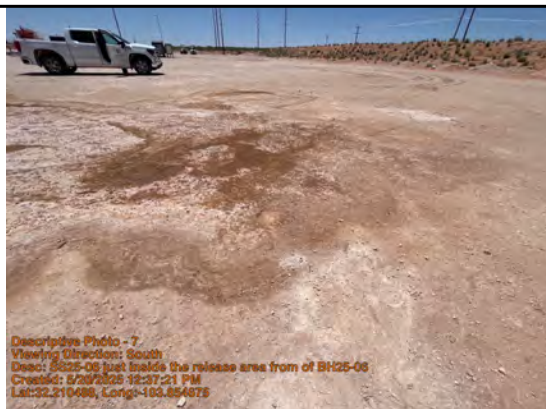
SS25-05 just inside the release area from of BH25-05

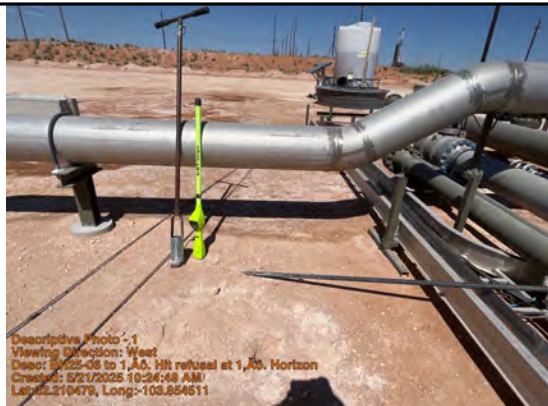
BH25-06 to 1'. Hit refusal at 1'. Horizontal

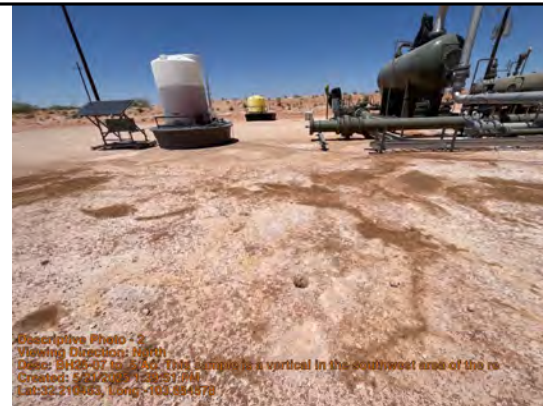
BH25-07 to .5'. This sample is a vertical in the southwest area of the release

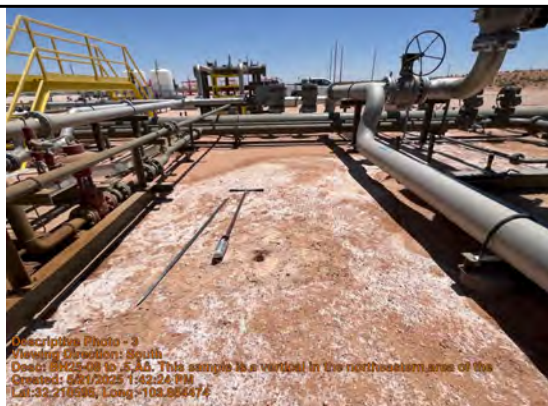
BH25-08 to .5'. This sample is a vertical in the northeastern area of the release

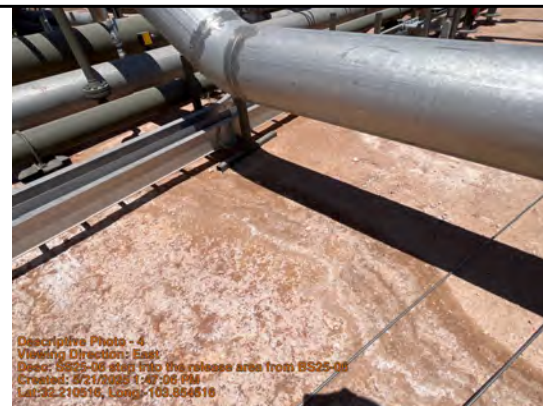
SS25-06 step into the release area from BS25-06

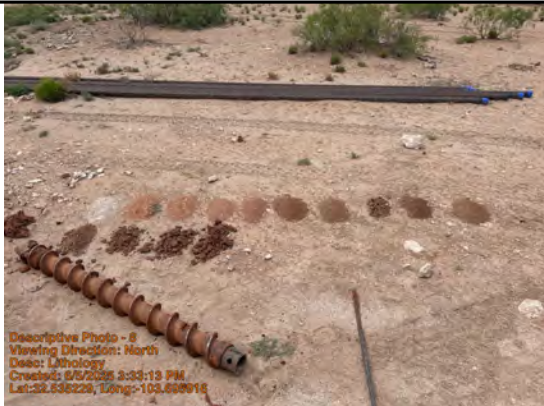
| <p><b>Viewing Direction: West</b></p> <p><small>Descriptive Photo - 7<br/>Viewing Direction: West<br/>Desc: Total well depth<br/>Created: 6/5/2025 3:34:05 PM<br/>Lat:32.535238, Long: -103.595894</small></p> <p>Total well depth 105.8'</p> | <p><b>Viewing Direction: North</b></p> <p><small>Descriptive Photo - 8<br/>Viewing Direction: North<br/>Desc: Lithology<br/>Created: 6/5/2025 3:35:13 PM<br/>Lat:32.535238, Long: -103.595894</small></p> <p>Lithology</p> |

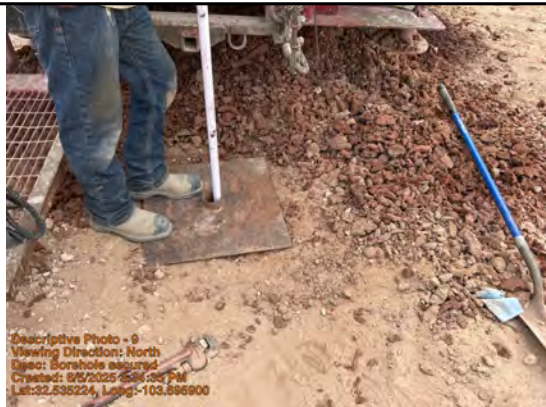
Borehole secured

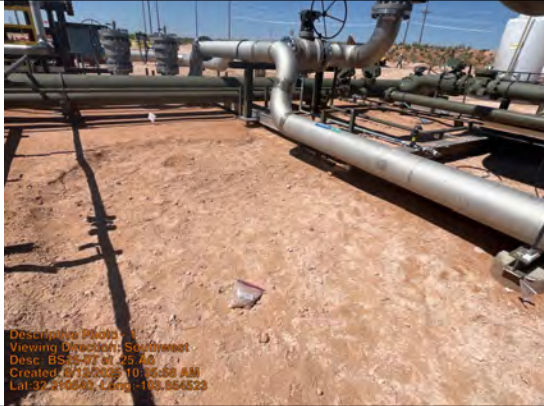
BS25-07 at .25'.

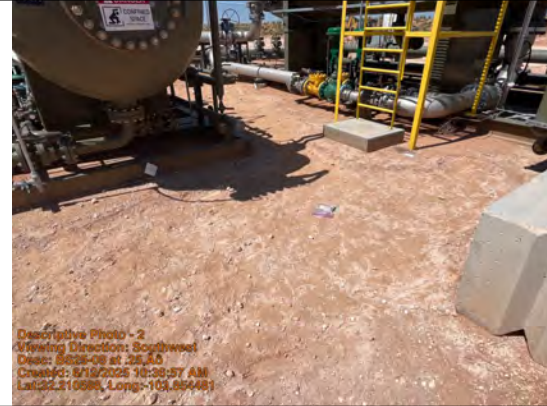
BS25-08 at .25'.

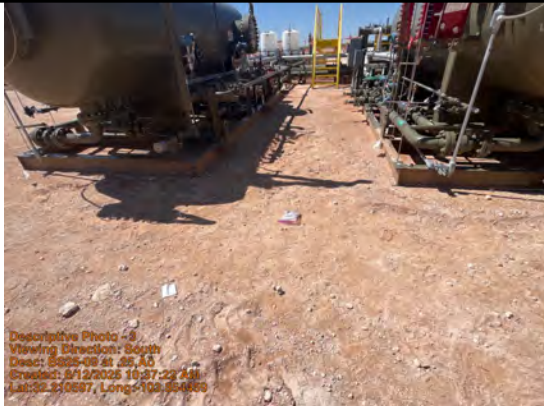
BS25-09 at .25'.

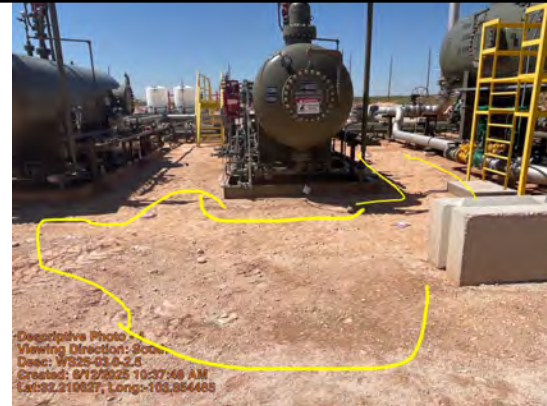
WS25-03 0-2.5. Around base samples 7-9

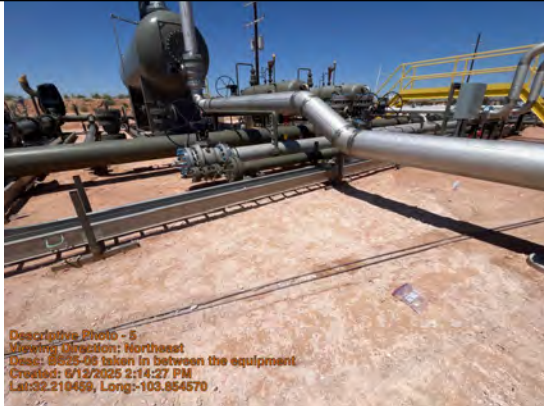
BS25-06 field screened from in between the equipment

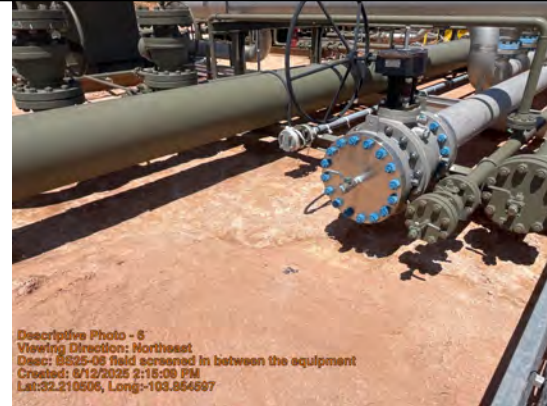
BS25-06 field screened in between the equipment

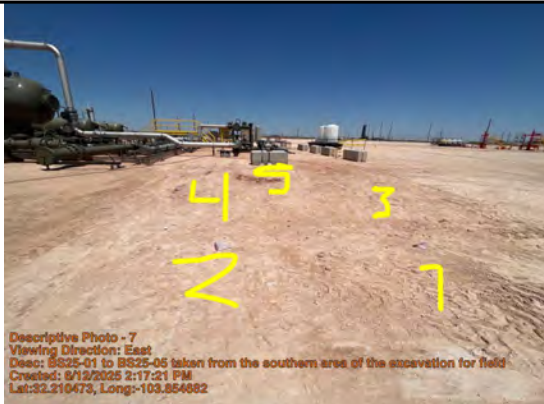
BS25-01 to BS25-05 taken from the southern area of the excavation for field screening

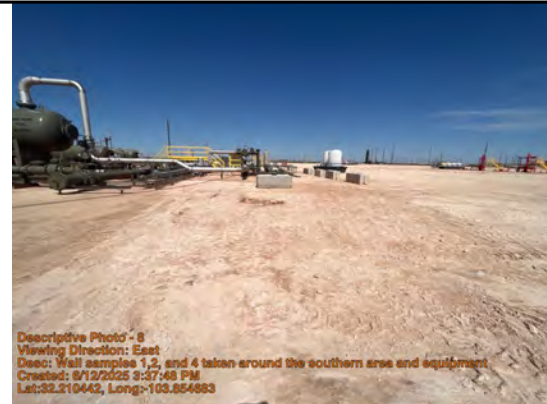
Wall samples 1,2, and 4 taken around the southern area and equipment for field screening

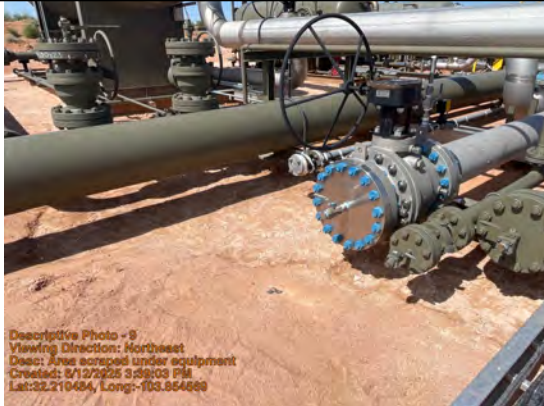
Area scraped under equipment

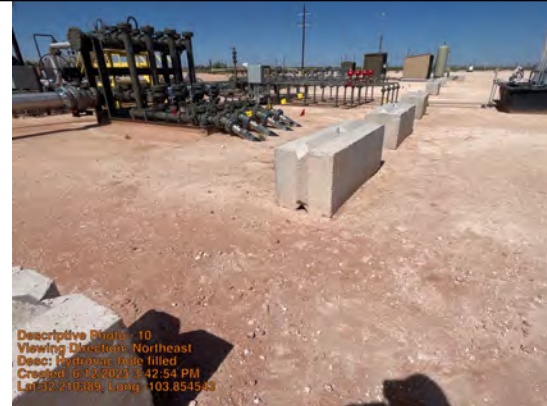
Hydrovac hole filled

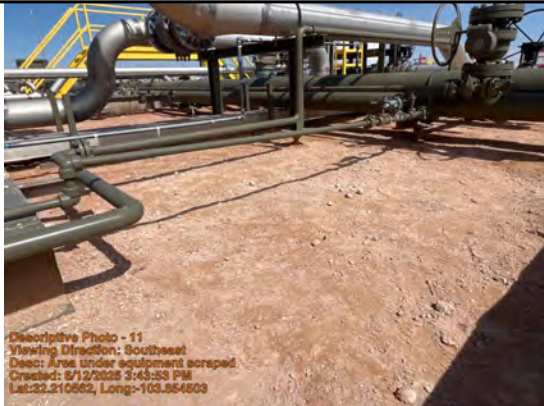
Area under equipment scraped

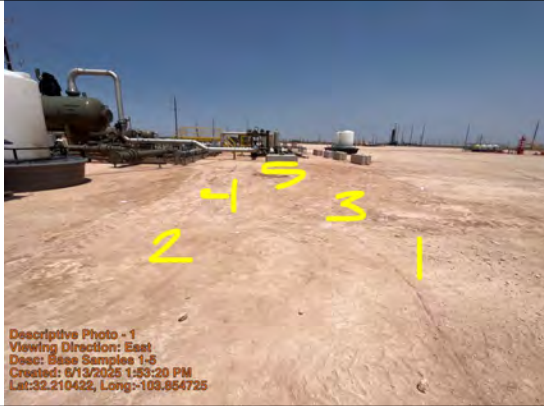
Base Samples 1-5

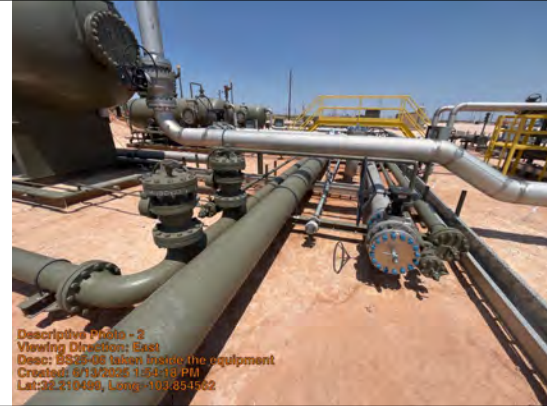
BS25-06 taken underneath the equipment

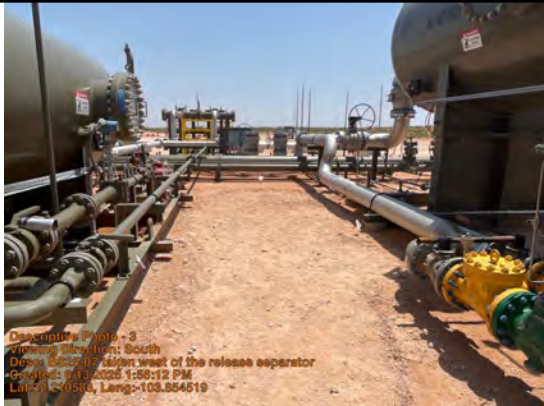
BS25-07 taken west of the release separator

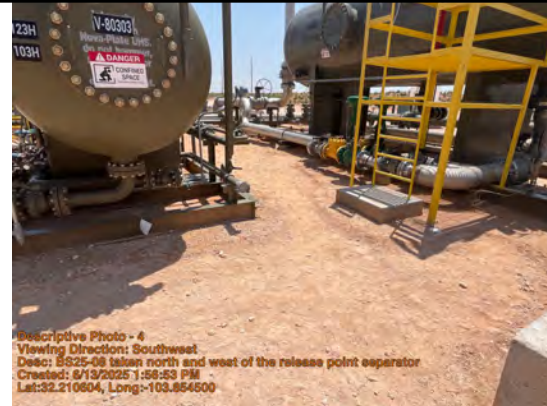
BS25-08 taken north and west of the release point separator

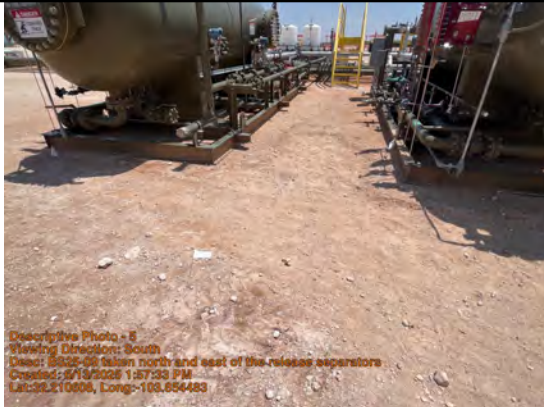
BS25-09 taken north and east of the release separators

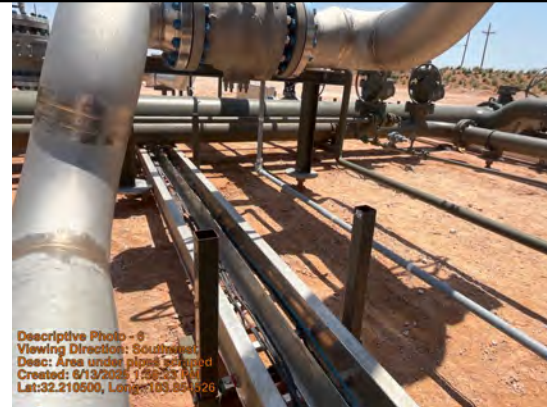
Area under pipes scraped

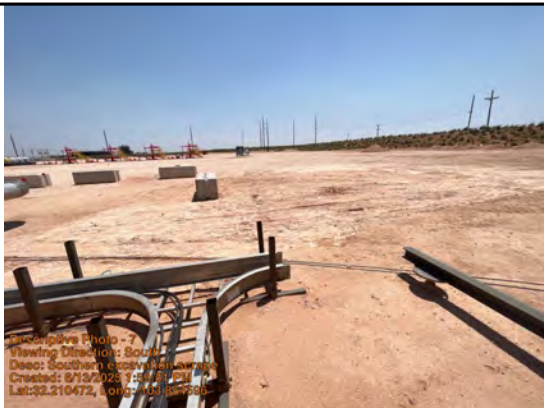
Southern excavation scrape

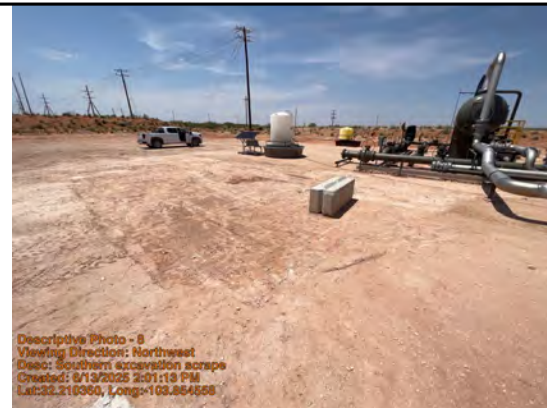
Southern excavation scrape
