July 23, 2025

Re: Site Characterization and Remediation Closure Request
Devon Energy Production Company
Hackberry Trunk Line 1700 FT SW of Mimosa 24 Fed 1
Unit H, Section 23, Township 19S, Range 31E
Site Coordinates: 32.647379, -103.833283
Eddy County, New Mexico
Incident ID: nAPP2427861348

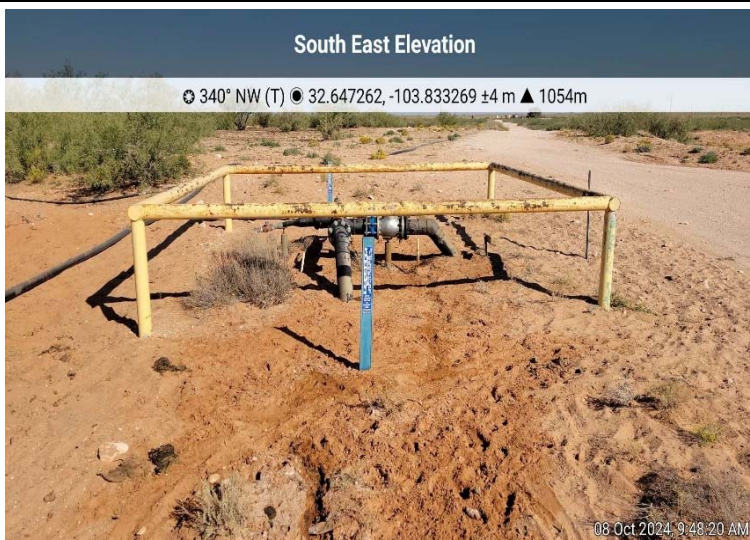
**Photograph No. 2**

Description:
Area of Concern

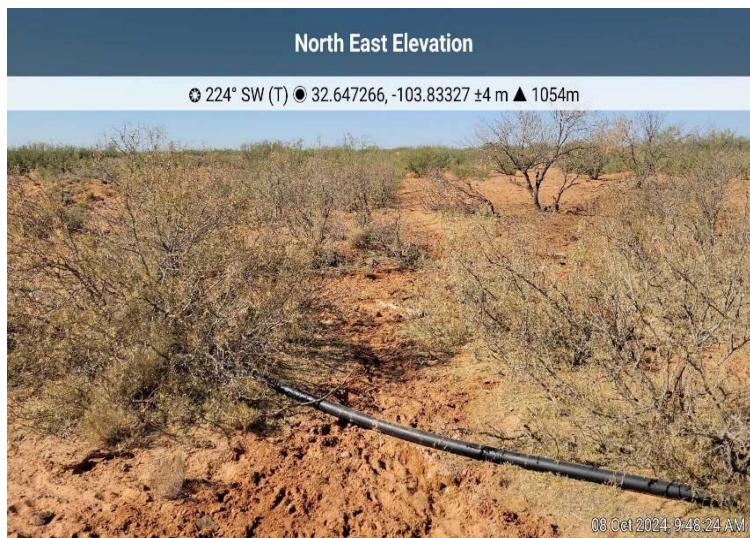
Photograph No. 4

Description:
Area of Concern

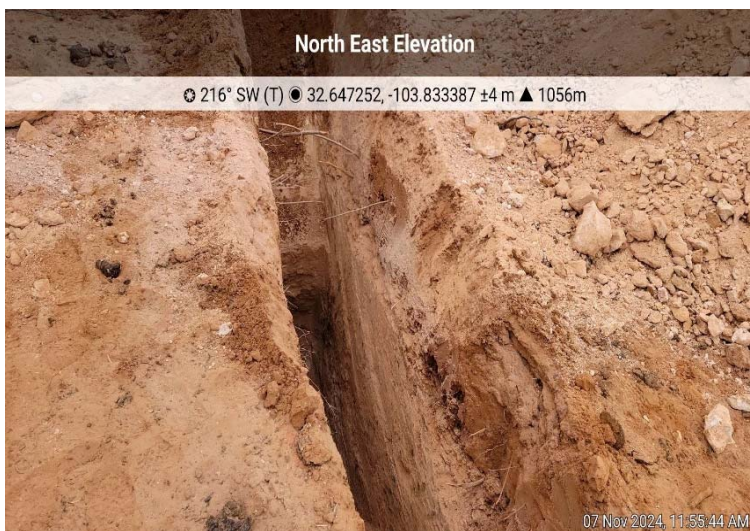
**Photograph No. 5**

Description:
Test Pit Installation

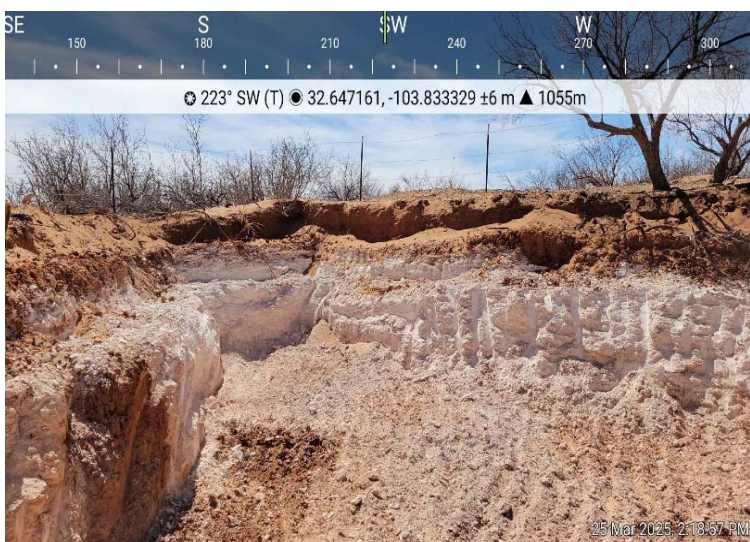
**Photograph No. 8**

Description:
Confirmation Sampling (1st Round)

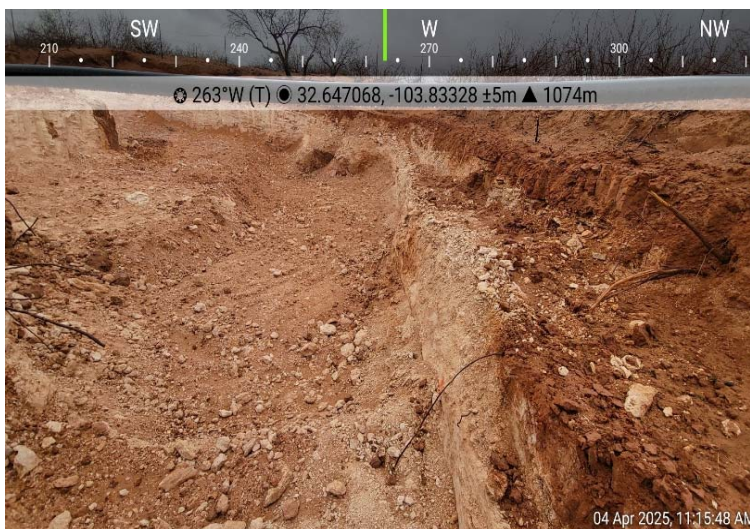
**Photograph No. 11**

Description:
Confirmation Sampling (2nd Round)

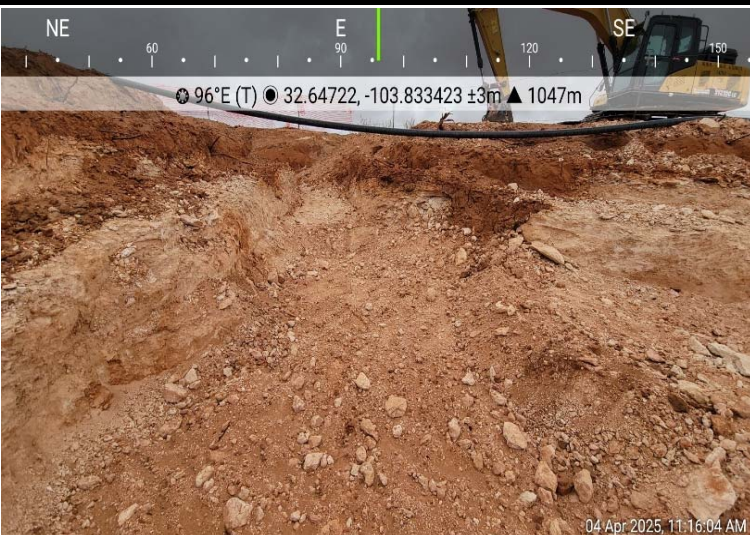
**Photograph No. 12**

Description:
Confirmation Sampling (2nd Round)

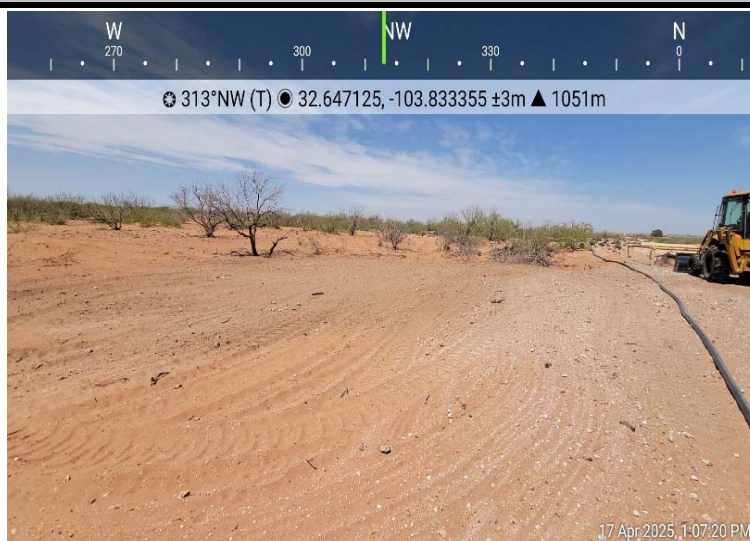
Photograph No. 13

Description:
Backfill photos of site

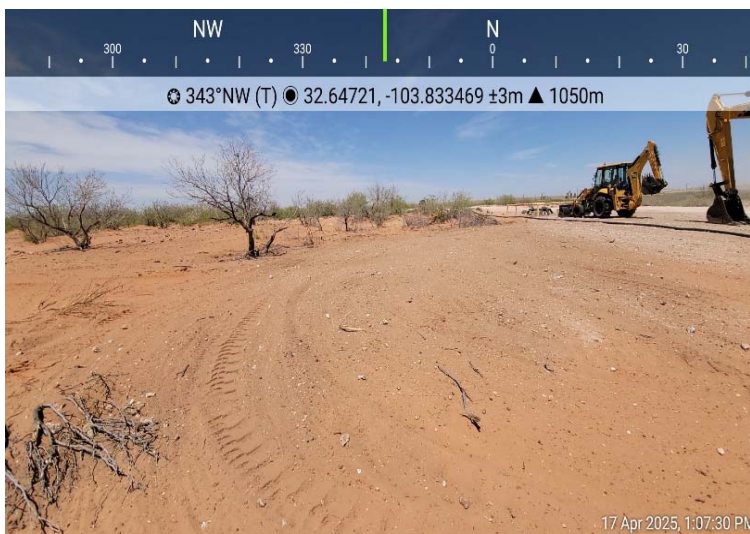
**Photograph No. 14**

Description:
Backfill photos of site
