Remediation Summary & Soil Closure Request

Mewbourne Oil Company Apollo Chile Verde Water Transfer Line

Eddy County, New Mexico
Unit Letter "J", Section 15, Township 21 South, Range 27 East
Latitude 32.4780968 North, Longitude 104.1706733 West
NMOCD Reference No. nAPP2315849467

Etech Environmental & Safety Solutions, Inc.
6309 Indiana Ave, Ste. D
Lubbock, Texas 79413

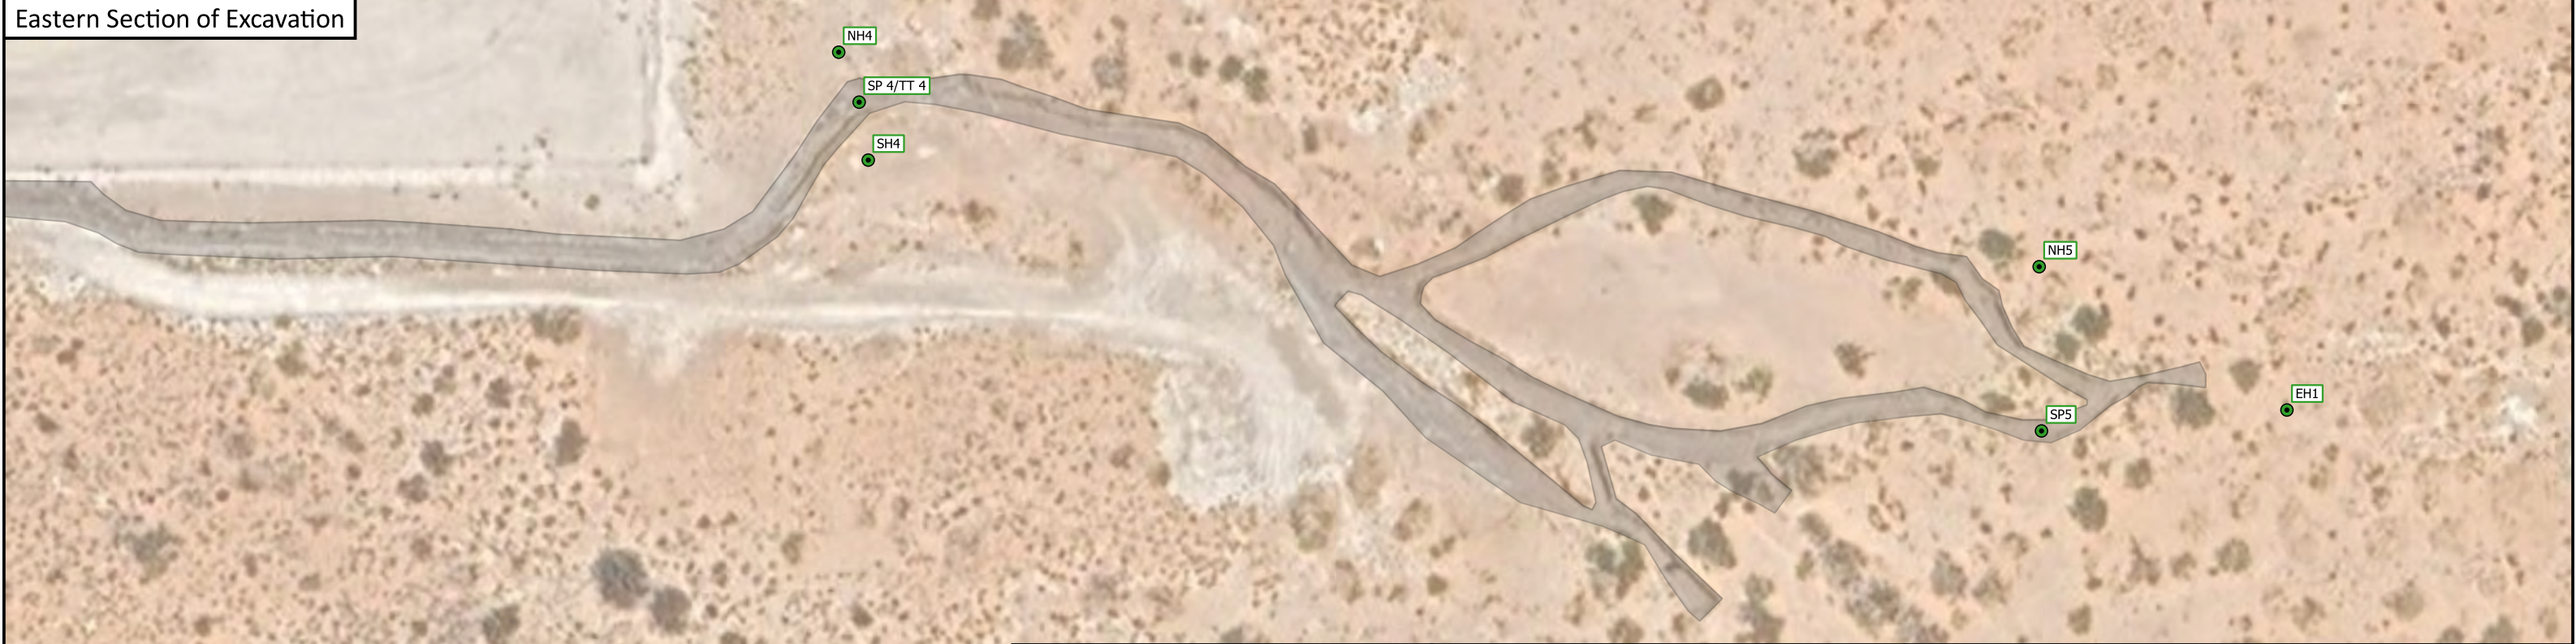
Figure 4C
Excavation Sample Location Map
Eastern Section
Apollo Chile Verde Water Transfer Line
GPS: 32.4780968, -104.1706733
Eddy County, New Mexico

Eastern Section of Excavation

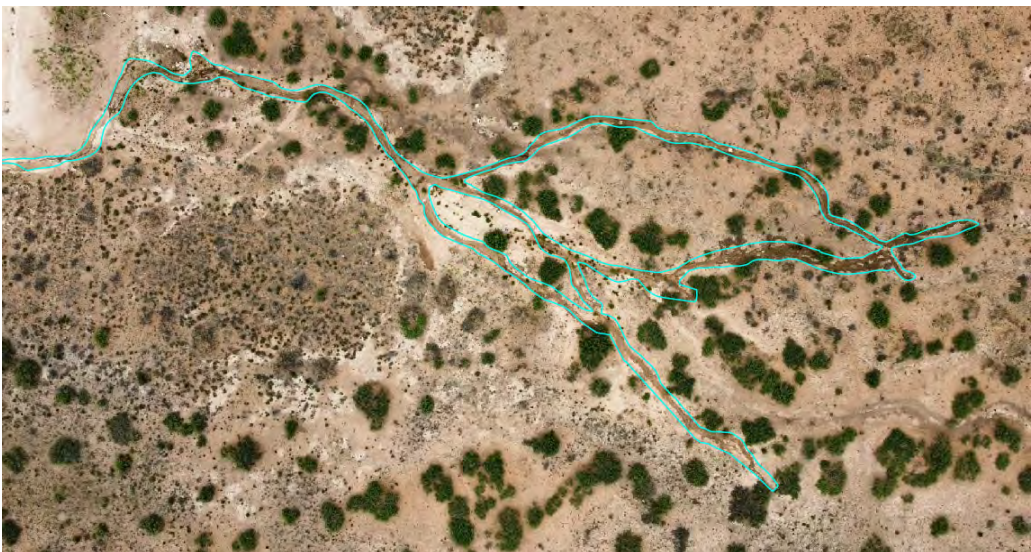
Photo Number: 1

Photo Direction: Overhead/Bird's Eye	
Coordinates: 32.477686,-104.165391	
Date/Time: 5/20/23, Time Unknown	
Photo Description: Aerial view of the eastern portion of the affected area (outlined in cyan).

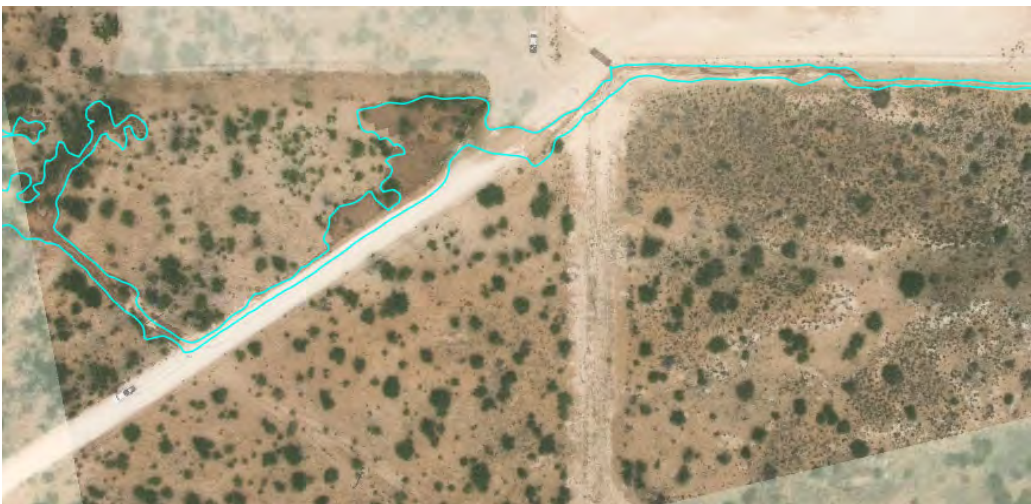
Photo Number: 2

Photo Direction: Overhead/Bird's Eye	
Coordinates: 32.477570,-104.167615	
Date/Time: 5/20/23, Time Unknown	
Photo Description: Aerial view of the central portion of the affected area (outlined in cyan).

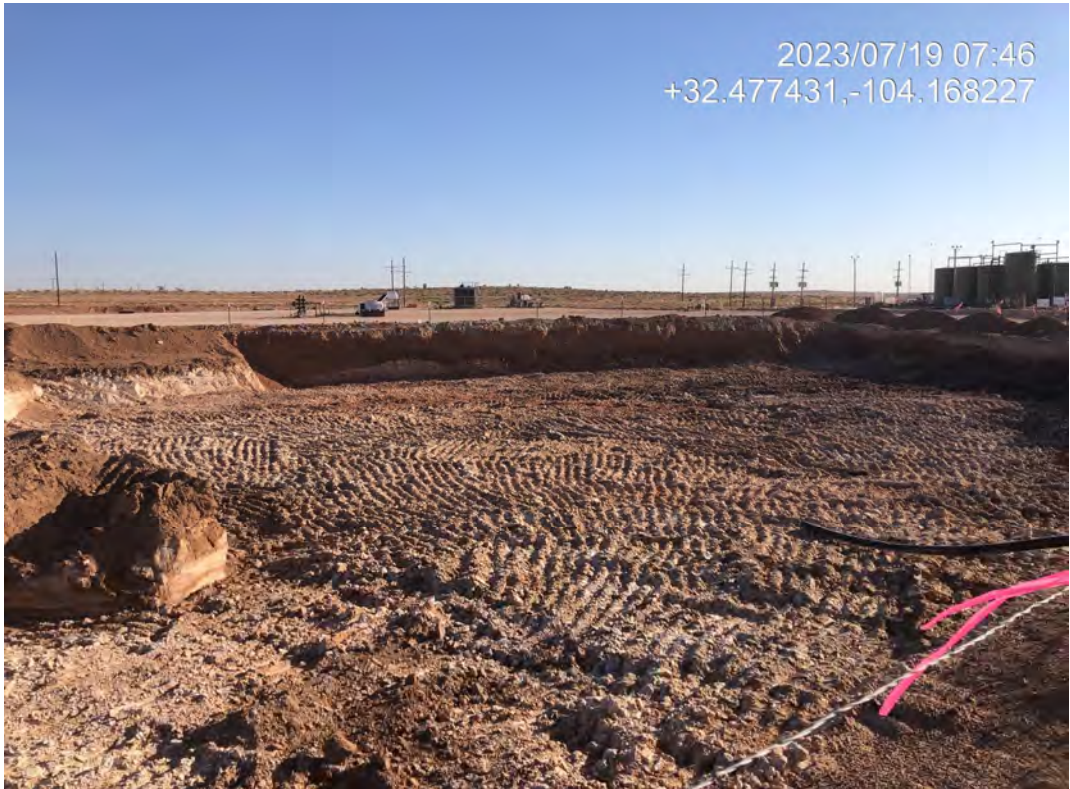
Photo Number: 6

Photo Direction: North	
Photo Description: View of the excavated area.

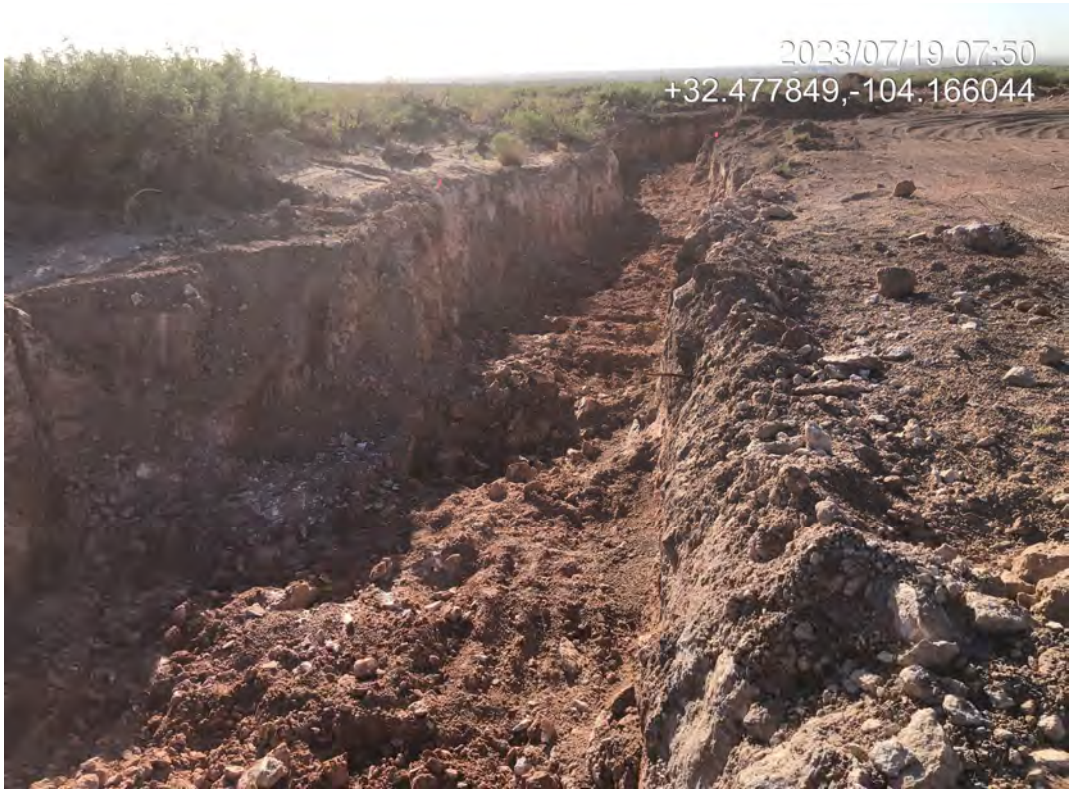
Photo Number: 9

Photo Direction: Northeast	
Photo Description: View of the excavated area.

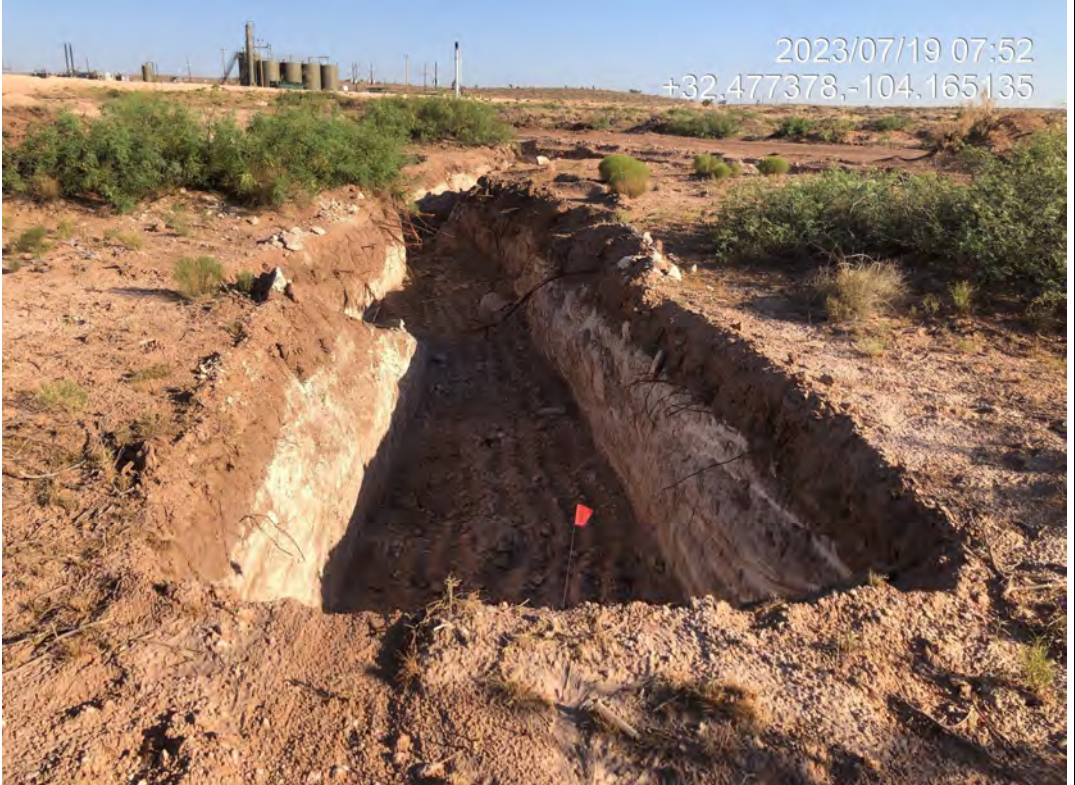
Photo Number: 12

<p>2023/07/19 07:52 +32.477378,-104.165135</p>
Photo Direction: Northwest	
Photo Description: View of the excavated area.

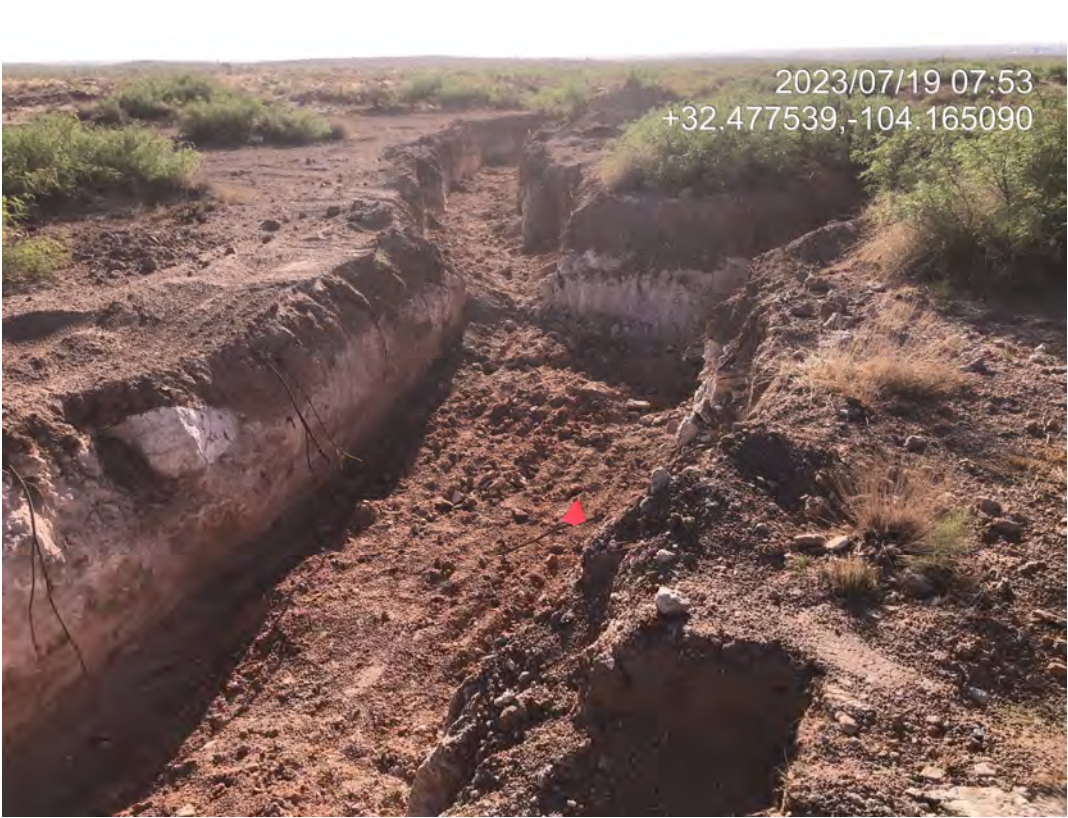
Photo Number: 15

Photo Direction: East	
Photo Description: View of the excavated area.

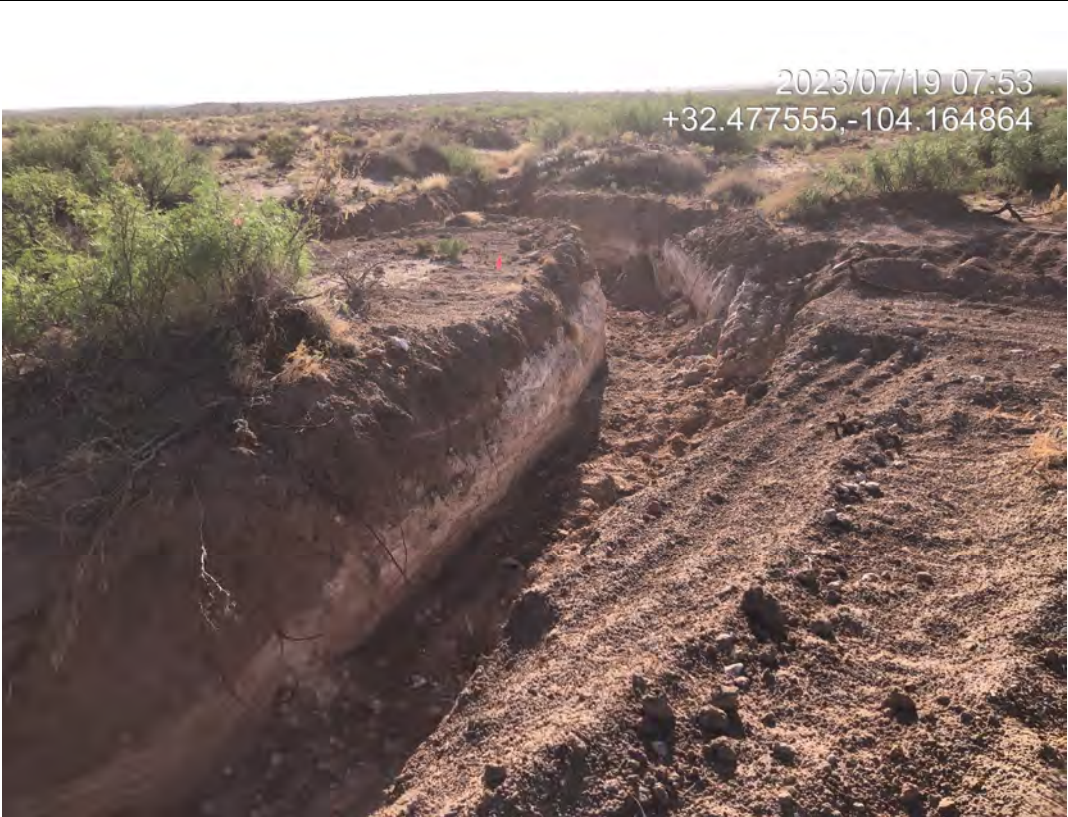
Photo Number: 16

Photo Direction: East	
Photo Description: View of the excavated area.

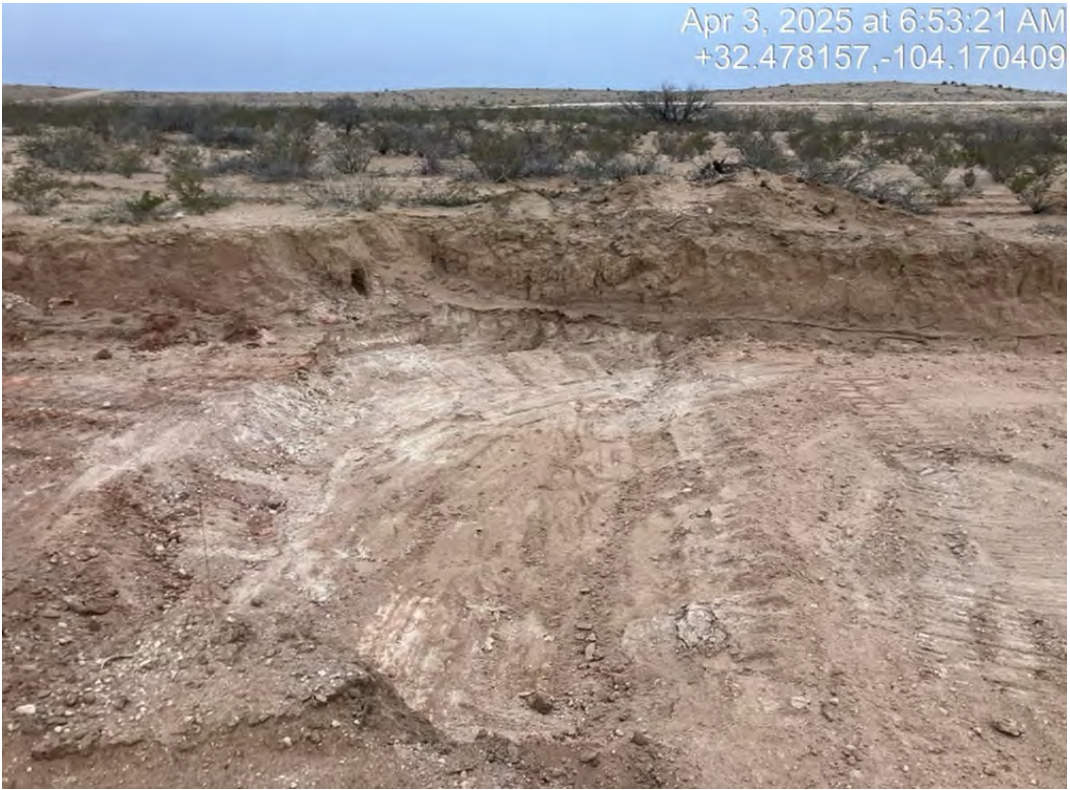
Photo Number: 19

Photo Direction: Northwest	
Photo Description: View of the excavated area.

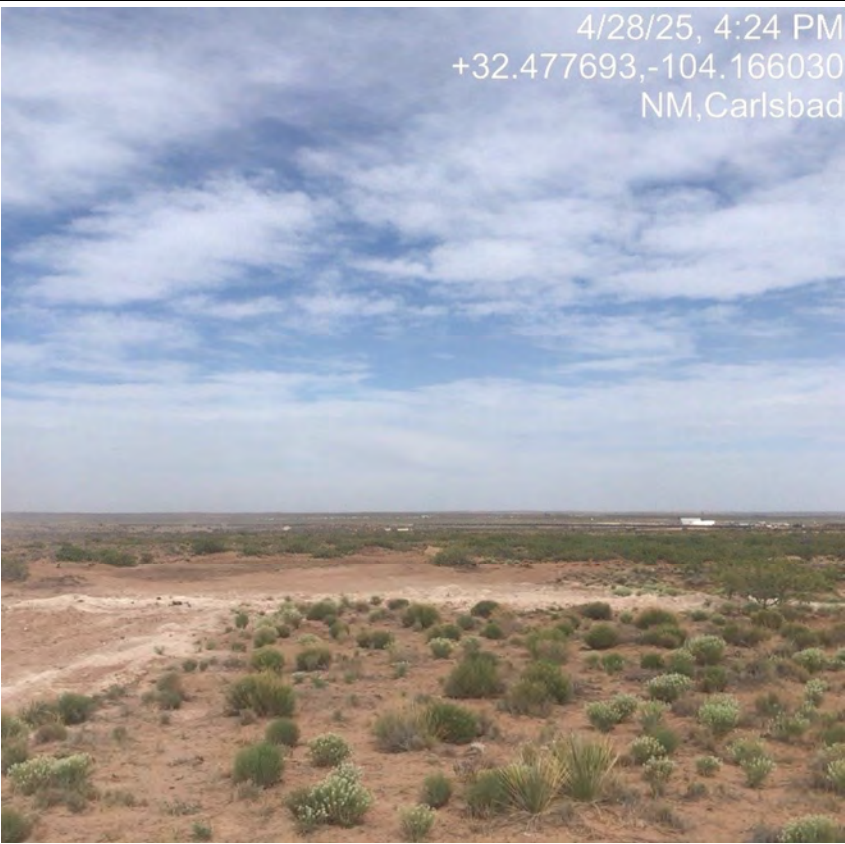
Photo Number: 25	<div>4/28/25, 4:24 PM +32.477693,-104.166030 NM, Carlsbad</div>

Photo Direction: East	
Photo Description: View of the remediated area following backfill and regrading.

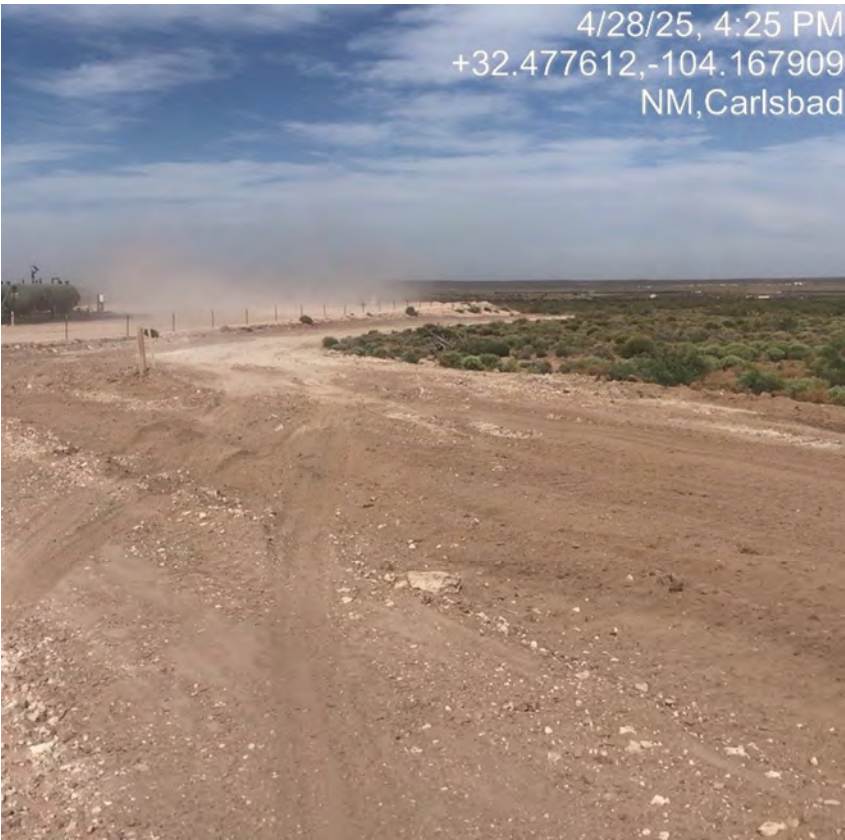
Photo Number: 26	<div>4/28/25, 4:25 PM +32.477612,-104.167909 NM, Carlsbad</div>

Photo Direction: Northeast	
Photo Description: View of the remediated area following backfill and regrading.

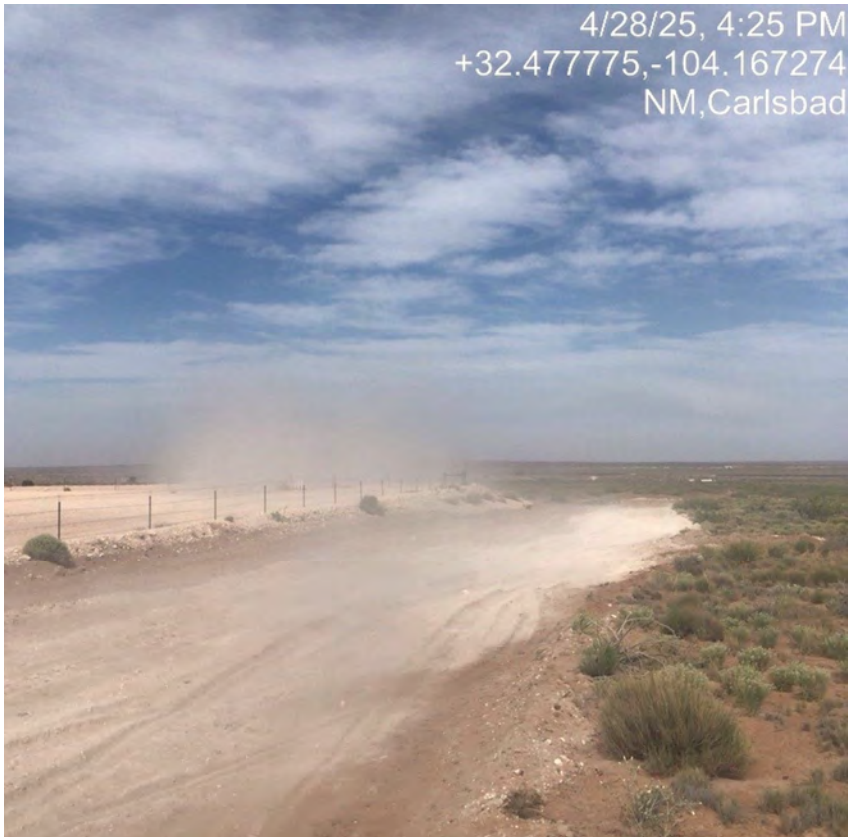
Photo Number: 27	<div>4/28/25, 4:25 PM +32.477775,-104.167274 NM, Carlsbad</div>

Photo Direction: East	
Photo Description: View of the remediated area following backfill and regrading.

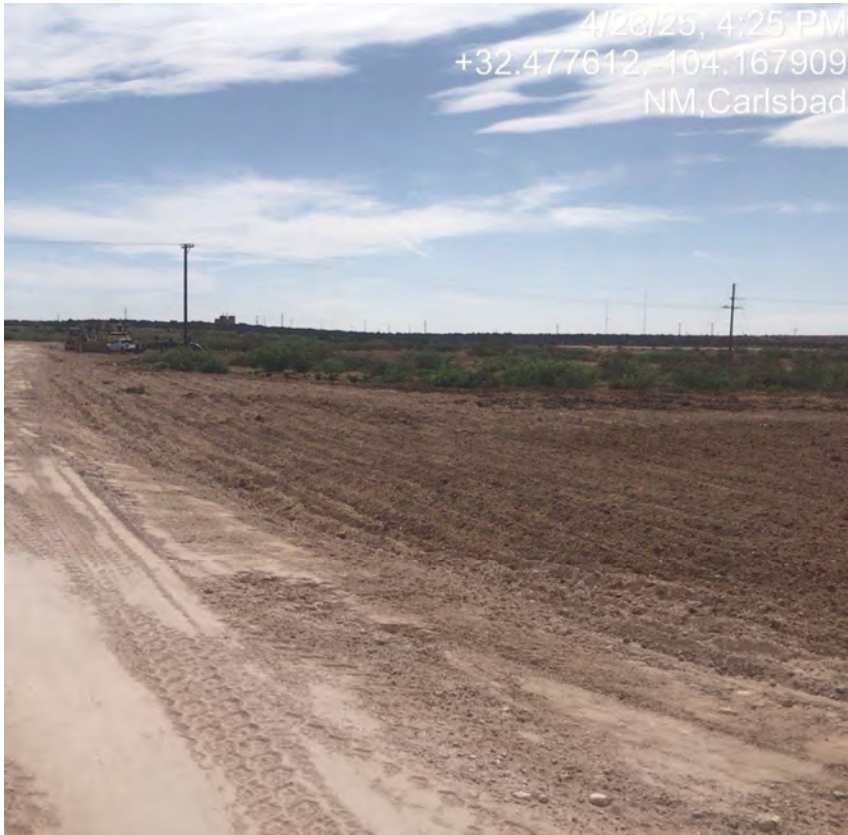
Photo Number: 28	<div>4/28/25, 4:25 PM +32.477612,-104.167909 NM, Carlsbad</div>

Photo Direction: West	
Photo Description: View of the remediated area following backfill and regrading.

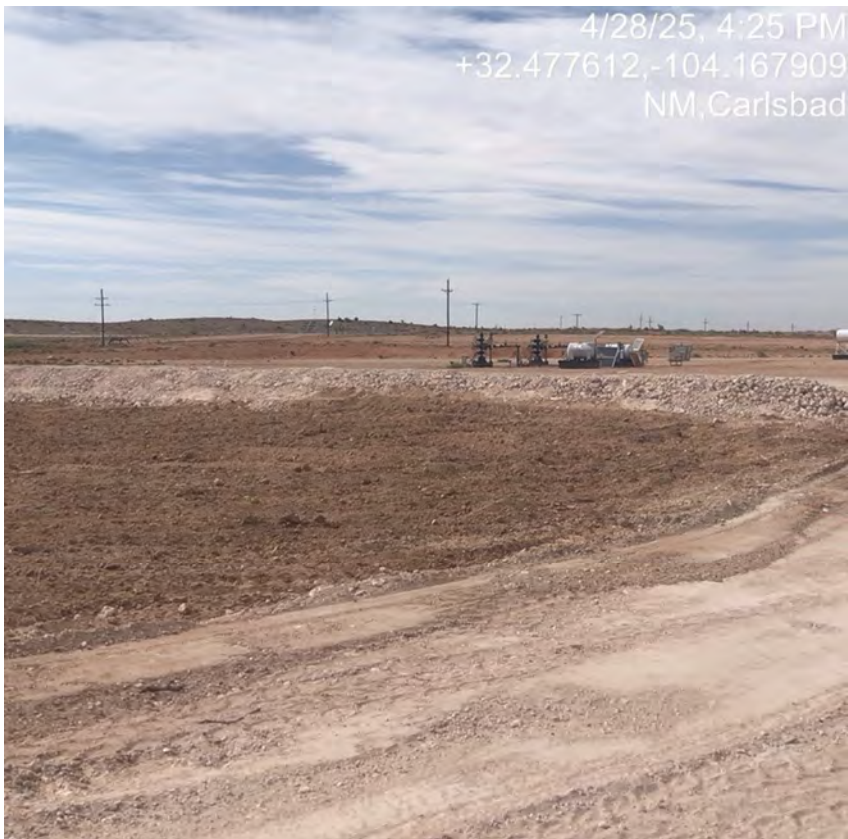
Photo Number: 29

Photo Direction: North	
Photo Description: View of the remediated area following backfill and regrading.

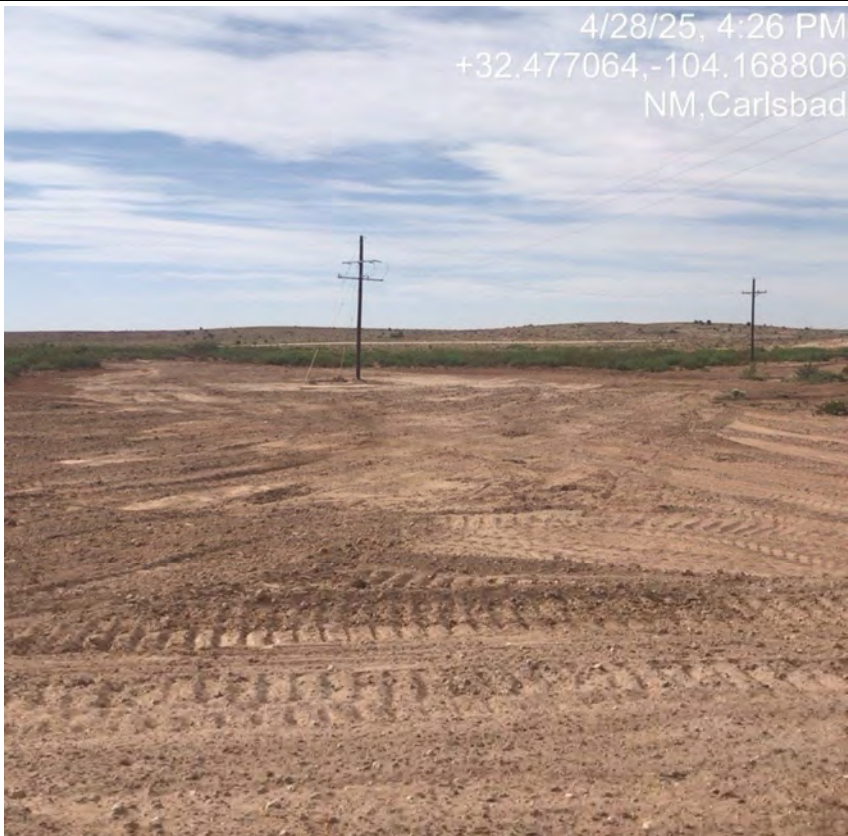
Photo Number: 30

Photo Direction: Northwest	
Photo Description: View of the remediated area following backfill and regrading.

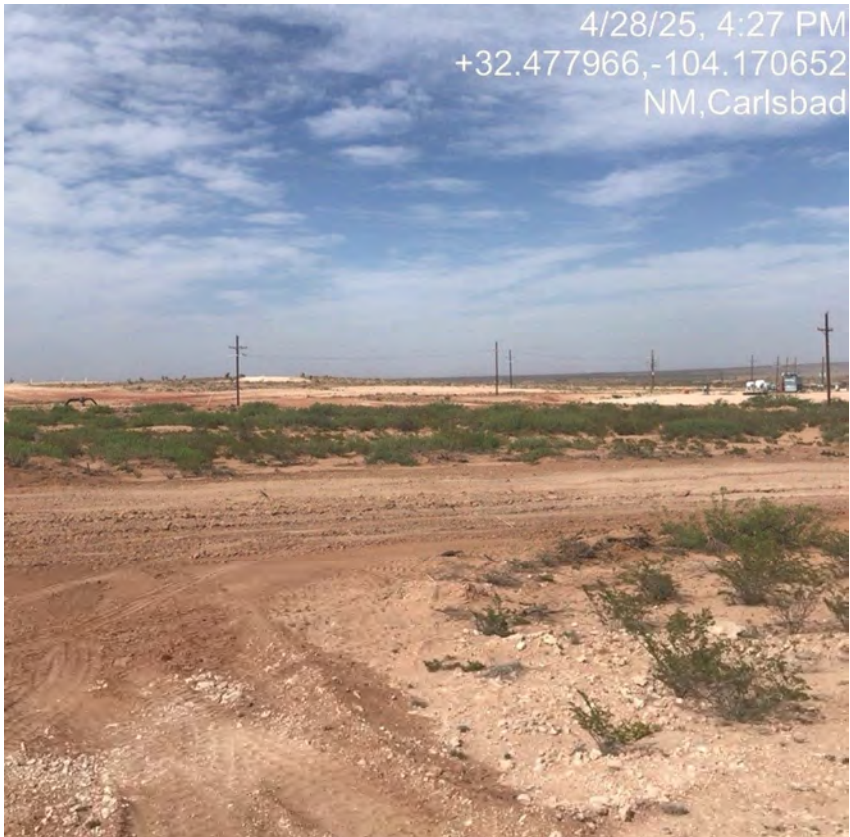
Photo Number: 31

Photo Direction: Northeast	
Photo Description: View of the remediated area following backfill and regrading.

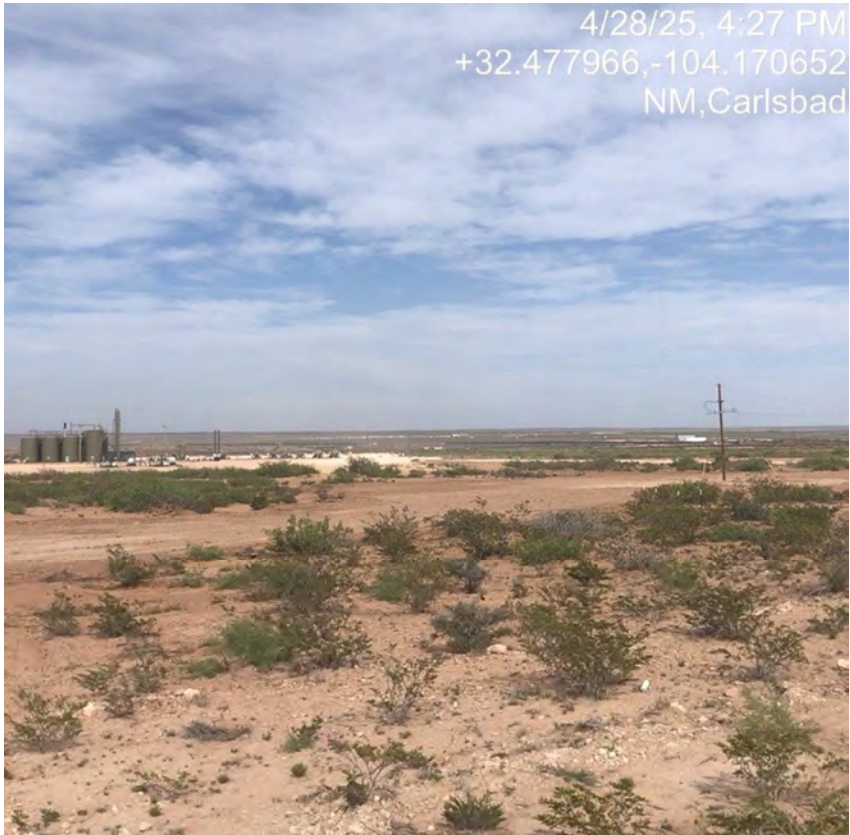
Photo Number: 32

Photo Direction: East	
Photo Description: View of the remediated area following backfill and regrading.

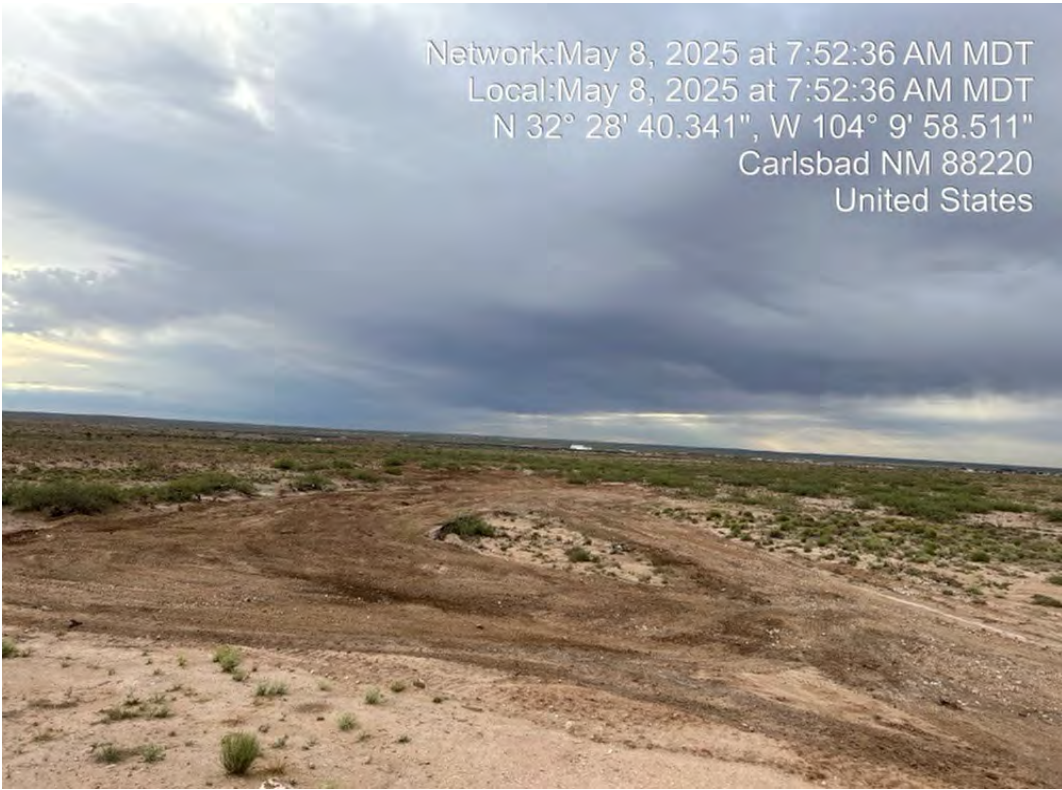
Photo Number: 33	<div>Network: May 8, 2025 at 7:52:36 AM MDT Local: May 8, 2025 at 7:52:36 AM MDT N 32° 28' 40.341", W 104° 9' 58.511" Carlsbad NM 88220 United States</div>

Photo Direction: East	
Photo Description: View of the remediated area during seeding event.

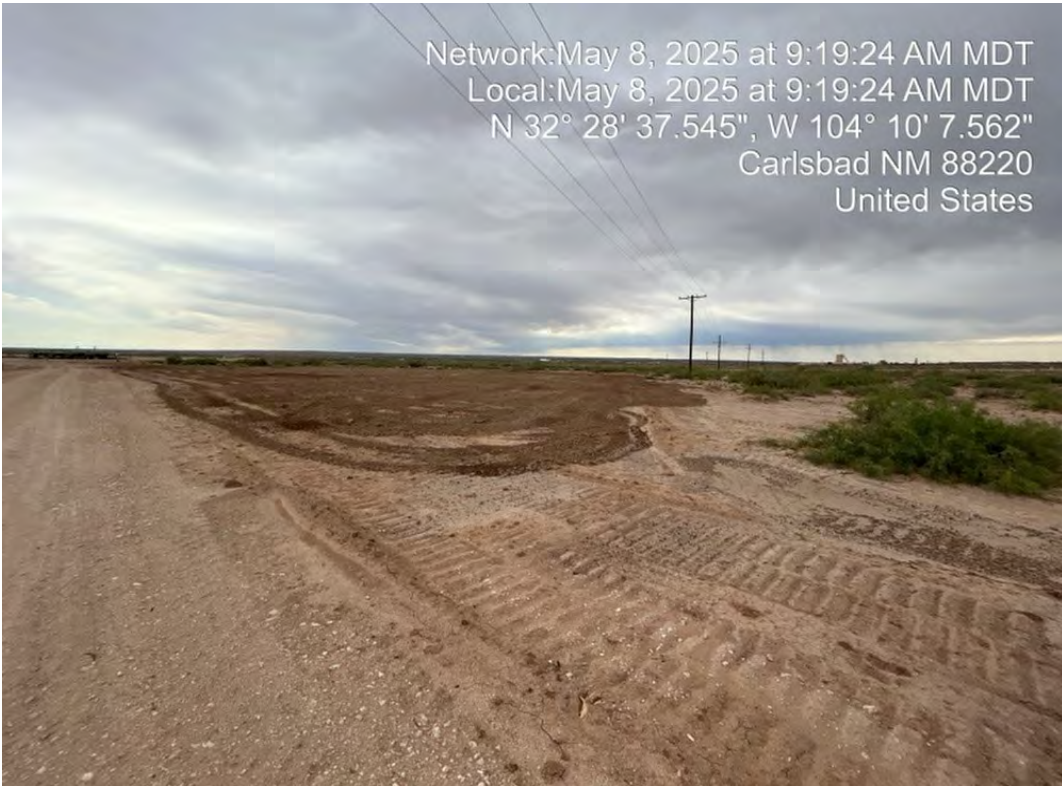
Photo Number: 35

Photo Direction: Northwest	
Photo Description: View of the remediated area following seeding event.

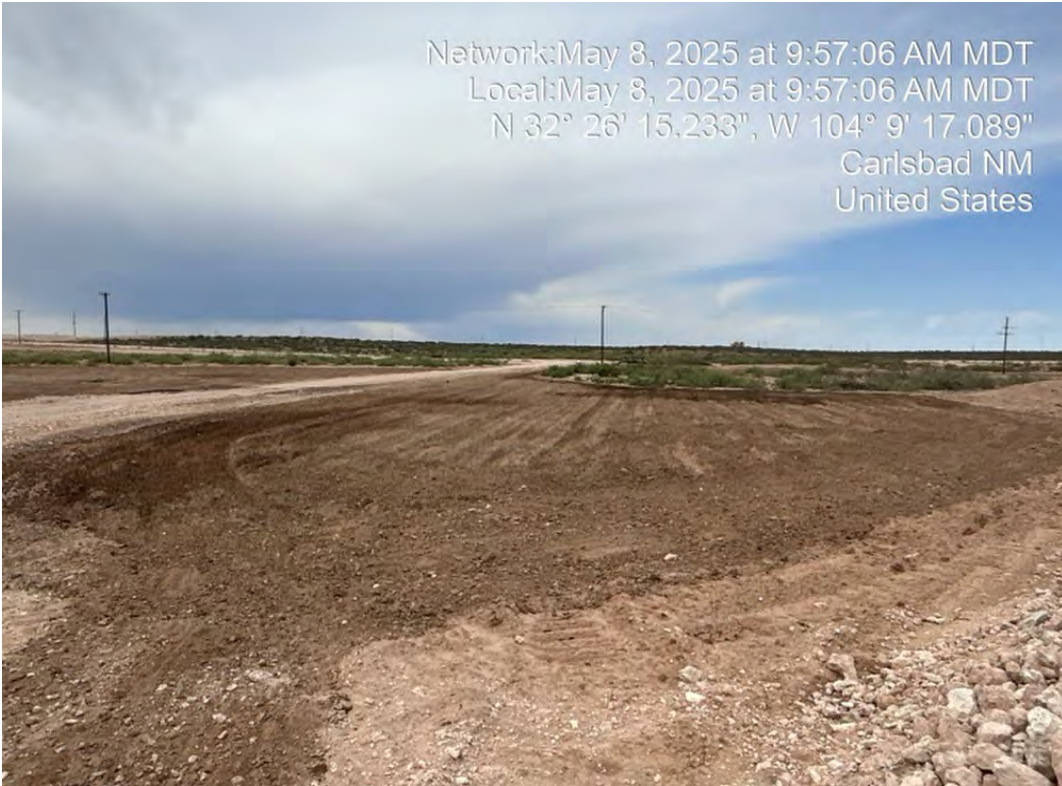
Photo Number: 36

Photo Direction: Southwest	
Coordinates: 32.477851,-104.167884	
Photo Description: View of the remediated area following seeding event.

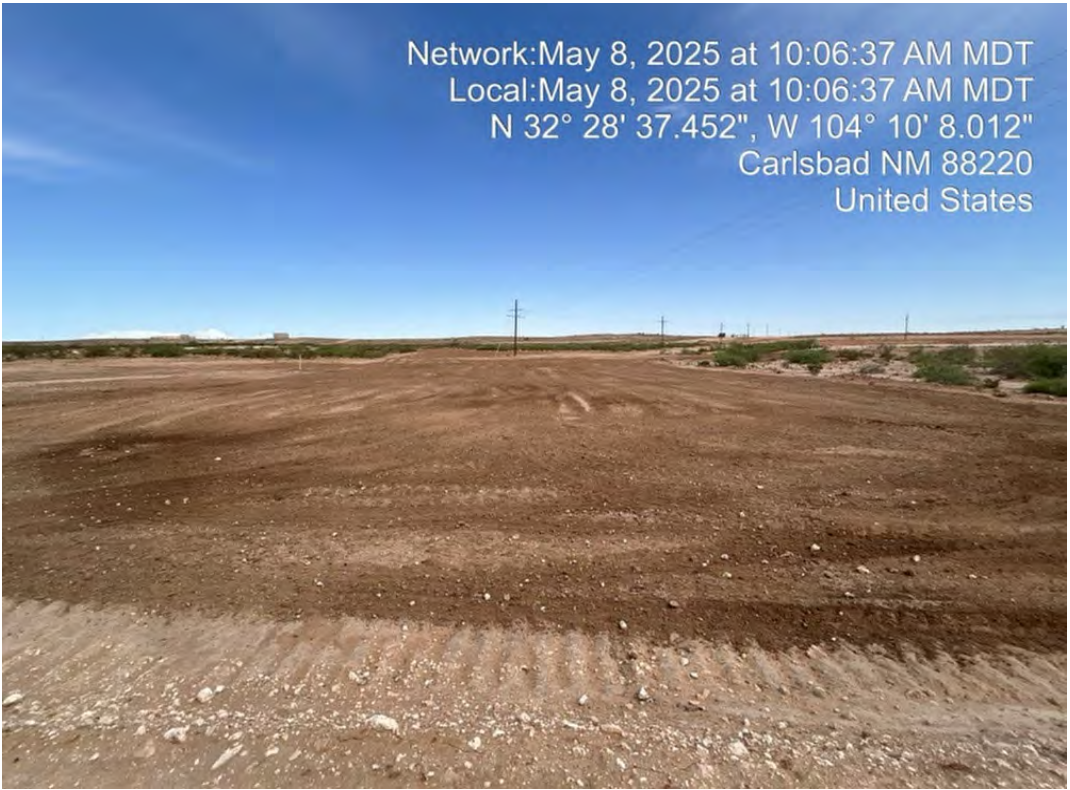
Photo Number: 37	<p>Network: May 8, 2025 at 10:06:37 AM MDT Local: May 8, 2025 at 10:06:37 AM MDT N 32° 28' 37.452", W 104° 10' 8.012" Carlsbad NM 88220 United States</p>

Photo Direction: Northwest	
Photo Description: View of the remediated area following seeding event.
