CLOSURE REQUEST REPORT

Flagler 8 CTB 1

Incident Number nAPP2106147760

Lea County, New Mexico

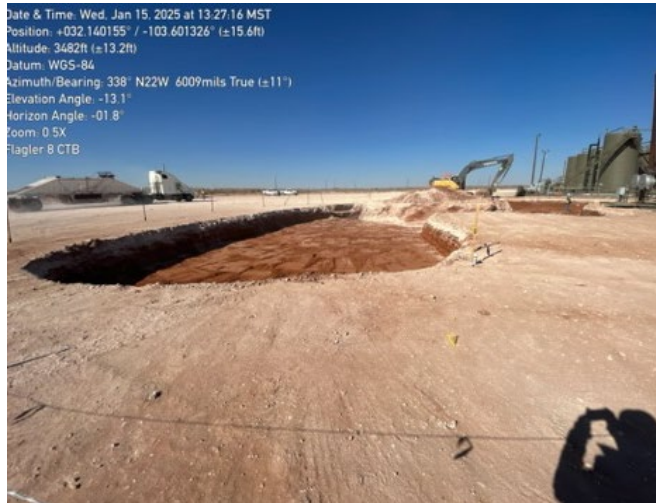
**Photograph 1****Date: 01/15/2025**

Description: Northwestern view of excavation activities.

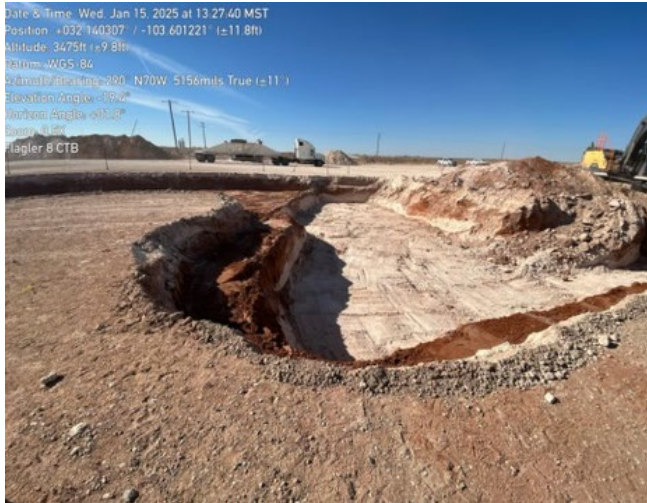
**Photograph 2****Date: 01/15/2025**

Description: Northwestern view of excavation activities.

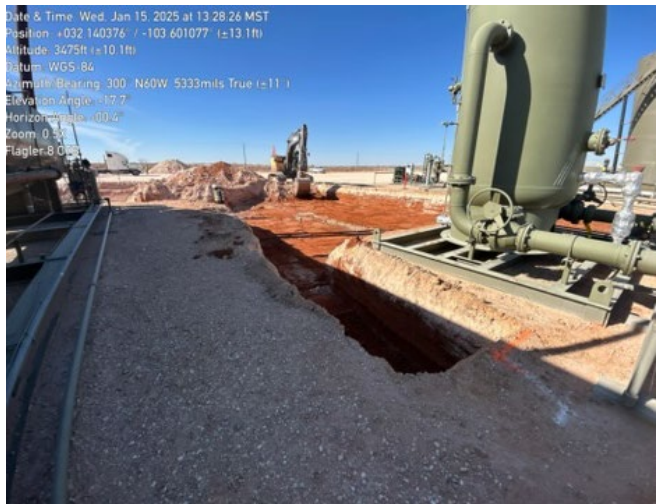
**Photograph 3****Date: 01/15/2025**

Description: Northwestern view of excavation activities.

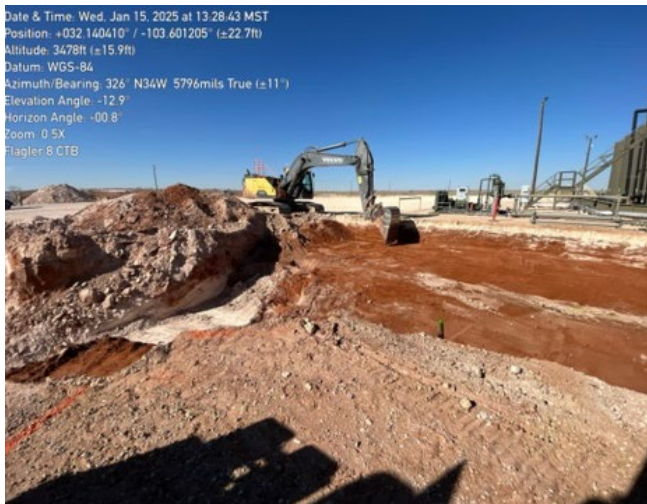
**Photograph 4****Date: 01/15/2025**

Description: Northwestern view of excavation activities.

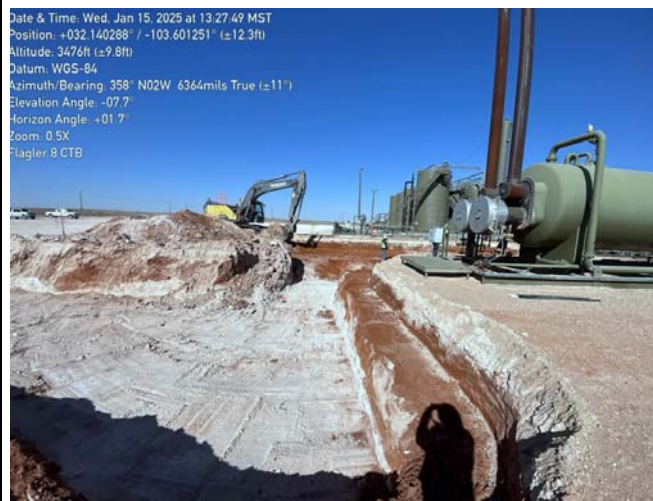
Photograph 5

Description: Northwestern view of excavation activities

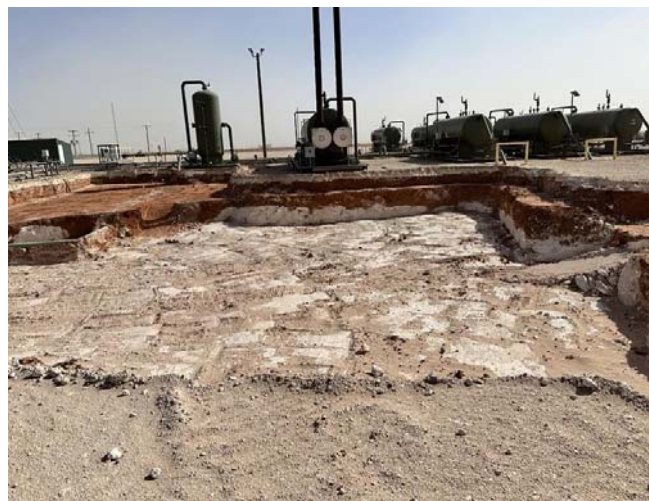
Photograph 6

Description: Eastern view of excavation activities

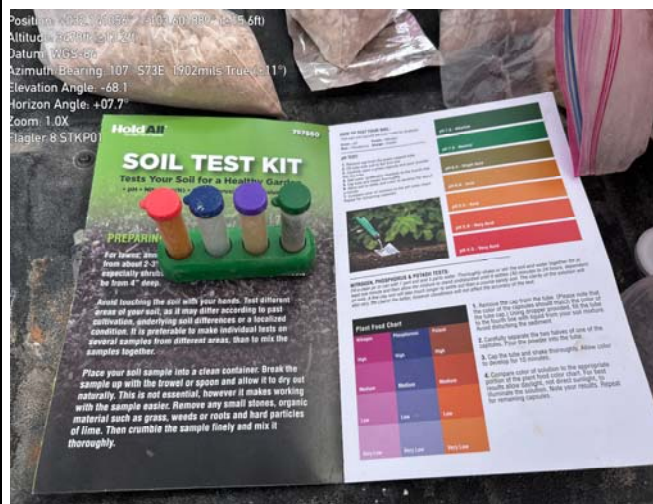
Photograph 7

Description: Southeastern view of results of the nutrient soil test for backfill STKP01 material.

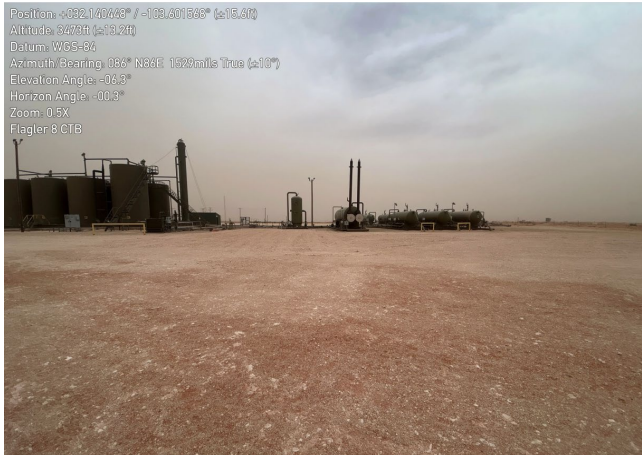
**Photograph 9****Date: 03/14/2025**

Description: Northeastern view of completed restoration.

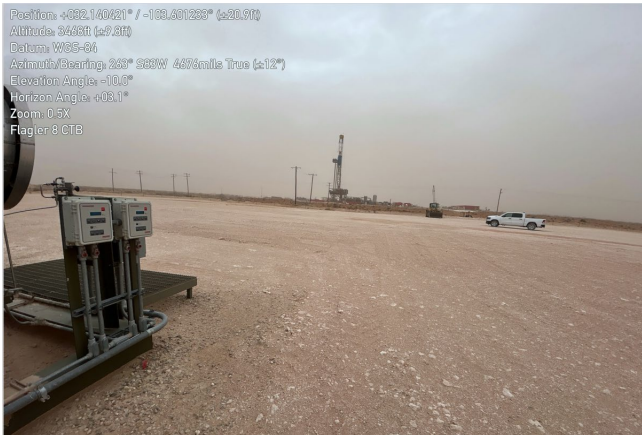
**Photograph 10****Date: 03/14/2025**

Description: Southwestern view of completed restoration.

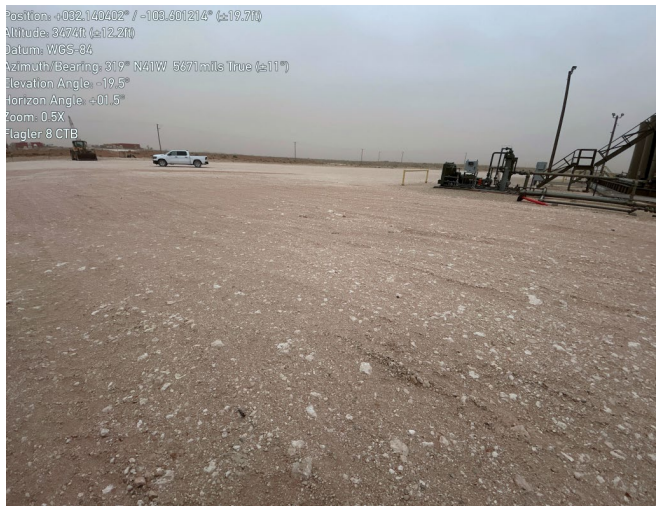
**Photograph 11****Date: 03/14/2025**

Description: Northwestern view of completed restoration.

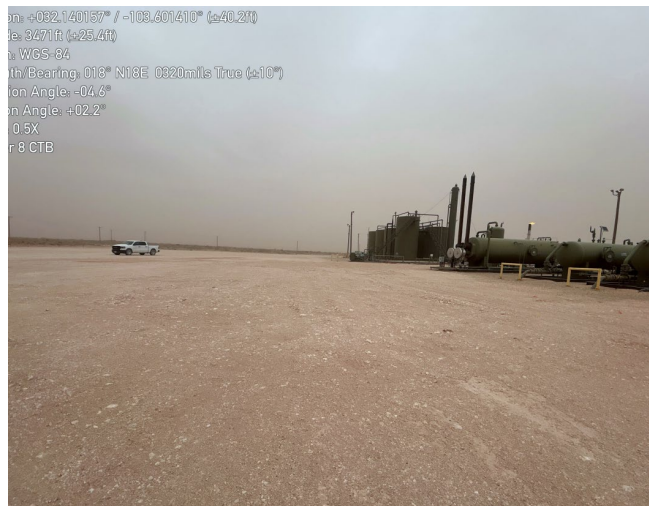
**Photograph 12****Date: 03/14/2025**

Description: Northeastern view of completed restoration.

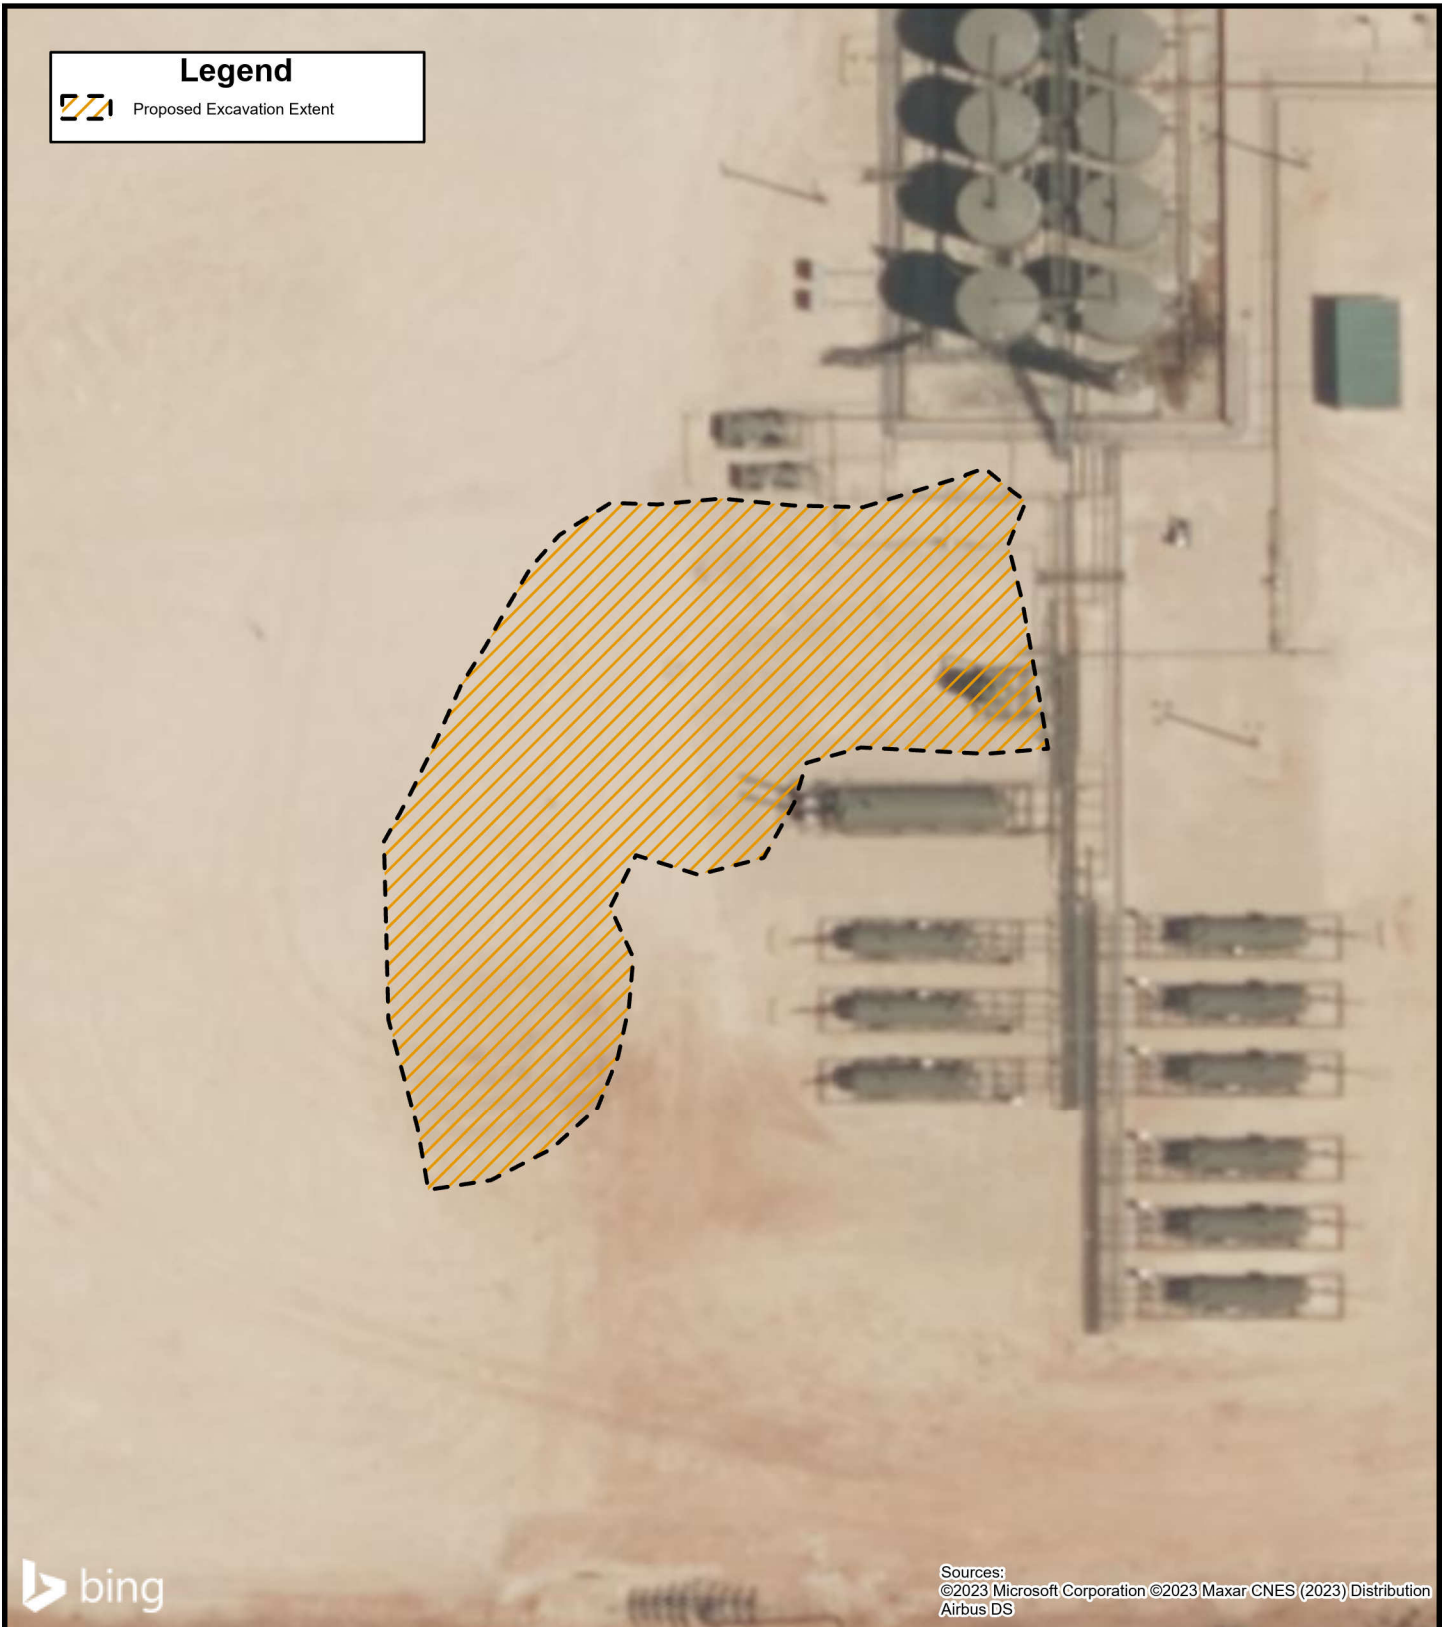
FIGURE 3

Proposed Excavation Extent

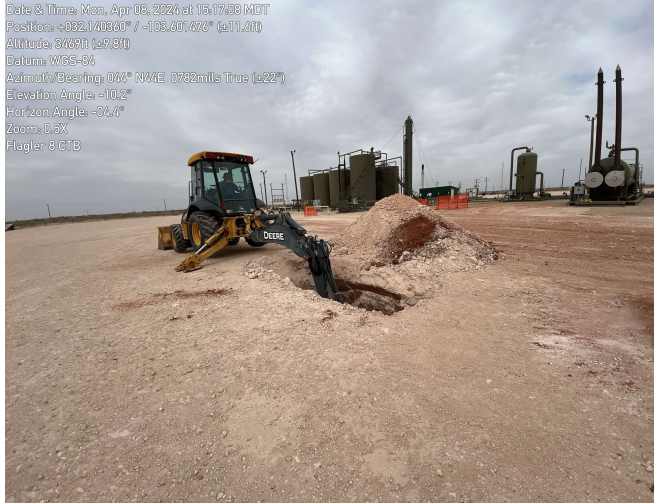
**Photograph 1****Date: 04/08/2024**

Description: Northeastern view of delineation activities.

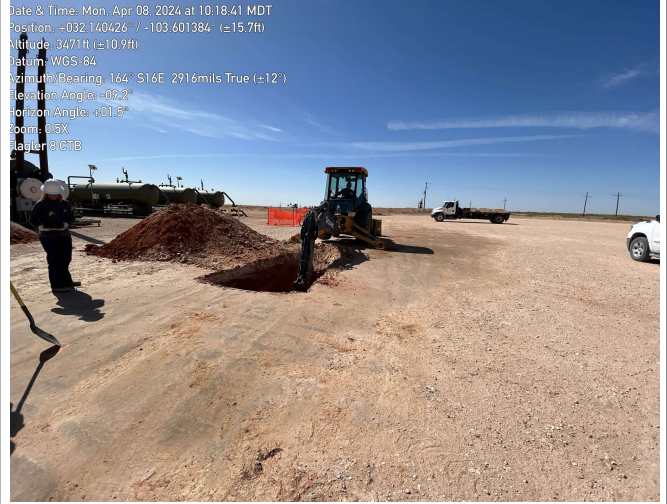
**Photograph 2****Date: 04/08/2024**

Description: Southeastern view of delineation activities.

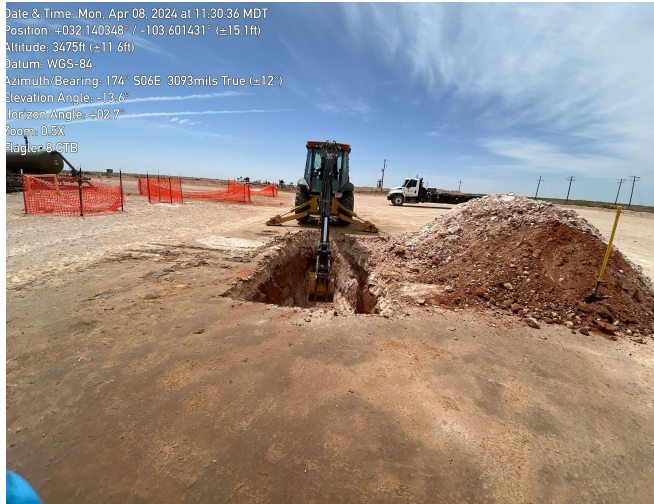
**Photograph 3****Date: 04/08/2024**

Description: Eastern view of delineation activities.

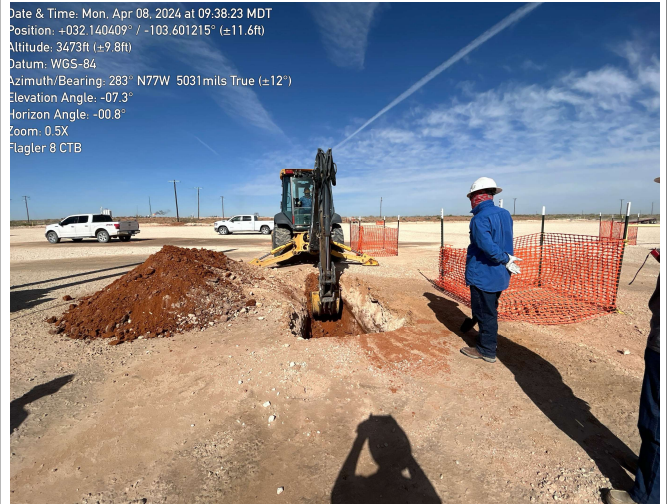
**Photograph 4****Date: 04/08/2024**

Description: Northwestern view of delineation activities.
