Re: Second Quarter 2025 – Solar SVE System Update

James Ranch Unit #10 Battery
Eddy County, New Mexico
XTO Energy, Inc.
NMOCD Incident Numbers NAB1535754357, NAB1521257588, and NAB1904653072

Ensolum, LLC (Ensolum), on behalf of XTO Energy, Inc. (XTO), presents this *Second Quarter 2025 - Solar SVE System Update* report summarizing the solar soil vapor extraction (SVE) system performance at the James Ranch Unit #10 Battery (Site), located in Unit H, Section 1, Township 23 South, Range 30 East in Eddy County, New Mexico (Figure 1). The SVE system has operated since May 27, 2022, to remediate residual subsurface soil impacts at the Site. This report summarizes Site activities performed in April, May, and June of 2025 for the New Mexico Oil Conservation Division (NMOCD).

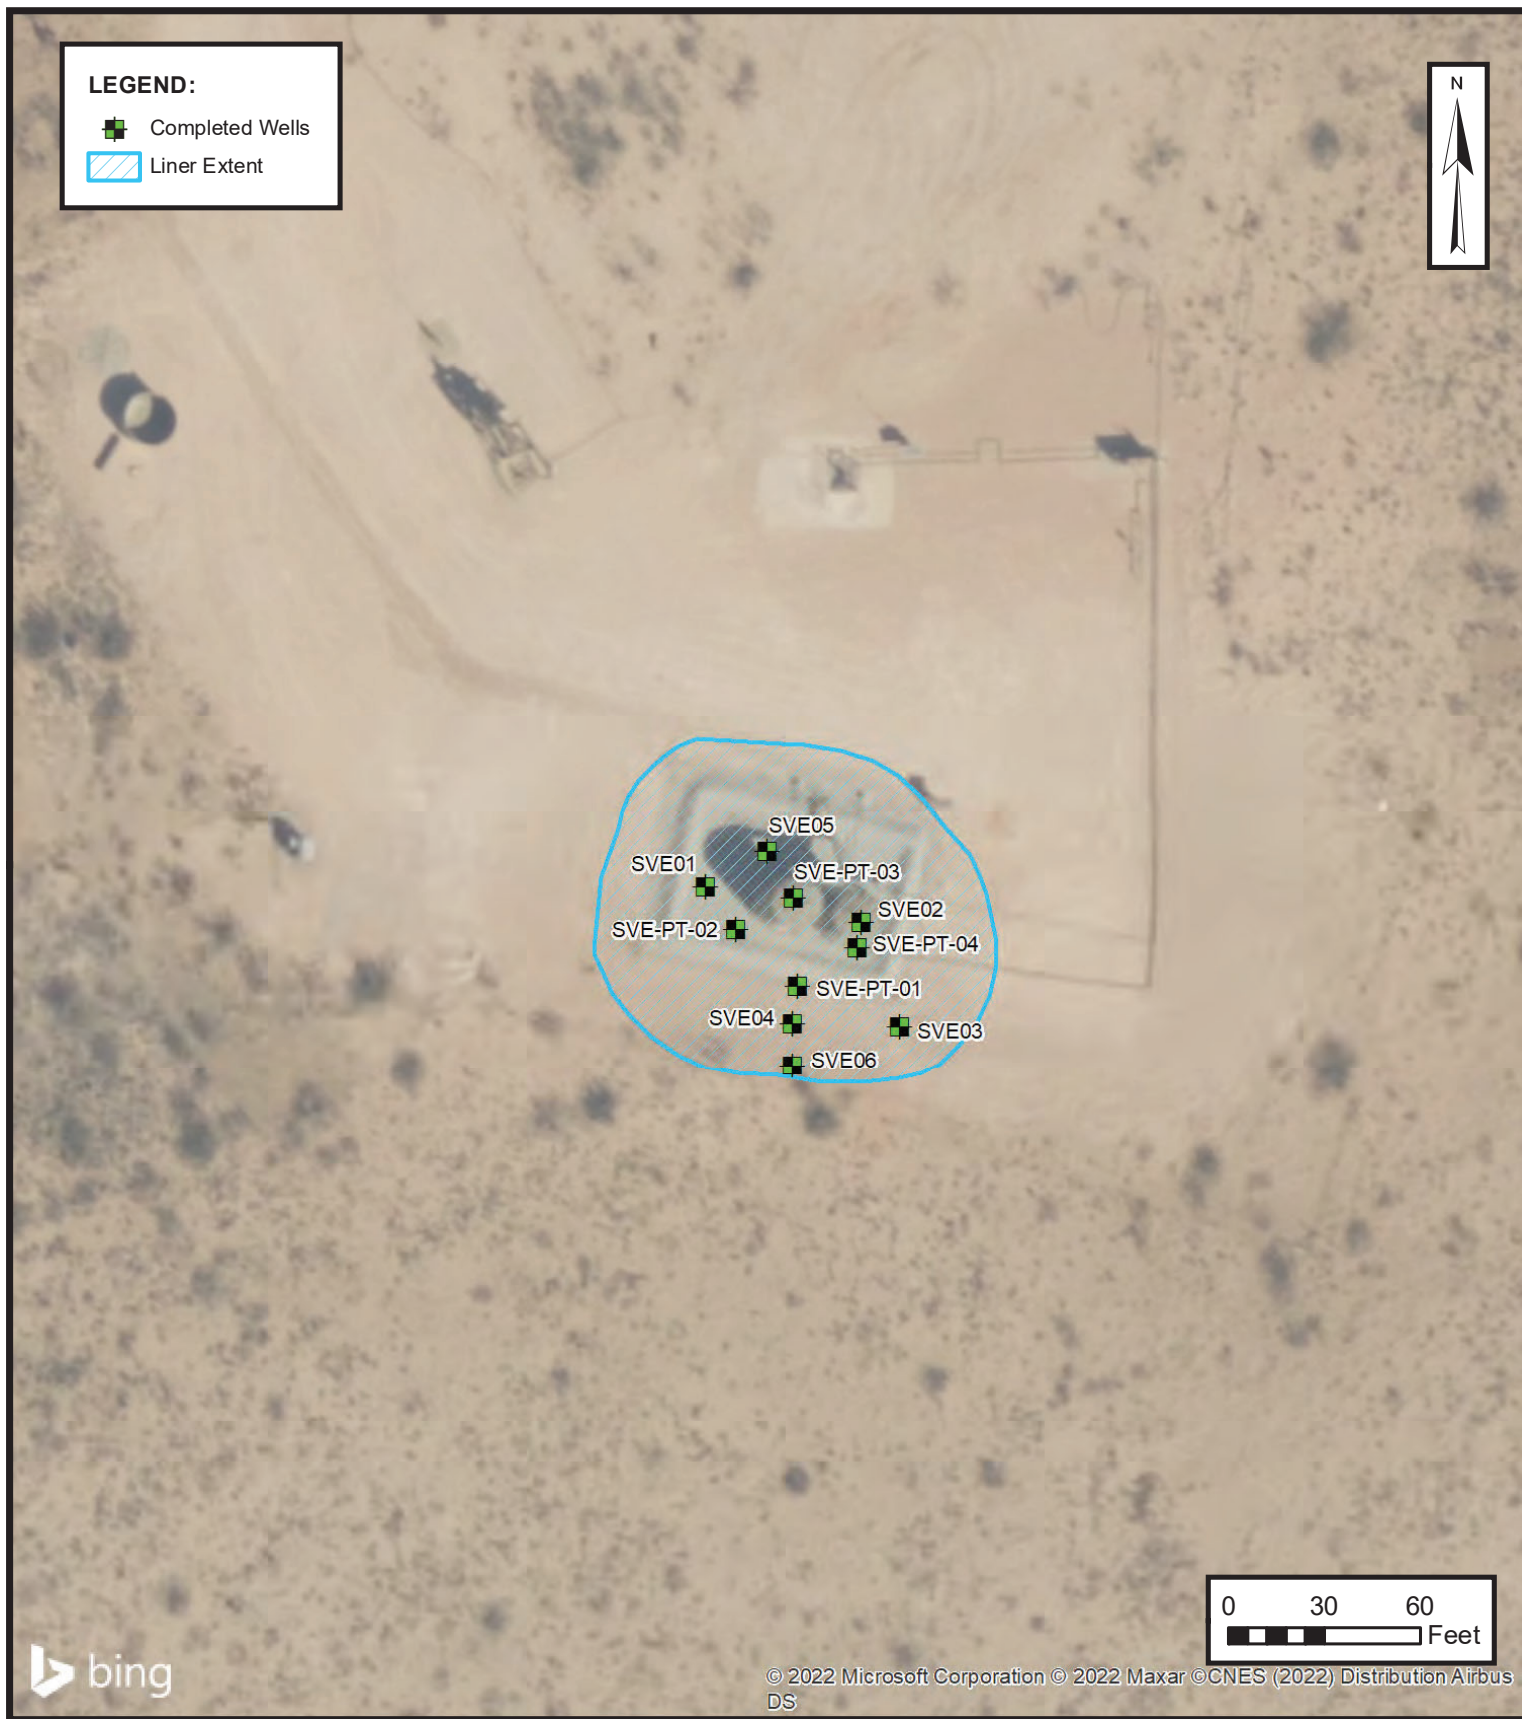
SVE SYSTEM CONFIGURATION

Ten SVE wells (SVE01 through SVE06 and SVE-PT-01 through SVE-PT-04) are currently installed at the Site, as depicted on Figure 2. In order to target total petroleum hydrocarbons (TPH) and benzene, toluene, ethylbenzene, and total xylenes (BTEX) soil impacts at different depth intervals, the screened intervals of the SVE wells were installed in shallow, medium, and deep zones. Specifically, SVE wells SVE01, SVE02, SVE03, and SVE04 target shallow zone impacts and are screened at depths between 5 feet and 20 feet below ground surface (bgs). SVE wells SVE-PT-02, SVE-PT-03, and SVE-PT-04 target medium zone impacts and are screened between 15 feet and 30 feet bgs. SVE wells SVE05, SVE06, and SVE-PT-01 target deep zone impacts and are screened at depths between 25 feet and 65 feet bgs.

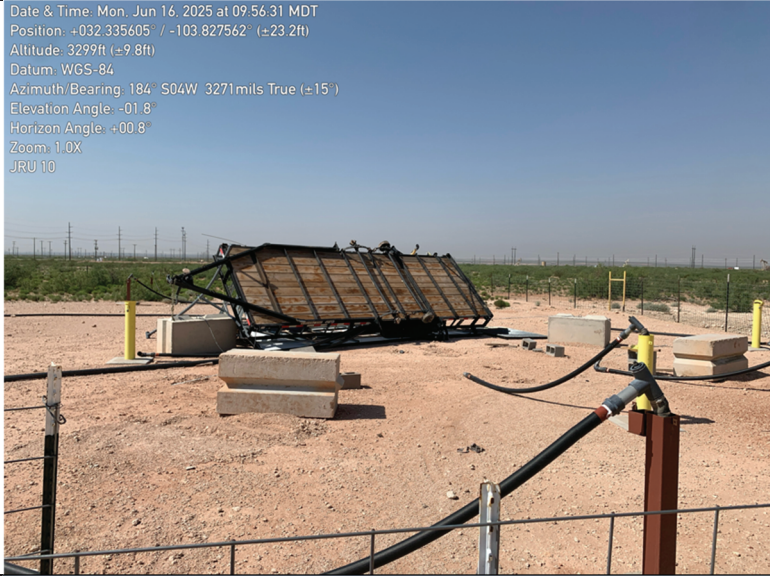
Photograph 1

On June 16, 2025, an O&M technician was driving by the Site and observed the SVE system disconnected from the anchors and flipped upside down, landing on the faces of the solar panels, likely due to recent high wind events. Upon further inspection, it was determined the existing system would no longer be operational without significant repairs and/or modifications to prevent similar incidents from occurring in the future. The SVE system was removed from the Site for storage at a nearby XTO yard. Photographs of the SVE system post-wind event are provided as Appendix B.

SVE System Post-Storm
June 16, 2025 at 9:56 AM

Due to the recent wind event in June 2025 that damaged the solar-powered SVE system beyond immediate repair, XTO is considering potential actions to be taken at the Site including, but not limited to, conducting confirmation soil sampling to assess the efficacy of the system and for potential Site closure, reinstallation of a solar-powered SVE system with additional anchoring systems to prevent future damage, or an assessment of alternative techniques to remediate remaining Site impacts. XTO will update the NMOCD in the third quarter 2025 report of any actions taken between July and September 2025. Additionally, an *Updated Remediation Work Plan* will be submitted to the NMOCD for review and approval if an alternate remedial technology is proposed for the Site.

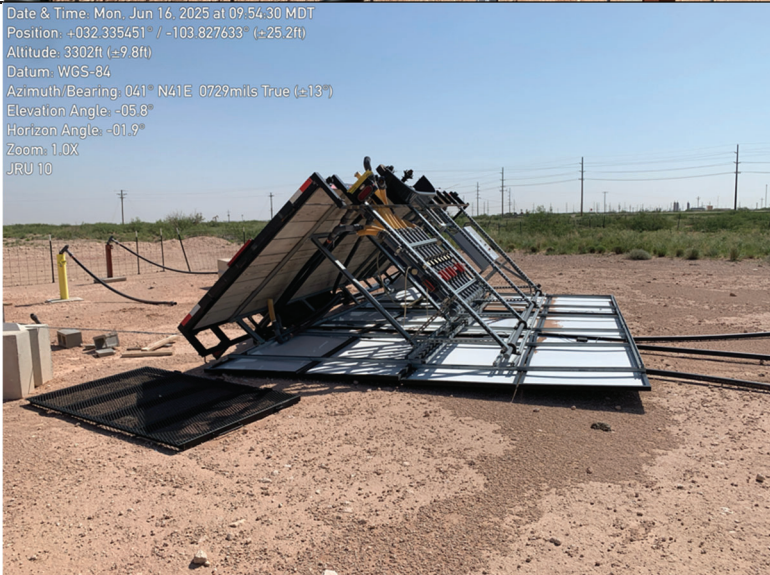
**Photograph 2**

SVE System Post-Storm
June 16, 2025 at 9:54 AM
