Remediation Summary and Closure Request

**Bagley SWD #004, Area 5
API 30-025-01015
Historical Produced Water Release
Incident No. nAPP2509978939
Lea County, New Mexico**

Crain Environmental
2925 East 17th Street
Odessa, Texas 79761

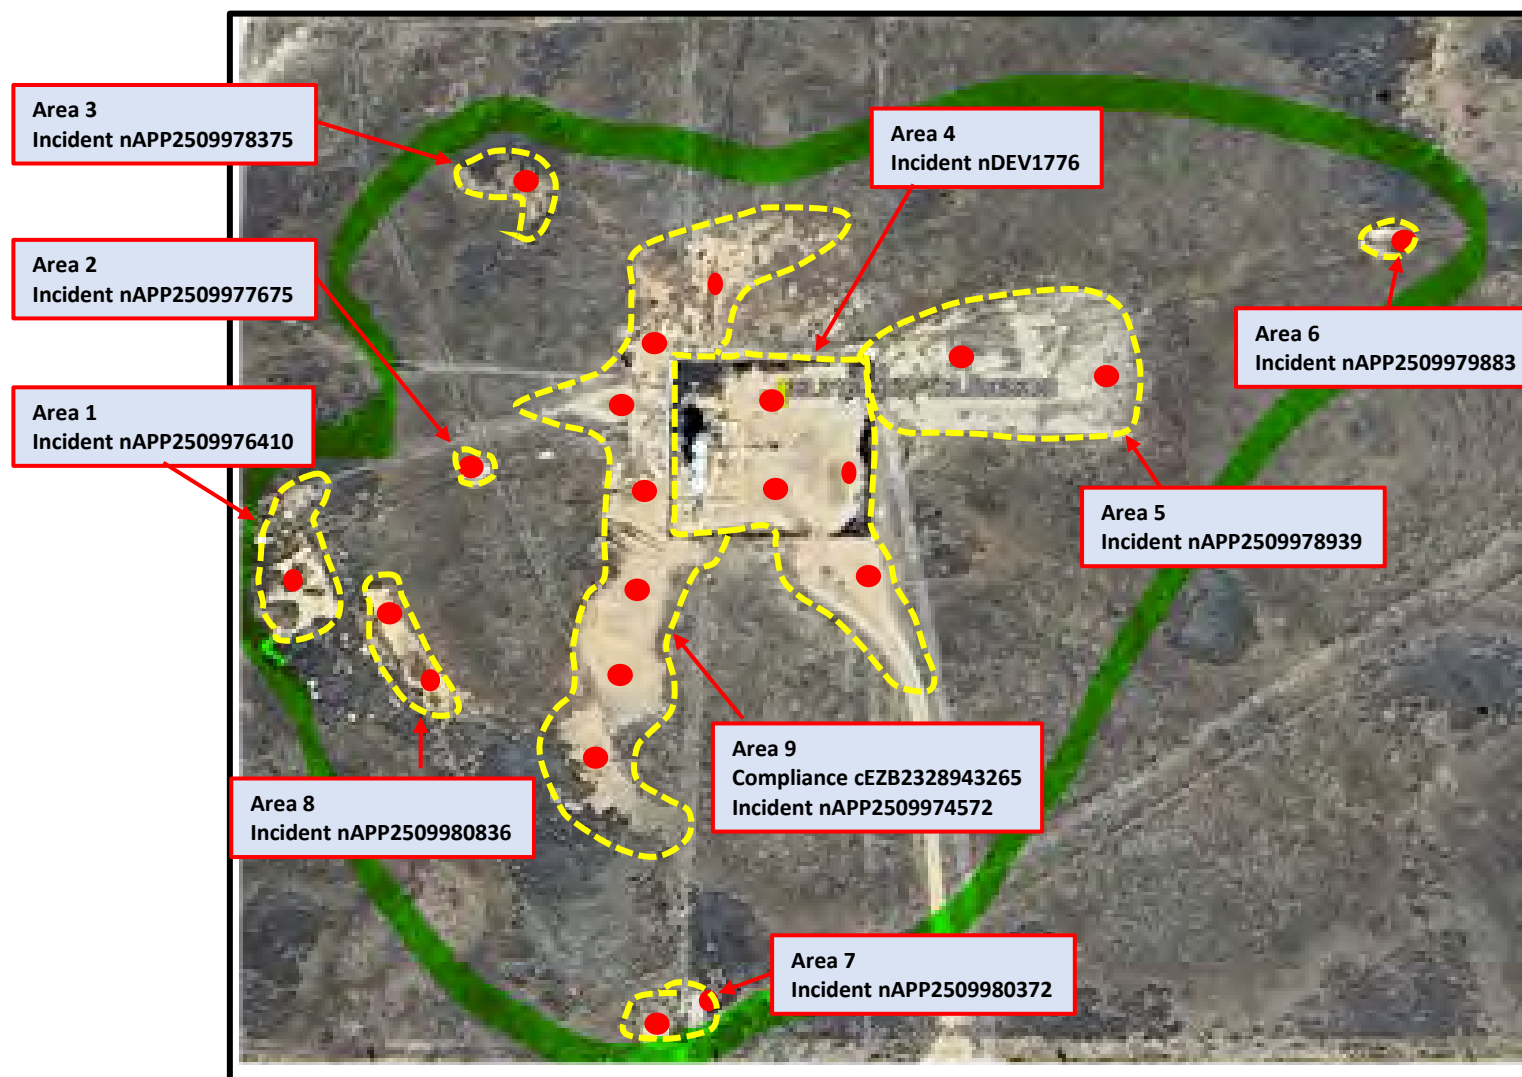
Figure 2 shows the areas of investigation with the respective Incident numbers.

LEGEND:		Figure 2			
	Investigation Sample Location	Estimated Remediation Area		Drafted by: CC Checked by: CC	
	ECO Investigation Boundary	Boundaries		Draft: April 10, 2025	
	Estimated Remediation Area Boundaries with Area and Incident Number	BXP Operating, LLC		GPS: 33.31699° -103.586021°	
Base Map from Google Earth Pro		Bagley SWD #004			
		Lea County, New Mexico

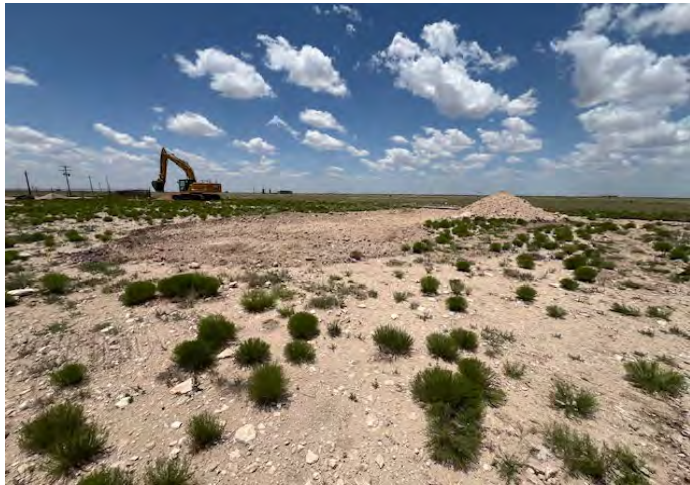
View to NW of E excavation and stockpile at Area 5 (6/19/25).

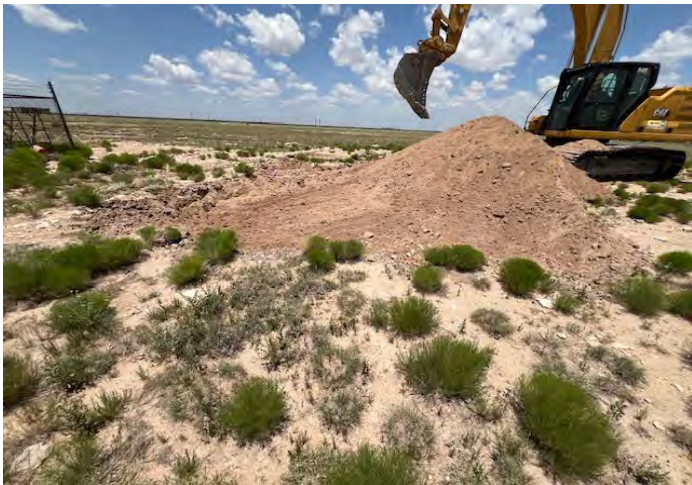
View to NW of W excavation at Area 5 (6/19/25).

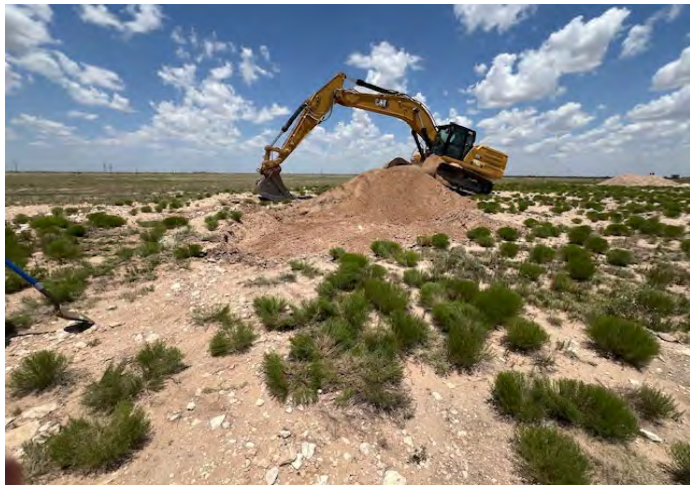
View to NE of W excavation (6/19/25).

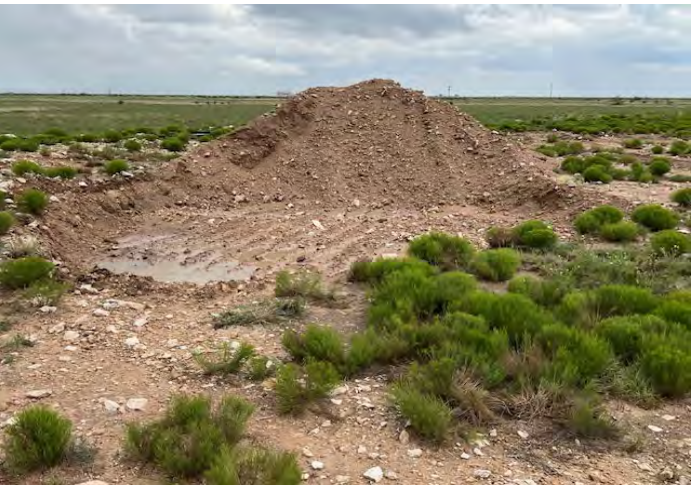
View to NE of W excavation (6/24/25).

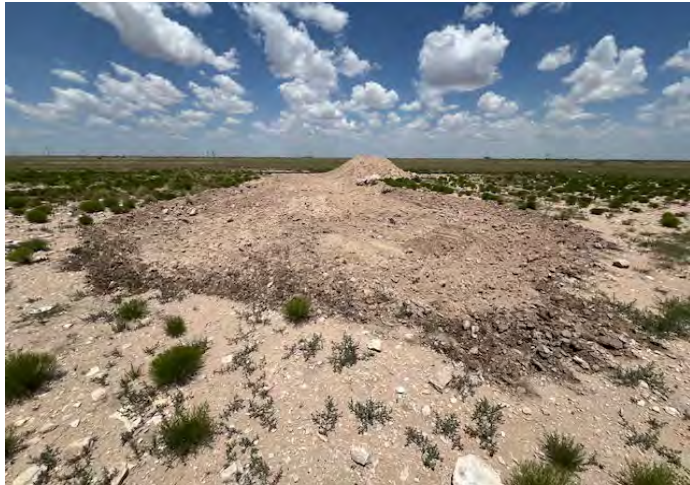
View to N of E excavation (6/24/25).

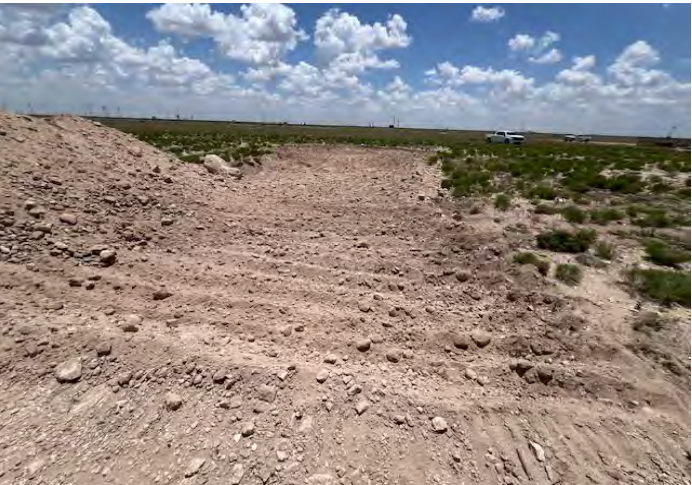
View to S of E excavation at Area 5 (6/24/25).
