DEVON ENERGY
Thistle Unit 22 CTB 2 Unit 185H

Workplan

UL A, Section 22, T23S, R33E
Lea County, New Mexico

NAPP2519126637

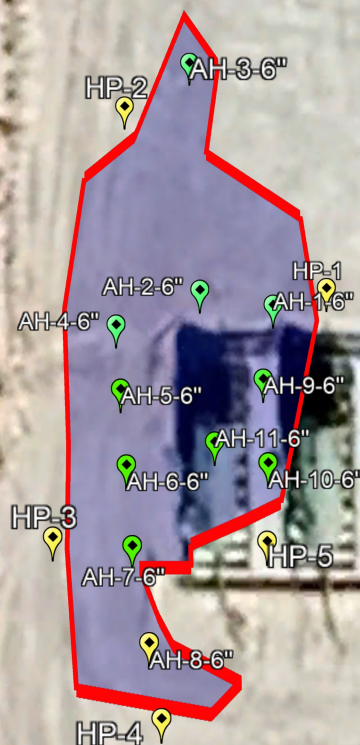
Site Map
Initial Site Assessment and Sampling Locations

On July 14, 2025, SESI mobilized the site to conduct a delineation investigation. A total of seventeen (17) soil samples were collected at the surface and at six inches bgs. Samples were field-tested for chloride and submitted to Cardinal Laboratories (Lab ID: H254241) under proper chain-of-custody protocols for full analysis of:

Following the delineation investigation conducted on July 14, 2025, SESI determined that the release impacted an area of approximately 3,923 square feet. The site is located in an area with low karst potential, and groundwater is present at a depth greater than 55 feet below ground surface (bgs). Based on these conditions, the applicable remediation standards under NMOCD Table 1 are 10,000 mg/kg for chloride and 2,500 mg/kg for total petroleum hydrocarbons (TPH). Laboratory analytical results indicate that several soil samples, including AH-2, AH-5, AH-7, and AH-9, contained chloride concentrations exceeding 10,000 mg/kg, while all BTEX and hydrocarbon fractions (DRO, GRO, and MRO) were reported below laboratory detection limits.

To address the impacted soils, SESI proposes to conduct excavation using backhoe equipment where accessible, or by hand digging in areas with limited access or near sensitive infrastructure. Excavation will be performed to a depth of approximately one to two feet bgs, or deeper if required, until confirmation samples indicate that vertical delineation meets the applicable closure criteria. All excavated material will be transported under manifest to an NMOCD-approved disposal facility. Due to the presence of existing infrastructure, excavation in certain portions of the affected area is not currently feasible. For these areas, SESI is requesting a deferral of remediation until final pad reclamation is performed at the time of facility abandonment.

Upon completion of excavation activities, confirmation soil samples will be collected from the base and sidewalls of the excavation. These samples will be submitted to Envirotech Laboratories for analysis in accordance with NMOCD-approved methods and Table 1 standards. Once laboratory results confirm that the regulatory closure criteria have been met, the excavated areas will be backfilled with clean, compatible material and restored to the surrounding grade.

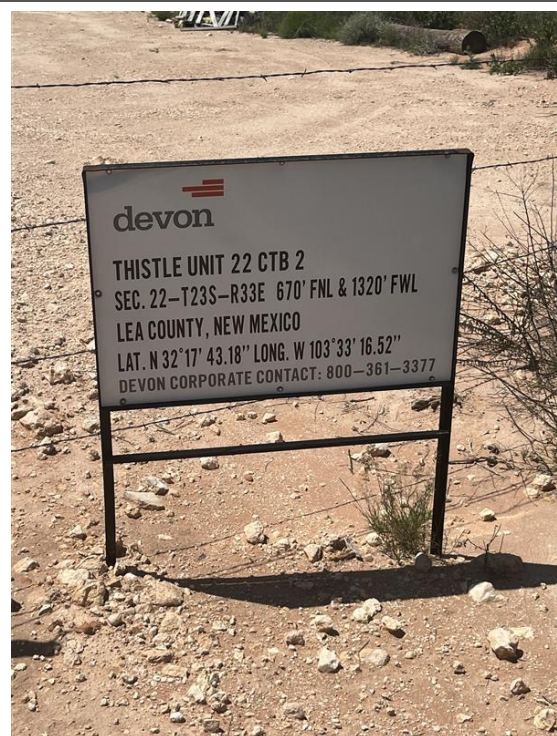
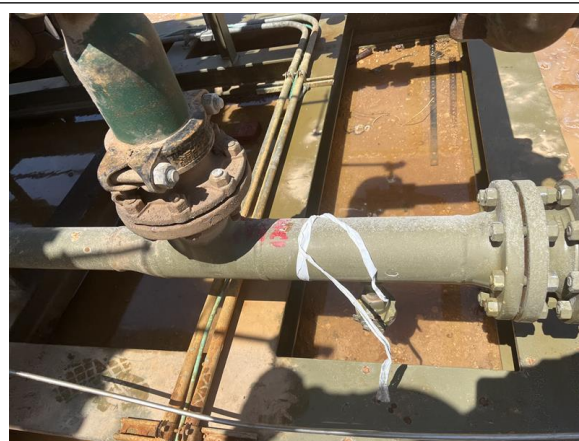
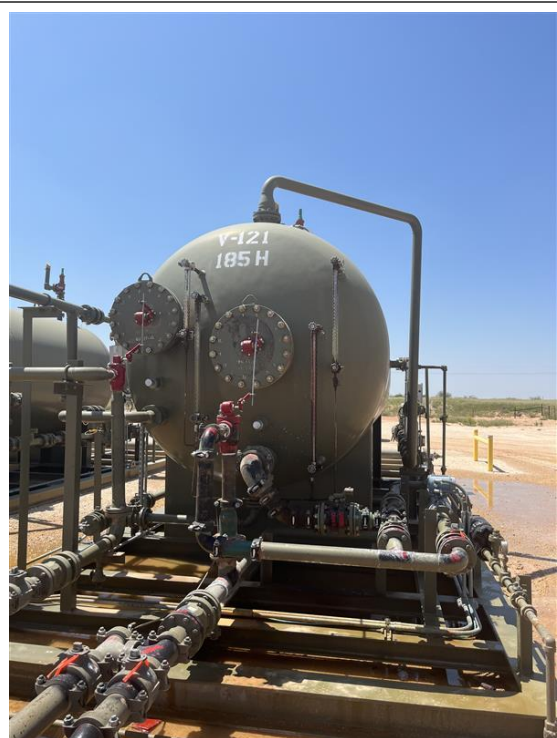
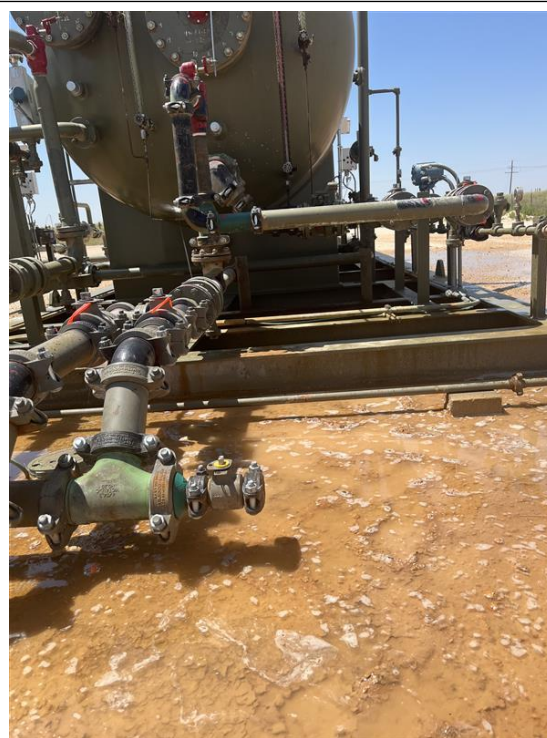
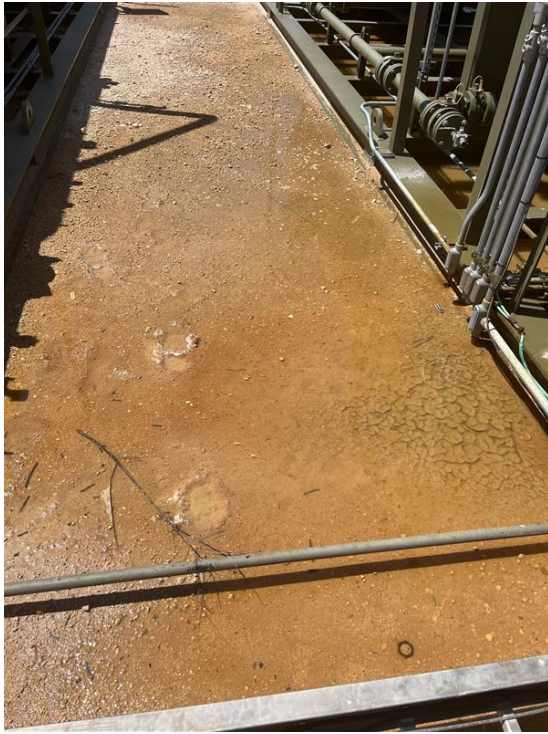
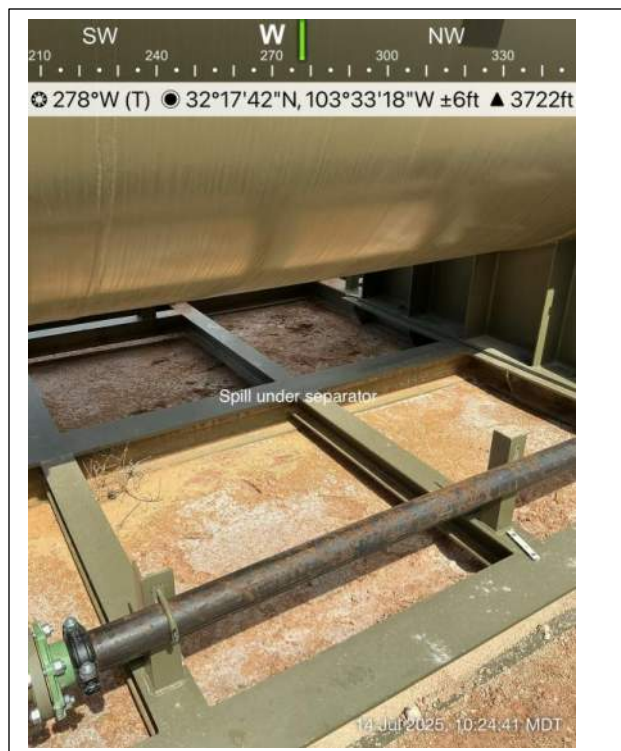
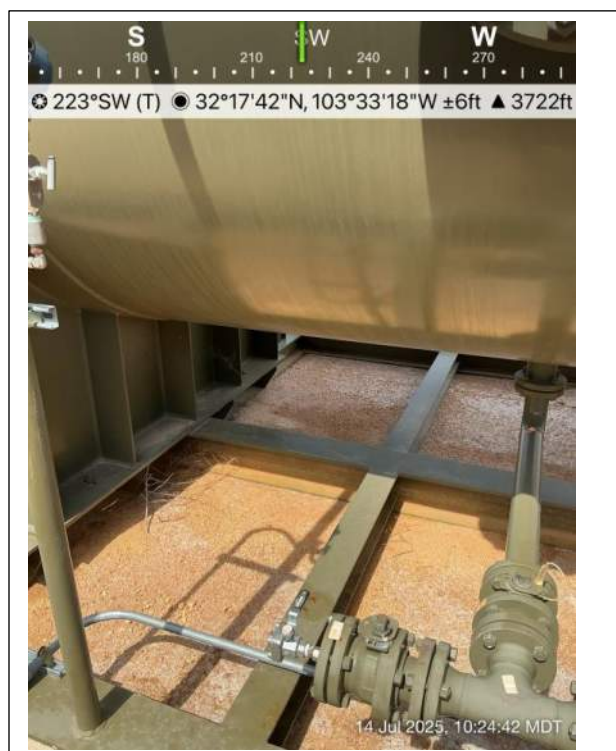
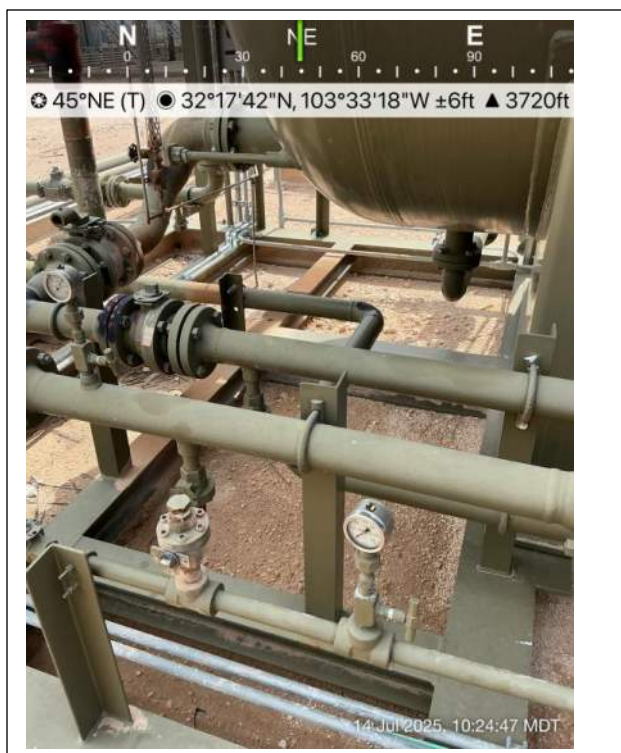
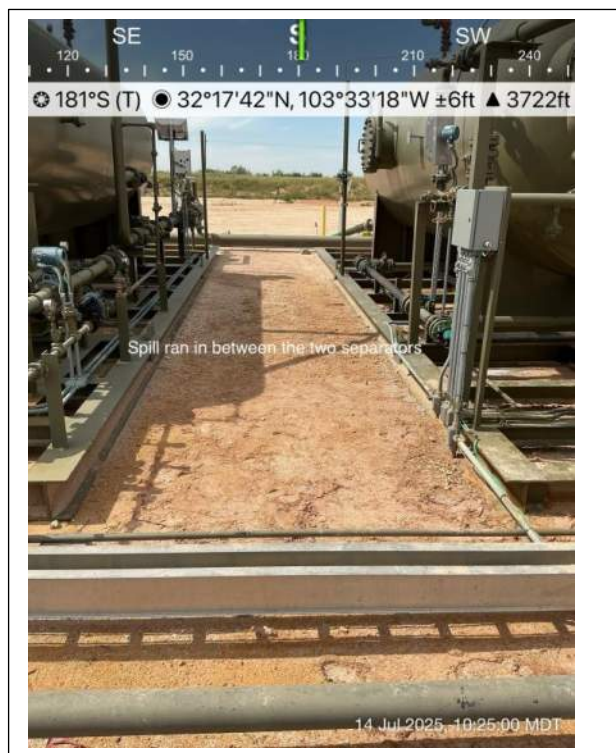
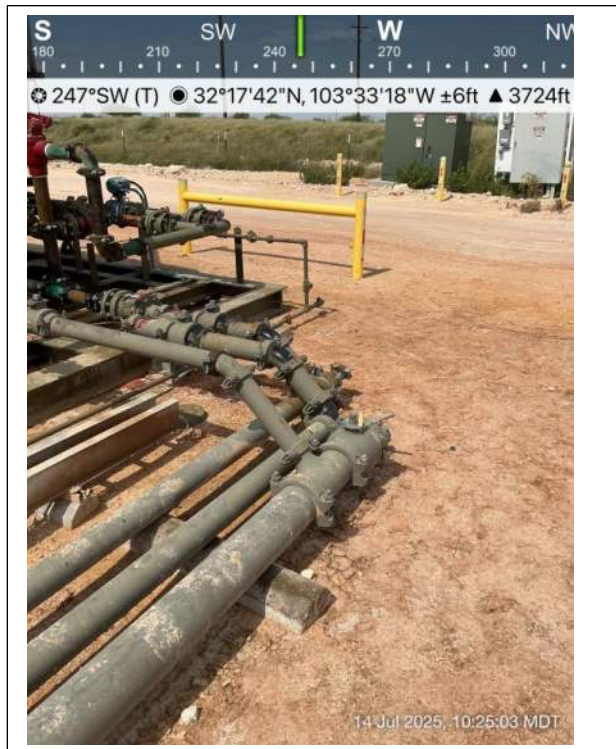
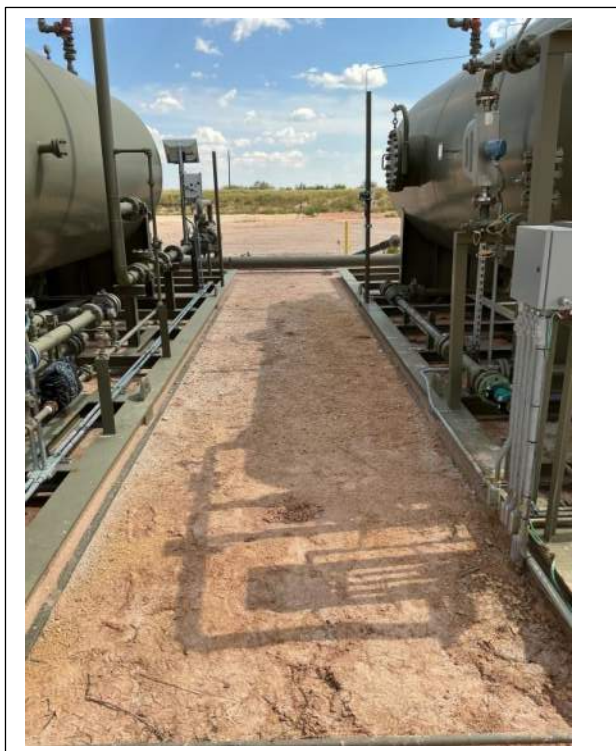
Thistle Unit 22 185H

Incident C-141 received on 07/16/2025 for release on 07/09/2025. The cause of the release was reported as equipment failure: "Leak on 3-phase separator dump spool allowed fluids to be released to separator skid, approx 7 bbls recovered, 1 bbl impacted pad surface by leaking from skid." approximately Produced Water | Released: 8 BBL | Recovered: 7 BBL | Lost: 1 BBL.
