**Re: Closure Request
PLU BS 19-24-31 Battery
Incident Number nAPP2512529220
Eddy County, New Mexico**

Ensolum, LLC (Ensolum) on behalf of XTO Energy, Inc. (XTO), has prepared this *Closure Request* to document assessment, excavation, and soil sampling activities performed at the PLU BS 19-24-31 Battery (Site). The purpose of the remediation activities was to assess for the presence or absence of impacts to soil resulting from a flare fire following a crude oil release at the Site. Based on confirmation soil sample laboratory analytical results, XTO is submitting this *Closure Request* for Incident Number nAPP2512529220.

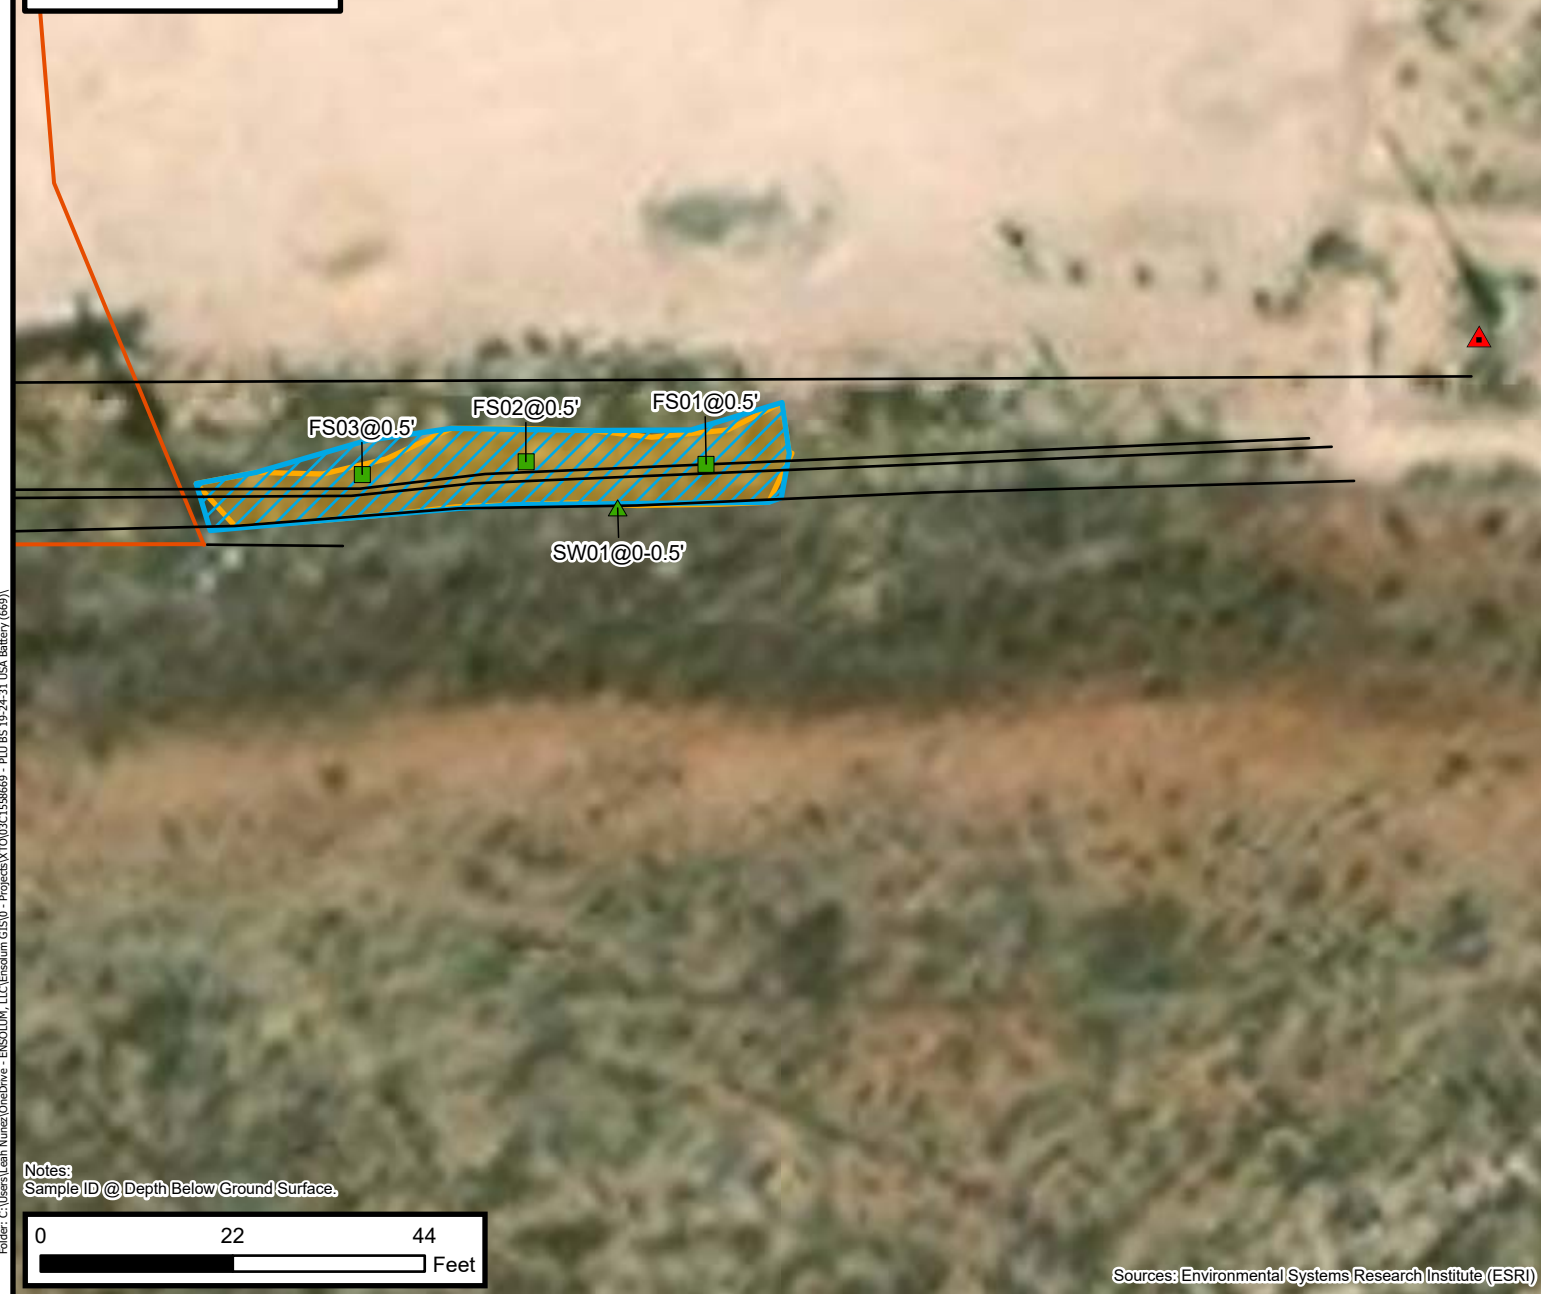
FIGURE
2

bgs. The excavation extent and confirmation soil sample locations were mapped utilizing a handheld GPS unit and are depicted on Figure 2.

Confirmation Soil Sample Locations

The final excavation area measured to approximately 560 square feet. Approximately 20 cubic yards of soil were removed during the excavation activities. The soil was transported and properly disposed of at the Northern Delaware Basin Landfill Disposal Facility located in Jal, New Mexico. Disposal manifests are included in Appendix C.

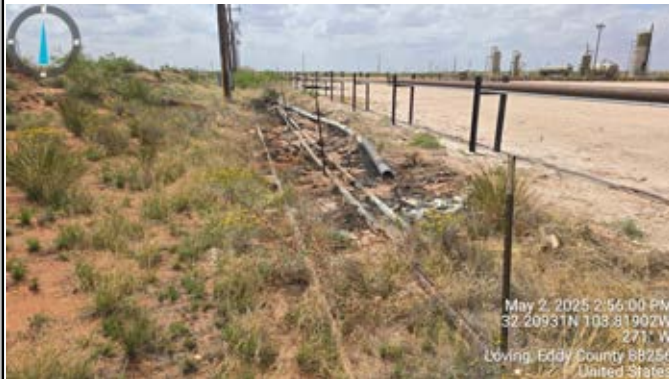
Photograph: 1 Date: 5/2/2025
 Description: Soil Staining view near FS01
 View: West

On May 27, 2025, Ensolum personnel returned to the Site to oversee excavation and soil sampling activities. Impacted soil was excavated from the release area as indicated by soil staining and visual observations. Excavation activities were performed utilizing hand tools and transport vehicles. The excavation occurred in a surface pipeline ROW, near flare equipment. To direct excavation activities, soil was field screened for volatile organic compounds (VOCs) utilizing a calibrated photoionization detector (PID) and chloride using Hach® chloride QuanTab® test strips. The excavation was completed to a depth of 0.5 feet bgs. Photographic documentation of the excavation activities is included in Appendix B.

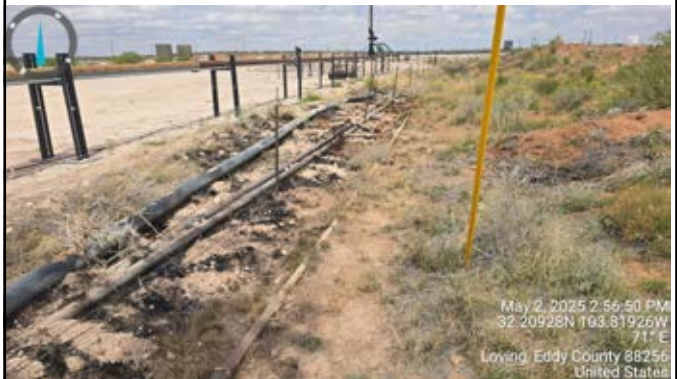
Photograph: 2 Date: 5/2/2025
 Description: Soil Staining view near FS03
 View: East

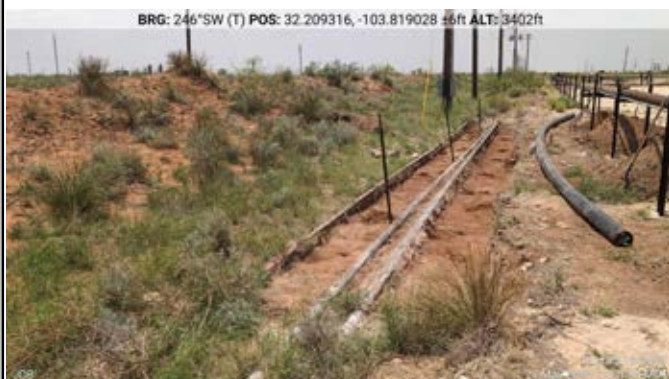
Photograph: 3 Date: 5/27/2025
 Description: Excavation activities near FS01
 View: Southwest

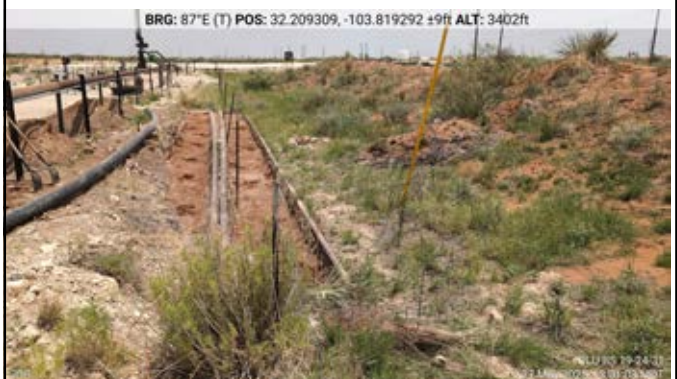
Photograph: 4 Date: 5/27/2025
 Description: Excavation activities near FS03
 View: East
