Closure Report
Red Hills Unit 127H (06.10.2025)
Lea County, New Mexico
Unit D Sec 32 T25S R33E
32.09312°, -103.60074°

Incident ID: NAPP2516257736

Crude Oil & Produced Water Release

Point of Release: Location instability caused a gasket on the separator to fail resulting in a release onto the well pad.

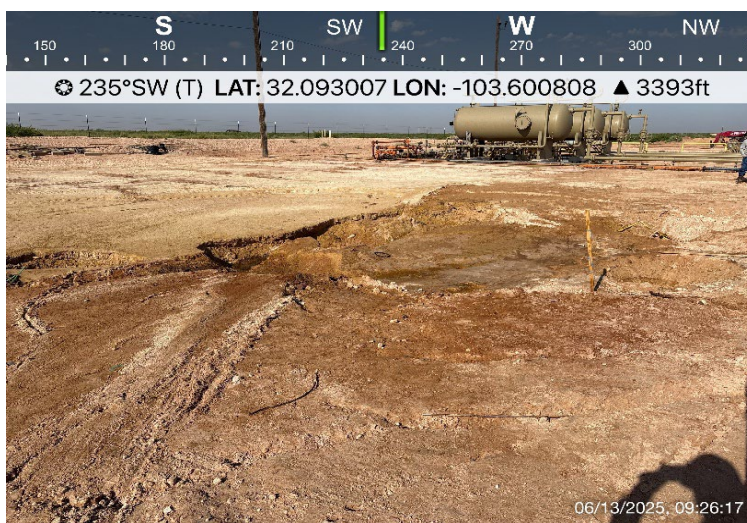
Photograph No. 2

View Southwest, release area with equipment removed.

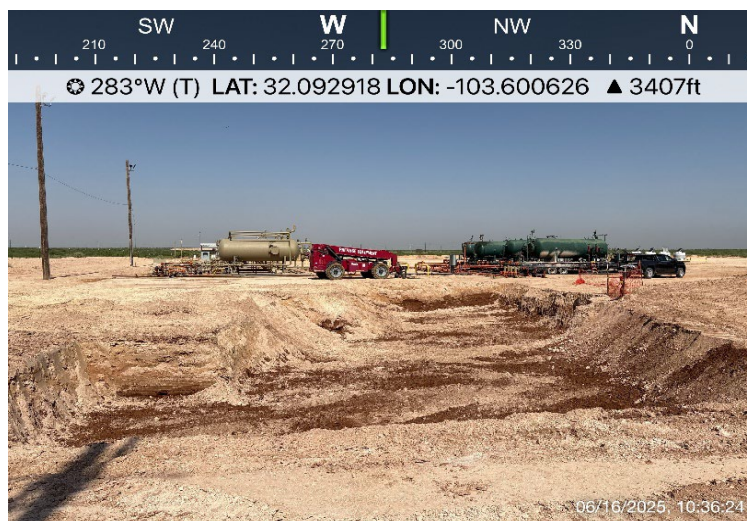
View West, area of S-1 through S-20.

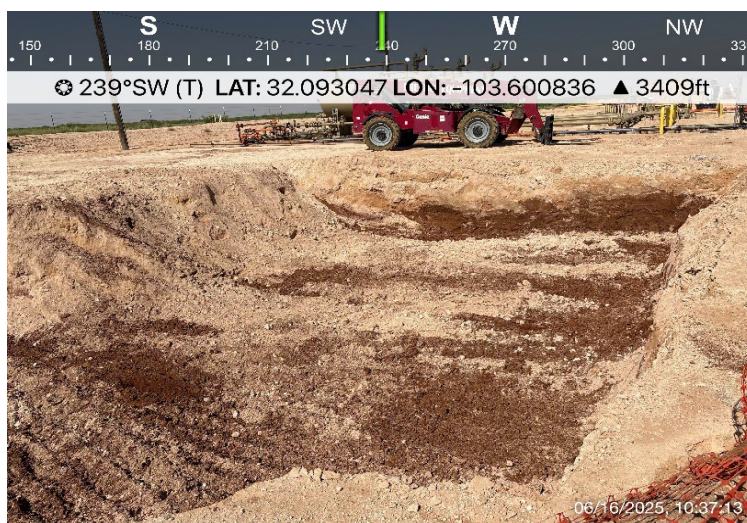
Photograph No. 5

View Southwest, area of CS-1 through CS-11.
