BRITT B #020
nGRL0835160441

PREPARED BY SAPEC-ECO, LLC.
PREPARED FOR MAVERICK PERMIAN, LLC.

Proposed Sampling and Remediation Work Plan

Re: Proposed Sampling and Remediation Work Plan
 NMOCD Incident Number: **nGRL0835160441**
 Britt B #020 API No. 30-025-20299
 Unit L, Section 10, Township 20S, Range 37E 1880 FSL 330 FWL Lea County, NM
 GPS Coordinates: Latitude 32.5855293 Longitude -103.2468491 NAD83

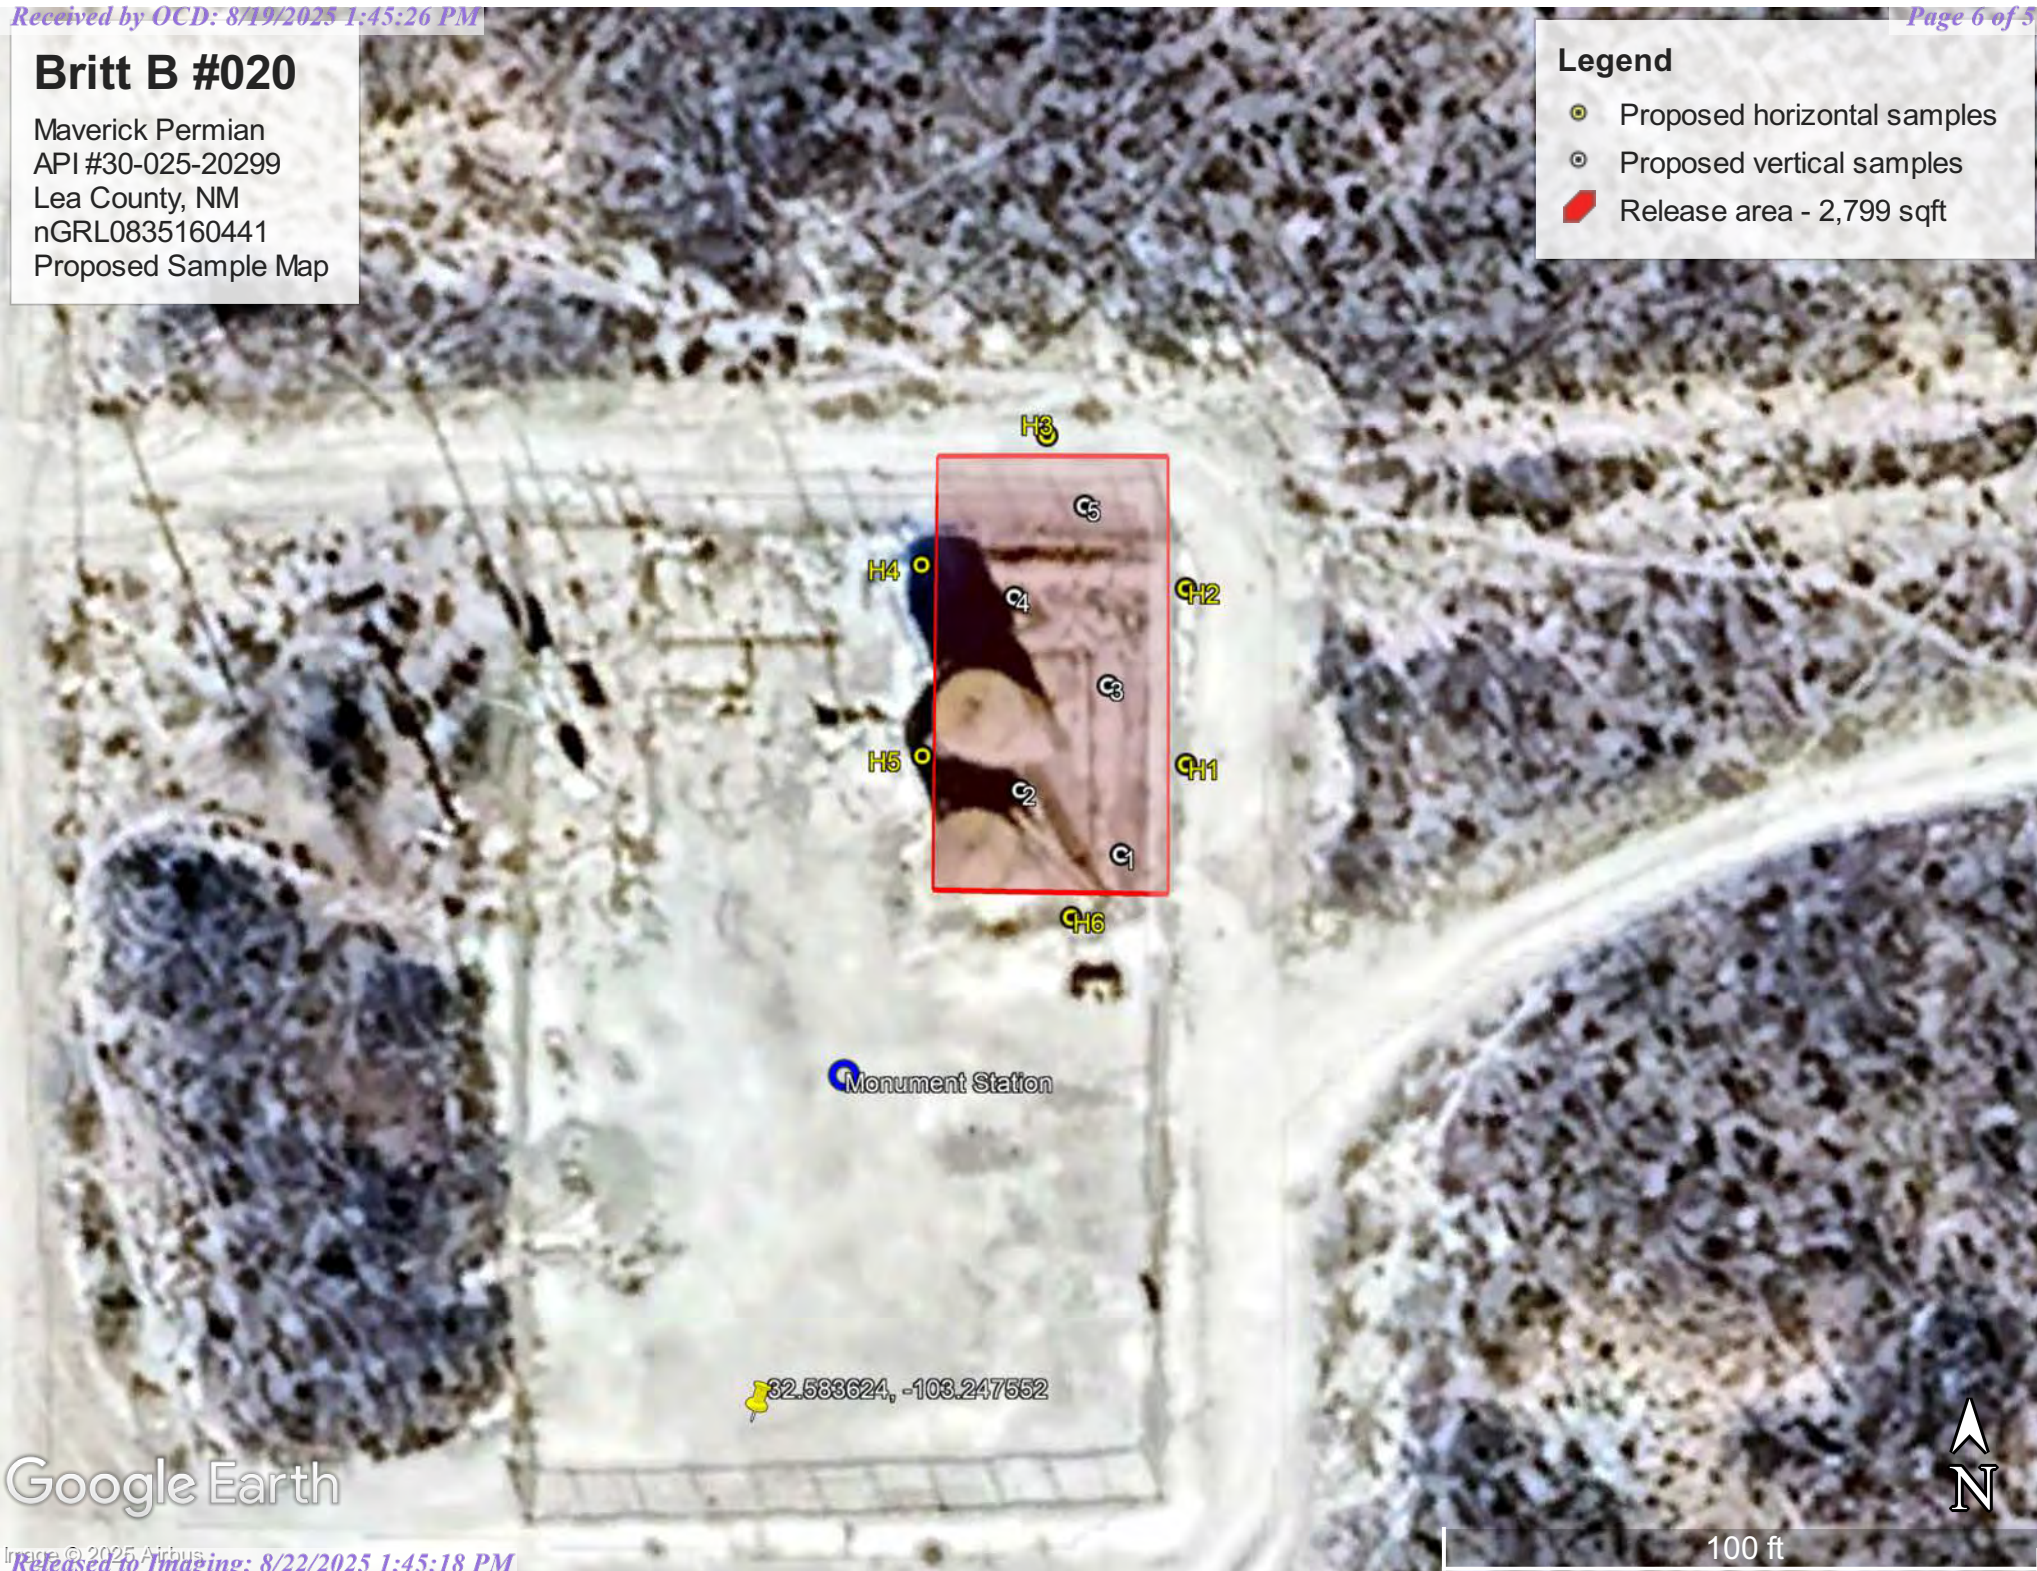
Maverick Permian
API #30-025-20299
Lea County, NM
nGRL0835160441
Proposed Sample Map

- Proposed horizontal samples
- Proposed vertical samples
- Release area - 2,799 sqft

- The area of concern measures approximately 2,799 square feet and is entirely on the pad surface within and outside the facility's perimeter fence.
- Permission needs to be obtained from Holly Energy Partners to enter the site and perform assessment activities.

- Once authorized, collect discrete samples from within and around the edges of the release area to evaluate the presence of contaminants. Twenty-five (25) samples will be collected from 5 different sample points within the release area from depths of surface, 1', 2', 3', and 4' bgs. Thirty (30) samples will be collected from 6 different sample points around the edges of the release area from depths of surface, 1', 2', 3', and 4' bgs.

- A 48-hour sampling notification will be issued to the NMOCD for these sampling events. A variance request is included below for permission to use the delineation samples as confirmation samples depending on the sample results of the soil. A Proposed Sample Map referencing the release area and the previously remediated area can be found in Figure 1.

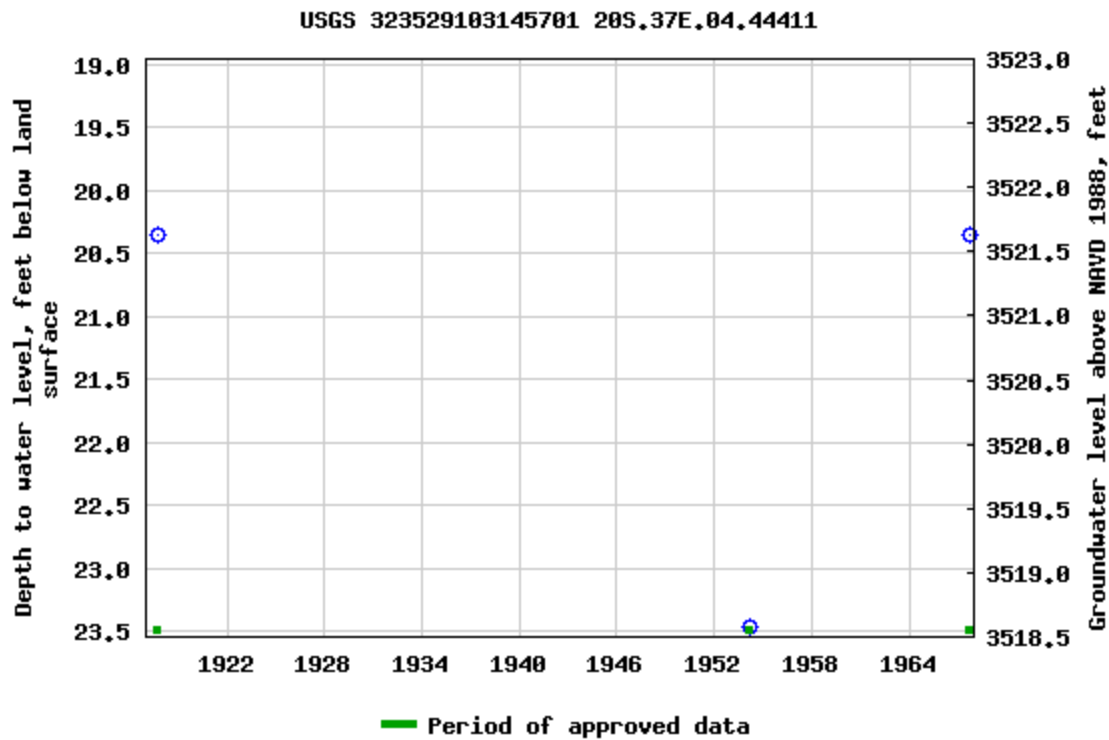
The depth of the well is 30 feet below land surface.

Breaks in the plot represent a gap of at least one year between field measurements.
