Remediation Summary & Soil Closure Request

Mewbourne Oil Company Dagger Draw Trunk Line

Eddy County, New Mexico
Unit Letter "O", Section 10, Township 20 South, Range 25 East
Latitude 32.580784 North, Longitude 104.470355 West
NMOCD Reference No. nAPP2409454303

Etech Environmental & Safety Solutions, Inc.
6309 Indiana Ave, Ste. D
Lubbock, Texas 79413

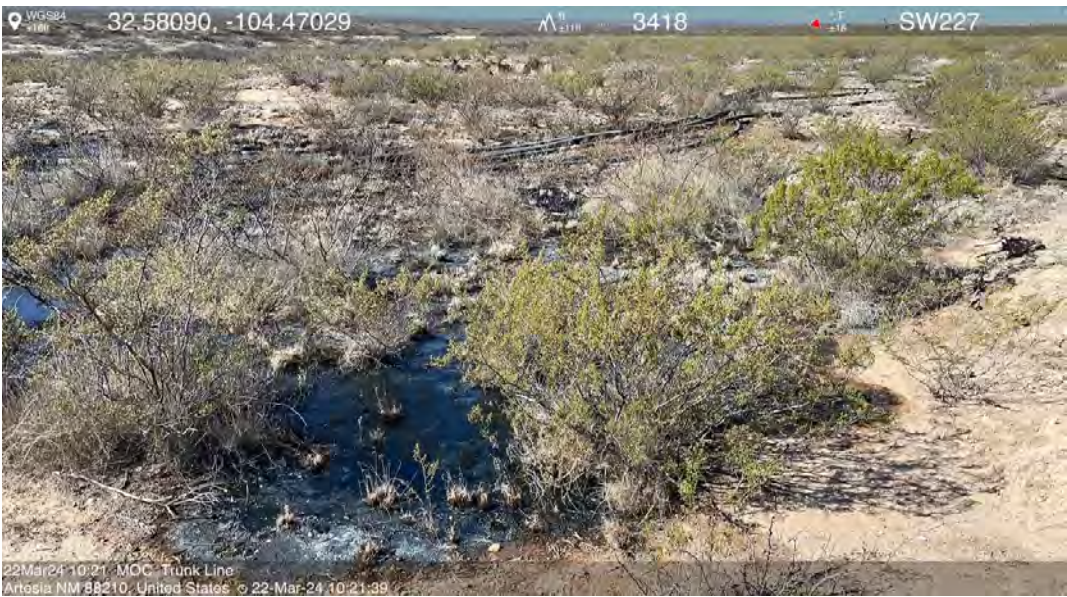
Photo Number: 2

Photo Direction: Southwest	
Photo Description: View of the affected area.

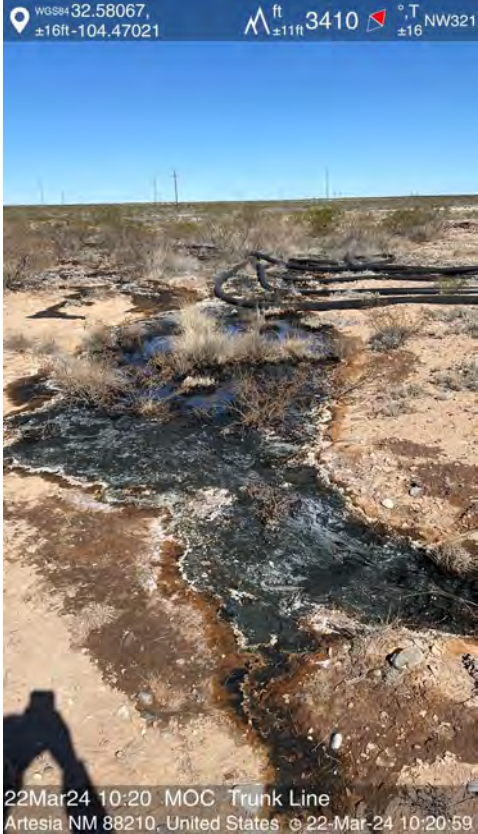
Photo Number: 3

<p>22Mar24 10:20 MOC Trunk Line Artesia NM 88210, United States © 22-Mar-24 10:20:59</p>
Photo Direction: Northwest	
Photo Description: View of the affected area.

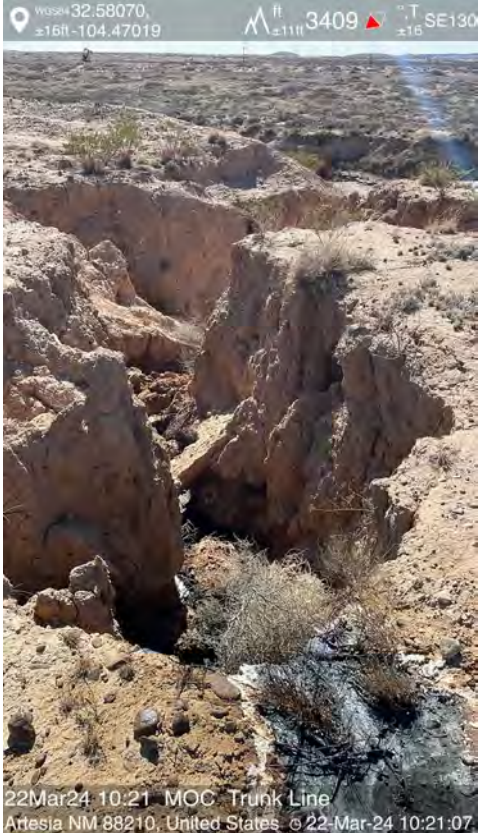
Photo Number: 4

<p>22Mar24 10:21 MOC Trunk Line Artesia NM 88210, United States © 22-Mar-24 10:21:07</p>
Photo Direction: Southeast	
Photo Description: View of the affected area.

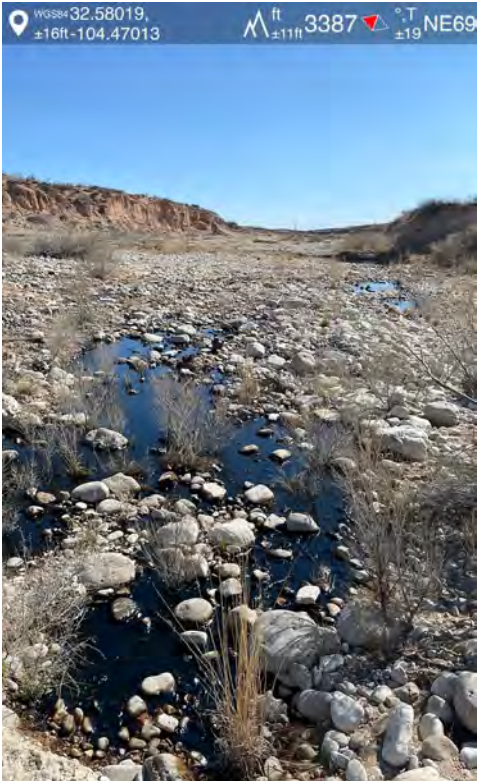
Photo Number: 6

Photo Direction: East-Northeast	
Photo Description: View of the affected area.

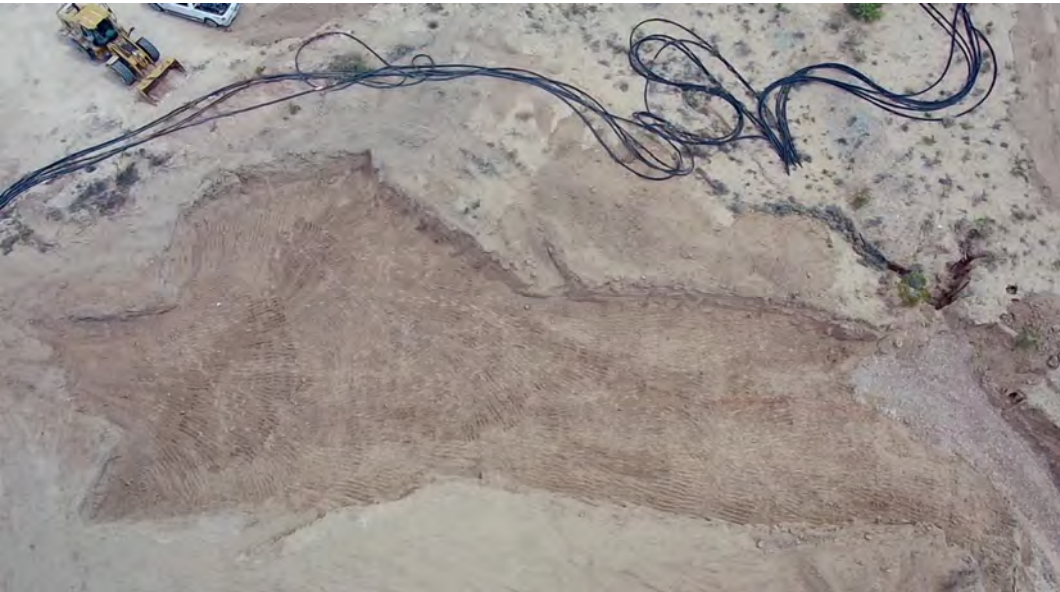
Photo Number: 9

Photo Direction: Overhead/Bird's Eye	
Coordinates: 32.580793,-104.470289	
Date Taken: 4/24/2024	
Photo Description: Aerial view of the Upper Excavation.

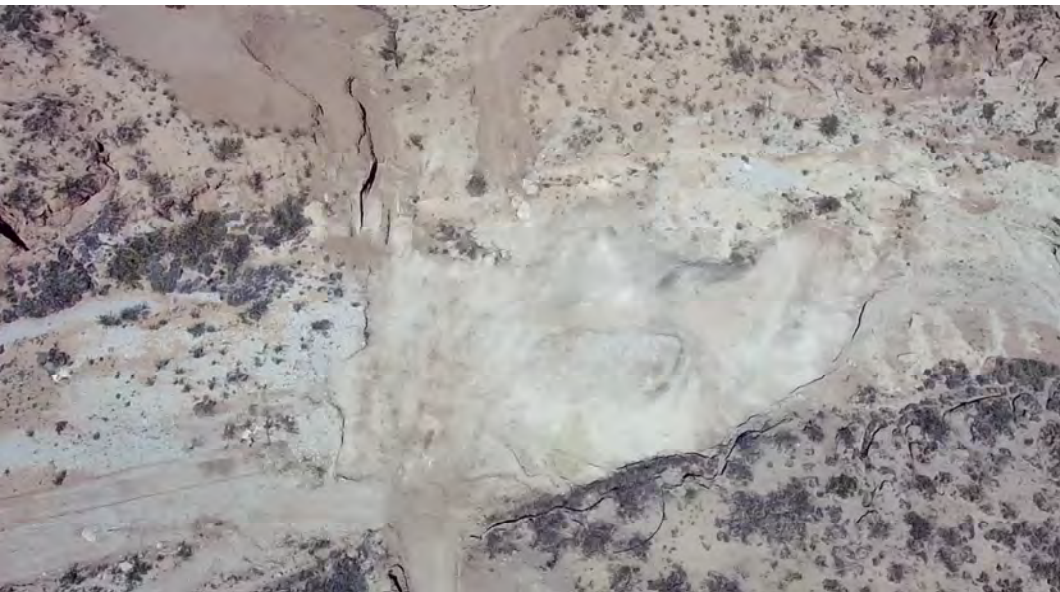
Photo Number: 10

Photo Direction: Overhead/Bird's Eye	
Coordinates: 32.580309,-104.469819	
Date Taken: 4/24/2024	
Photo Description: Aerial view of the Lower Excavation, arroyo, and bluff.

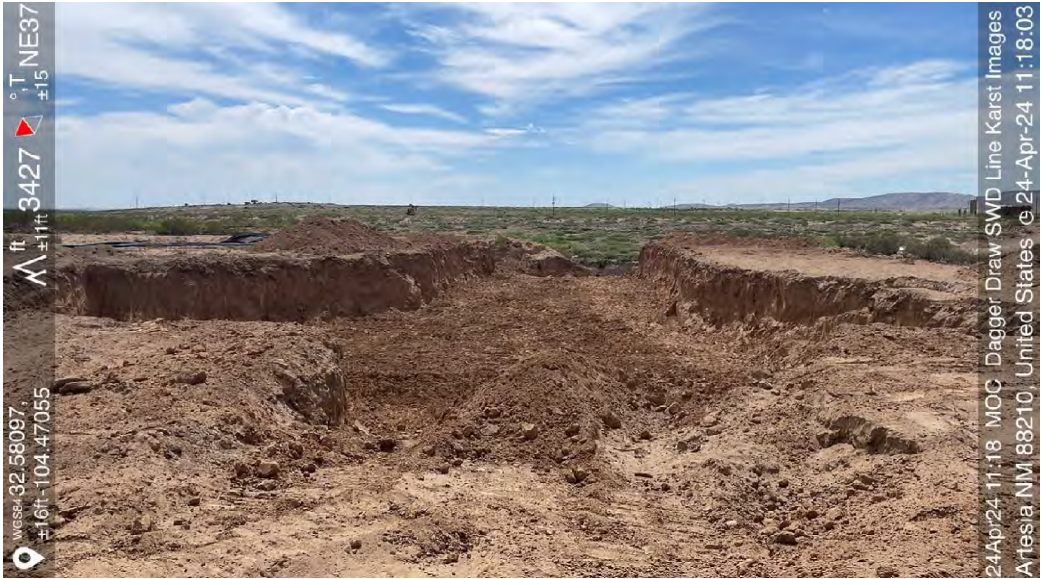
Photo Number: 11

Photo Direction: Northeast	
Photo Description: View of the excavated area.

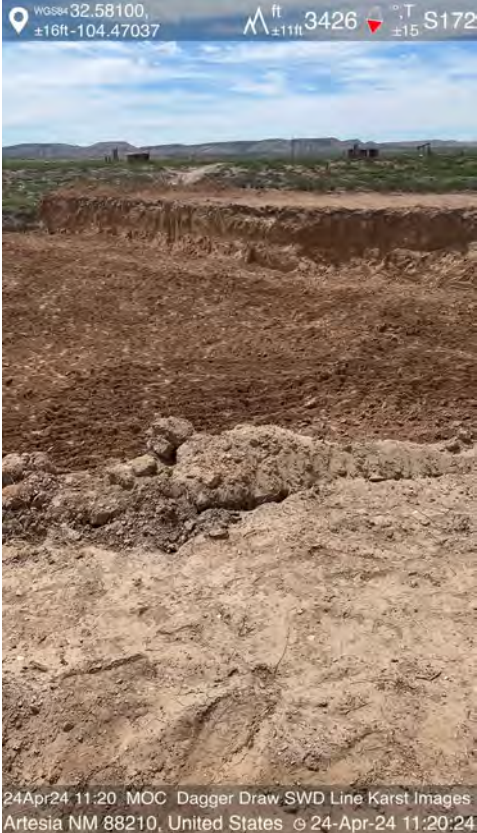
Photo Number: 14

Photo Direction: South	
Photo Description: View of the excavated area.

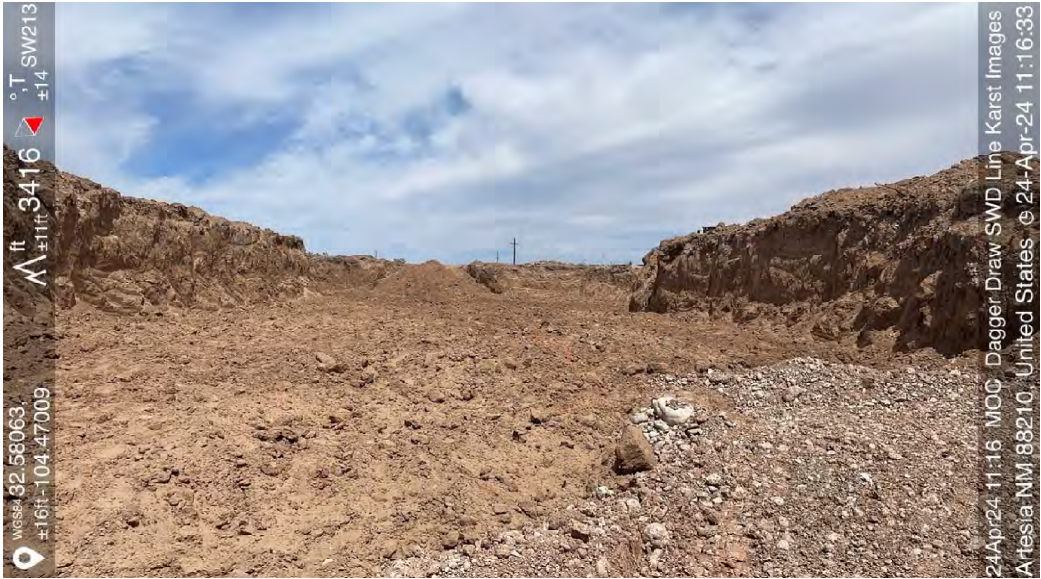
Photo Number: 15

Photo Direction: South-Southwest	
Photo Description: View of the excavated area.

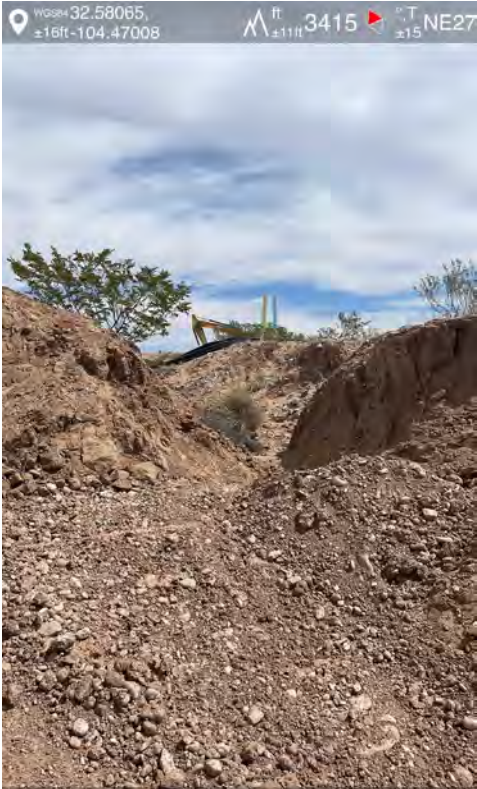
Photo Number: 16

Photo Direction: North-Northeast	
Photo Description: View of the excavated area.

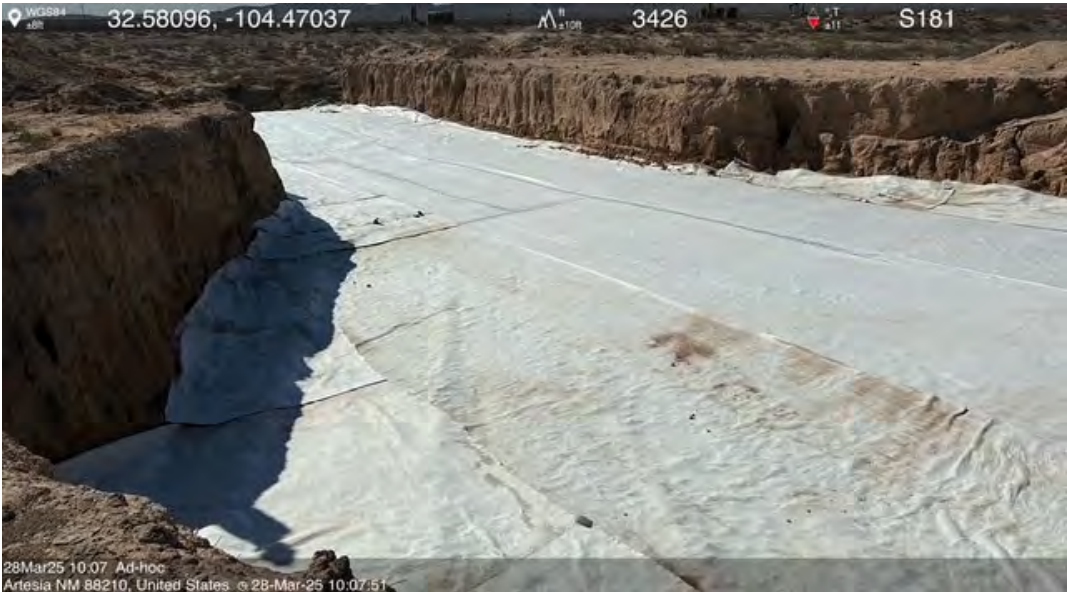
Photo Number: 18

Photo Direction: South	
Photo Description: View of the bentonliner.

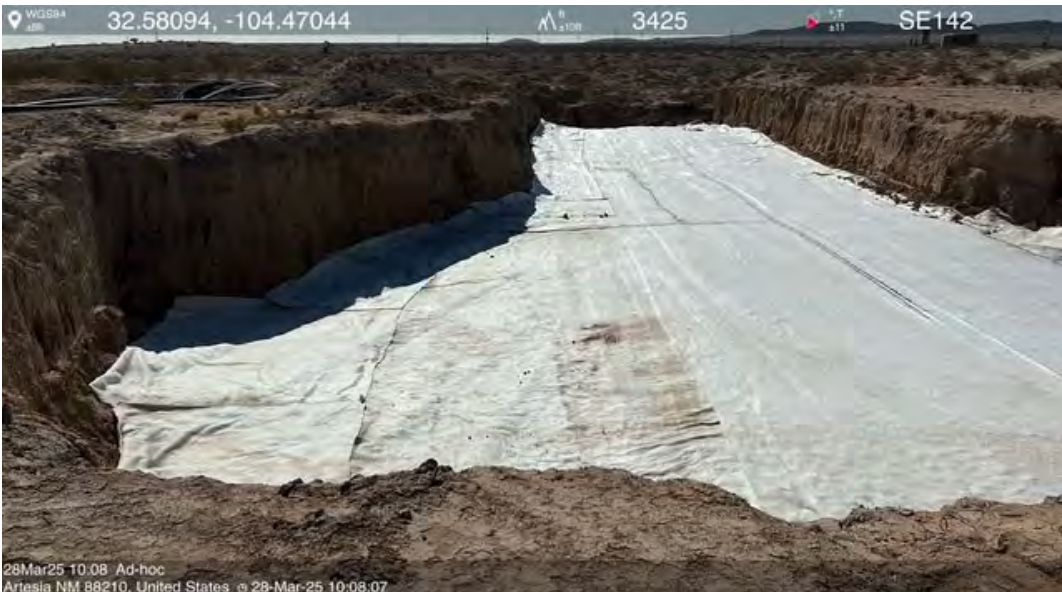
Photo Number: 20

Photo Direction: Southeast	
Photo Description: View of the bentonliner.

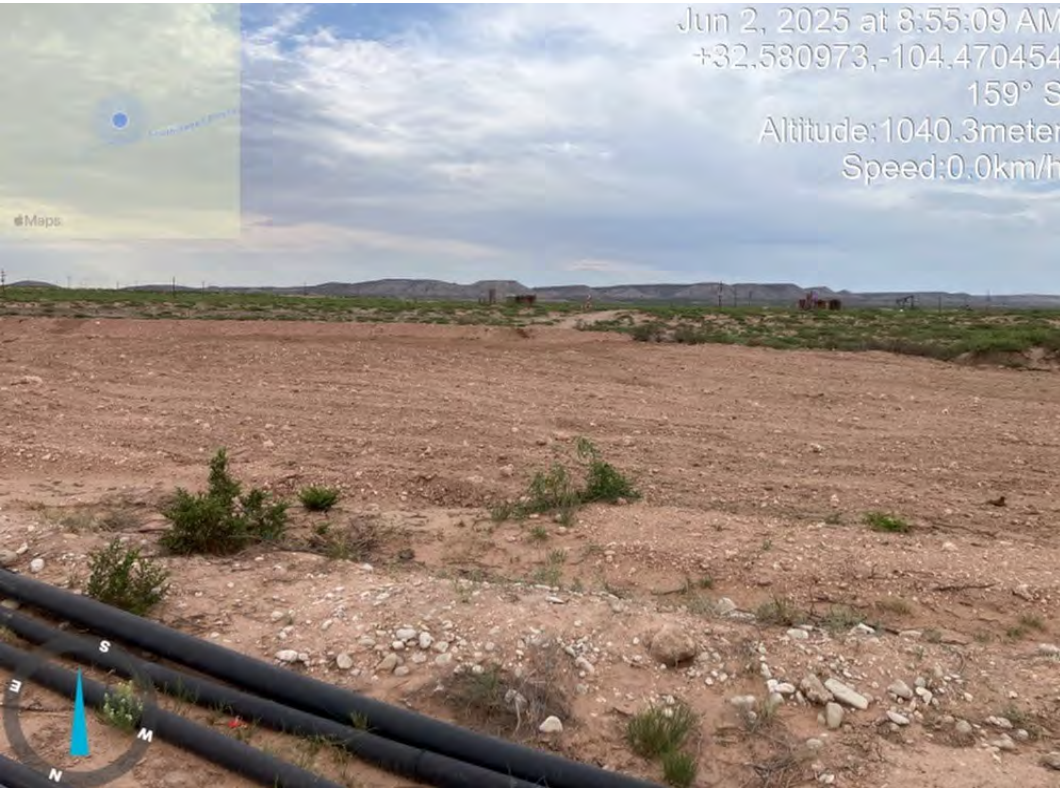
Photo Number: 27

Photo Direction: South-Southeast	
Photo Description: View of the backfilled Upper Excavation following seeding event.

Upon receipt of confirmation soil sample results and installation of the clay liner system, areas affected by remediation and closure activities were substantially restored to the condition that existed prior to the release, to the extent practicable. Excavated areas were backfilled with locally sourced, non-impacted, "like" material placed at or near original relative positions. The affected areas were compacted and contoured to achieve erosion control, stability, and preservation of surface water flow.

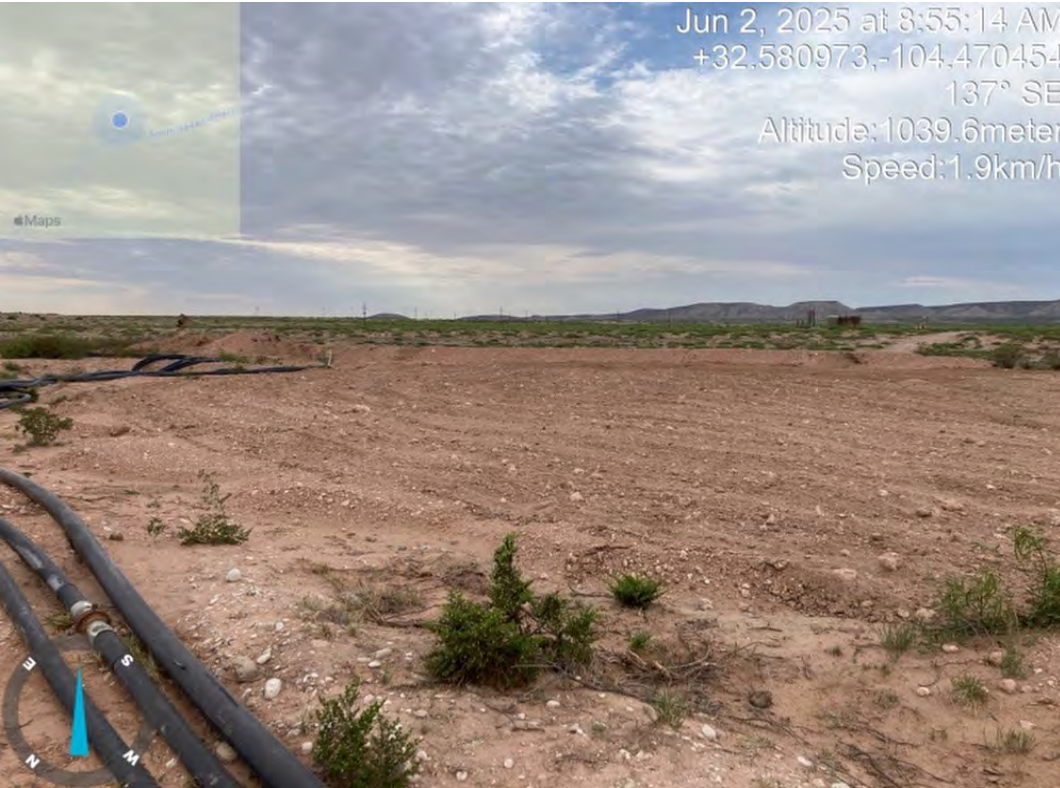
Photo Number: 28

Photo Direction: Southeast	
Photo Description: View of the backfilled Upper Excavation following seeding event.
