## Release Assessment and Closure

Dolores AIL Federal #3

Section 14, Township 22 South, Range 31 East

API: 30-015-26722

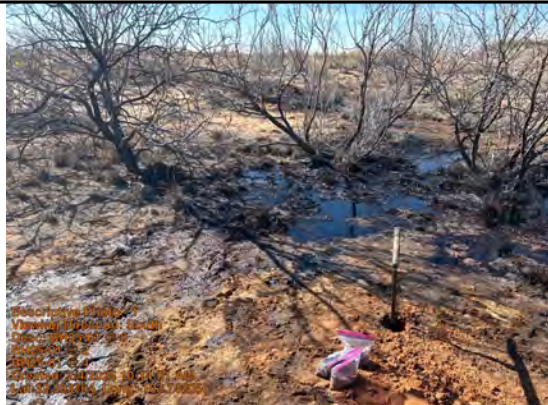
Viewing Direction: South

BH25-01 @ 0  
BH25-01 @ 2  
BH25-01 @ 4

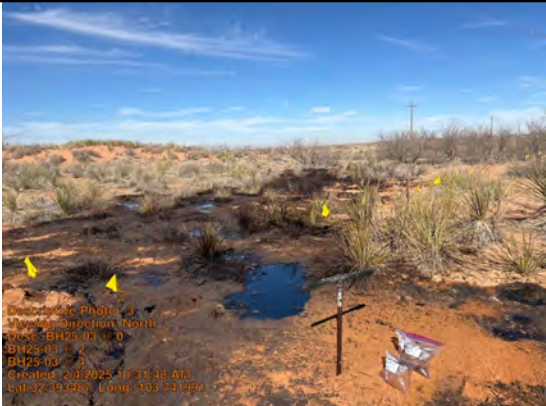
<p><b>Viewing Direction: North</b></p>

<p>Descriptive Photo - 3 Viewing Direction: North Desc: BH25-03 @ 0 BH25-03 @ 0 Created: 2/4/2025 10:31:48 AM Lat: 32.39386, Long: 103.742146</p> <p>BH25-03 @ 0 BH25-03 @ 2 BH25-03 @ 4</p>	<p><b>Viewing Direction: East</b></p>

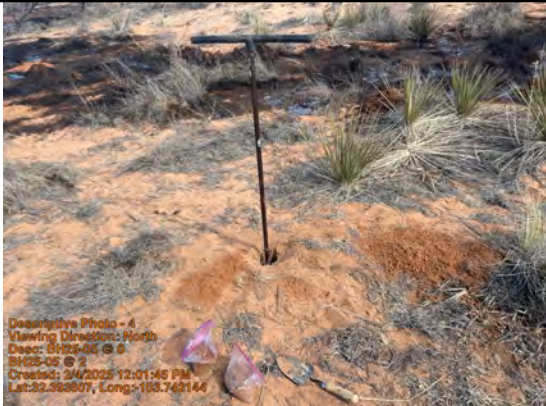
<p>Descriptive Photo - 4 Viewing Direction: East Desc: BH25-05 @ 0 BH25-05 @ 2 Created: 2/4/2025 12:01:45 PM Lat: 32.39386, Long: 103.742146</p> <p>BH25-05 @ 0 BH25-05 @ 2</p>
<p><b>Viewing Direction: South</b></p>

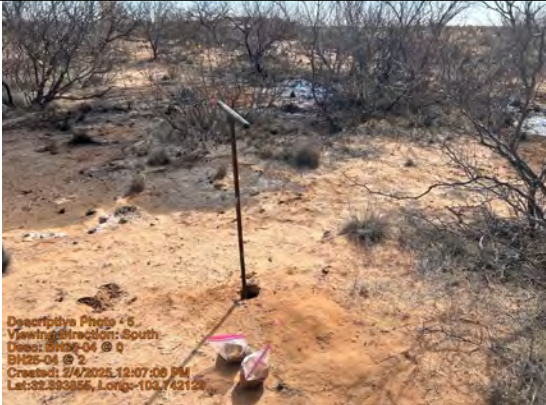
<p>Descriptive Photo - 5 Viewing Direction: South Desc: BH25-04 @ 0 BH25-04 @ 2 Created: 2/4/2025 12:07:00 PM Lat: 32.39386, Long: 103.742146</p> <p>BH25-04 @ 0 BH25-04 @ 2</p>	<p><b>Viewing Direction: West</b></p>

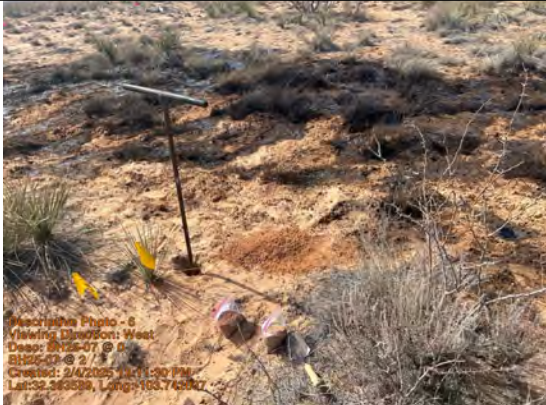
<p>Descriptive Photo - 6 Viewing Direction: West Desc: BH25-07 @ 0 BH25-07 @ 2 Created: 2/4/2025 12:11:30 PM Lat: 32.39386, Long: 103.742146</p> <p>BH25-07 @ 0 BH25-07 @ 2</p>

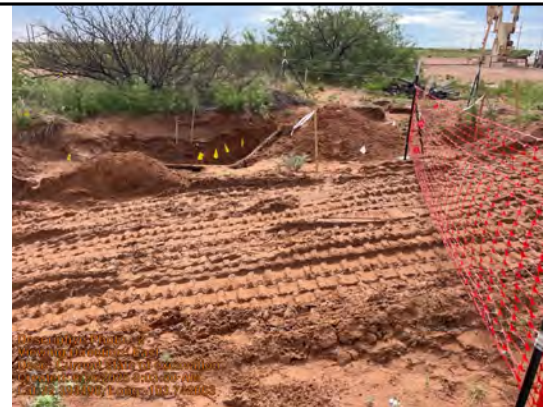
Viewing Direction: East

Current state of excavation: southeast end incomplete.

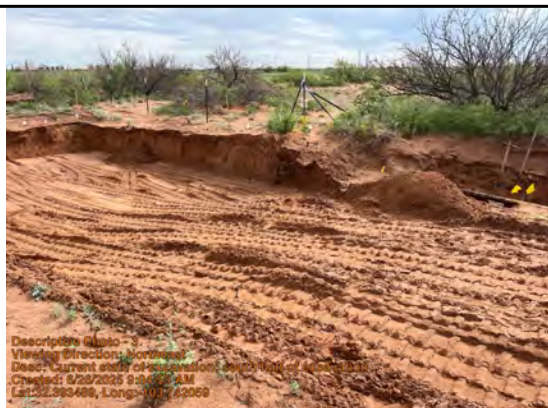
Viewing Direction: Northeast

Current state of excavation: south half of excavation.

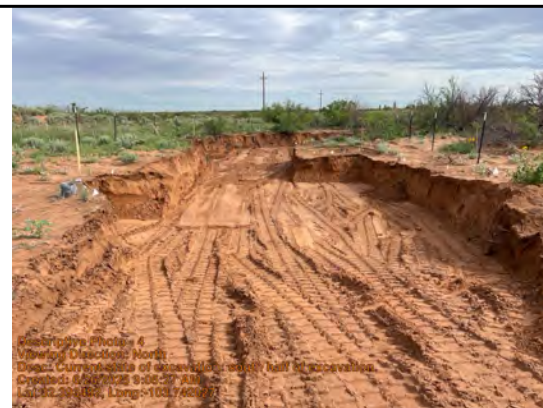
Viewing Direction: North

Current state of excavation: south half of excavation.

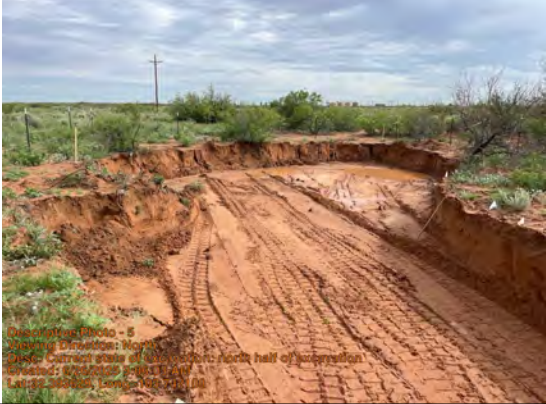
<p><b>Viewing Direction: North</b></p>

<p>Descriptive Photo - 5 Viewing Direction: North Desc: Current state of excavation: north half of excavation Created: 8/28/2025 9:07:06 AM Lat: 38.953514, Long: -103.742156</p> <p>Current state of excavation: north half of excavation</p>	<p><b>Viewing Direction: South</b></p>

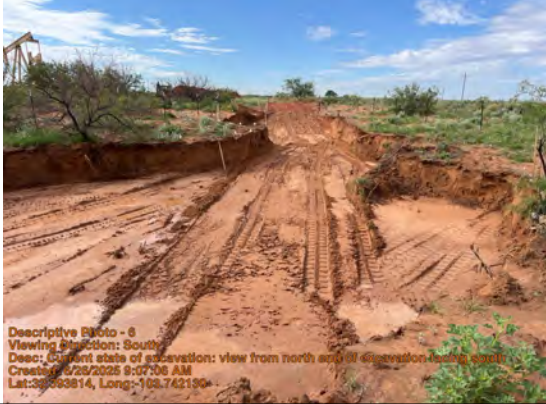
<p>Descriptive Photo - 6 Viewing Direction: South Desc: Current state of excavation: view from north end of excavation facing south Created: 8/28/2025 9:07:06 AM Lat: 38.953514, Long: -103.742156</p> <p>Current state of excavation: view from north end of excavation facing south.</p>
<p><b>Viewing Direction: Northwest</b></p>

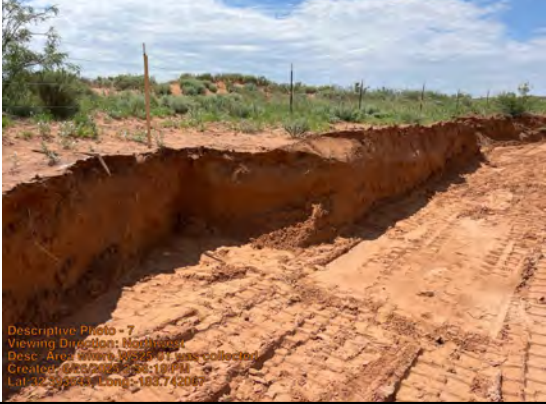
<p>Descriptive Photo - 7 Viewing Direction: Northwest Desc: Area where WS25-01 was collected Created: 8/28/2025 9:07:06 AM Lat: 38.953514, Long: -103.742156</p> <p>Area where WS25-01 was collected.</p>	<p><b>Viewing Direction: Northwest</b></p>

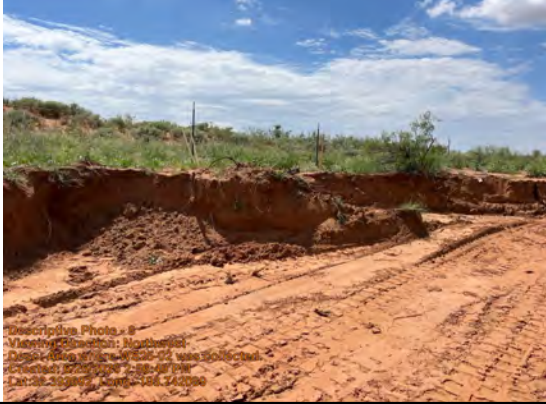
<p>Descriptive Photo - 8 Viewing Direction: Northwest Desc: Area where WS25-02 was collected Created: 8/28/2025 9:07:06 AM Lat: 38.953514, Long: -103.742156</p> <p>Area where WS25-02 was collected.</p>

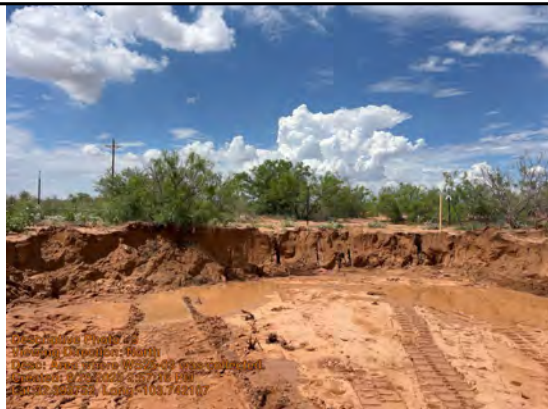
**Viewing Direction: North**

Area where WS25-03 was collected.

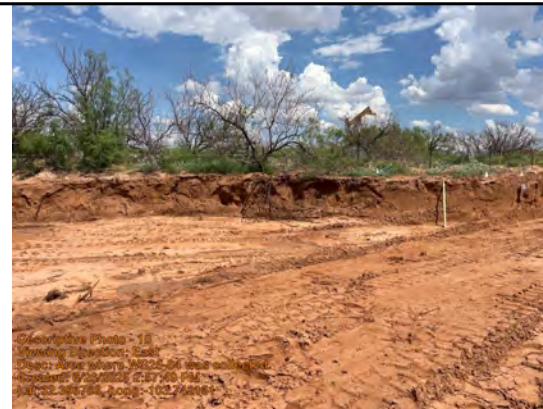
**Viewing Direction: East**

Area where WS25-04 was collected.

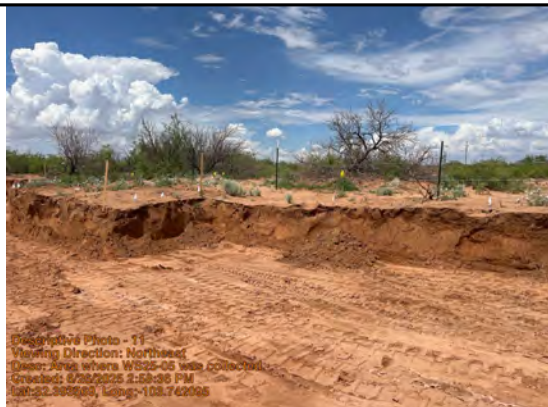
**Viewing Direction: Northeast**

Area where WS25-05 was collected.

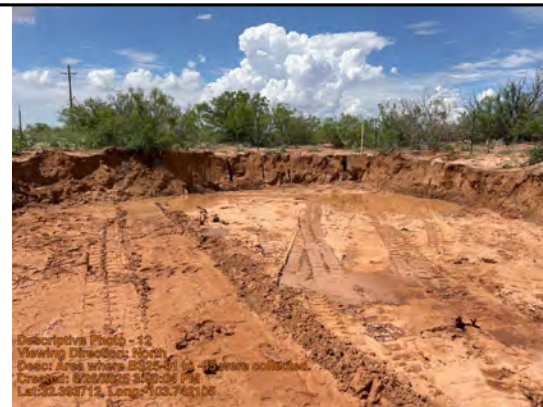
**Viewing Direction: North**

Area where BS25-01 to -05 were collected.

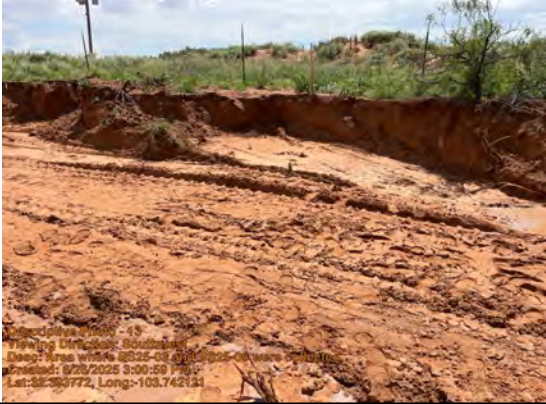
<p>Descriptive Photo - 13 Viewing Direction: Southwest Desc: Area where BS25-03 and BS25-06 were collected. Created: 8/29/2025 3:00:59 PM Lat: 32.59772, Long: -103.742121</p> <p>Area where BS25-03 and BS25-06 were collected.</p>	<p><b>Viewing Direction: South</b></p>

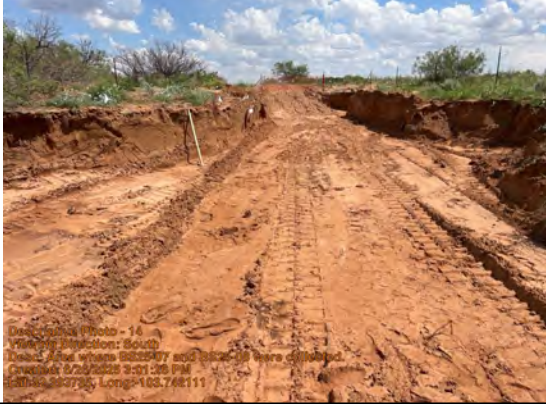
<p>Descriptive Photo - 14 Viewing Direction: South Desc: Area where BS25-07 and BS25-08 were collected. Created: 8/29/2025 3:01:25 PM Lat: 32.59772, Long: -103.742111</p> <p>Area where BS25-07 and BS25-08 were collected.</p>
<p><b>Viewing Direction: South</b></p>

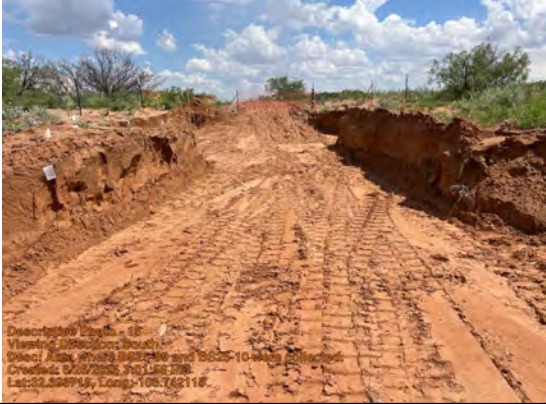
<p>Descriptive Photo - 15 Viewing Direction: South Desc: Area where BS25-09 and BS25-10 were collected. Created: 8/29/2025 3:01:52 PM Lat: 32.598944, Long: -103.742118</p> <p>Area where BS25-09 and BS25-10 were collected.</p>	<p><b>Viewing Direction: Southeast</b></p>

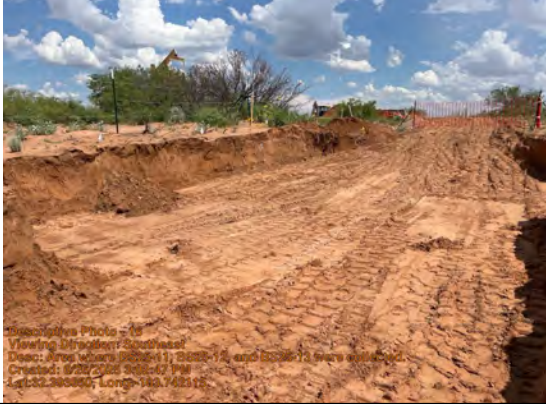
<p>Descriptive Photo - 16 Viewing Direction: Southeast Desc: Area where BS25-11, BS25-12, and BS25-13 were collected. Created: 8/29/2025 3:02:42 PM Lat: 32.598944, Long: -103.742118</p> <p>Area where BS25-11, BS25-12, and BS25-13 were collected.</p>

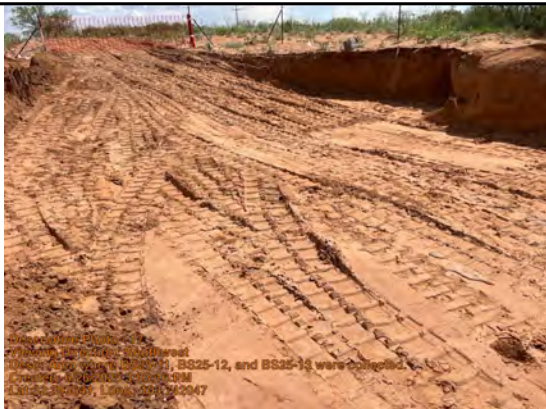
**Viewing Direction: Southwest**

Area where BS25-11, BS25-12, and BS25-13 were collected.

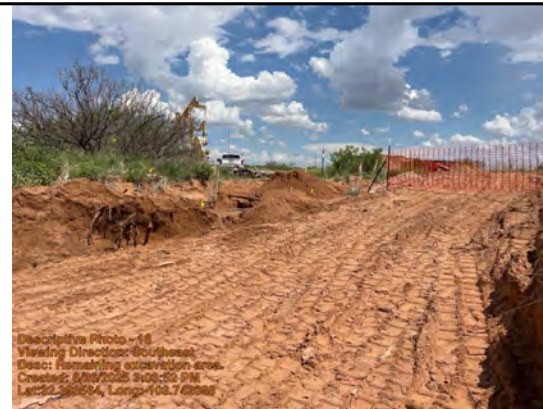
**Viewing Direction: Southeast**

Remaining excavation area.

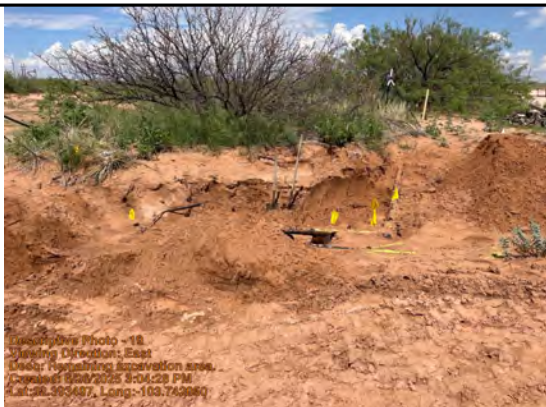
**Viewing Direction: East**

Remaining excavation area.

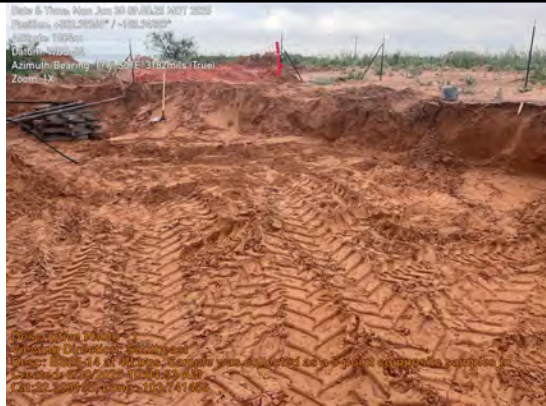
## Viewing Direction: Southeast

BS25-14 at 4ft bgs. Sample was collected as a 5-point composite samples in a 200 sq ft area.

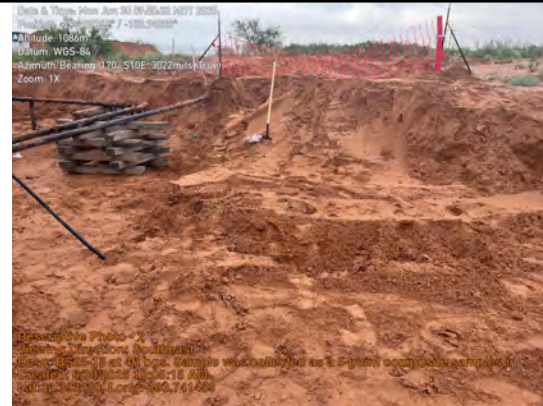
## Viewing Direction: Southeast

BS25-15 at 4ft bgs. Sample was collected as a 5-point composite samples in a 200 sq ft area.

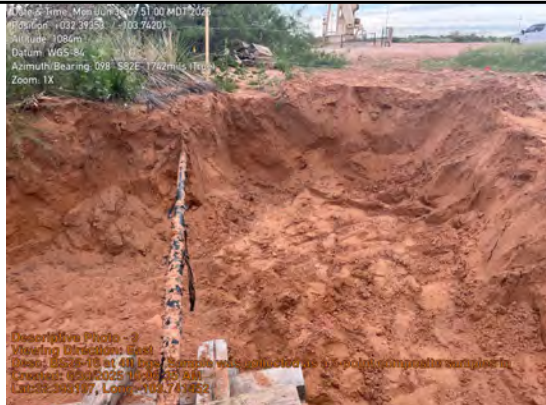
## Viewing Direction: East

BS25-16 at 4ft bgs. Sample was collected as a 5-point composite samples in a 200 sq ft area.

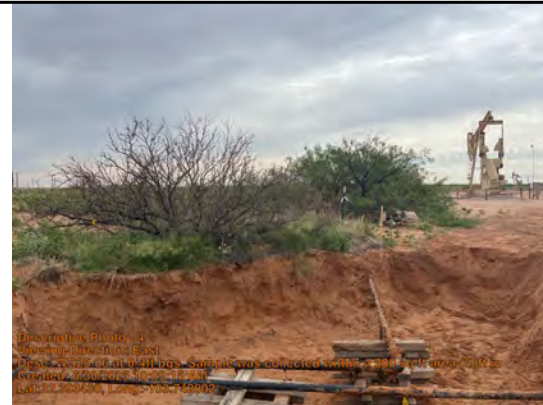
## Viewing Direction: East

WS25-06 at 0-4ft bgs. Sample was collected within a 200 sq ft area (50ft increments).

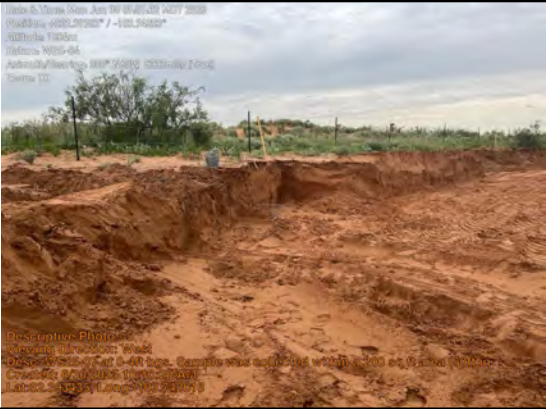
<p>WS25-07 at 0-4ft bgs. Sample was collected within a 200 sq ft area (50ft increments).</p>	<p><b>Viewing Direction: Northeast</b></p>

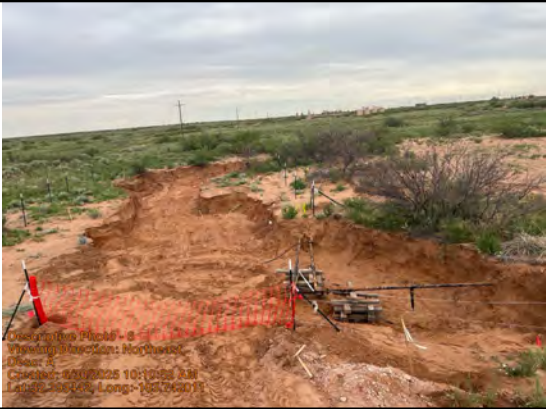
<p>Overview of the 4ft bgs excavation from the south wall.</p>
<p><b>Viewing Direction: North</b></p>

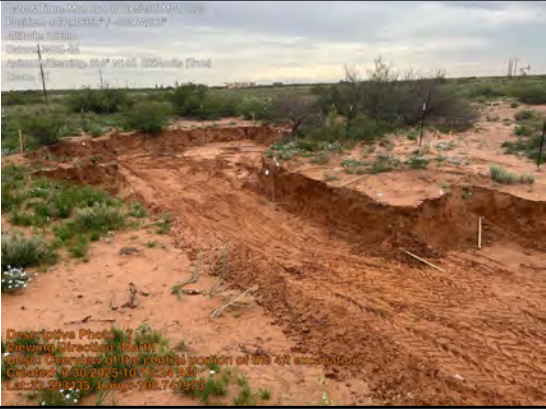
<p>Overview of the central portion of the 4ft excavation.</p>	<p><b>Viewing Direction: Northeast</b></p>

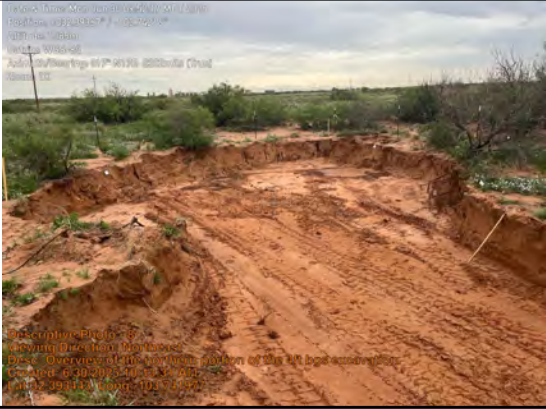
<p>Overview of the northern portion of the 4ft bgs excavation.</p>

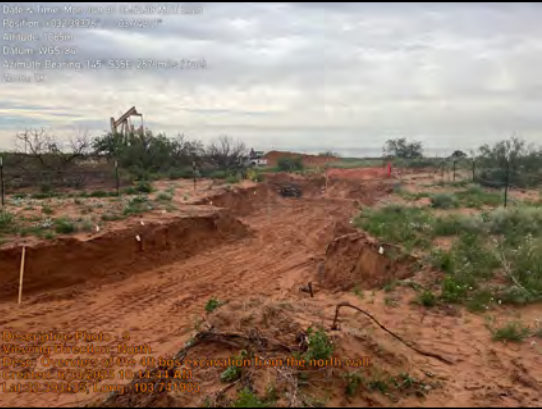
<p>Overview of the 4ft bgs excavation from the north wall.</p>	<p><b>Viewing Direction: North</b></p>

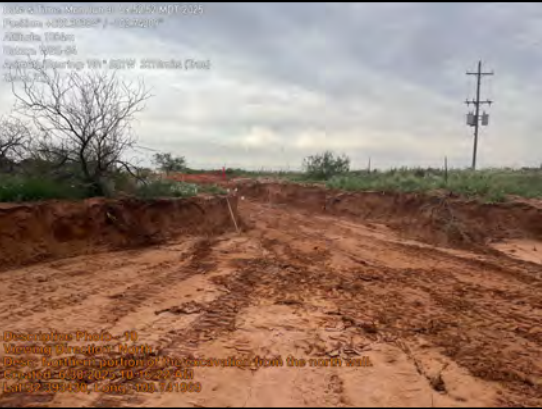
<p>Northern portion of the excavation from the north wall.</p>
<p><b>Viewing Direction: South</b></p>

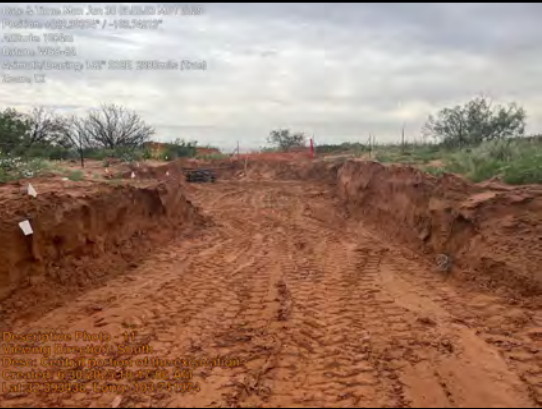
<p>Central portion of the excavation.</p>	<p><b>Viewing Direction: East</b></p>

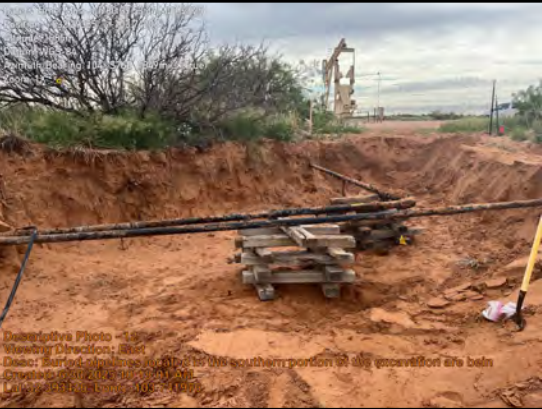
<p>Buried pipelines located in the southern portion of the excavation are being held up by skids to maintain structural integrity of the pipelines.</p>

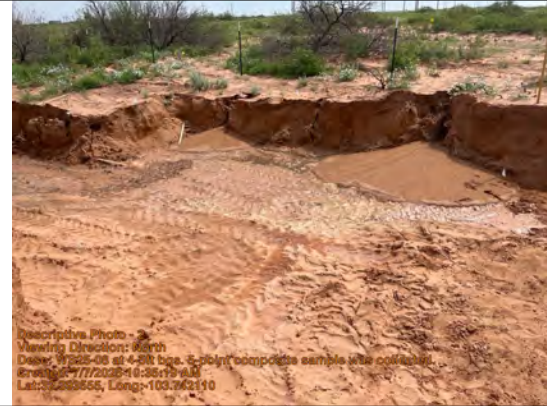
Viewing Direction: North

Central portion of the excavation.

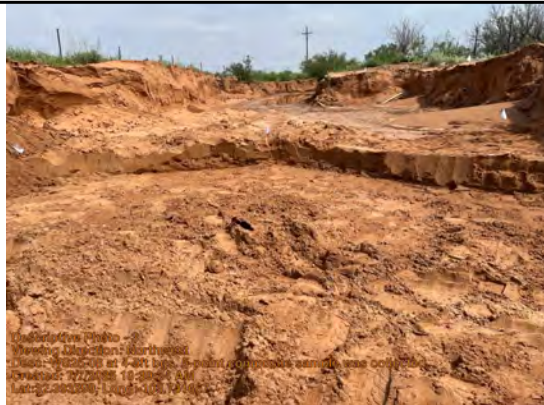
Viewing Direction: Northwest

WS25-08 at 4-5ft bgs. 5-point composite sample was collected.

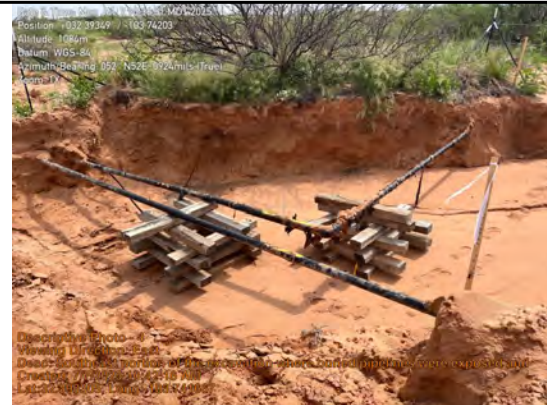
Viewing Direction: East

Southeast portion of the excavation where buried pipelines were exposed and put on skids for stability.

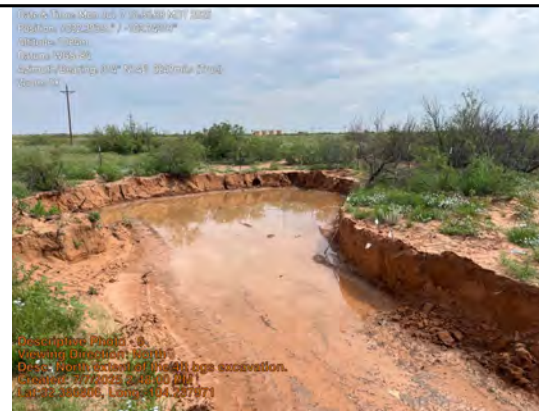
Viewing Direction: North

North extent of the 4ft bgs excavation.

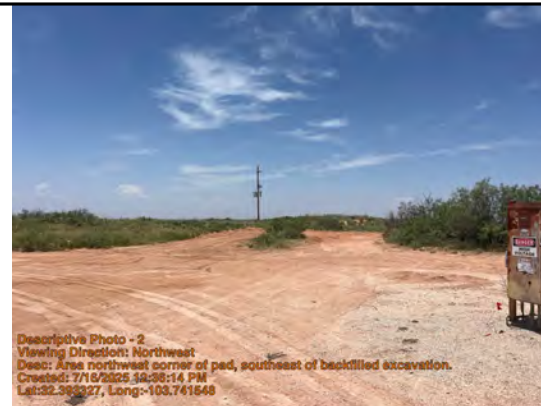
Viewing Direction: Northwest

Area northwest corner of pad, southeast of backfilled excavation.

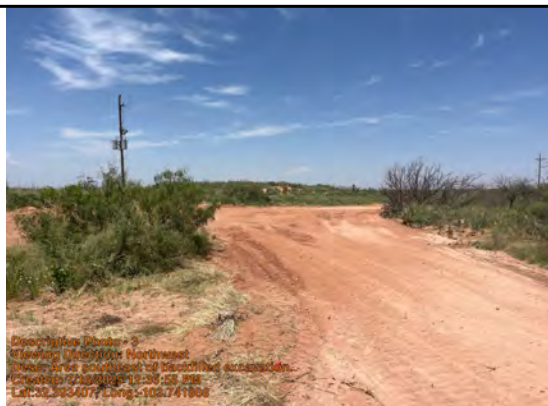
Viewing Direction: Northwest

Area southeast of backfilled excavation.

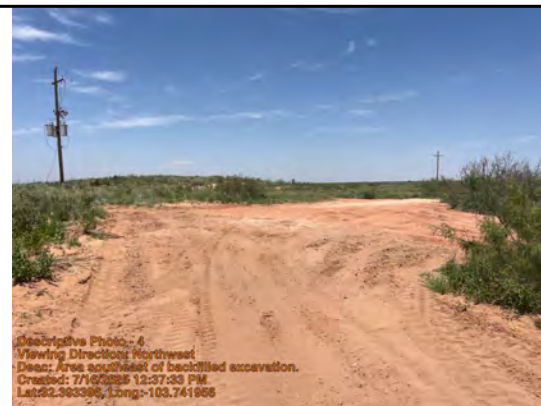
Viewing Direction: Northwest

Area southeast of backfilled excavation.

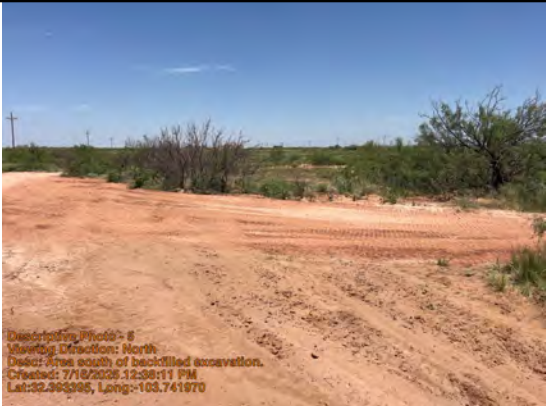
<p>Descriptive Photo - 6 Viewing Direction: North Desc: Area south of backfilled excavation. Created: 7/16/2025 12:38:11 PM Lat:32.393385, Long:-103.741970</p>	<p><b>Viewing Direction: North</b></p>

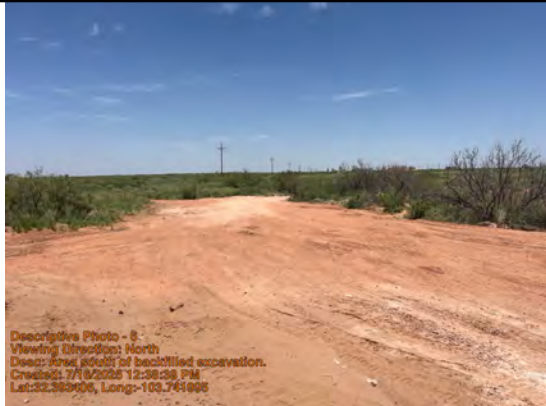
<p>Descriptive Photo - 6 Viewing Direction: North Desc: Area south of backfilled excavation. Created: 7/16/2025 12:38:38 PM Lat:32.393505, Long:-103.741995</p>
Area south of backfilled excavation.	Area south of backfilled excavation.
<p><b>Viewing Direction: North</b></p>

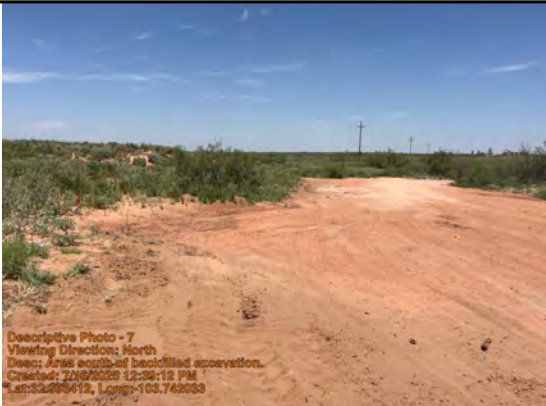
<p>Descriptive Photo - 7 Viewing Direction: North Desc: Area south of backfilled excavation. Created: 7/16/2025 12:39:12 PM Lat:32.393612, Long:-103.742033</p>	<p><b>Viewing Direction: North</b></p>

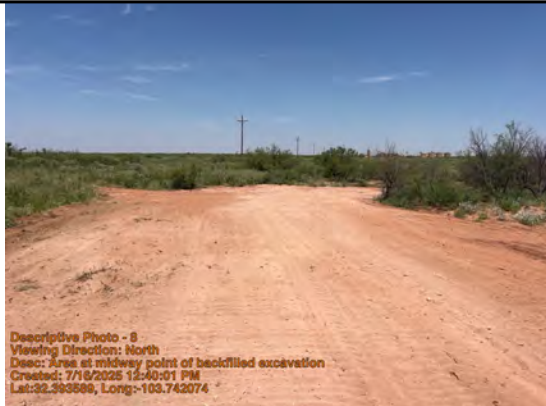
<p>Descriptive Photo - 8 Viewing Direction: North Desc: Area at midway point of backfilled excavation Created: 7/16/2025 12:40:01 PM Lat:32.393589, Long:-103.742074</p>
Area south of backfilled excavation.	Area at midway point of backfilled excavation

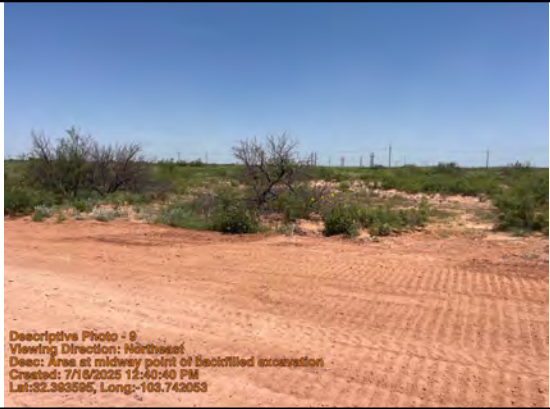
<p>Descriptive Photo - 9 Viewing Direction: Northeast Desc: Area at midway point of backfilled excavation Created: 7/16/2025 12:40:40 PM Lat:32.383595, Long:-103.742053</p>	<p><b>Viewing Direction: Northwest</b></p>

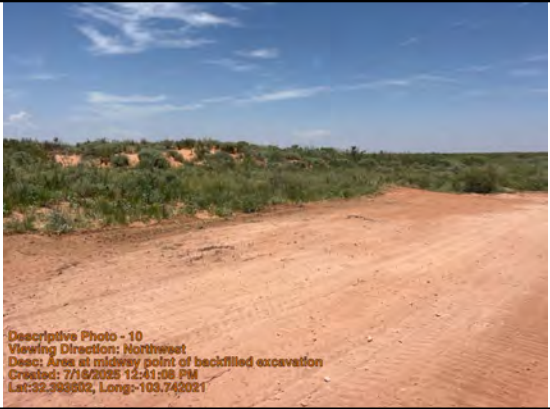
<p>Descriptive Photo - 10 Viewing Direction: Northwest Desc: Area at midway point of backfilled excavation Created: 7/16/2025 12:41:08 PM Lat:32.383592, Long:-103.742021</p>
Area at midway point of backfilled excavation	Area at midway point of backfilled excavation
<p><b>Viewing Direction: North</b></p>

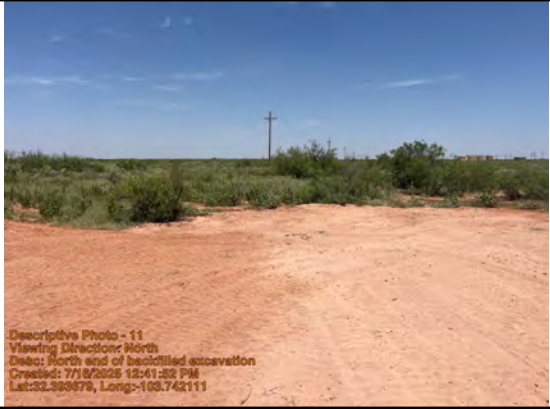
<p>Descriptive Photo - 11 Viewing Direction: North Desc: North end of backfilled excavation Created: 7/16/2025 12:41:52 PM Lat:32.383578, Long:-103.742111</p>	<p><b>Viewing Direction: Northeast</b></p>

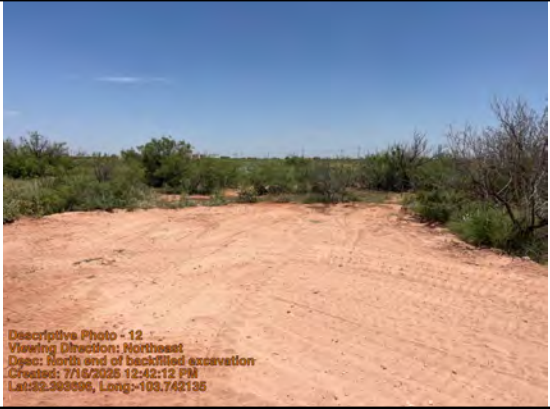
<p>Descriptive Photo - 12 Viewing Direction: Northeast Desc: North end of backfilled excavation Created: 7/16/2025 12:42:12 PM Lat:32.383596, Long:-103.742135</p>

North end of backfilled excavation	North end of backfilled excavation

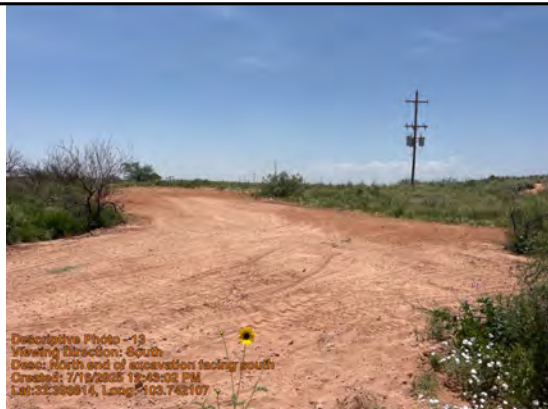
**Viewing Direction: South**

North end of backfilled excavation facing south

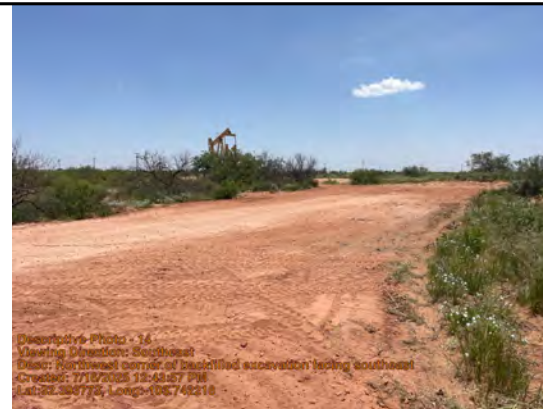
**Viewing Direction: Southeast**

Northwest corner of backfilled excavation facing southeast

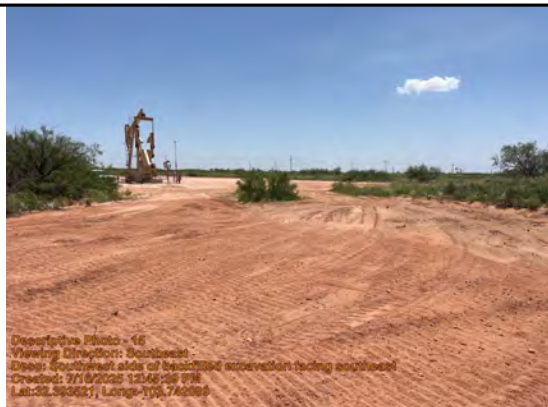
**Viewing Direction: Southeast**

Southwest side of backfilled excavation facing southeast
