# Site Assessment Summary, Proposed Remediation Plan & Alternative Sampling Plan

## Mewbourne Oil Company Red Hills West Unit 27 Battery

Lea County, New Mexico  
Unit Letter "O", Section 9, Township 26 South, Range 32 East  
Latitude 32.05274° North, Longitude 103.67691° West  
NMOCD Reference No. nAPP2521353327

August 20, 2025

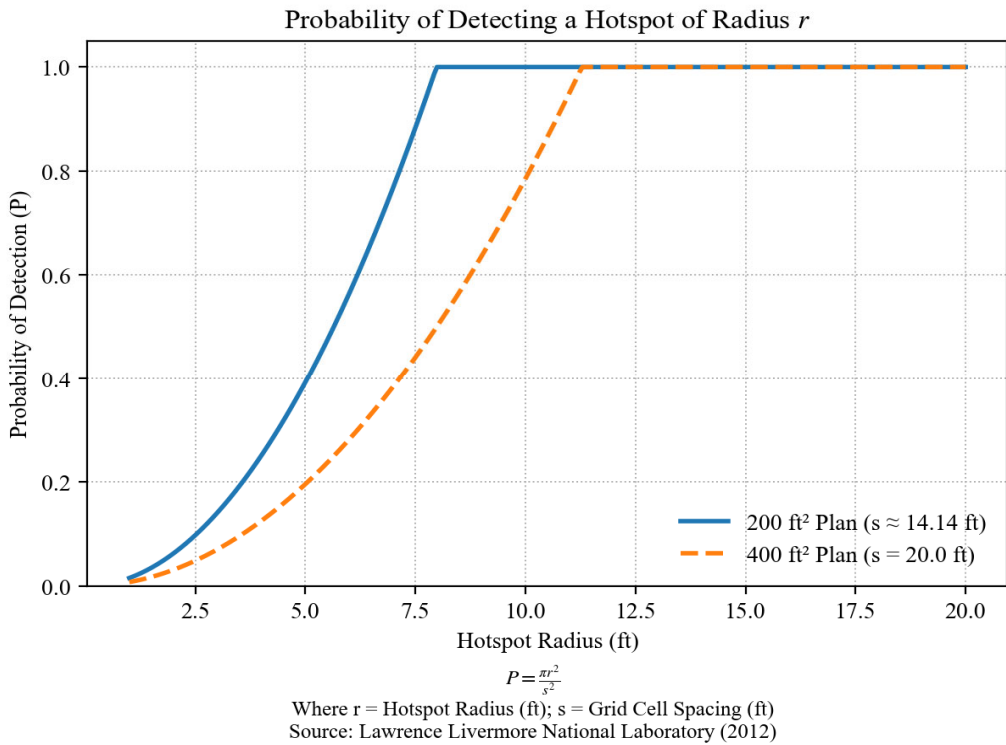
**Detection Probabilities for Selected Hotspot Radii**

Since each individual composite sample will incorporate soil from five (5) spots within a 400-square-foot zone, this effectively equates to a total of approximately 745 sample points, which decreases the likelihood that any hotspots will be missed, as illustrated in the graph and table below. Furthermore, discrete soil samples will be collected from wet and/or visibly stained areas, as necessary.

Grid Area (ft²)	s	r = 2.5	r = 5	r = 10	r = 15	r = 20
200	14.14	9.82%	39.3%	>99.9%	>99.9%	>99.9%
400	20.0	4.91%	19.6%	78.5%	>99.9%	>99.9%

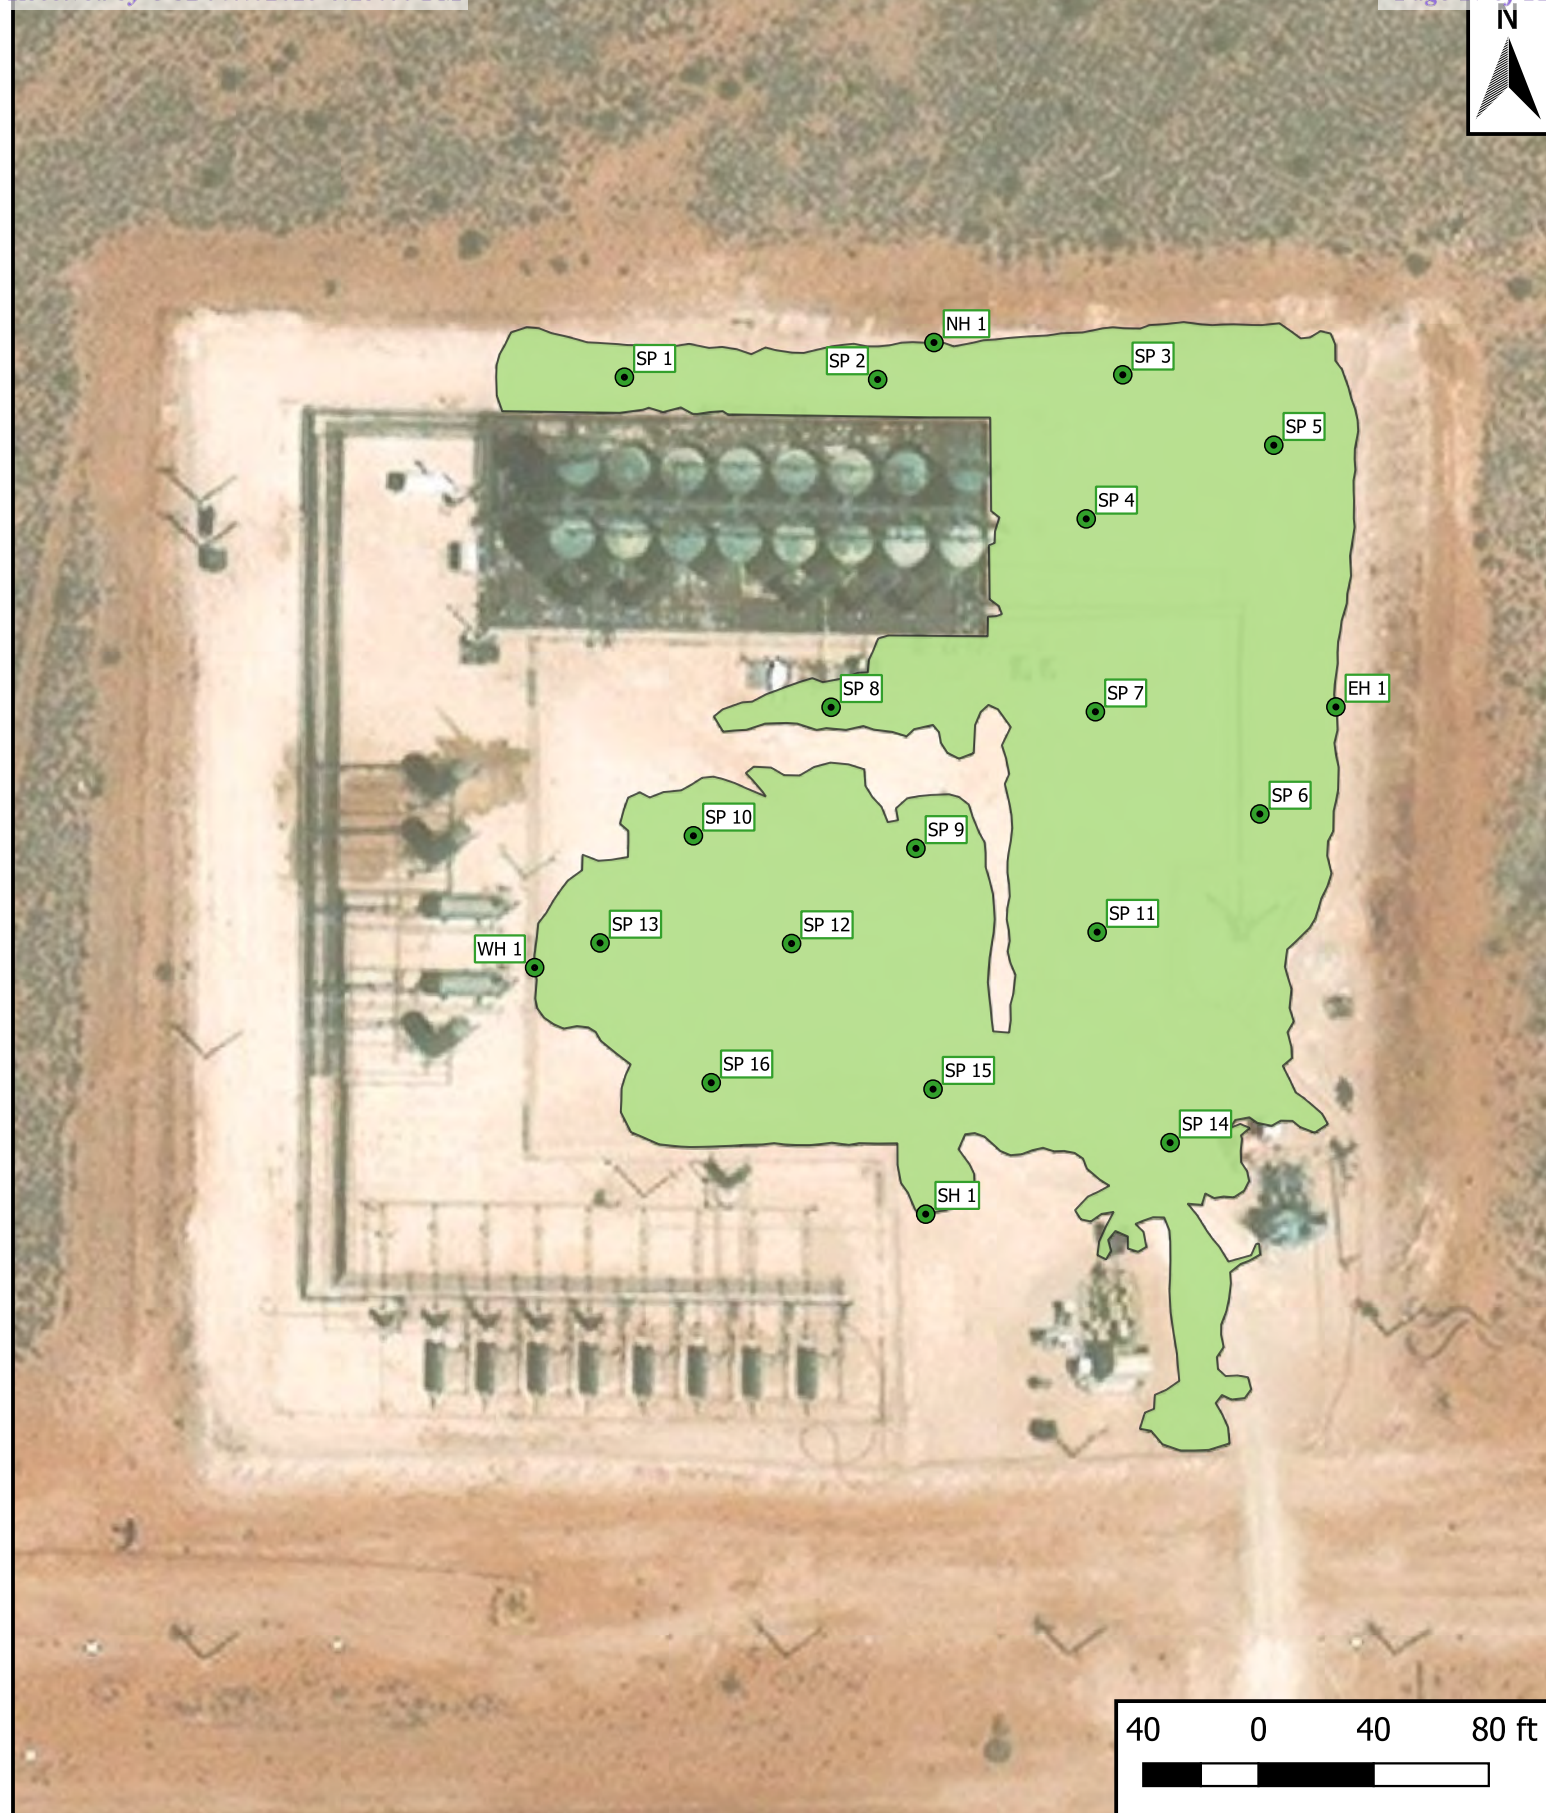
### **Sample Location Map**

- Affected Area (~59,586 ft<sup>2</sup>)
- Delineation Sample Location

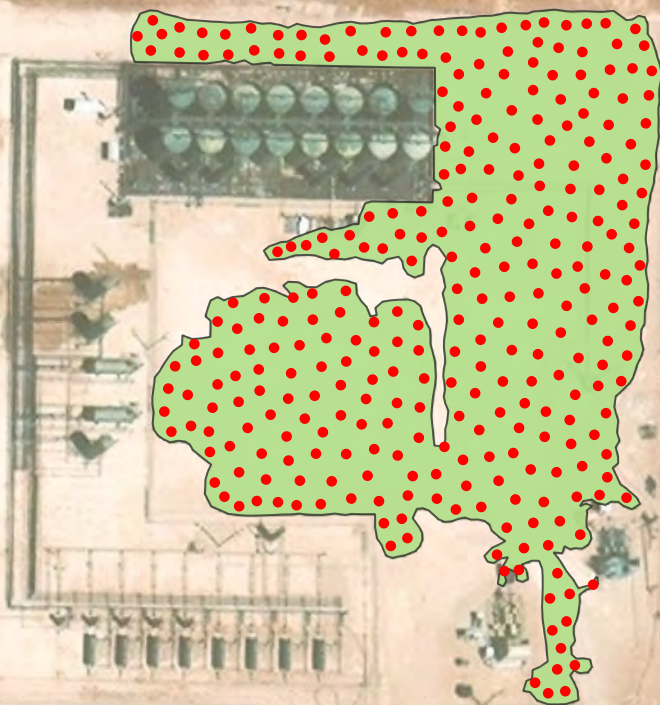
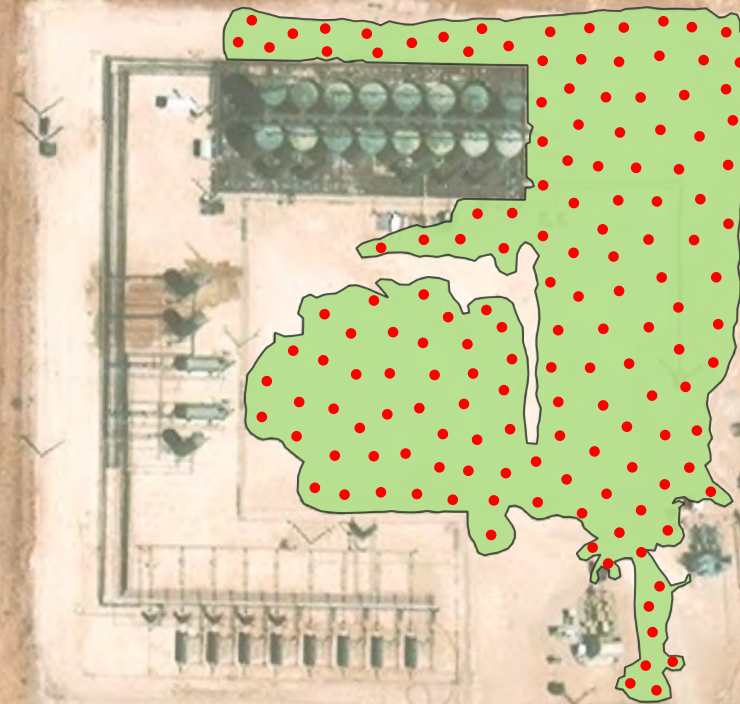
### **Sampling Plan Comparison Map**

200 ft<sup>2</sup> Grid400 ft<sup>2</sup> Grid

Based on the size of the affected area (~59,8564 square feet), approximately 149 composite soil samples will be collected from the floor of the excavated area under the proposed alternative sampling plan, as opposed to approximately 298 samples under a standard 200-square-foot plan. Figure 4 provides a side-by-side comparison of the 200-square-foot and 400-square-foot sampling plans. The map illustrates that, while there are fewer total composite samples in the 400-square-foot plan, there is a nominal difference between the spatial coverage of the plans, and both plans are equally representative of the affected area, with minimal gaps between each sampling section/zone.

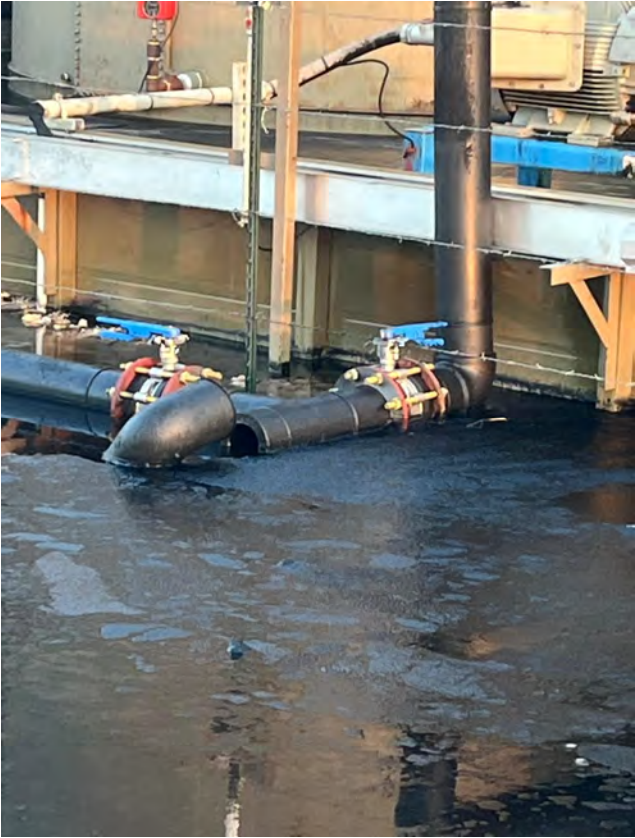
<b>Photo Number:</b> 1

<b>Photo Direction:</b> Southeast	
<b>Date:</b> 7/19/2025	
<b>Coordinates:</b> 32.052844,-103.676771	
<b>Photo Description:</b>  Release point.

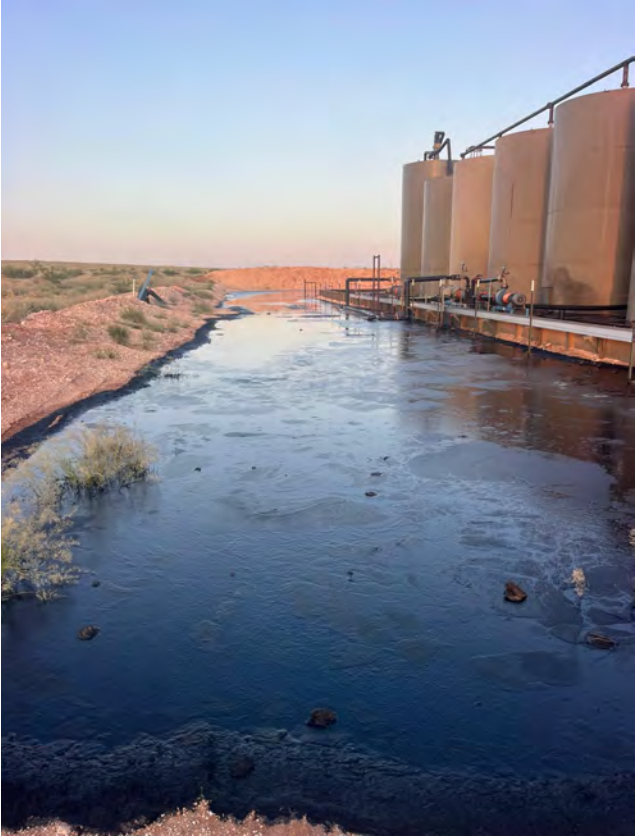
<b>Photo Number:</b> 2

<b>Photo Direction:</b> East	
<b>Date:</b> 7/19/2025	
<b>Coordinates:</b> 32.052879,-103.677009	
<b>Photo Description:</b>  View of the affected area.

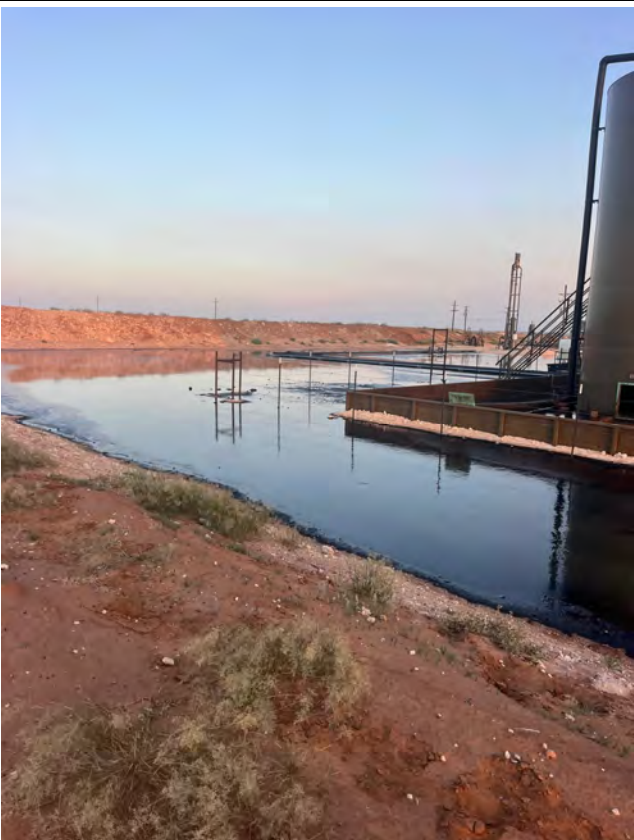
<b>Photo Number:</b> 3

<b>Photo Direction:</b> Southeast		
<b>Date:</b> 7/19/2025		
<b>Coordinates:</b> 32.052916,-103.676553		
<b>Photo Description:</b>  View of the affected area.

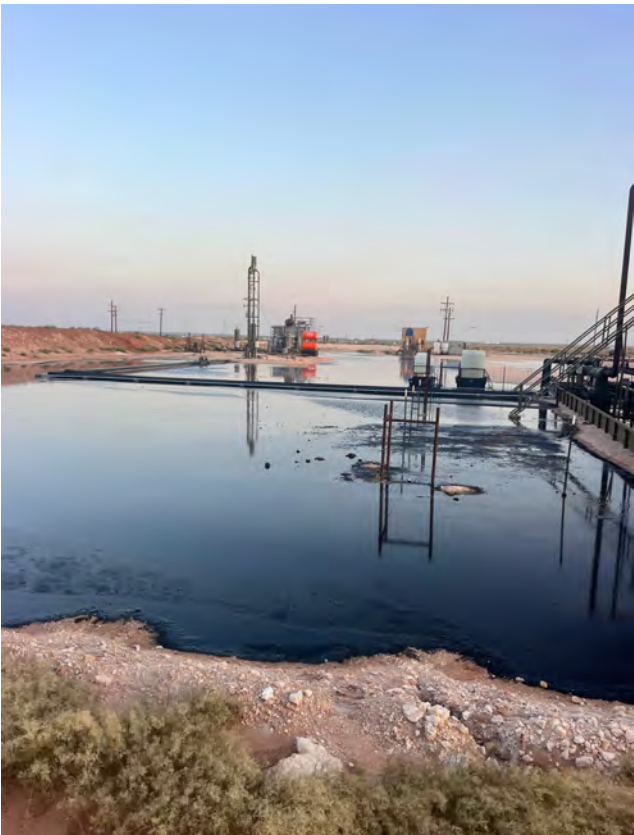
<b>Photo Number:</b> 4

<b>Photo Direction:</b> South		
<b>Date:</b> 7/19/2025		
<b>Coordinates:</b> 32.052925,-103.676276		
<b>Photo Description:</b>  View of the affected area.

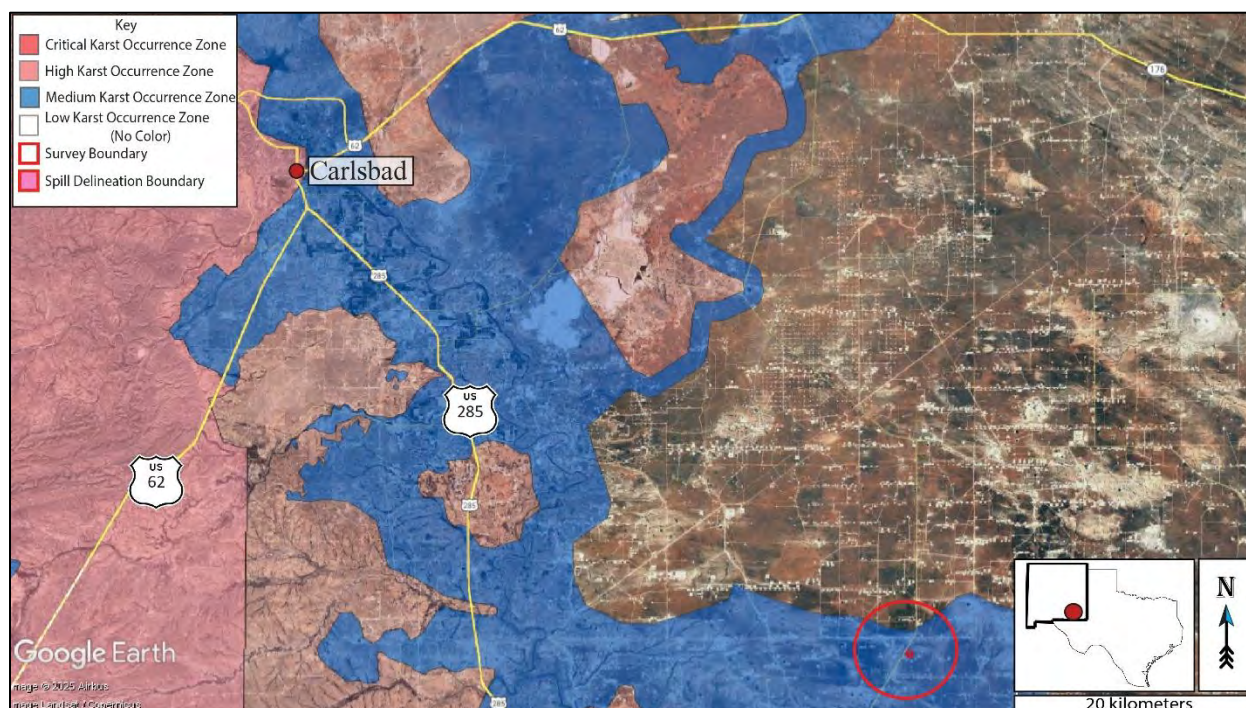
The Bureau of Land Management (BLM) categorizes all areas within the Carlsbad Field Office (CFO) zone of responsibility as having either low, medium, high, or critical cave potential based on geology, occurrence of known caves, density of karst features, and potential impacts to freshwater aquifers<sup>[4]</sup>. These designations are also recognized by the New Mexico State Land Office (NMSLO). This project occurs within a **MEDIUM** karst occurrence zone (MKOZ)<sup>[5]</sup> (**Figure 1**).

**Figure 1: Karst occurrence zone overview.** Background image credit: Google Earth. Image date: December 12, 2023. Image datum: WGS-84.

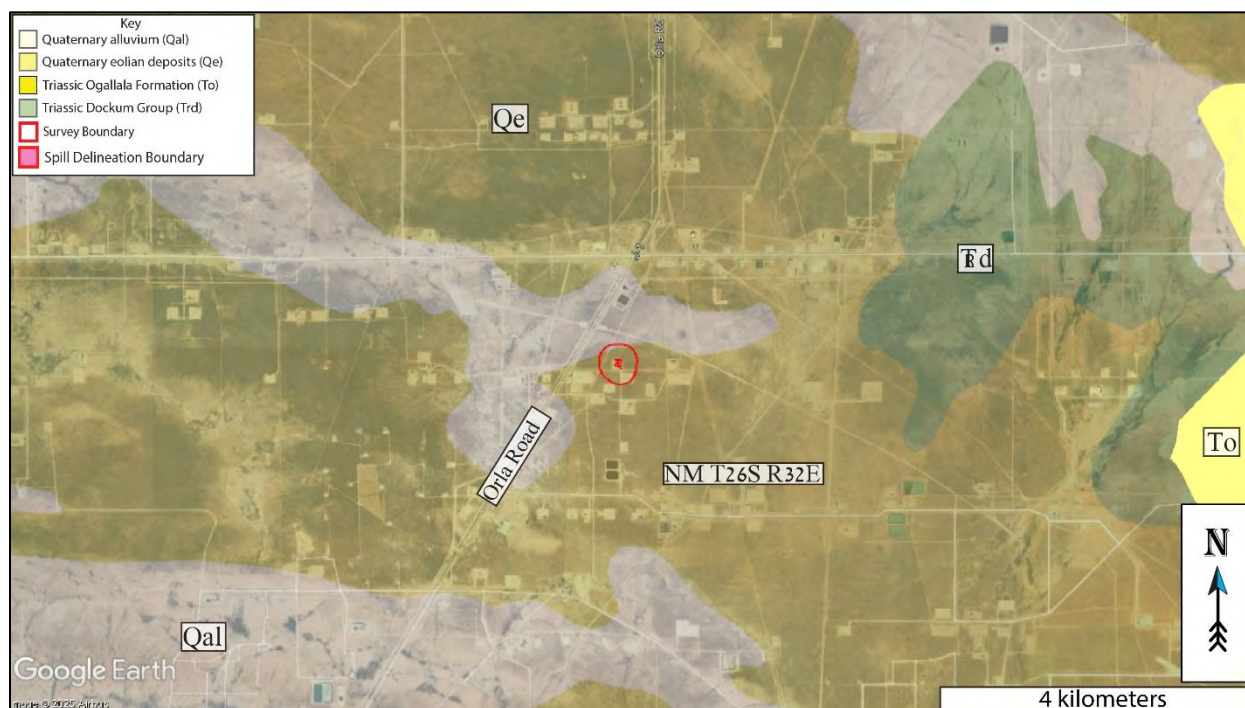
The Pru overlies the Permian Salado Formation (Psl – not shown), a layer of extremely soluble halite which can readily dissolve to create caves, sinkholes, and other karst features; however, due to its extremely soluble nature, only non-soluble silt and sand remain from the dissolution of this layer at the surface<sup>[12]</sup>. The Rustler Formation may be subject to collapse if a void has developed beneath it in the Salado Formation<sup>[13]</sup>.

**Figure 3: Geology overview.** Geology map credit: The Digital Geologic Map of New Mexico in ARC/INFO Format. Background image credit: Google Earth. Image date: December 12, 2023. Image datum: WGS-84.

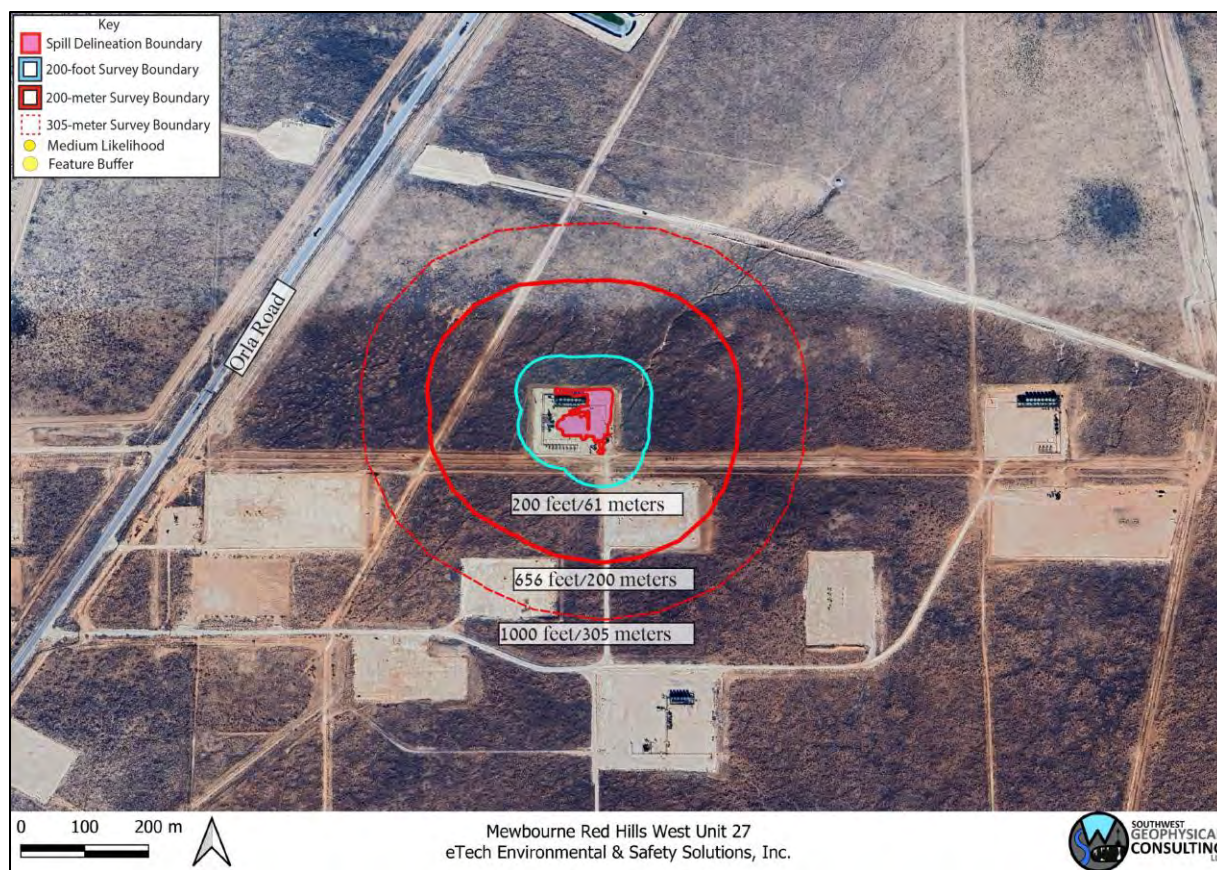
Surface karst surveys are conducted by sUAS at low elevation within 200 meters of the spill delineation boundary<sup>[3]</sup> (**Figure 4**) following a preplanned raster pattern flightpath designed for the purpose of generating at least 75% imagery overlap. The collected high-resolution, georeferenced imagery is stitched together to develop orthomosaic imagery which is further developed into a digital elevation model (DEM); the DEM is then processed into a local relief model (LRM) (**Figure 6**). This LRM is color coded to enhance differences in elevation of as little as five centimeters. The orthoimagery, DEM, and LRM are uploaded to a server where they are analyzed by an experienced karst geologist. Finally, the data is reviewed by a senior karst geologist for quality assurance and downloaded into a table for inclusion in a written report<sup>[16]</sup>.

Figure 4: Surface survey overview. Background image credit: Google Earth. Image date: December 12, 2023. Datum: WGS-84.

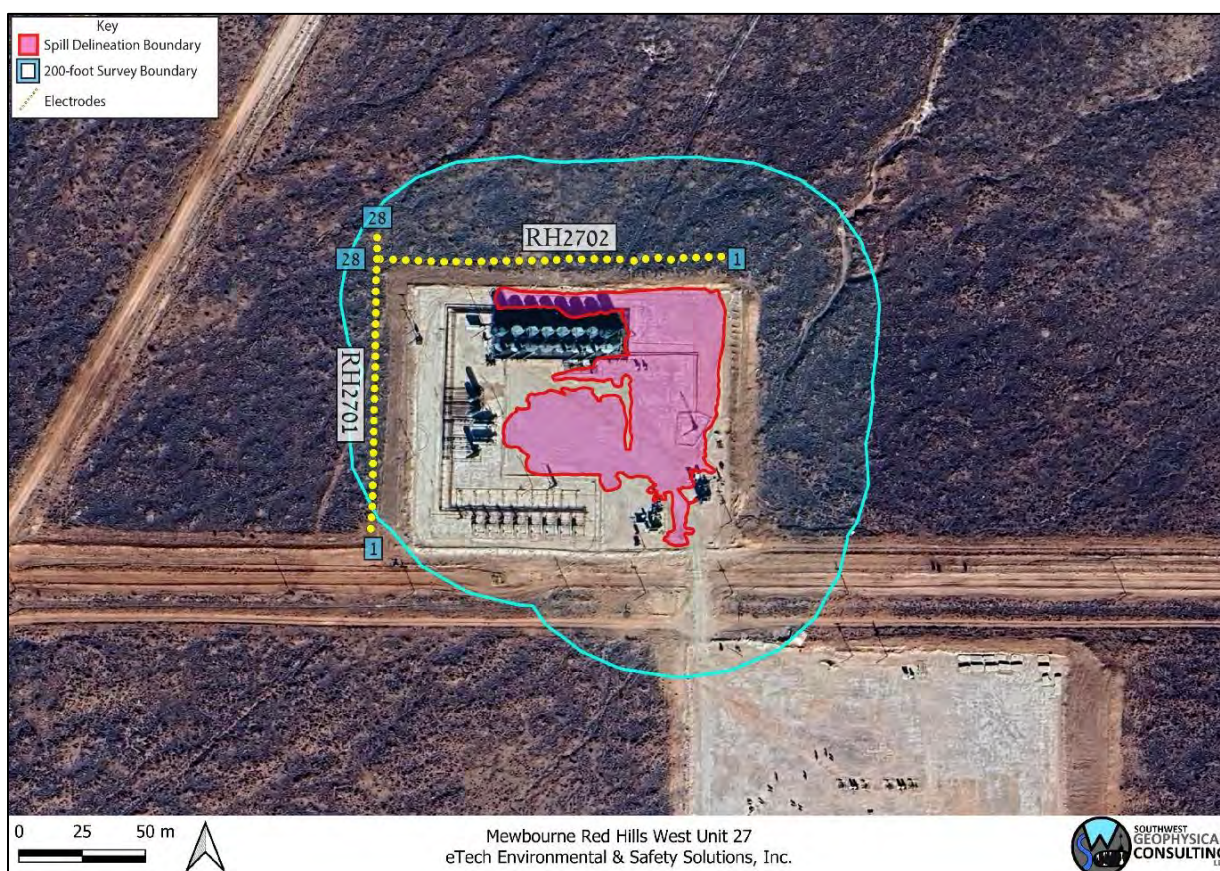
For this survey, a Guideline Geo Inc. ABEM Terrameter LS 2, a 28-electrode array of 40-centimeter-long electrodes, and a tablet controller were used to image the subsurface. This survey consisted of two resistivity lines in a dipole-dipole configuration: line RH2701 was laid out south to north, while line RH2702 was laid out east to west. Both RH2701 and RH2702 consisted of 28 electrodes, at 5-meter spacing, resulting in 135-meter-long arrays (**Figure 5, Table 1**). One preconfigured command file was used to run the data collection (DiDi28). The 28-electrode configuration provided a depth of investigation of 27 meters (89 feet), all with a resolution of 2.5 to 3.0 meters (8.2 to 9.8 feet) within the first 5 to 8 meters (16 to 26 feet) from the surface. A Leica GS18 GPS was used to record electrode locations and elevations.

**Figure 5: Geophysical survey overview.** Both RH2701 and RH2702 were conducted with 28 electrodes each: all at 5-meter spacing (yellow dots denoted with blue numbers). Background image credit: Google Earth. Image date: December 12, 2023. Image datum: WGS-84.

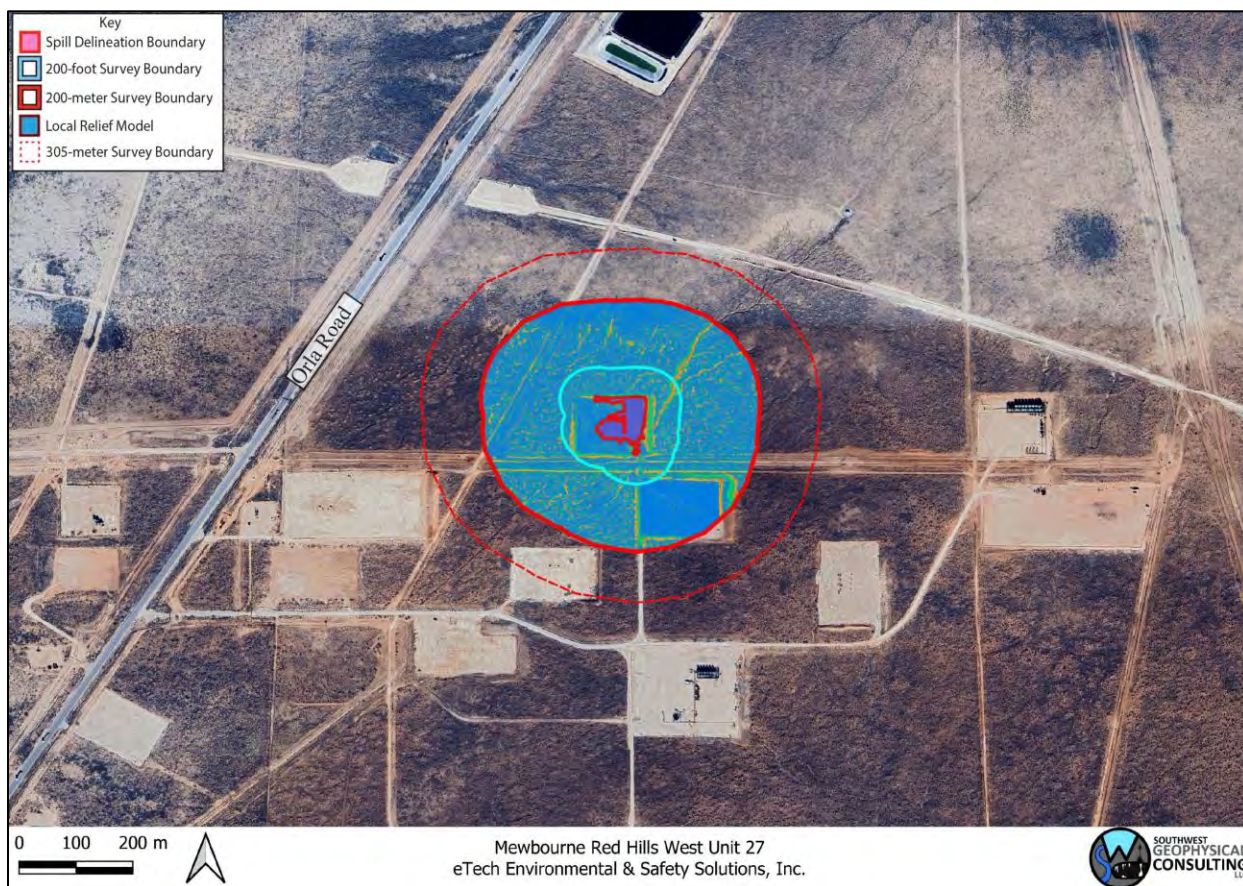
No springs exist within the 1,000-foot (305-meter)<sup>[1]</sup> survey boundary.

The lack of surface karst features does not mean the area is not karstified and the survey area may still contain buried karst features. Caution should be exercised while clearing brush and during any excavation, trenching, or construction operations. Employing a BLM-CFO approved karst monitor on site during these operations should be considered.

Figure 6: Surface karst survey results. Background image credit: Google Earth. Image date: July 14, 2024. Image datum: WGS-84.

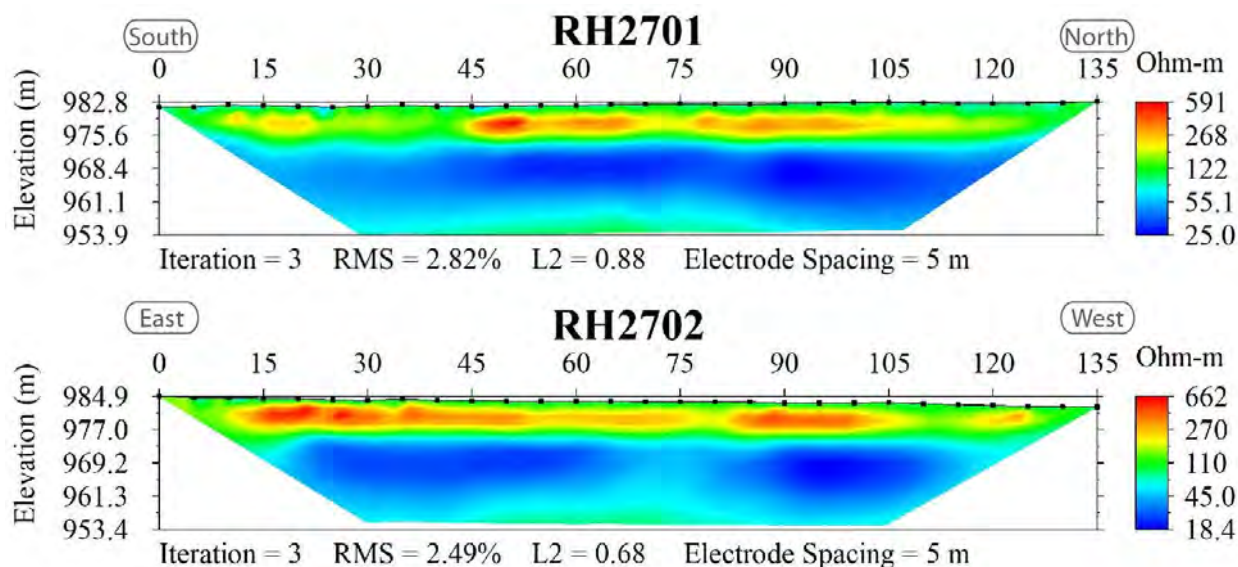
The results of this study indicate a moderately well-layered geologic system with resistivities between 18.4 and 662 Ohm-m (**Figure 7**). Please keep in mind when viewing the 2D inverted resistivity sections that color maps can be widely different for each view. Always check the color map located on the right side of the image when viewing the 2D images to ensure you understand the range of resistivities presented. Distances along the top and depths along the left side are in meters. The color map along the right side is in Ohm-m. Due to the nature of the survey, shallower zones have higher resolution between electrodes than deeper zones; therefore, small features at depth will not be visible.

**Figure 7: 2D inverted resistivity sections.** Reds and oranges indicate higher resistivity values. Yellows and greens are medium-resistivity values. Blues are low-resistivity values. Please note that the color scale is relative.

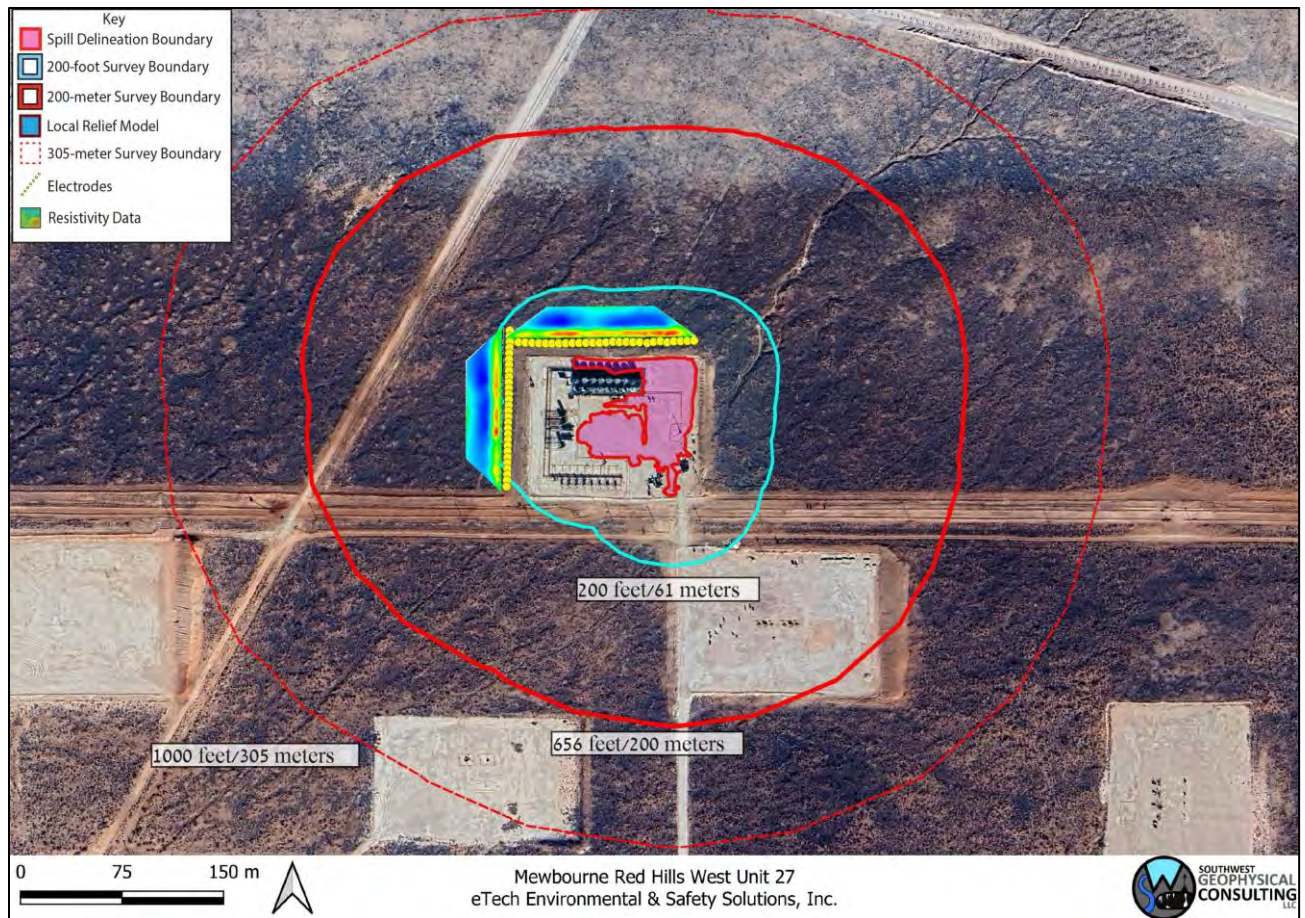
**Figure 8: Data overlay. Colored trapezoids are 2D inverted resistivity lines. Background image credit: Google Earth. Image date: July 14, 2024.**
