Re: Closure Request

Big Sinks 02-24-30 State Battery Incident Number nAPP2515347796 Eddy County, New Mexico

Ensolum, LLC (Ensolum), on behalf of XTO Energy, Inc (XTO), has prepared this *Closure Request* to document the findings of a liner integrity inspection conducted at the Big Sinks 02-24-30 State Battery (Site) following a release of produced water within a lined containment. Based on the liner integrity inspection activities, XTO is submitting this *Closure Request*, describing the inspection results and requesting closure for Incident Number nAPP2515347796.

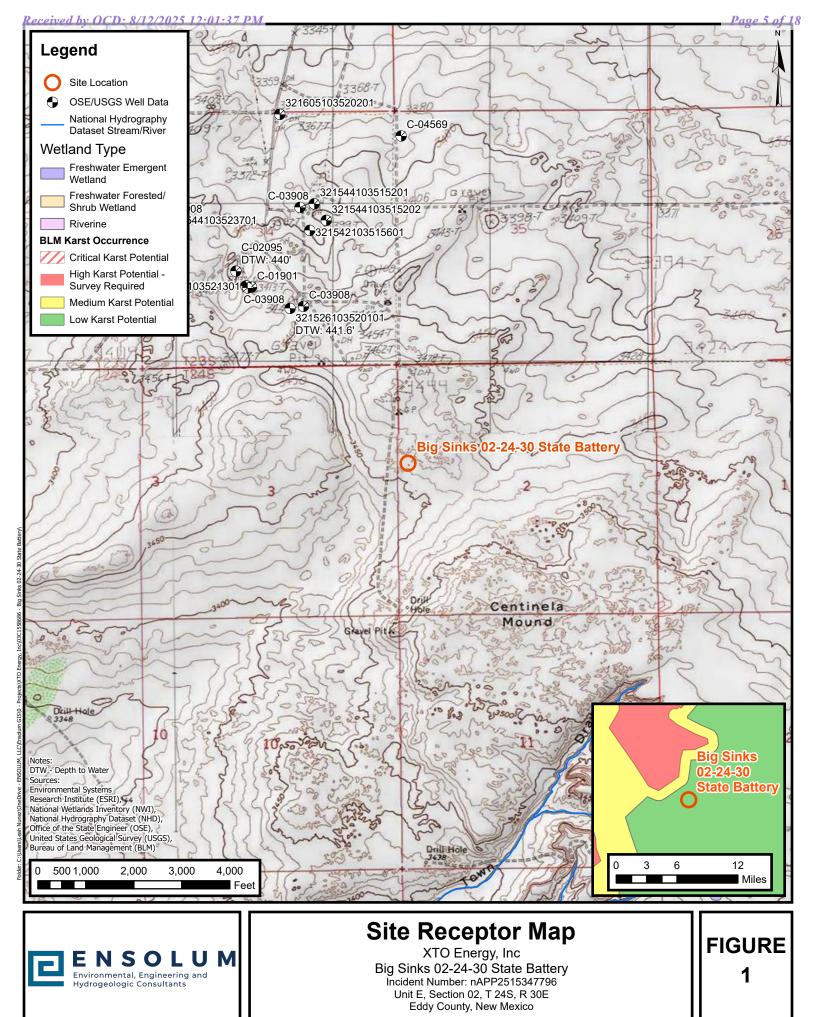
Figure 1 Site Receptor Map

The Site was characterized to assess the applicability of Table I Closure Criteria for Soils Impacted by a Release, of Title 19, Chapter 15, Part 29 (19.15.29) of the New Mexico Administrative Code (NMAC). Results from the characterization desktop review are presented below and potential Site receptors are identified on Figure 1.

total depth of the well is 567 feet bgs. All wells used for depth to groundwater determination are presented on Figure 1. The Well Record and Log is included in Appendix A.

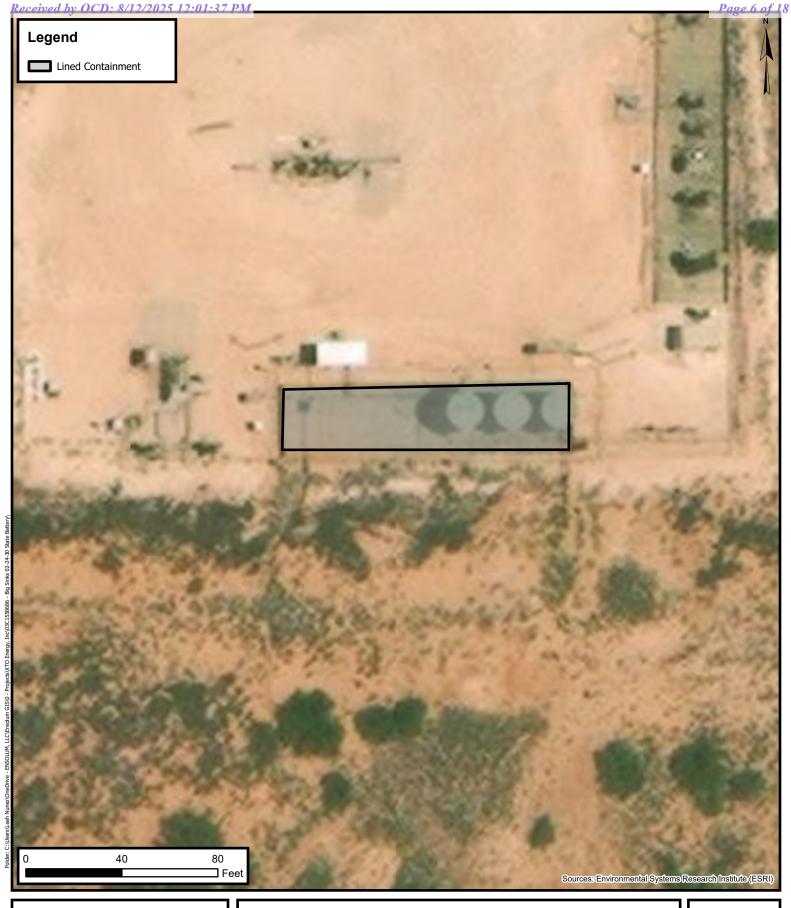
XTO Energy, Inc Big Sinks 02-24-30 State Battery Incident Number: nAPP2515347796 Unit E, Section 02, T 24S, R 30E Eddy County, New Mexico FIGURE 2

# Site Map

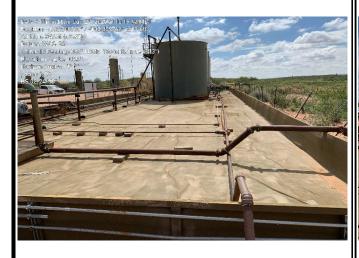
Photograph: 5 Date: 6/23/2025

Description: Liner inspection activites; well sign

View: East
