## REMEDIATION CLOSURE REPORT

**Bell Lake 19 CTB 3**

**Re: Site Assessment, Remediation, and Closure Report**  
**Bell Lake 19 CTB 3**  
**API No. N/A**  
**GPS: Latitude 32.1971 Longitude -103.60613**  
**UL - P, Section 19, T24S, R33E**  
**Lea County, NM**  
**NMOCD Ref. No. NAPP2412428329**

Pima Environmental Services, LLC. (Pima) has been contracted by Devon Energy Production Company, LP (Devon) to prepare this Site Assessment, Remediation, and Closure Report for a produced water release that occurred at the Bell Lake 19 CTB 3 (Bell Lake). The incident was assigned ID: NAPP2412428329 on May 3, 2024, by the New Mexico Oil Conservation Division (NMOCD).

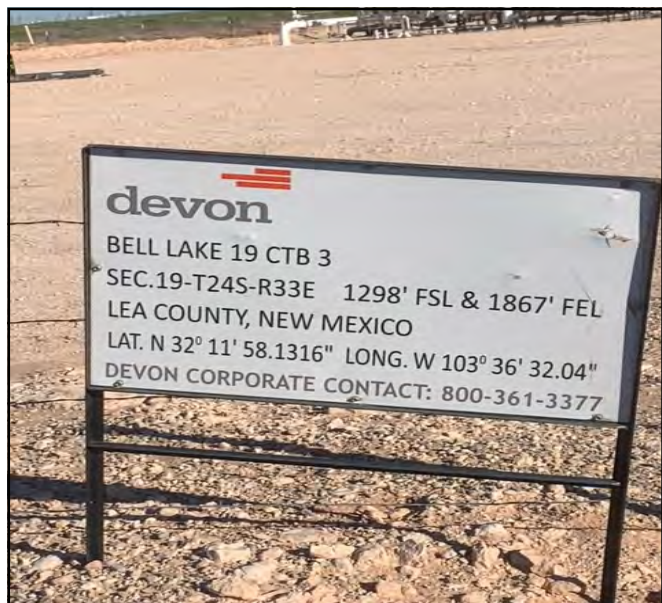
Sign Site Information

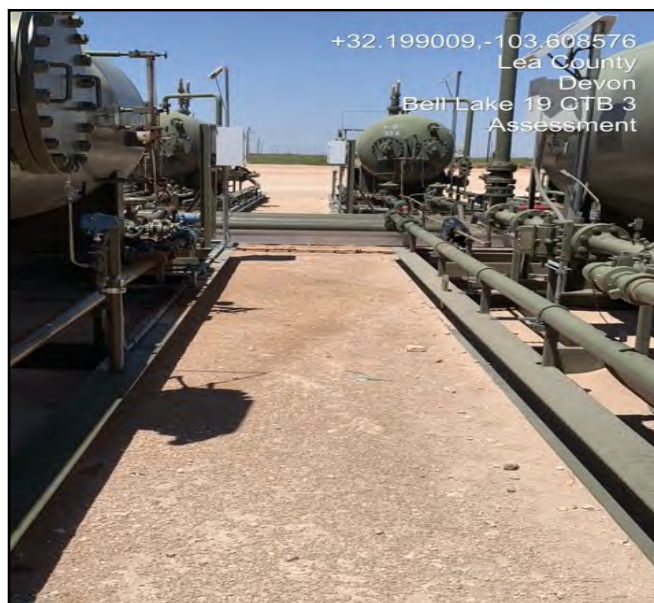
Photograph capturing the evaluation of the release event.

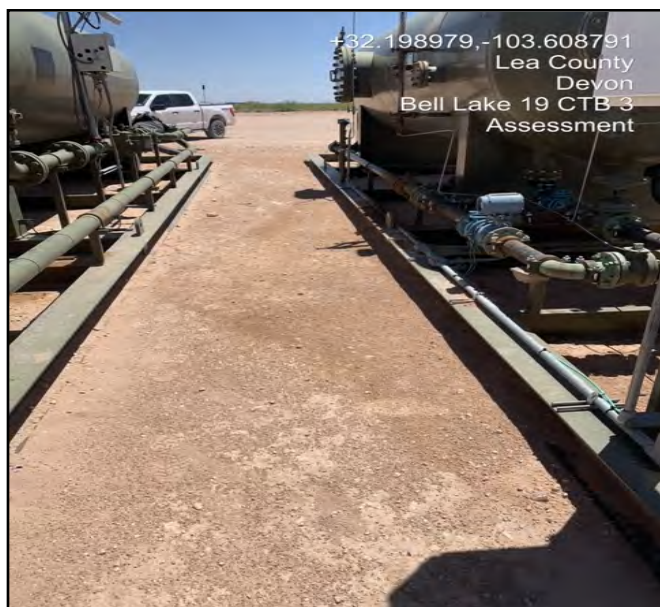
Photograph capturing the evaluation of the release event.

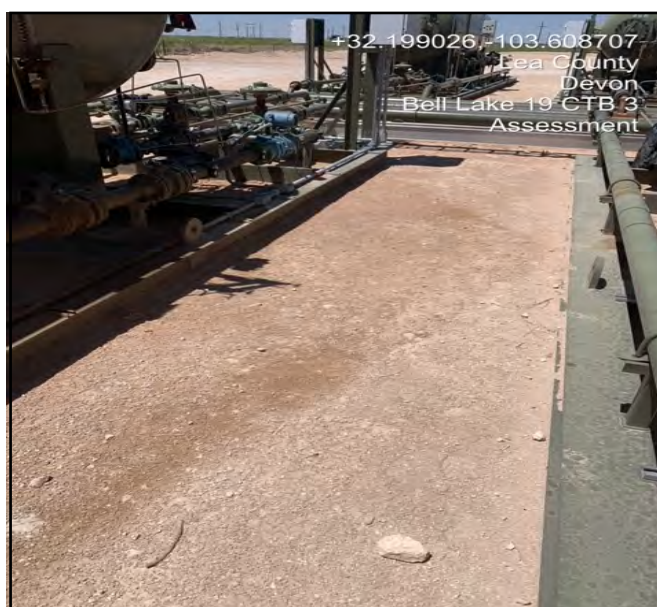
Photograph capturing the evaluation of the release event.

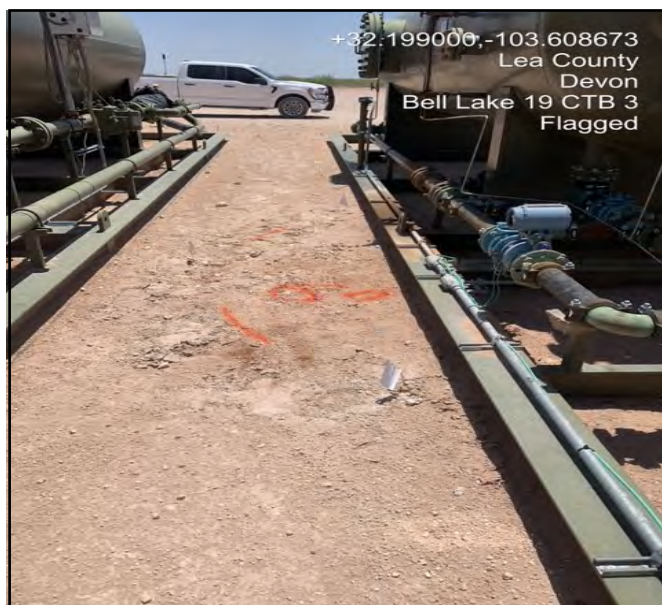
Photograph of flagging indicating designated excavation areas.

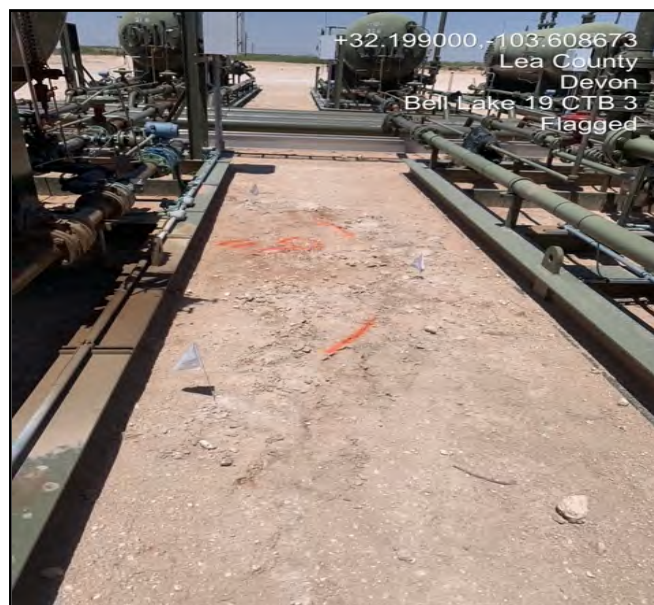
Photograph of flagging indicating designated excavation areas.

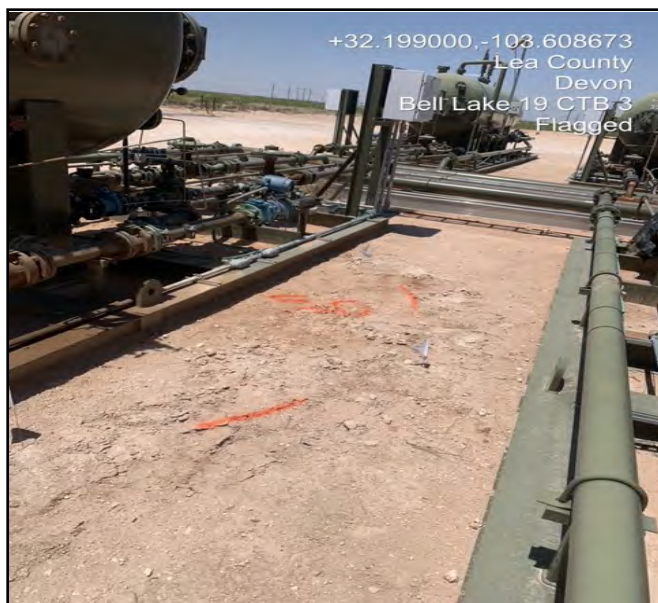
Photograph of flagging indicating designated excavation areas.

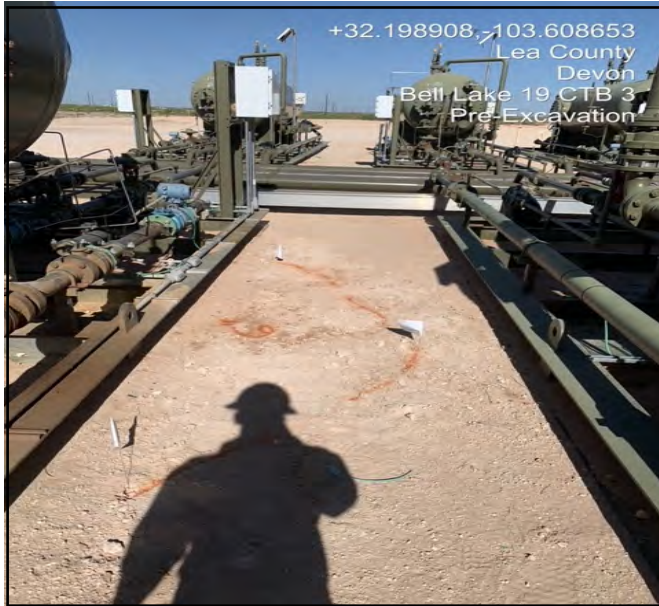
Photograph documenting the site prior to excavation.

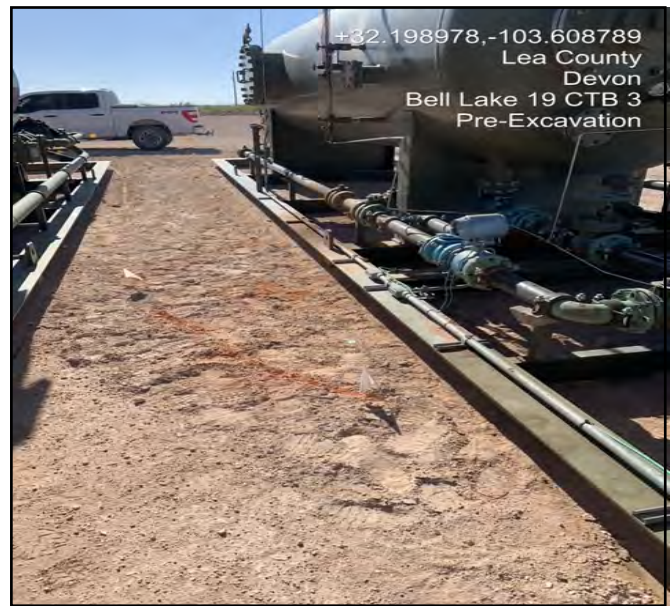
Photograph documenting the site prior to excavation.

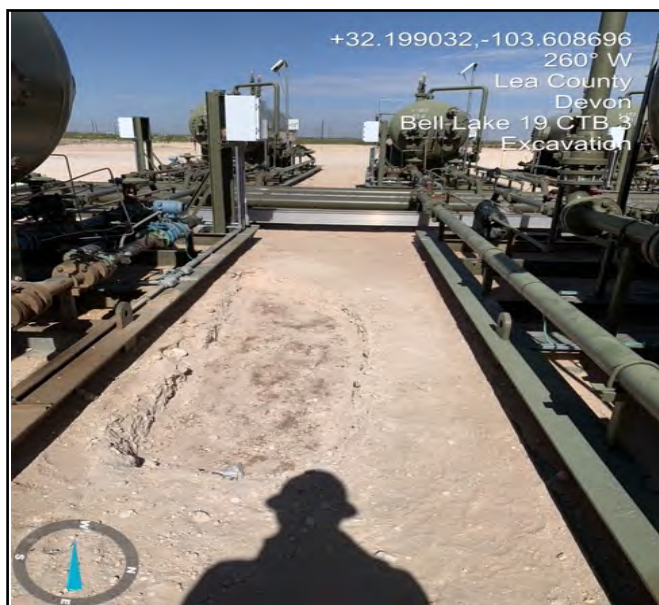
Photograph capturing the site in the midst of excavation facing West.

On May 21, 2024, the Devon Construction Department mobilized personnel and equipment to initiate immediate remediation activities. They began excavating the area to a depth of 6" inches below ground surface (BGS). A total of 1 cubic yard of contaminated soil was hauled to Lea Land LLC, an approved, lined disposal facility and clean backfill material was brought in.

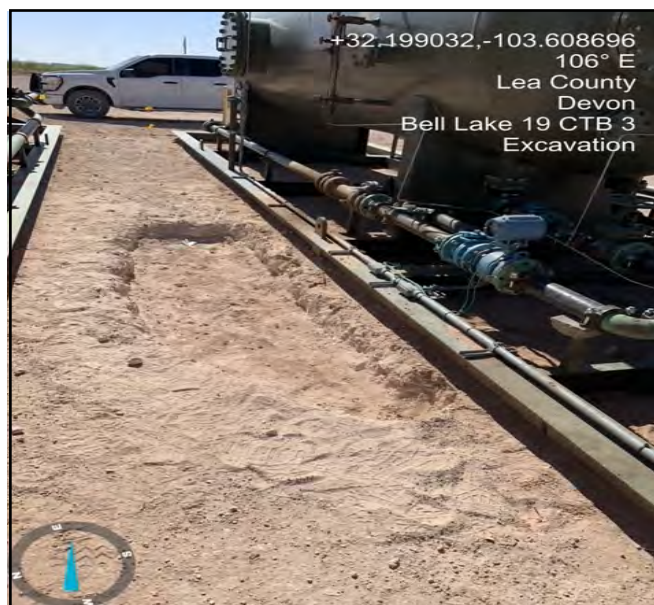
Photograph capturing the site in the midst of excavation facing East.

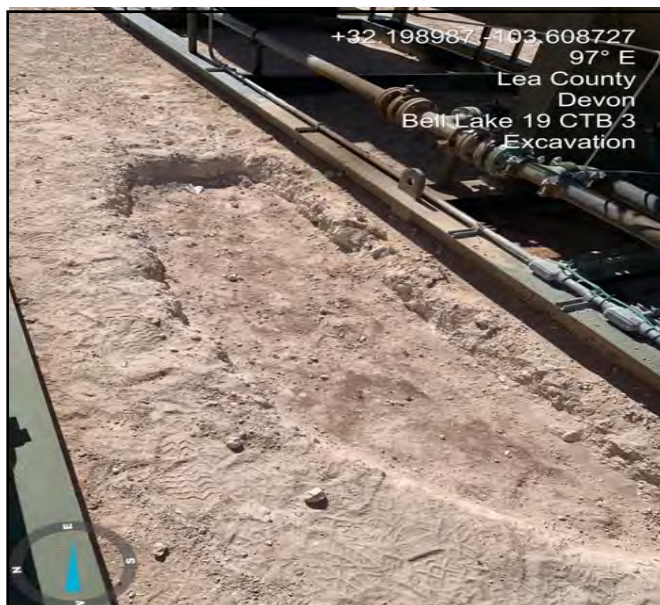
Photograph capturing the site in the midst of excavation facing East.

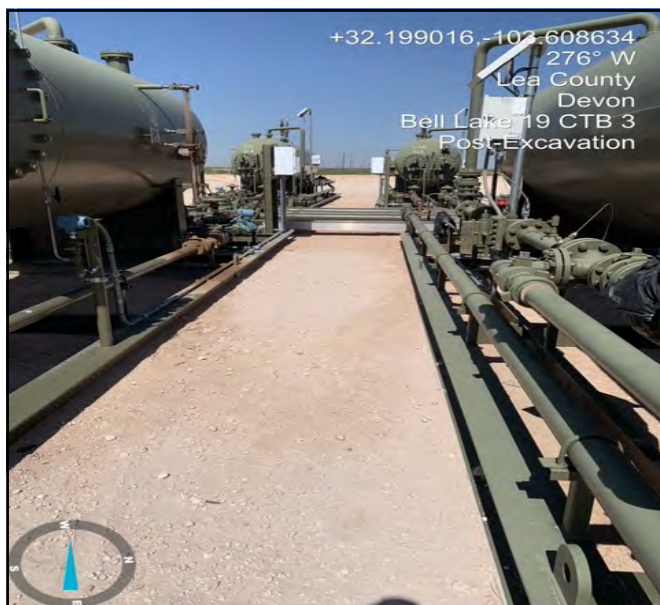
Photograph illustrating the area after backfilling with clean material facing West.

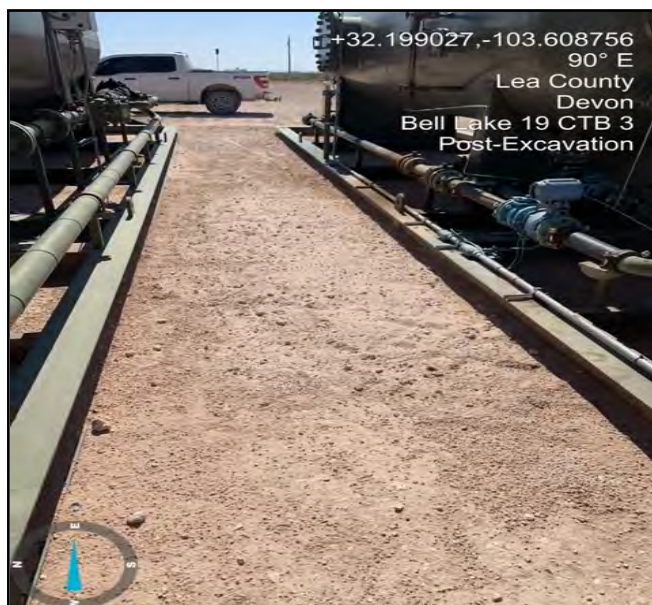
Photograph illustrating the area after backfilling with clean material facing East.

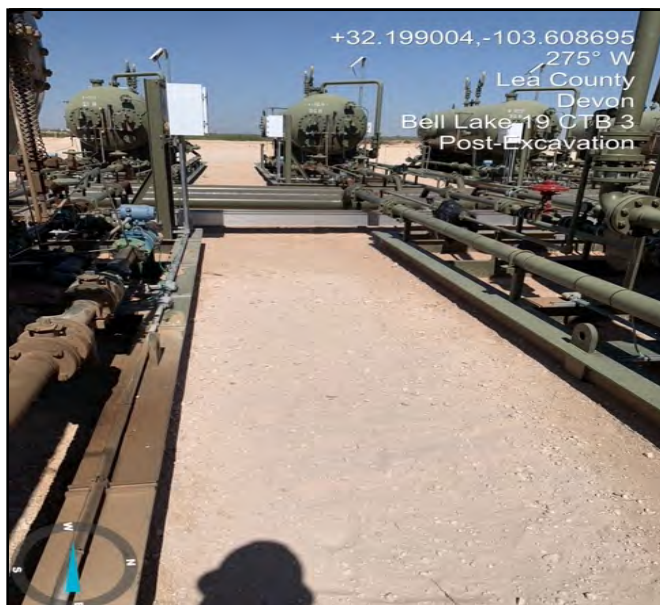
Photograph illustrating the area after backfilling with clean material facing West.
