Closure Report
Eagle #1 CTB (07.22.2025)
Incident ID: NAPP2520429493
Lea County, New Mexico
Unit E, Sec 12, T10S, R33E
33.463112164°, -103.527814776°

Produced Water Release
Point of Release: Pin Hole on Water Line
Release Date: 07.22.2025
Volume Released: 33 Barrels of Produced Water
Volume Recovered: 0 Barrels of Produced Water

Re: **Closure Report**
Eagle #1 CTB (07.22.2025)
Incident ID: NAPP2520429493
BTA Oil Producers, LLC
Site Location: Unit E, S12, T10S, R33E
33.463112164° -103.527814776°
Lea County, New Mexico

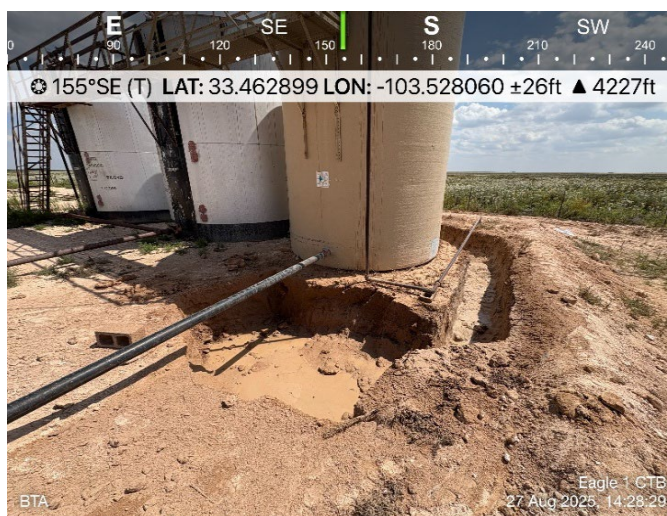
Photograph No. 1

View Southeast, Hydro-excavated area of CS-1 through CS-3.

Beginning on August 27, 2025, Carmona Resources personnel were onsite to supervise the remediation activities, collect confirmation samples, and document backfill activities. Before collecting composite confirmation samples, the NMOCD division office was notified via NMOCD portal on August 25, 2025, per Subsection D of 19.15.29.12 NMAC. See Appendix C. The area was excavated to a depth of 3.5 ft bgs. A total of five (5) confirmation floor samples (CS-1 through CS-5) were collected, and eight (8) sidewall samples (SW-1 through SW-8) were collected every 200 square feet to ensure the proper removal of the contaminated soil. For chemical analysis, the soil samples were collected and placed into laboratory-provided sample containers, stored on ice, and transported under the proper chain-of-custody protocol to Cardinal Laboratories in Hobbs, New Mexico. All collected samples were analyzed for TPH analysis by EPA method 8015 modified, BTEX by EPA Method 8021B, and Chloride by EPA method 4500. Copies of laboratory analysis and chain-of-custody documentation are included in Appendix E.

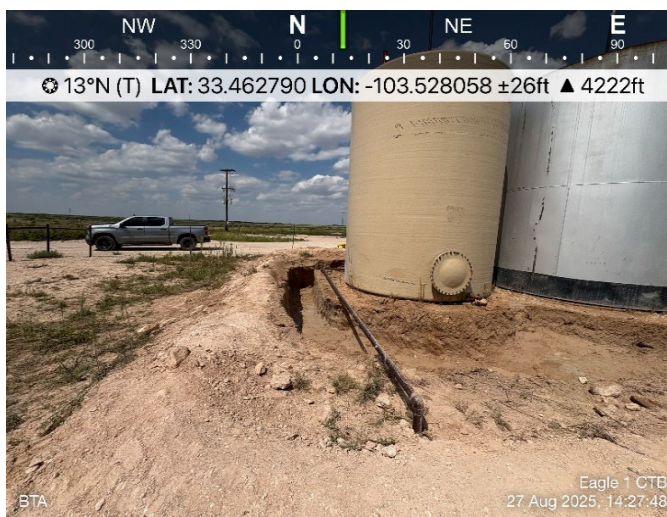
Photograph No. 2

View North, Hydro-excavated area of CS-4 and CS-5.

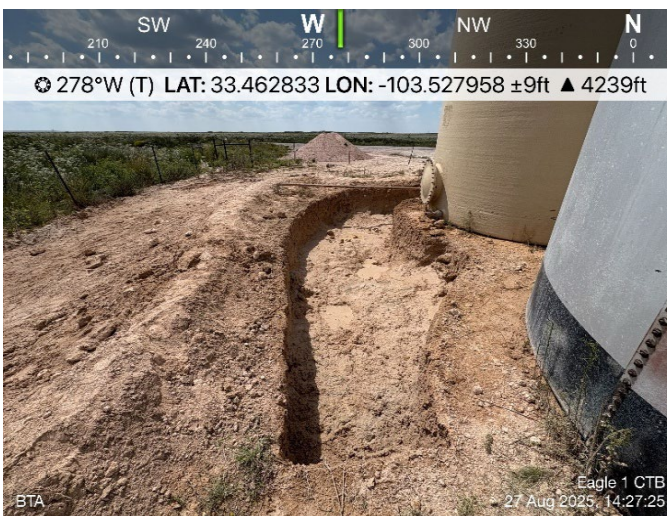
Photograph No. 3

View West, Hydro-excavated area of CS-4 and CS-5.

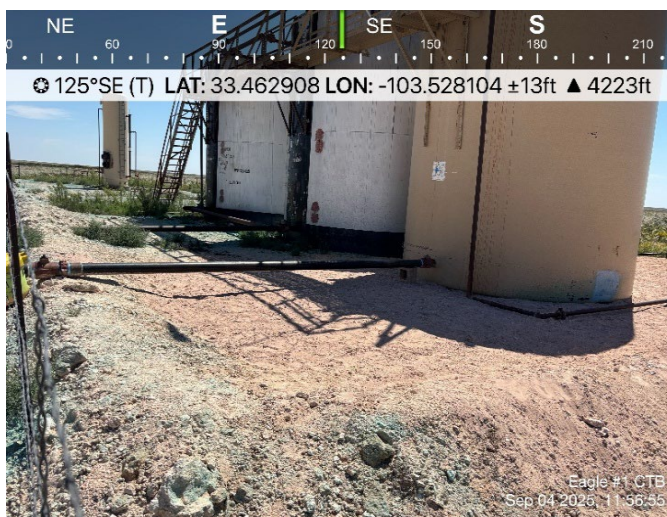
View Southeast, Backfilled area of CS-1 and CS-2.

Once the remediation activities were completed, the excavated areas were backfilled with clean material to surface grade. A composite sample of the backfill material was collected for laboratory analysis on August 27, 2025, before being utilized. The backfill material was sourced from the Gandy Marley Land farm at 33.384095, -103.827756. Refer to Table 2. Approximately 225 square feet of contamination was remediated, resulting in 60 cubic yards of material being excavated and transported offsite for proper disposal.

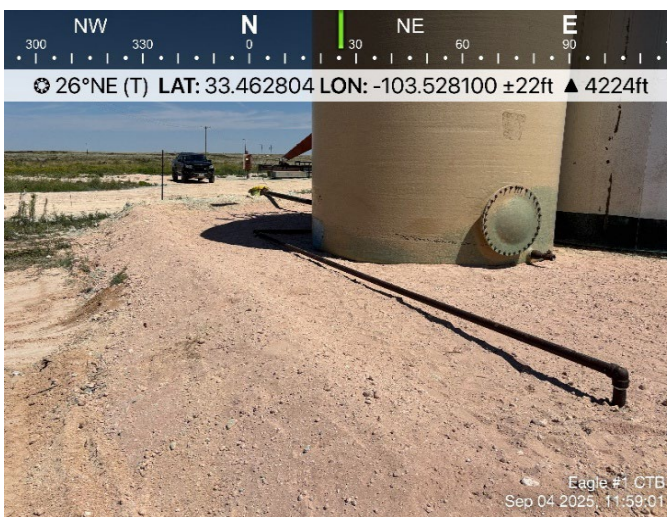
View Northeast, Backfilled area of CS-3 and CS-4.

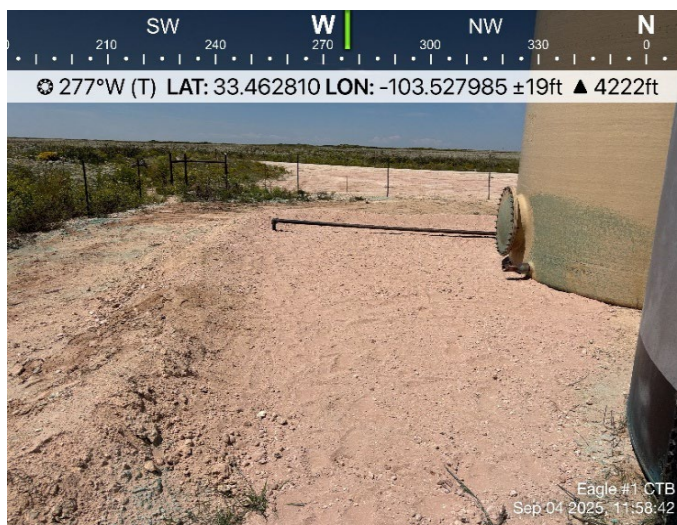
View West, Backfilled area of CS-3 and CS-4.
