**Re: Closure Report  
ConocoPhillips  
Deckard Federal Com #002H Flowline Release  
Unit Letter C, Section 13, Township 24 South, and Range 33 East  
Lea County, New Mexico  
Incident ID NAPP2418342470  
Landowner: Private**

Closure Report  
July 25, 2025

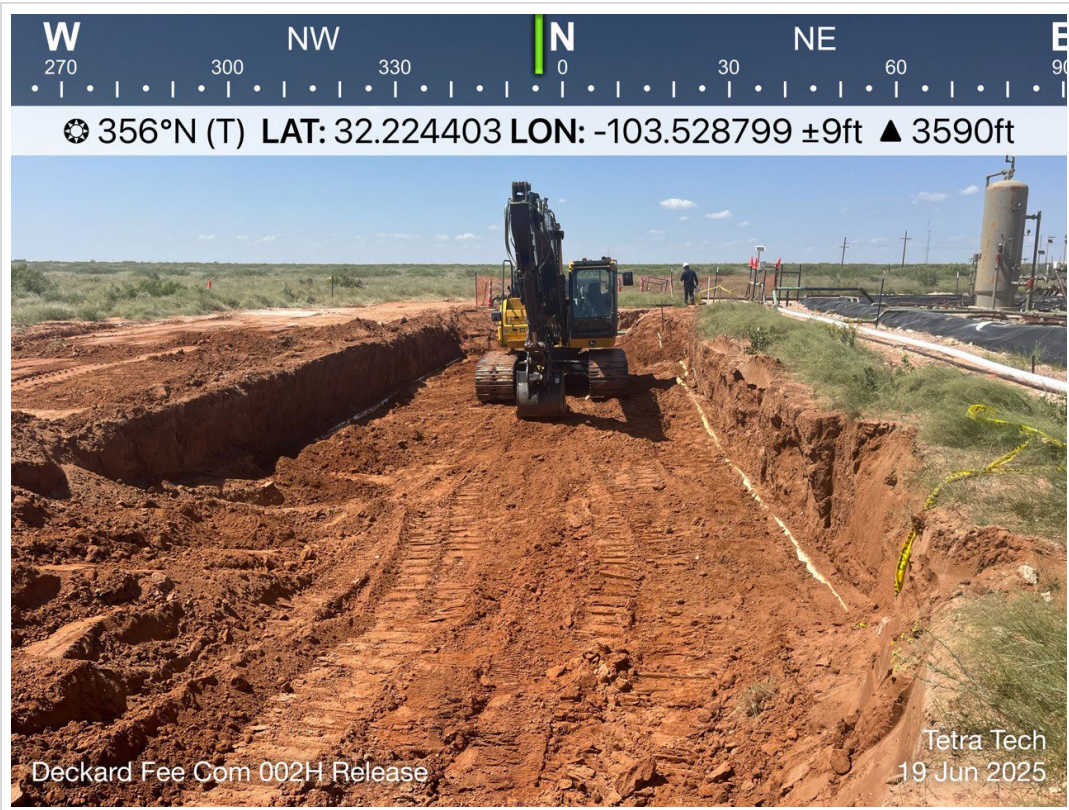
TETRA TECH, INC. PROJECT NO. 212C-MD-03575	DESCRIPTION	View North. View of excavation activities.	1
	SITE NAME	Deckard Federal Com 002H	6/19/2025

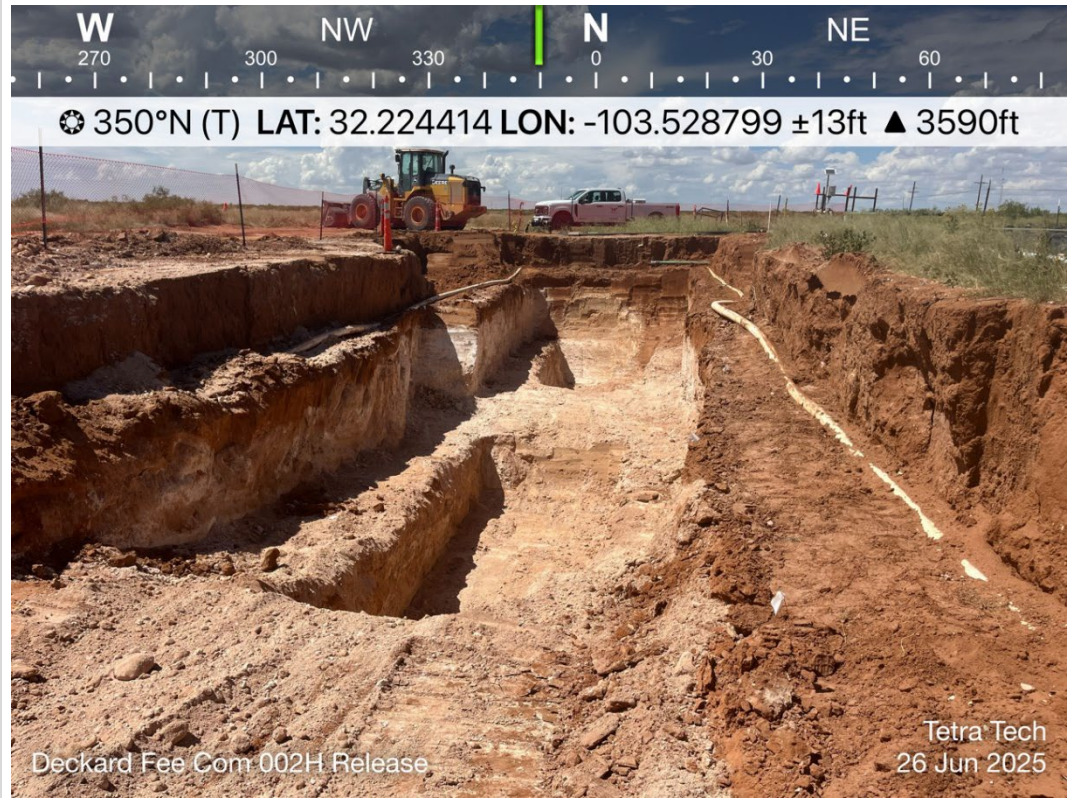
TETRA TECH, INC. PROJECT NO. 212C-MD-03575	DESCRIPTION	View north. Tiered excavation and benching.	2
	SITE NAME	Deckard Federal Com 002H	6/26/2025

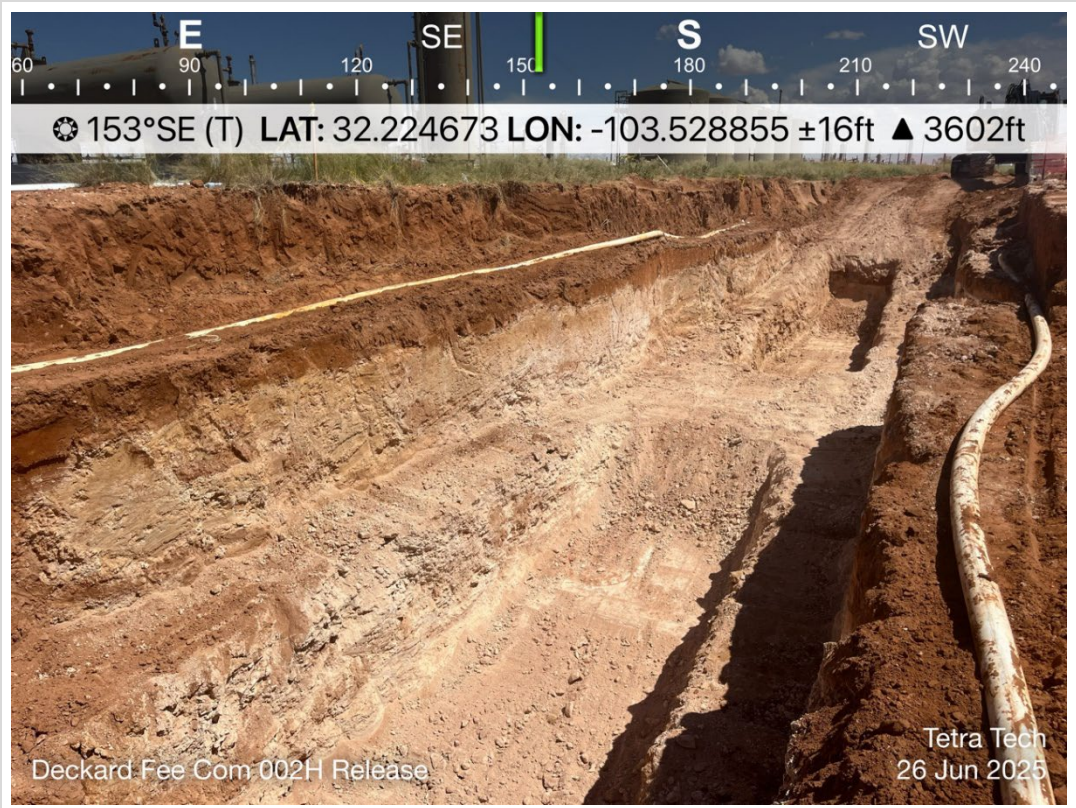
TETRA TECH, INC. PROJECT NO. 212C-MD-03575	DESCRIPTION	View southeast. Tiered excavation and benching. View of exposed pressurized lines.	5
	SITE NAME	Deckard Federal Com 002H	6/26/2025

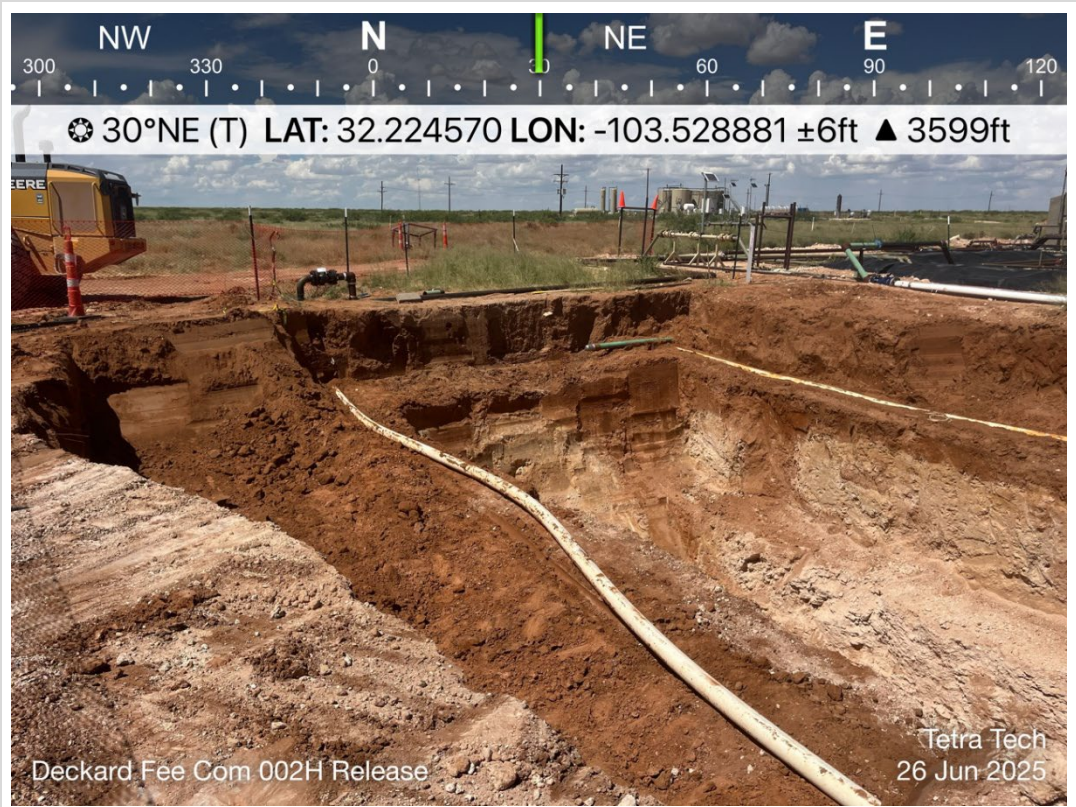
TETRA TECH, INC. PROJECT NO. 212C-MD-03575	DESCRIPTION	View north. View excavation activities. View of both pressurized lines between excavation extent.	6
	SITE NAME	Deckard Federal Com 002H	6/26/2025

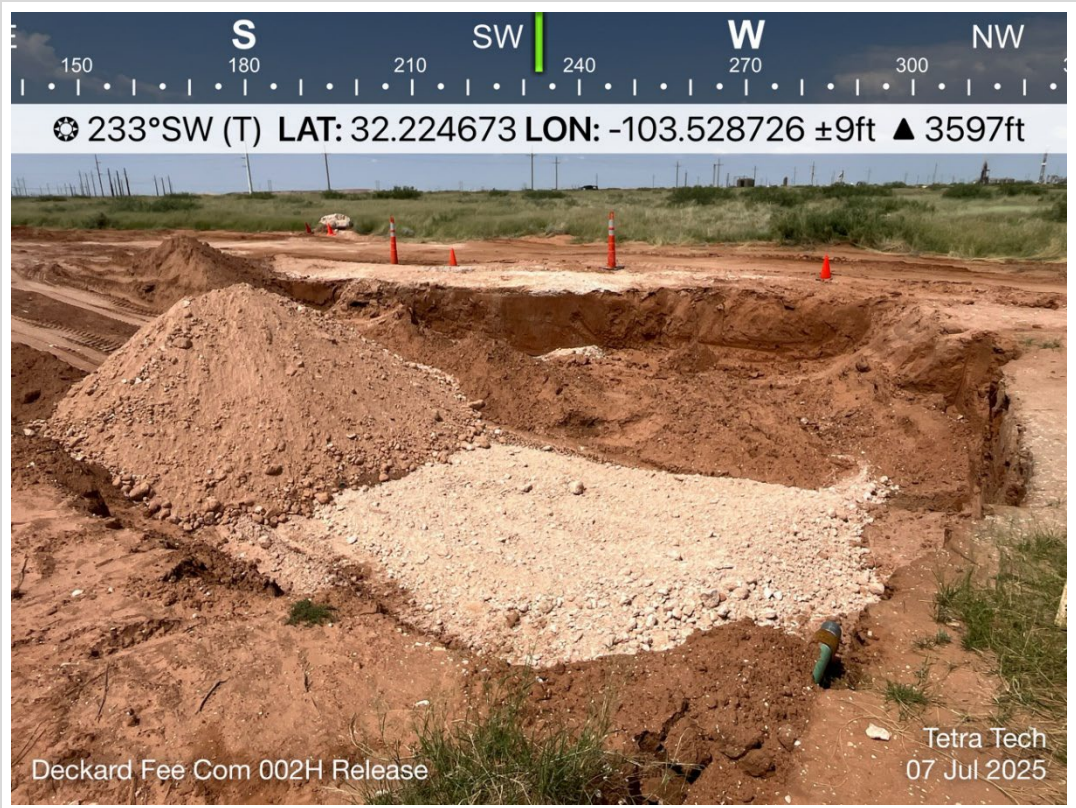
TETRA TECH, INC. PROJECT NO. 212C-MD-03575	DESCRIPTION	View southwest. View of backfill activities.	9
	SITE NAME	Deckard Federal Com 002H	7/7/2025

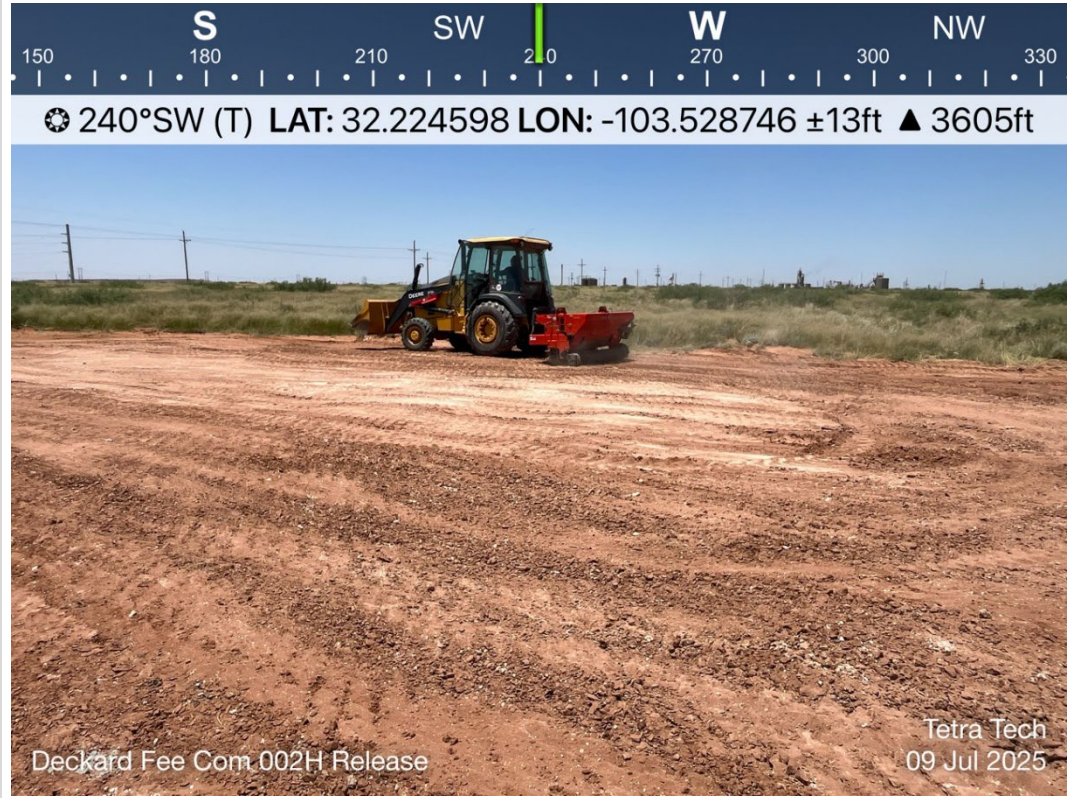
TETRA TECH, INC. PROJECT NO. 212C-MD-03575	DESCRIPTION	View southwest. View of backfilled excavation extent. View of seeding activities.	12
	SITE NAME	Deckard Federal Com 002H	7/9/2025

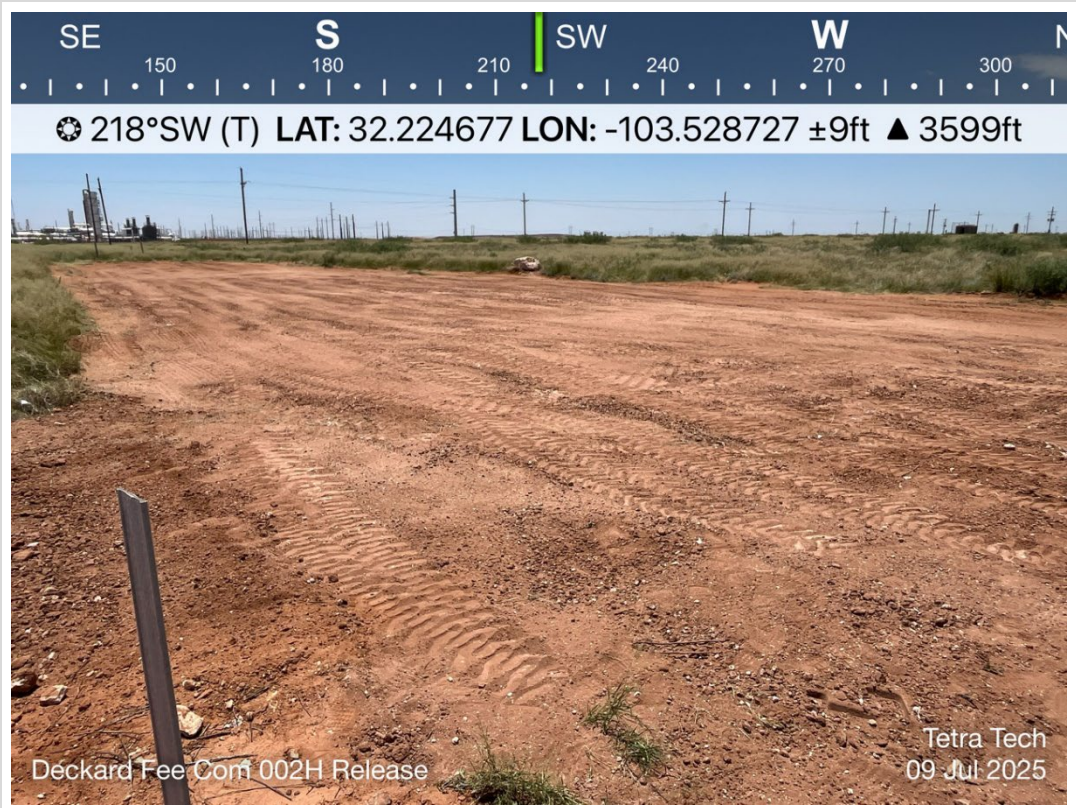
TETRA TECH, INC. PROJECT NO. 212C-MD-03575	DESCRIPTION	View southwest. View of backfilled and seeded area.	13
	SITE NAME	Deckard Federal Com 002H	7/9/2025

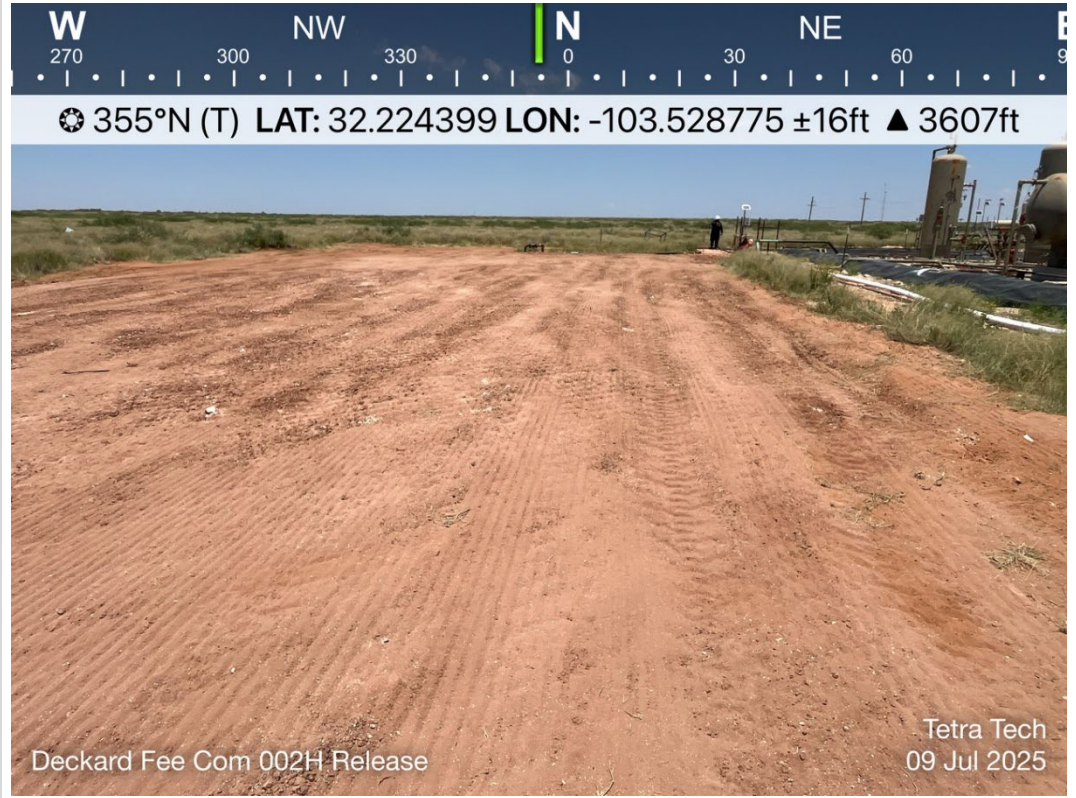
TETRA TECH, INC. PROJECT NO. 212C-MD-03575	DESCRIPTION	View north. View of backfilled and seeded area.	14
	SITE NAME	Deckard Federal Com 002H	7/9/2025
