**Closure Report**  
**Hornsby 35 Federal Com #002H (06.08.2025)**  
**Incident ID: NAPP2516049014**  
**Eddy County, New Mexico**  
**Unit E, Sec 35, T26S, R27E**  
**32.00046, -104.16464**

**Produced Water Release**  
**Point of Release: Corrosive at Valve**  
**Release Date: 06.08.2025**  
**Volume Released: 42 Barrels of Produced Water**  
**Volume Recovered: 42 Barrels of Produced Water**

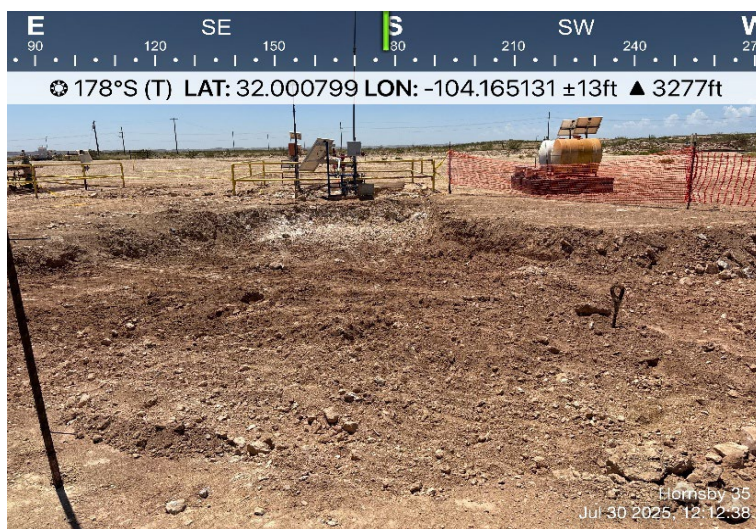
View South, area of CS-1 through CS-10.

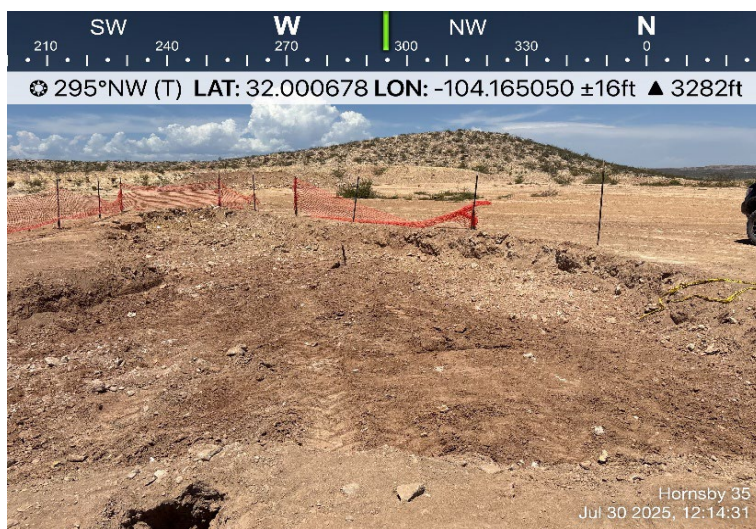
## Photograph No. 3

View Northwest, area of CS-1 through CS-15.

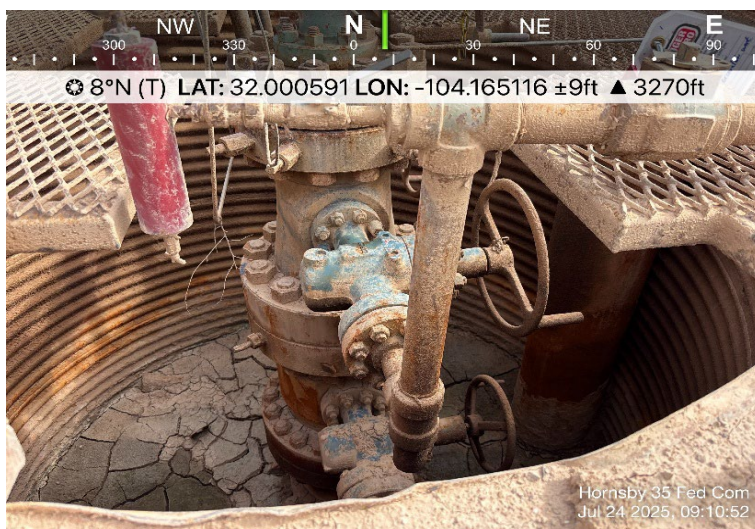
## Photograph No. 5

View North, area of the well cellar with fluids removed and no holes detected in the well cellar walls.
