Vadose Zone Assessment and Incident Closure Request

Hobbs Gas Plant
Lea County, New Mexico
AP-122
NMOCD Incident # nPAC0706832026

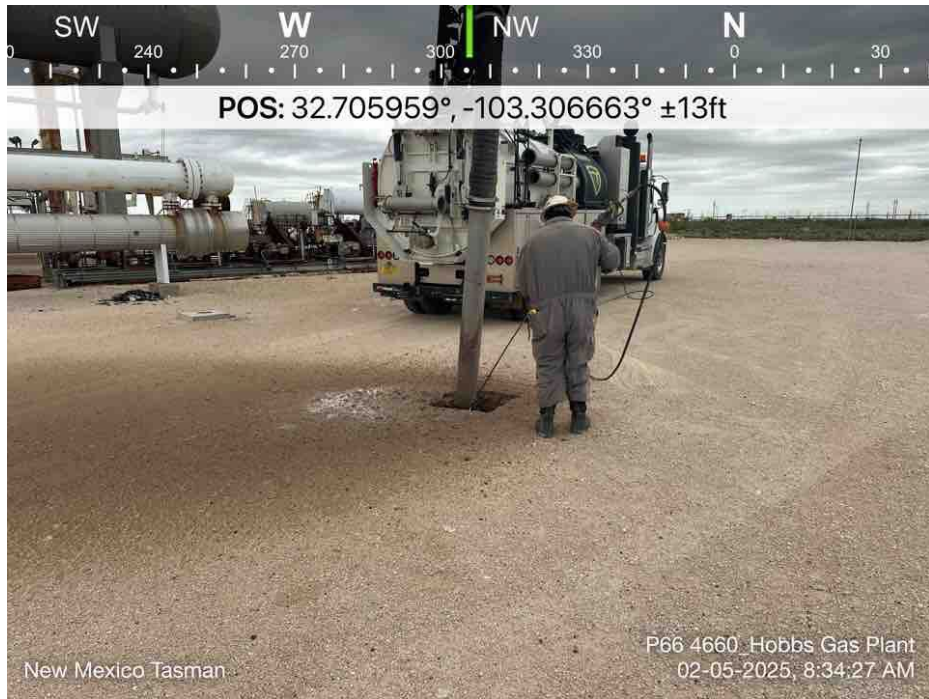
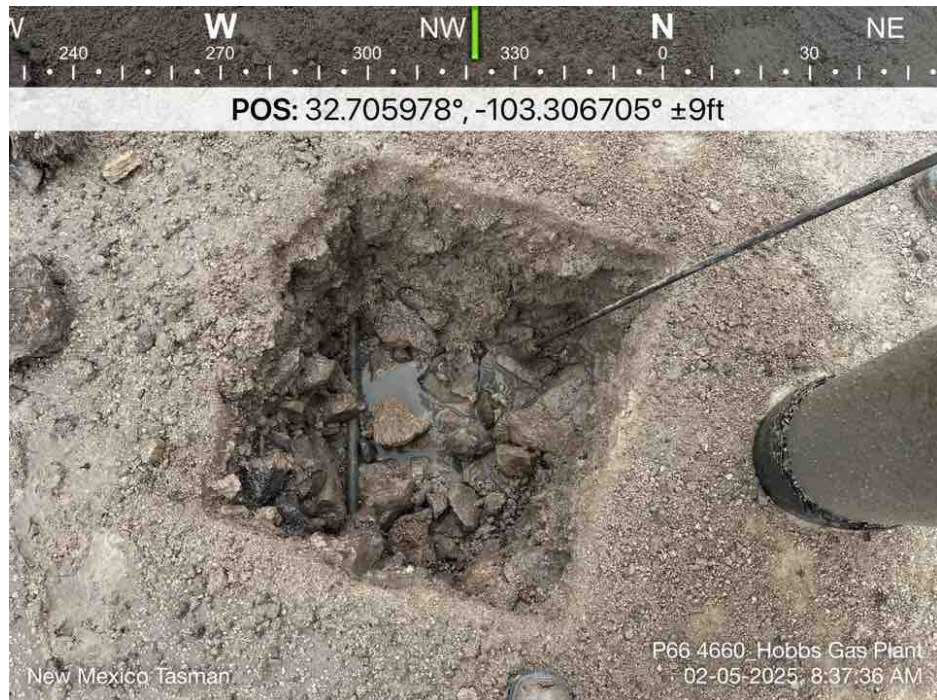
On May 2, 2025, Tasman mobilized to the site to clear the soil boring locations for underground utilities utilizing hydro-excavation. Based on previous experience onsite and regional lithologic conditions, caliche is typically encountered within the first couple feet bgs and then intermittently throughout the subsurface. The utility clearance potholing was completed to approximately two feet bgs at each location due to encountering caliche material which inhibited further vertical progress of the potholes. Prior to hydro-excavating the five designated soil bore locations, Tasman also screened and collected surficial soil samples (0.5 feet bgs) from each location for transport to Cardinal Laboratory for analysis.

Due to the soil composition, suspected caliche layers, and difficult drilling conditions, partial refusal was encountered and exceeded the drilling equipment's capabilities for retrieving a sample core from the split spoon barrel at a majority of the planned sampling intervals. Following multiple failed attempts to collect sufficient sample volume for laboratory analysis using a split spoon, it was determined that the most representative soil sample from each interval should be collected directly from the drill cuttings and split

During borehole advancement through the vadose zone, each soil boring was logged for lithological conditions based on soil cuttings/samples collected at approximate 5-foot intervals and recorded on the soil boring logs. Soil samples were collected for laboratory analysis and field screened using a photoionization detector (PID) every 10 feet until the total depth of the boring. Lithologic observations identified that the site is predominately composed of sand with intermittent pockets of gravel (likely pulverized caliche). The soil boring logs are provided as Appendix B and a photographic log has been included as Appendix C to this closure summary report.
