Remediation Report and Closure Request  
McClanahan 6 Pipeline Release  
Lat: 36.6525100 Long: -107.8688500  
San Juan County, New Mexico

Photo Page  
McClanahan 6 Pipeline Release  
Lat: 36.652510 Long: -107.868850

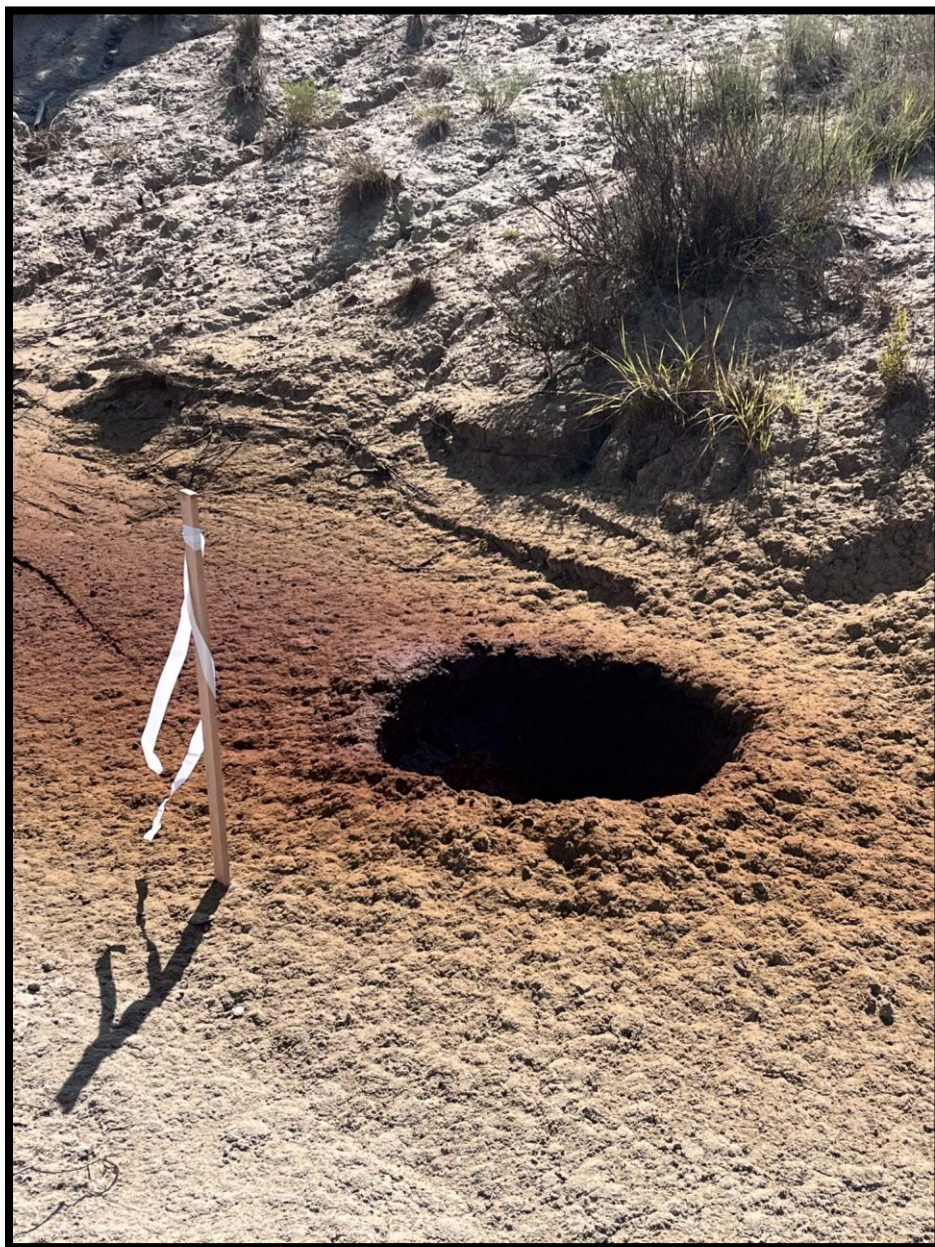
Harvest was notified of a potential leak on the McClanahan 6 pipeline at Latitude 36.6525100 Longitude -107.8688500. A Harvest tech responded to the reported location and visually confirmed leak with a small amount of liquids on the ground and blowing gas. Tech isolated the pipeline and blew down the line stopping the release. The release was in a dry wash. Tech scrapped up the area misted by the liquids from the pipeline and contained area for further contamination. Notification of release was submitted on the NMOCD online E-permitting website and notice was sent to the BLM via email. Liquid volume was calculated to 0.5bbls. See *"Email Notification"*, and *"Volume Calculation"* for reference.

Photo 1: Release Discovered

A crew was onsite to excavate pipeline and make repairs. Failed piping was cut out and replaced with new four-inch piping. It was determined that the hole formed in the pipeline was caused by external corrosion. 35 yards of soil were removed from excavation and hauled to Envirotech's land farm. New soil was brought in from Envirotech. Gas loss was calculated to be 1.19 Mcf. See *"Volume Calculation"* for reference.

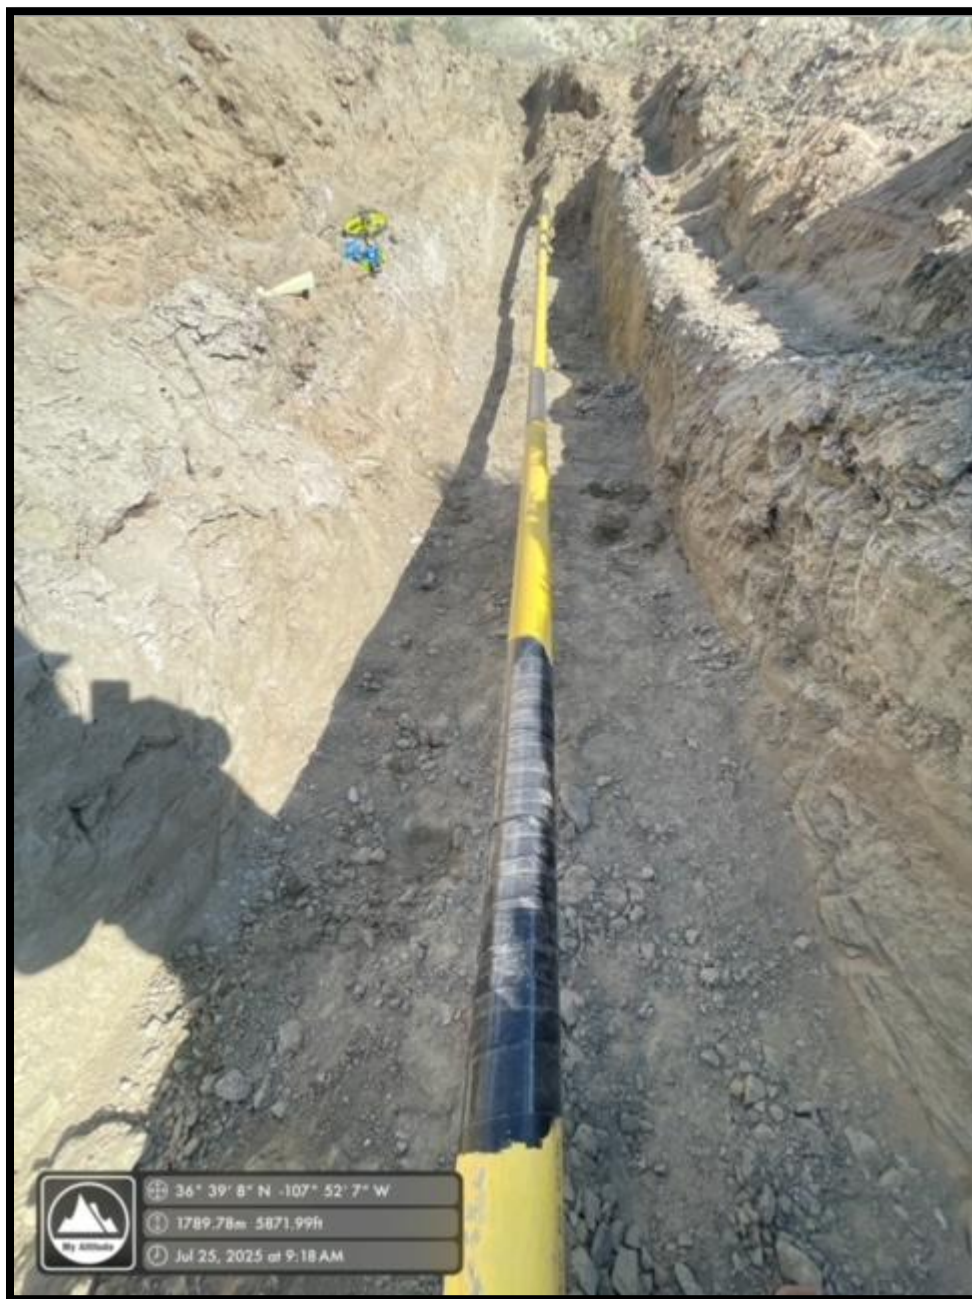
Photo 2: Sampling Event on 7/25/2025 Showing "Bottom"

Harvest personnel were onsite to perform sampling activities. A total of five composite samples were collected from the excavation. Each composite sample collected was within a two square foot area. Once samples were collected samples were sent in for lab analysis of Chlorides, BTEX, and TPH. See *"Sample Map"* for reference.

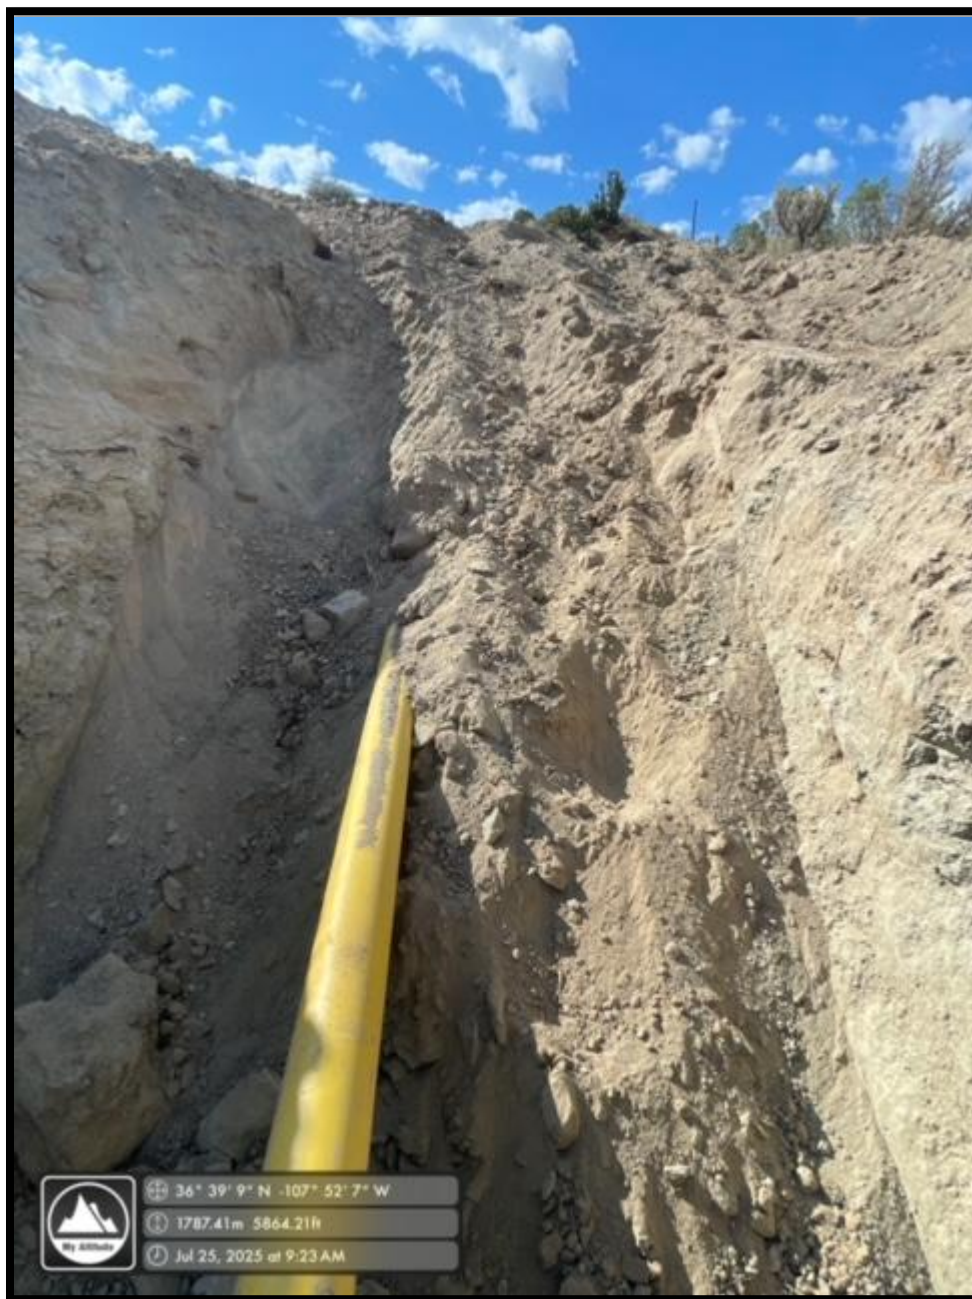
Photo 3: Sampling Event on 7/25/2025 Showing "South Wall"

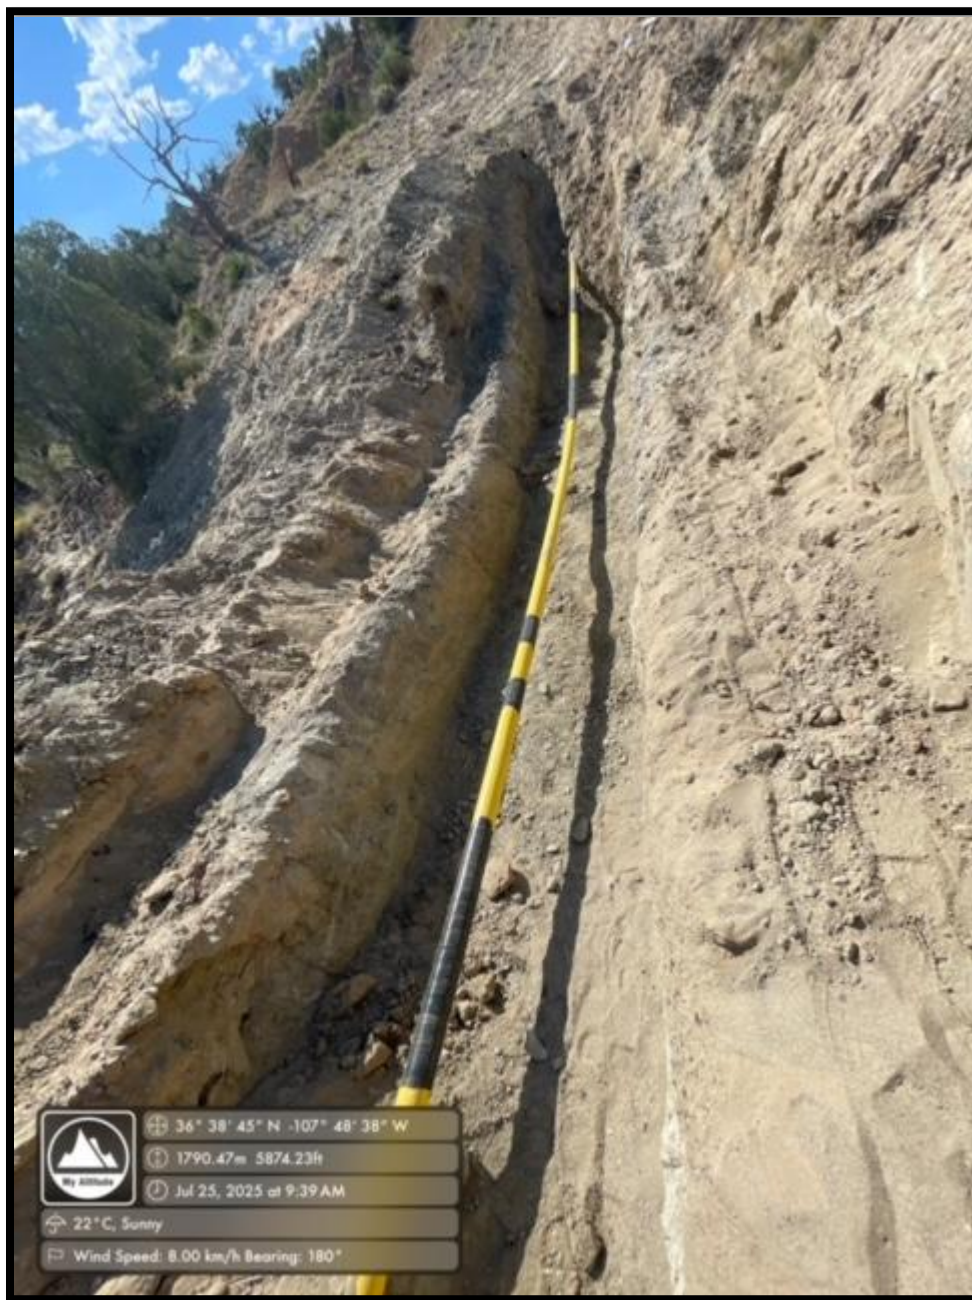
Photo 4: Sampling Event on 7/25/2025 Showing "West Wall"

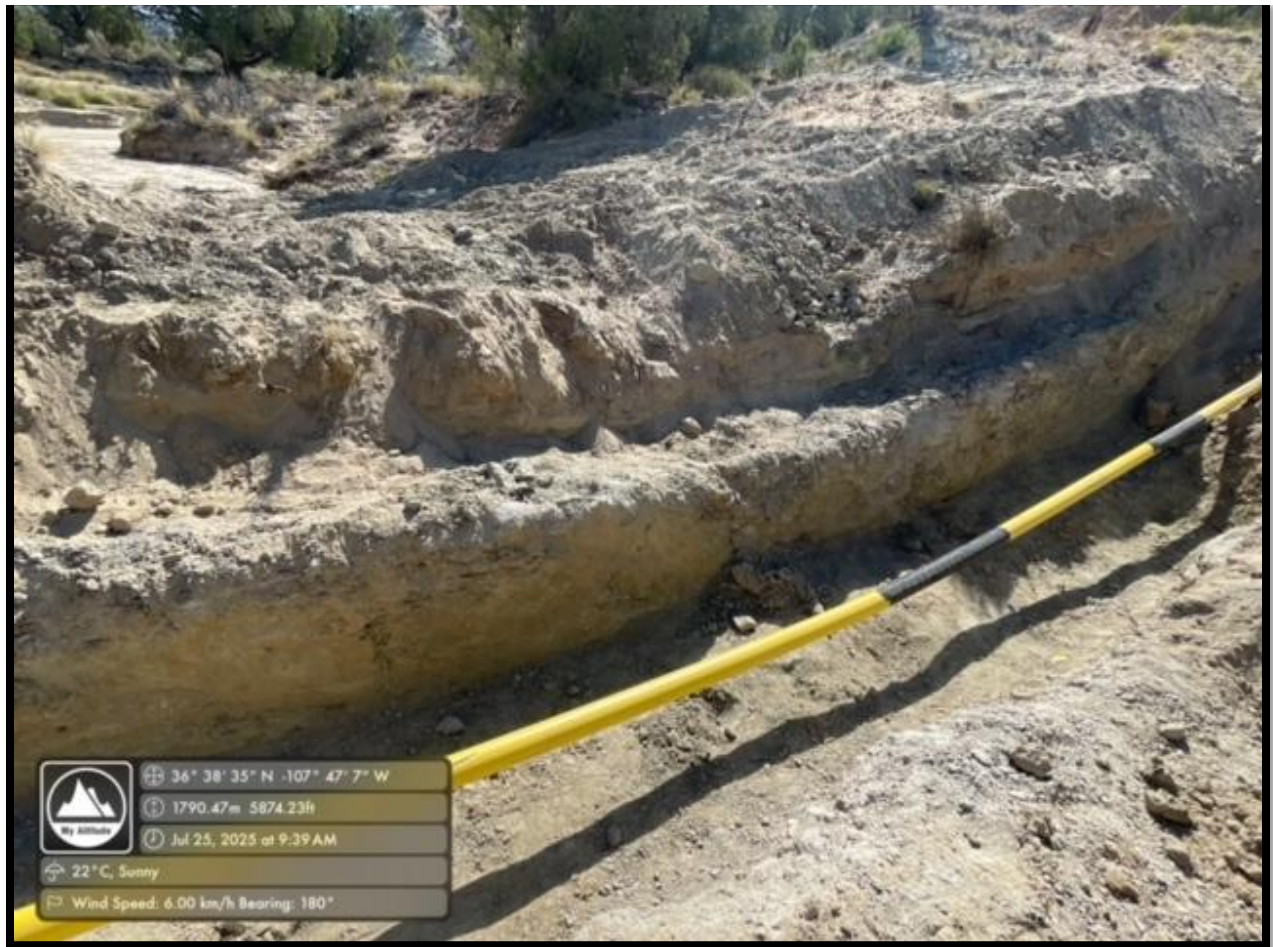
Photo 5: Sampling Event on 7/25/2025 Showing "East Wall"

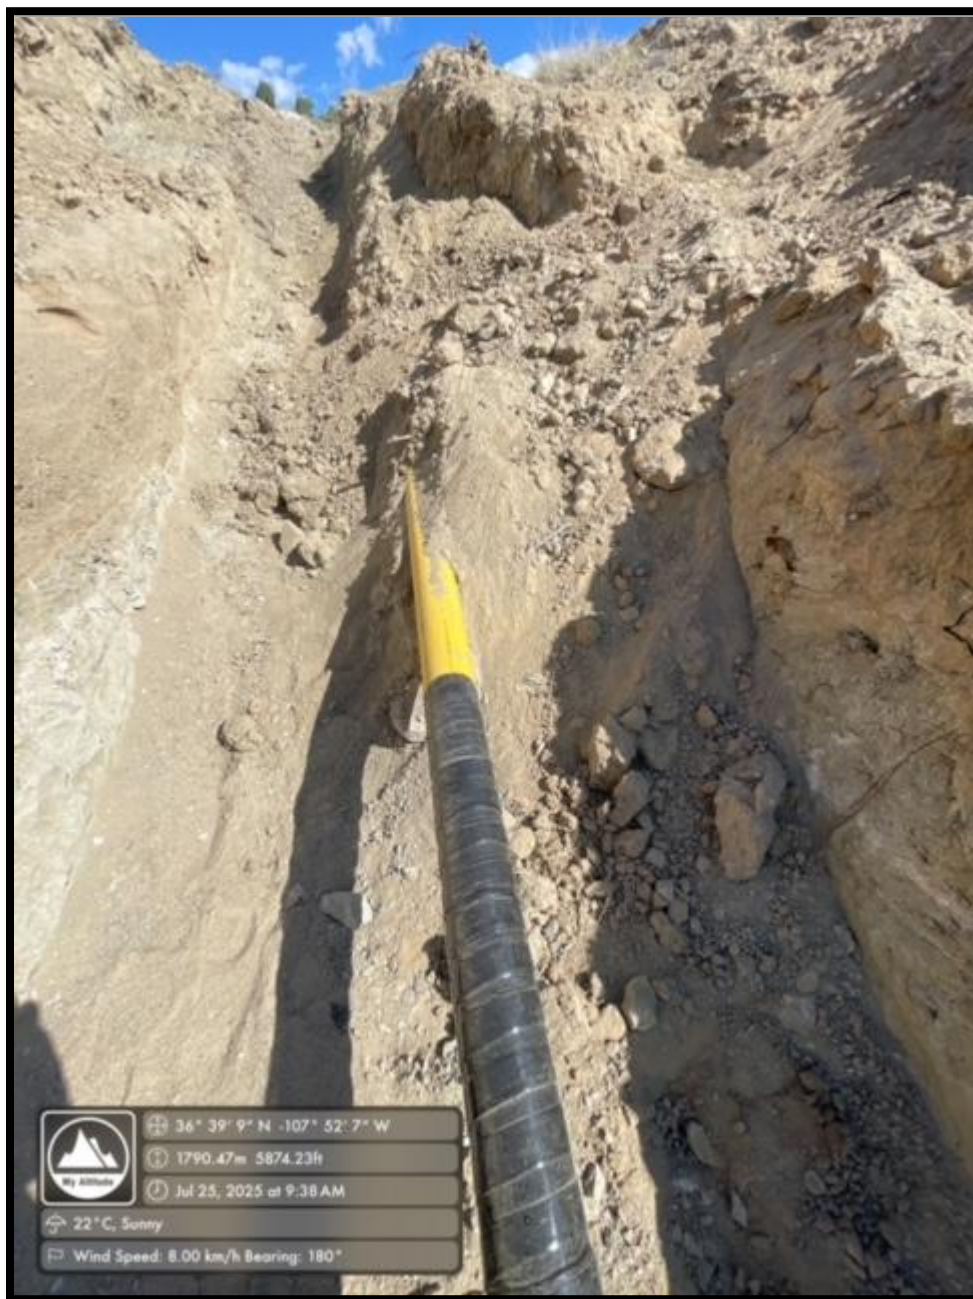
Photo 6: Sampling Event on 7/25/2025 Showing "North Wall"
