# Remediation Summary Final Closure Request

**OXY USA, INC**

**Mesa Verde WC Unit #19H**

**NMOCD Incident # nAPP2523231324**

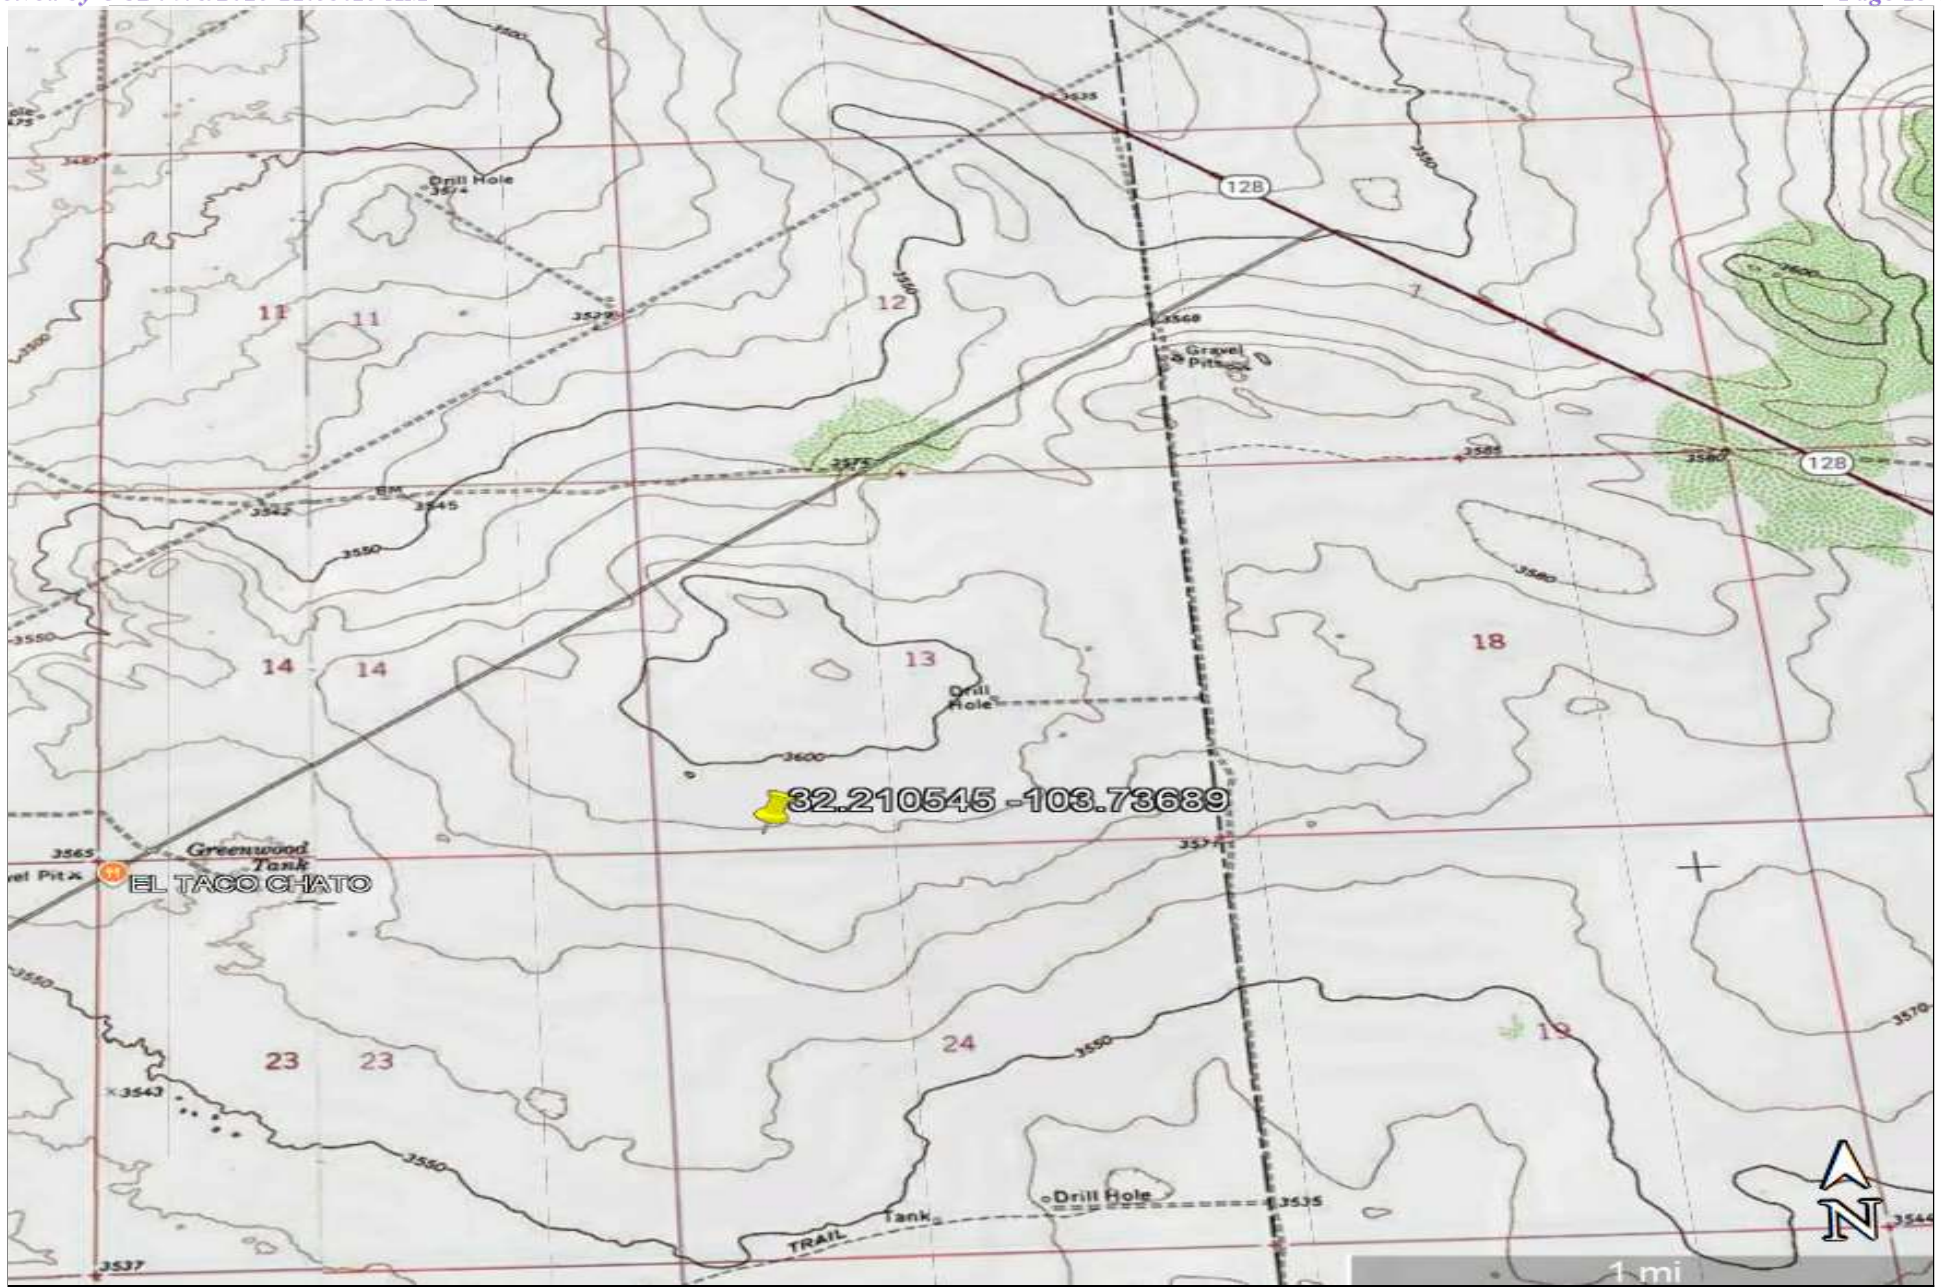
| Legend | Topo Map | Figure 1 |

A search of the New Mexico Office of the State Engineer (NMOSE) and United States Geological Survey (USGS) groundwater databases was completed to determine the horizontal distance to known water sources within a (½) half-mile radius of the Release Site. Probable groundwater depth was determined using data generated by numeric models based on available water well data and published information. Site characterization shows the area is low karst and no other receptors (residence, school, hospital, institution, church, mining or other ordinance boundaries) were located within the regulatorily promulgated distances from the Site. Depth to groundwater information is provided as Attachment II and the results are depicted on Figures 1, 2, and 3.

Depth to groundwater information is provided and the results are depicted in Figures 1 and 2.

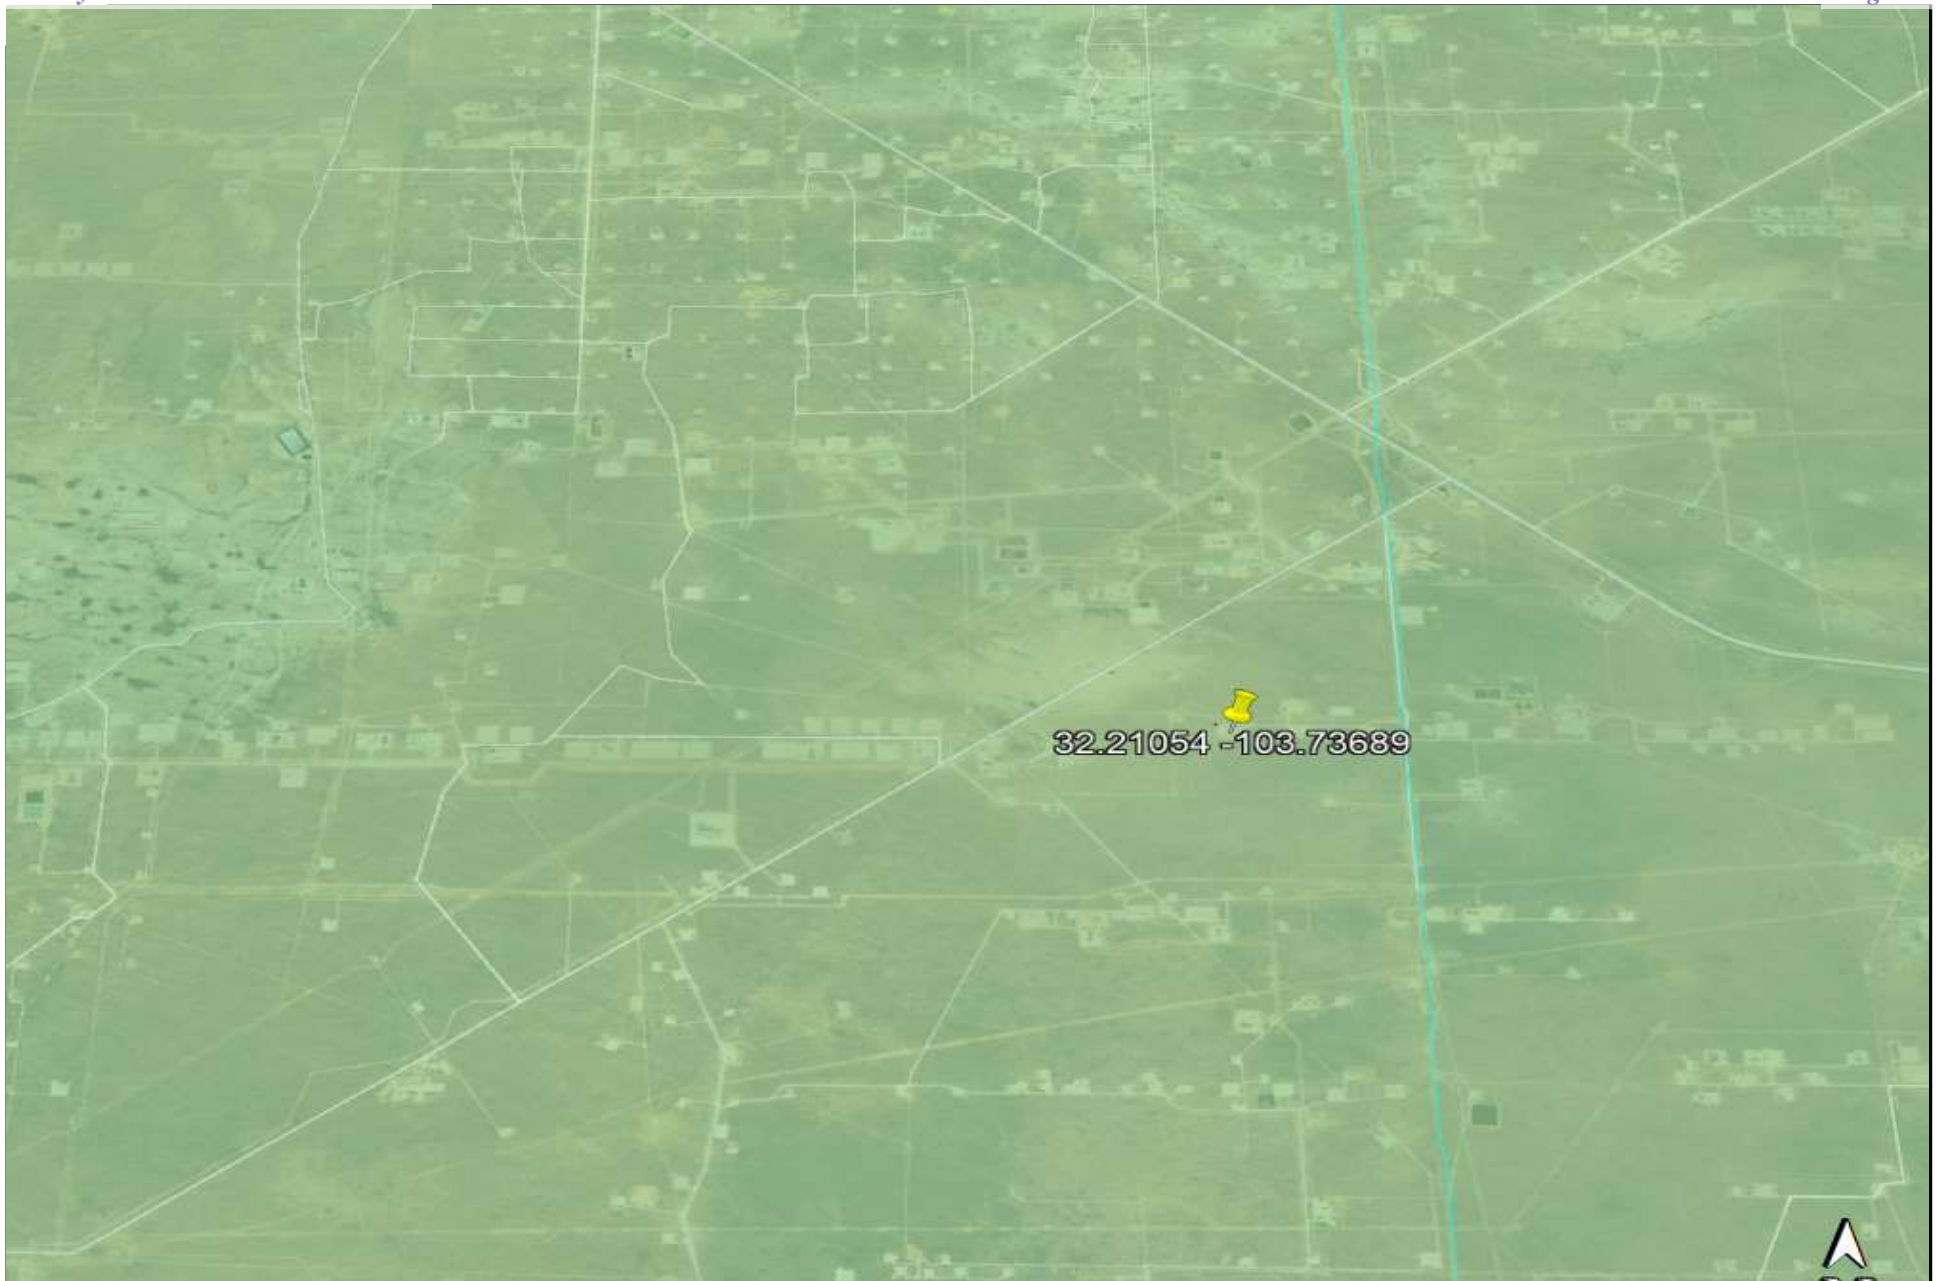
| Legend | Karst Map | Figure 3 |
|---|---|---|
| <div data-bbox="205 1409 256 1442" style="display: inline-block; width: 15px; height: 10px; background-color: #90EE90; border: 1px solid black; margin-right: 5px;"></div> Low Karst<br><div data-bbox="205 1450 256 1482" style="display: inline-block; width: 15px; height: 10px; background-color: #ADD8E6; border: 1px solid black; margin-right: 5px;"></div> Medium Karst<br><div data-bbox="205 1490 256 1523" style="display: inline-block; width: 15px; height: 10px; background-color: #FF0000; border: 1px solid black; margin-right: 5px;"></div> High Karst | <p style="text-align: center;">Oxy<br/>Mesa Verde wc Unit #019H<br/>Low Karst</p> | |

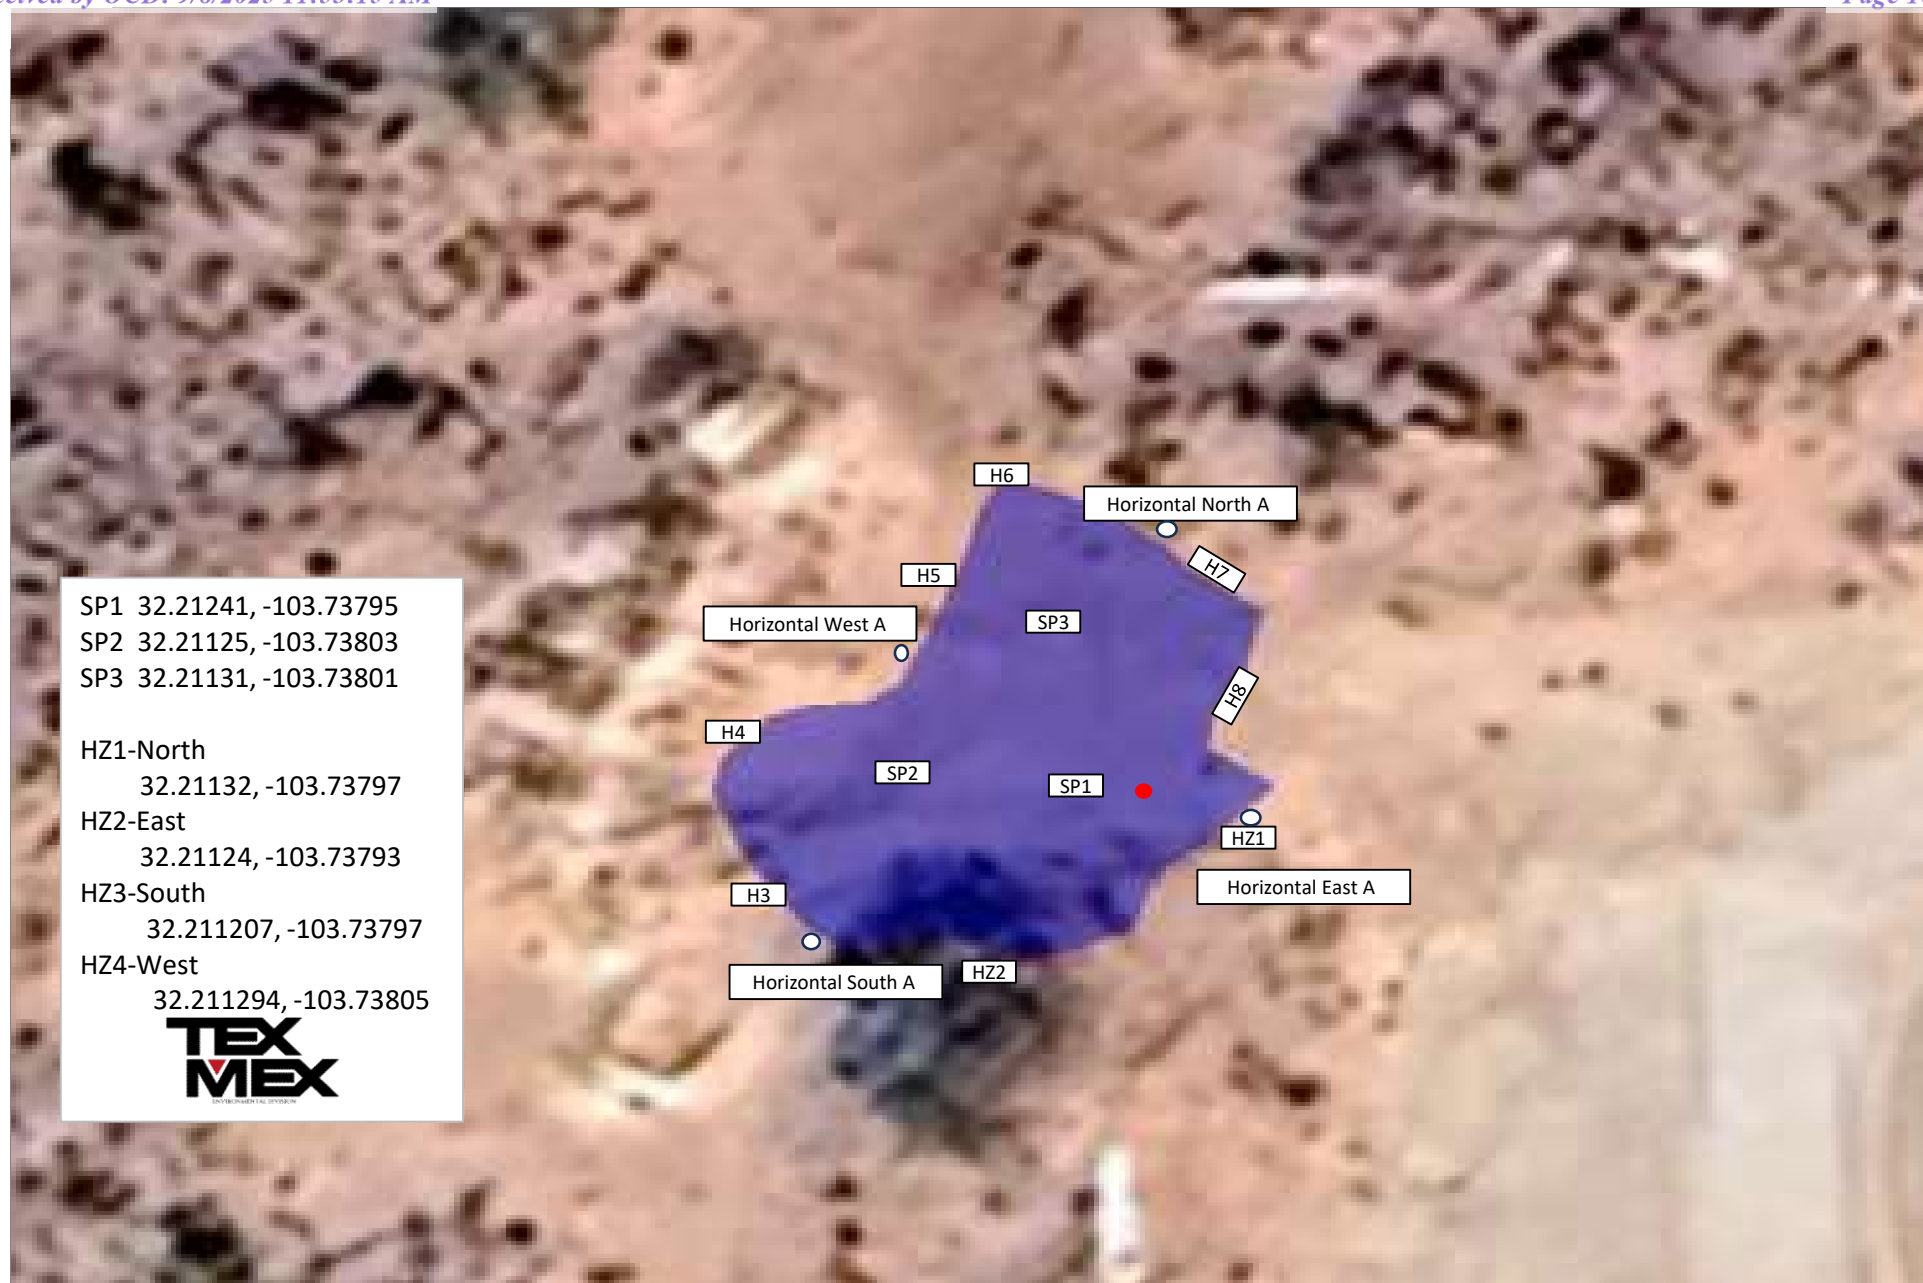
| Legend | Delineation Sample Map | Figure 4 |

| Legend | Delineation Sample Map | Figure 4 |
|---|---|---|
| SP1-SP3      Vertical Delineation<br>HZ1-HZ8      Horizontal Delineation<br>●      Point of Release | Oxy<br>Mesa Verde<br>32.211243, -103.94378<br>NAPP2523231324 | <b>TEX MEX</b><br>ENVIRONMENTAL DIVISION |

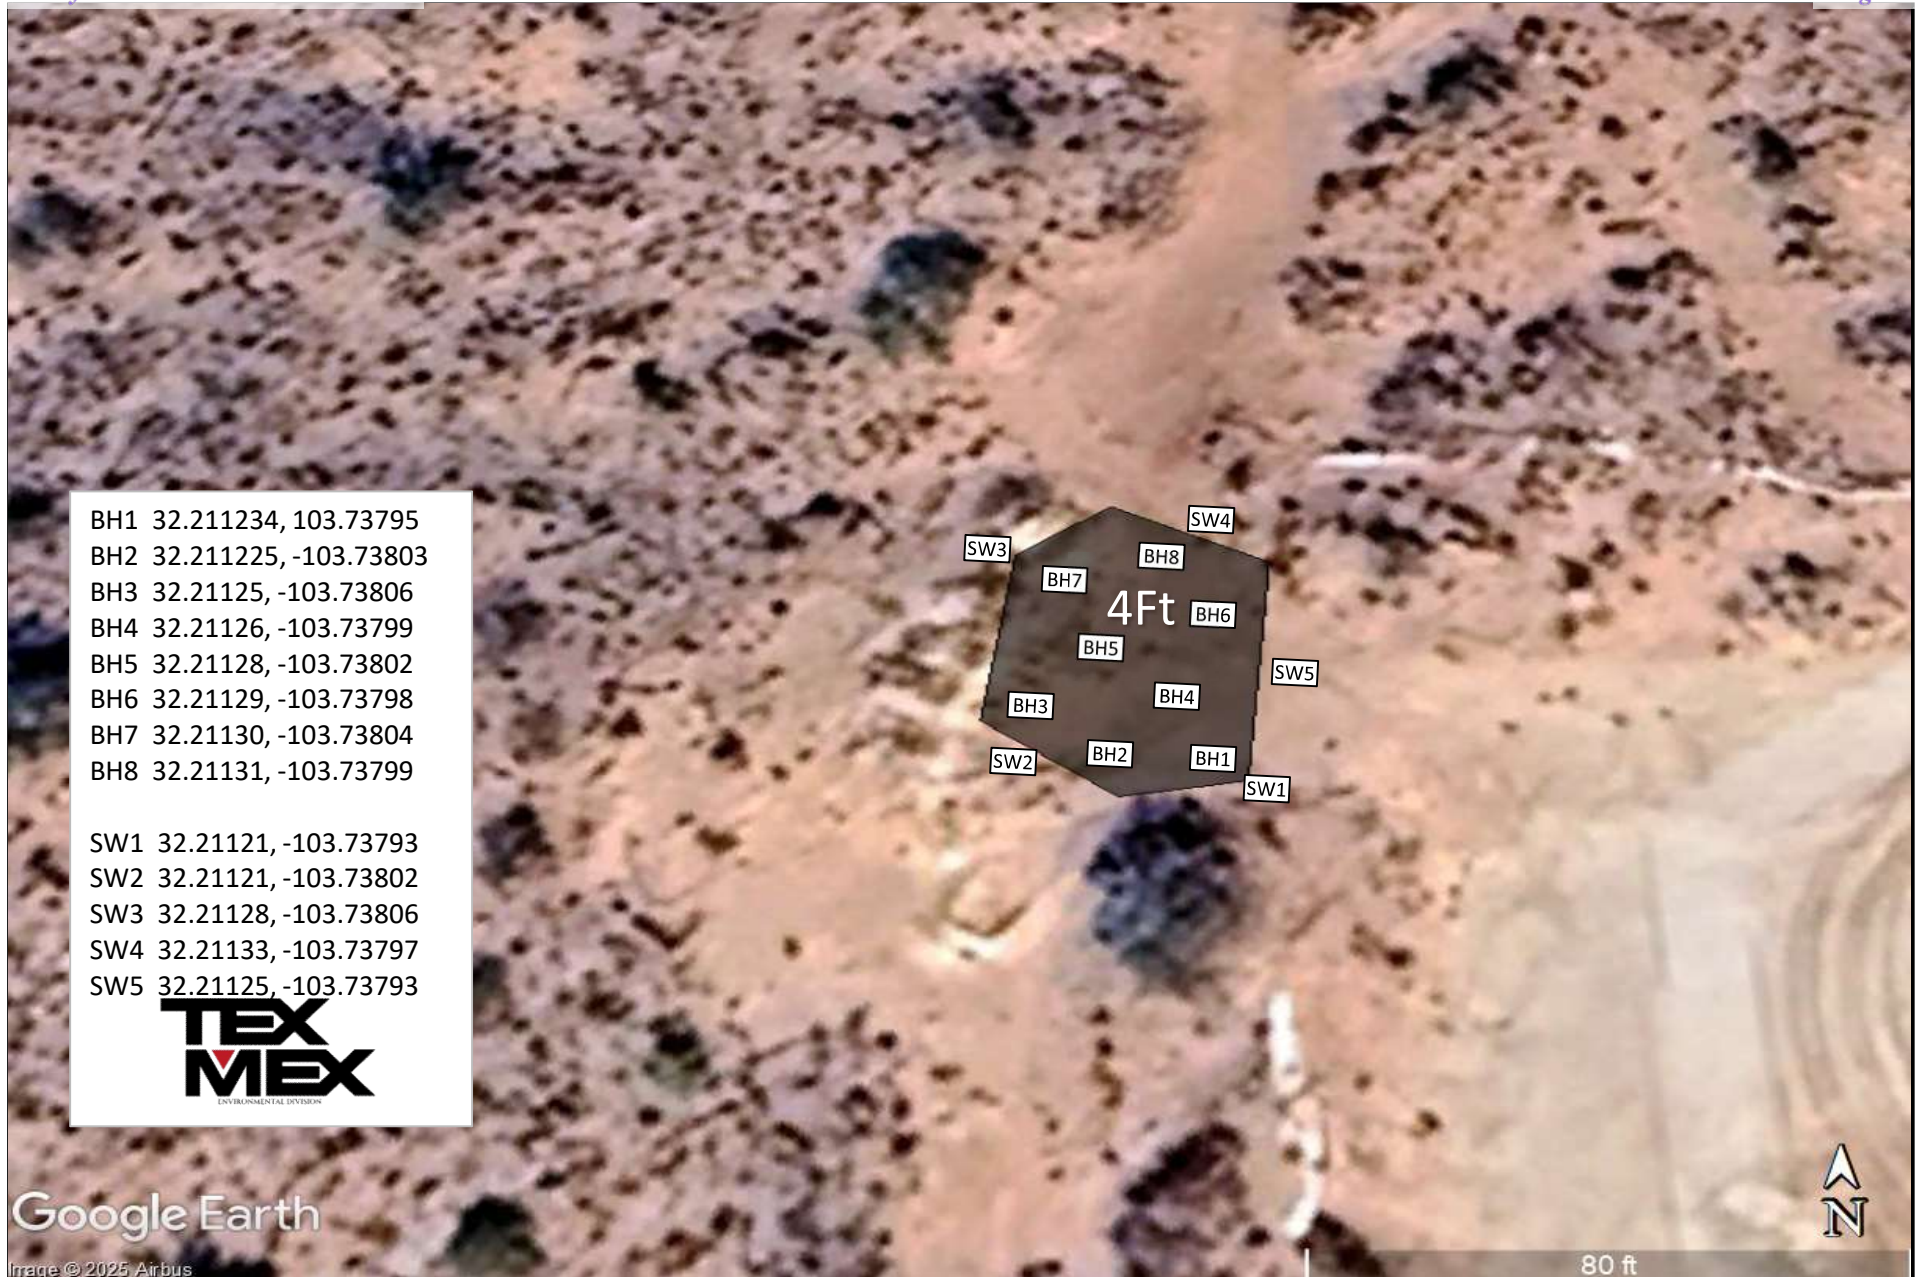
| Legend | Excavation Map | Figure 5 |
|---|---|---|
| <div style="display: flex; align-items: center;"> <div style="border: 1px solid black; width: 20px; height: 10px; margin-right: 5px;"></div> <div>BH Bottom hole composite sample location</div> </div> <div style="display: flex; align-items: center;"> <div style="border: 1px solid black; width: 20px; height: 10px; margin-right: 5px;"></div> <div>SW Sidewall composite sample location</div> </div> <div style="display: flex; align-items: center;"> <div style="background-color: black; width: 20px; height: 10px; margin-right: 5px;"></div> <div>4Ft excavation depth</div> </div> | <p>Oxy<br/> Mesa Verde<br/> <b>1600 Sq Ft Excavation</b></p> | <p><b>TEX MEX</b><br/> ENVIRONMENTAL DIVISION</p> |
