Amended Remediation Summary & Soil Closure Request

Mewbourne Oil Company Pavo Frio to Westall SWD Line

Eddy County, New Mexico
Unit Letter "L", Section 18, Township 18 South, Range 29 East
Latitude 32.74355 North, Longitude 104.11546 West
NMOCD Reference No. nAPP2424249029

Etech Environmental & Safety Solutions, Inc.

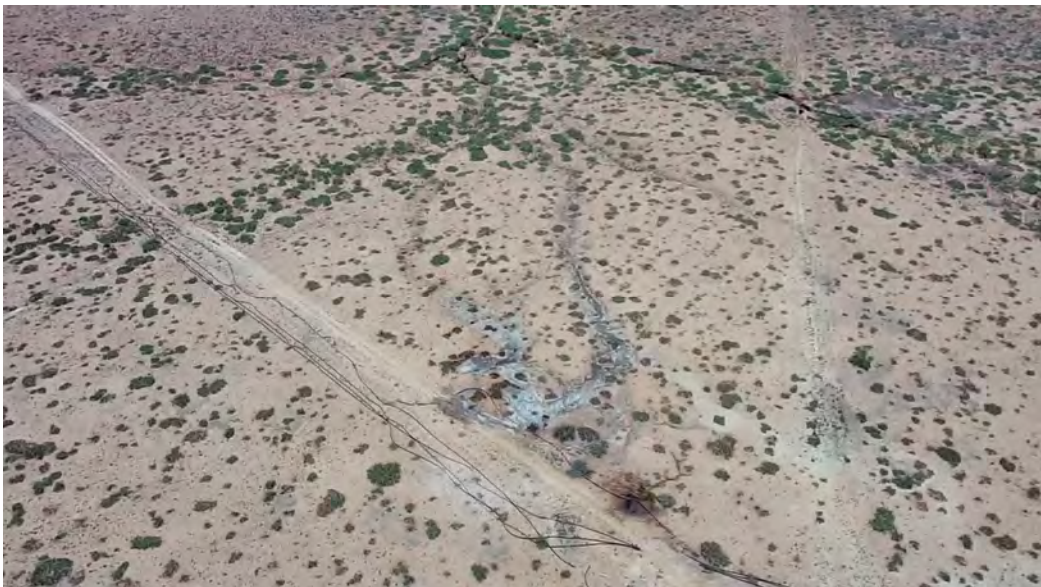
Photo Number: 1

Date: 8/15/2024	
Coordinates: 32.744481,-104.115218	
Photo Direction: South-Southwest	
Photo Description: Aerial view of the affected area.

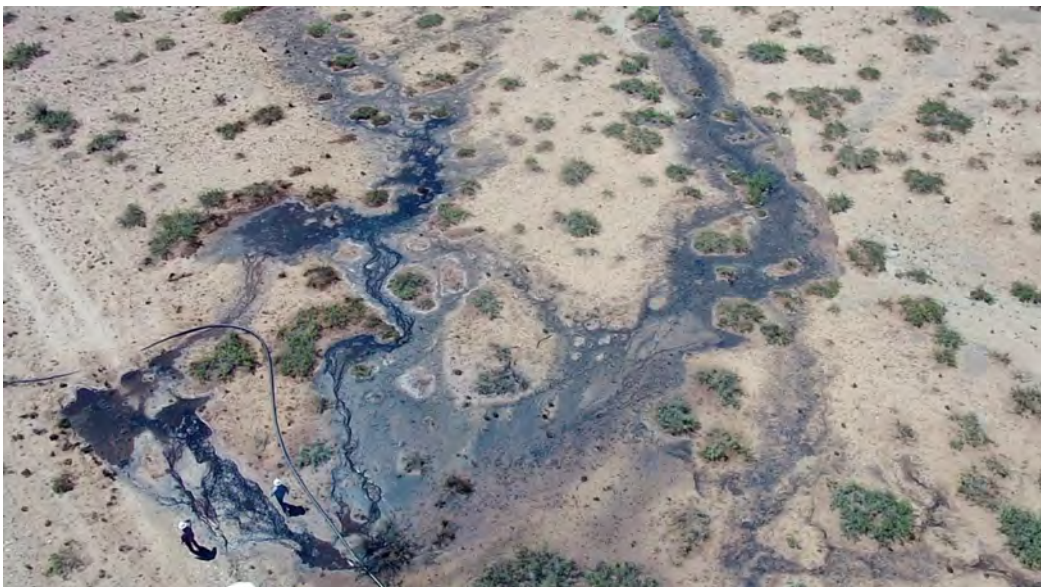
Photo Number: 2

Date: 8/15/2024	
Coordinates: 32.744258,-104.115317	
Photo Direction: South-Southwest	
Photo Description: Aerial view of the affected area.

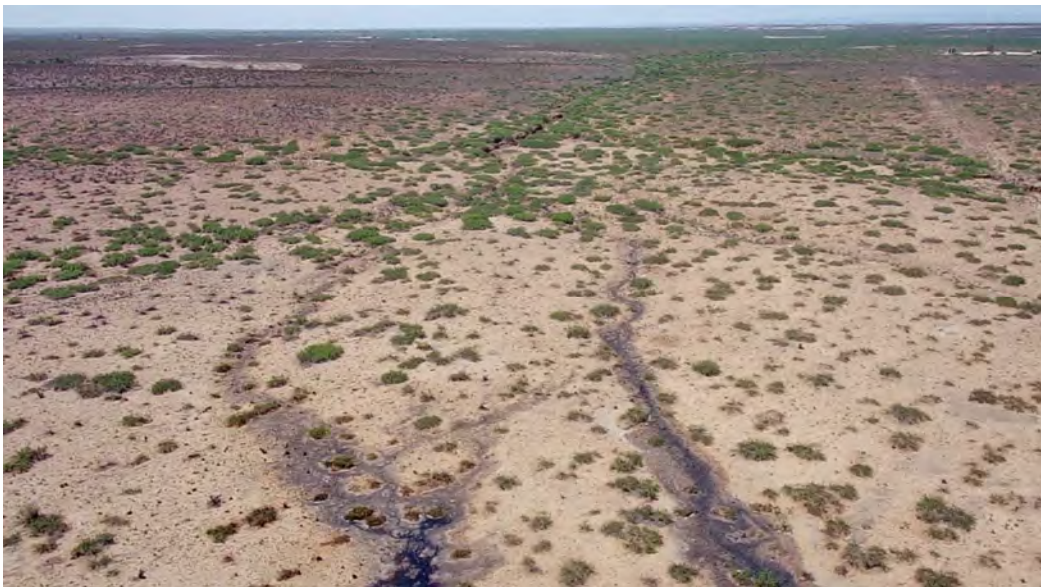
Photo Number: 3

Date: 8/15/2024	
Coordinates: 32.743521,-104.115462	
Photo Direction: South-Southwest	
Photo Description: Aerial view of the affected area.

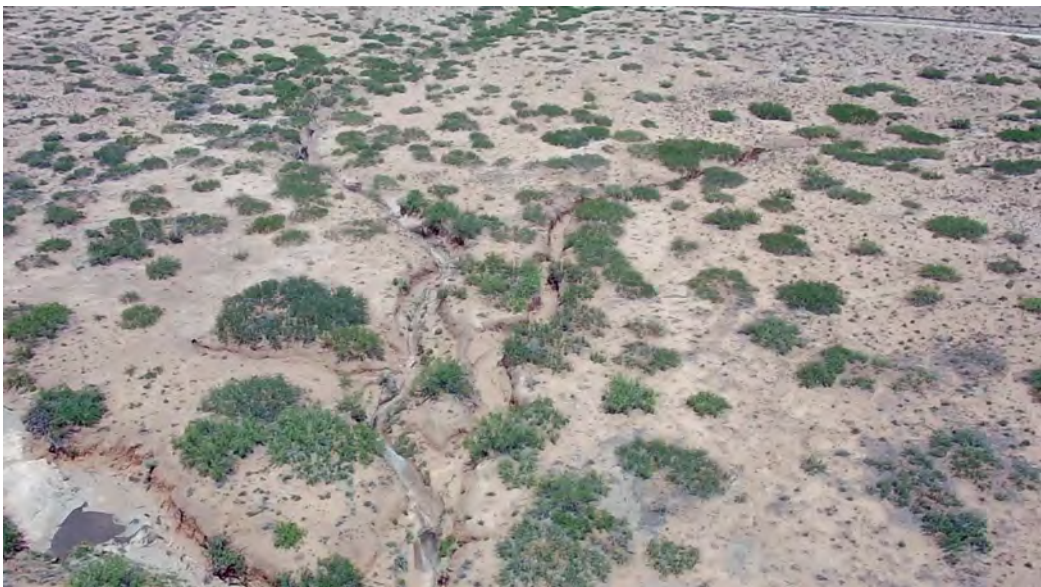
Photo Number: 4

Date: 8/15/2024	
Coordinates: 32.741315,-104.116237	
Photo Direction: North-Northeast	
Photo Description: Aerial view of the affected area.

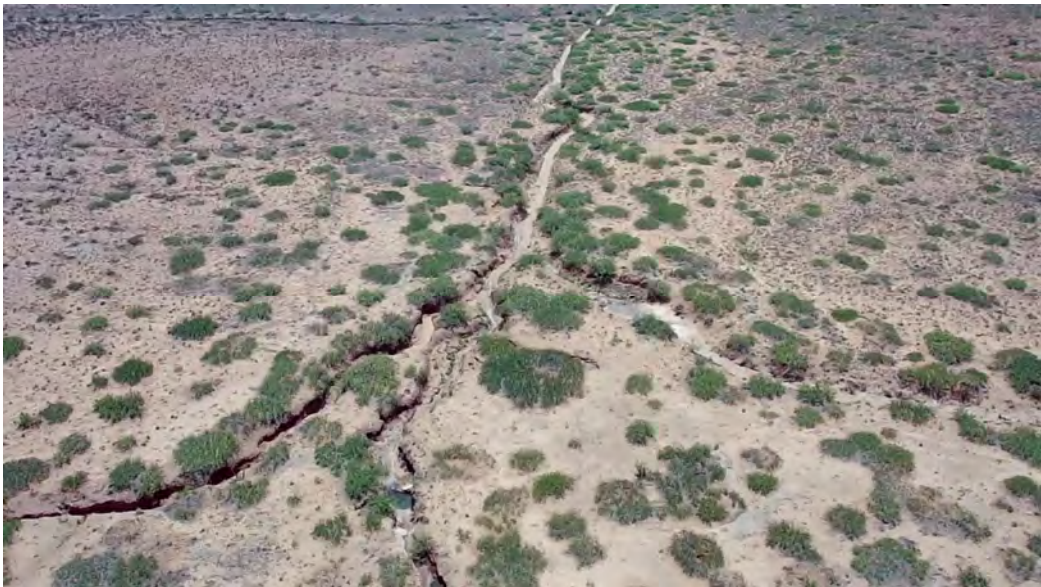
Photo Number: 5

Date: 8/15/2024	
Coordinates: 32.742655,-104.115323	
Photo Direction: South-Southwest	
Photo Description: Aerial view of the affected area.

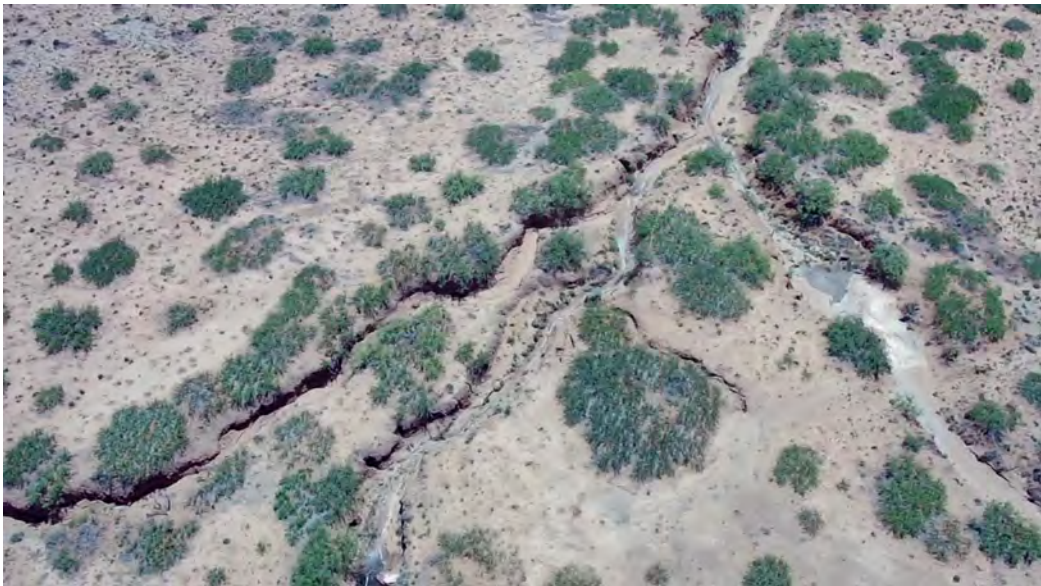
Photo Number: 6

Date: 8/15/2024	
Coordinates: 32.741689,-104.116127	
Photo Direction: South	
Photo Description: Aerial view of the affected area.

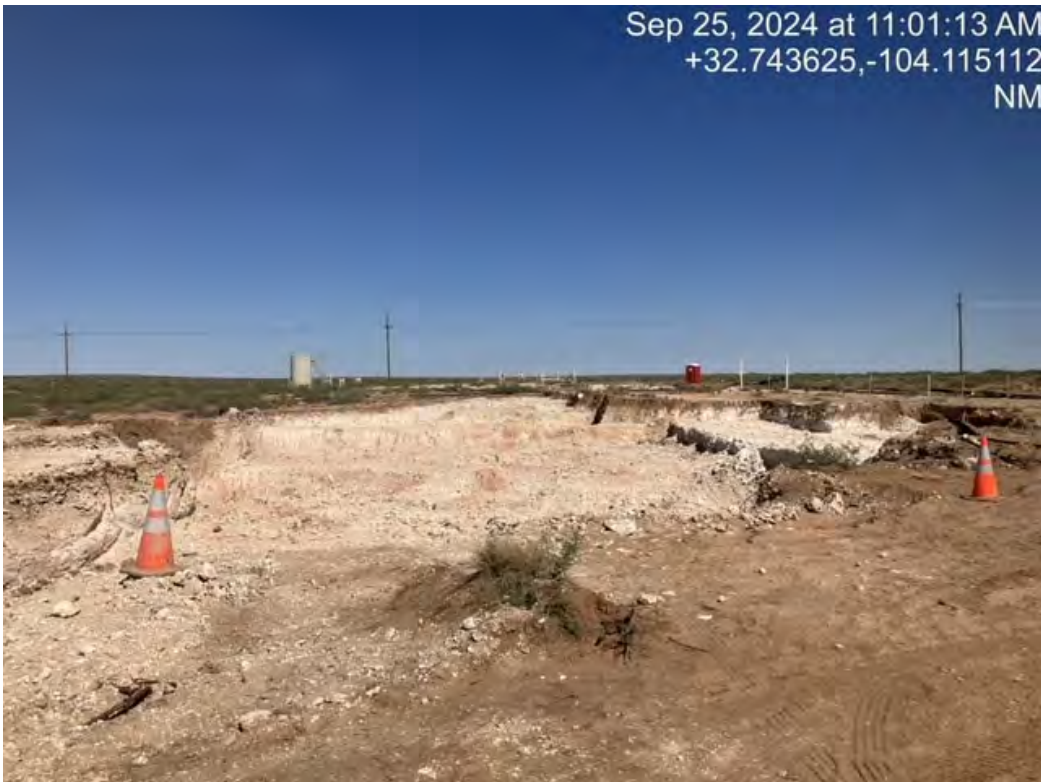
Photo Number: 7	<div>Sep 25, 2024 at 11:01:13 AM +32.743625,-104.115112 NM</div>

Photo Direction: North-Northwest	
Photo Description: View of the excavated area.

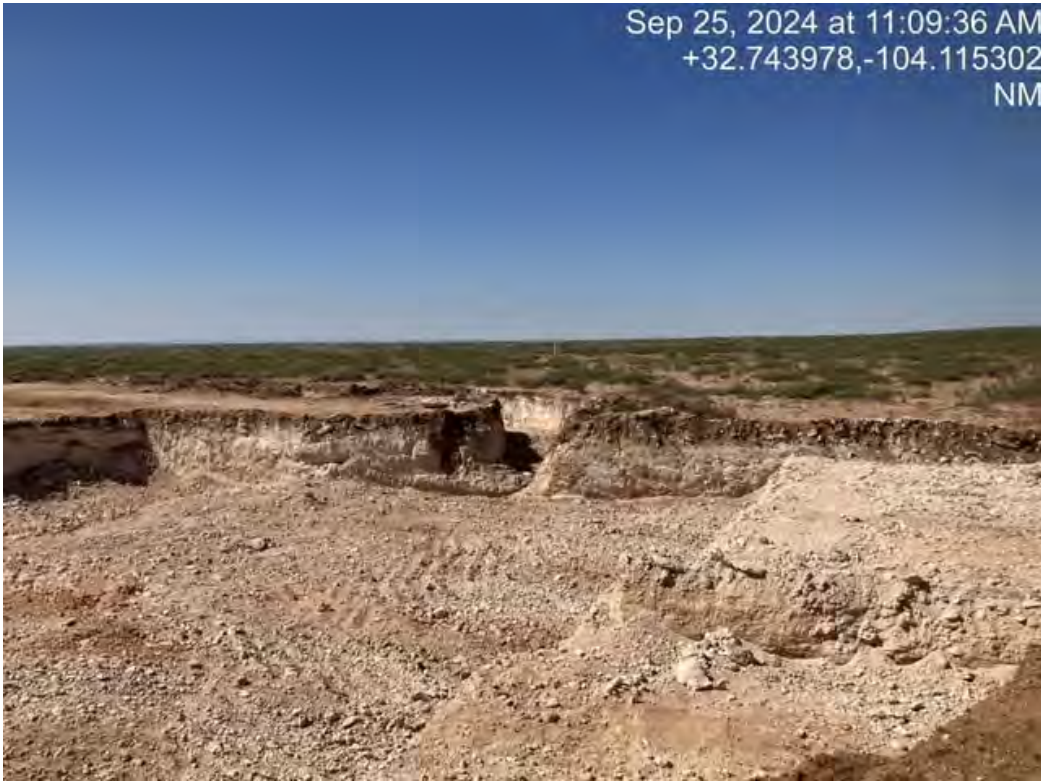
Photo Number: 8	<div>Sep 25, 2024 at 11:09:36 AM +32.743978,-104.115302 NM</div>

Photo Direction: South-Southwest	
Photo Description: View of the excavated area.

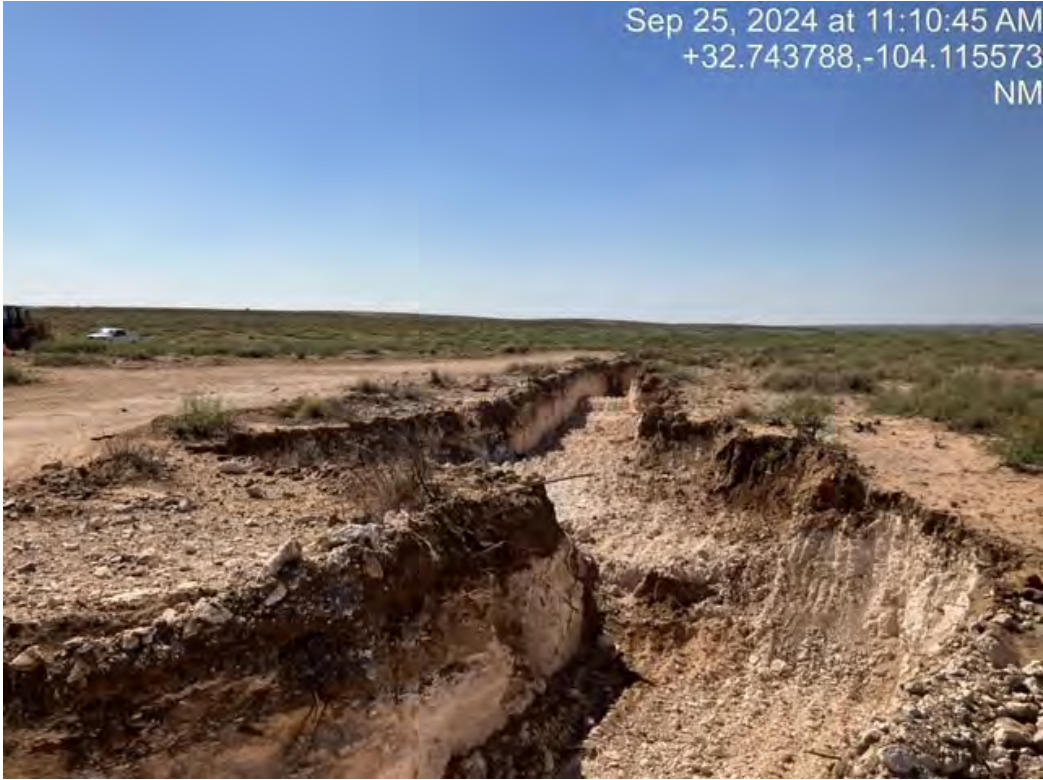
Photo Number: 9

Photo Direction: South-Southwest	
Photo Description: View of the excavated area.

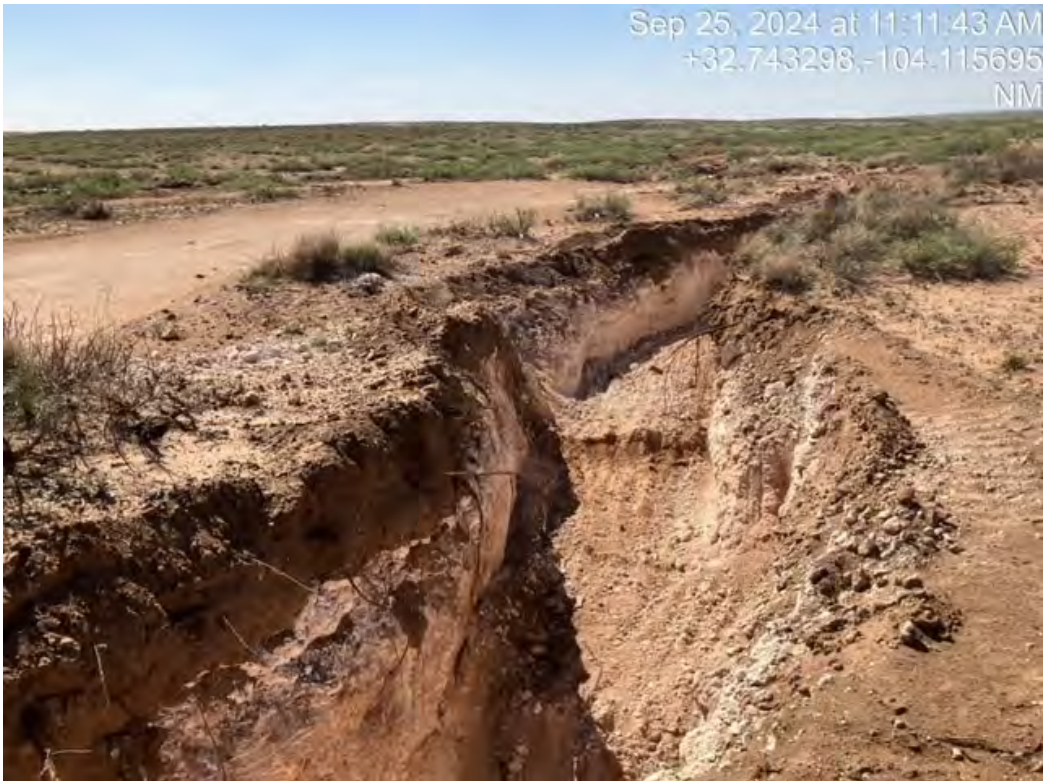
Photo Number: 10

Photo Direction: South-Southwest	
Photo Description: View of the excavated area.

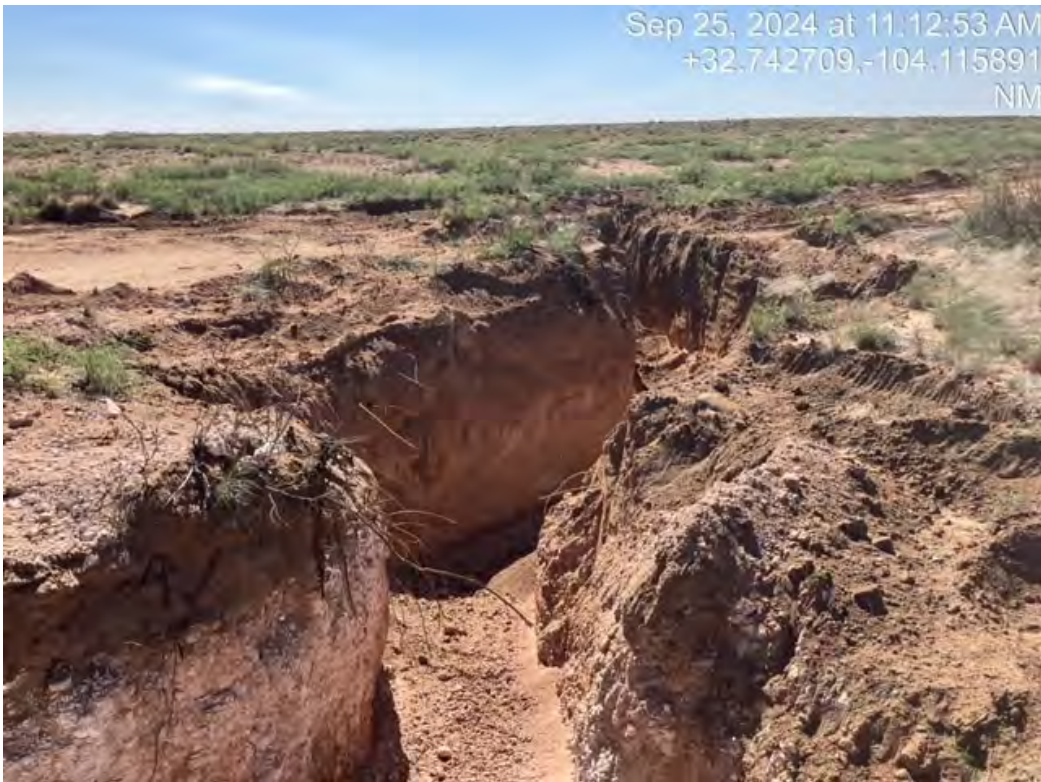
Photo Number: 11

Photo Direction: South-Southwest	
Photo Description: View of the excavated area.

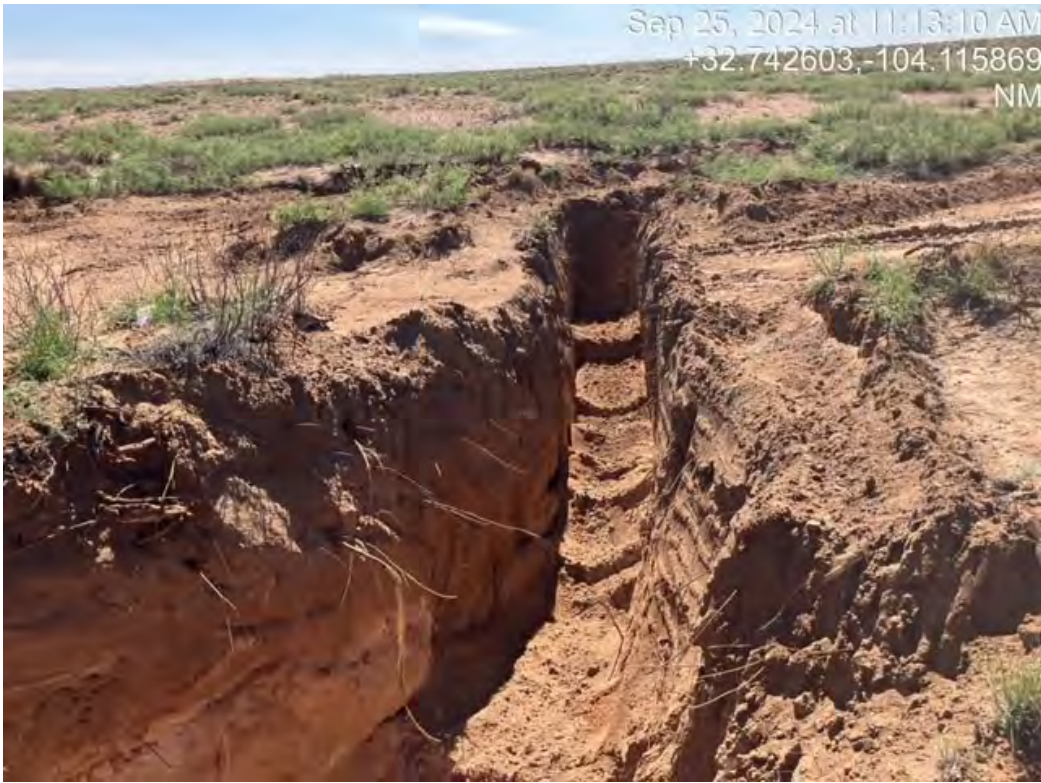
Photo Number: 12

Photo Direction: South-Southwest	
Photo Description: View of the excavated area.

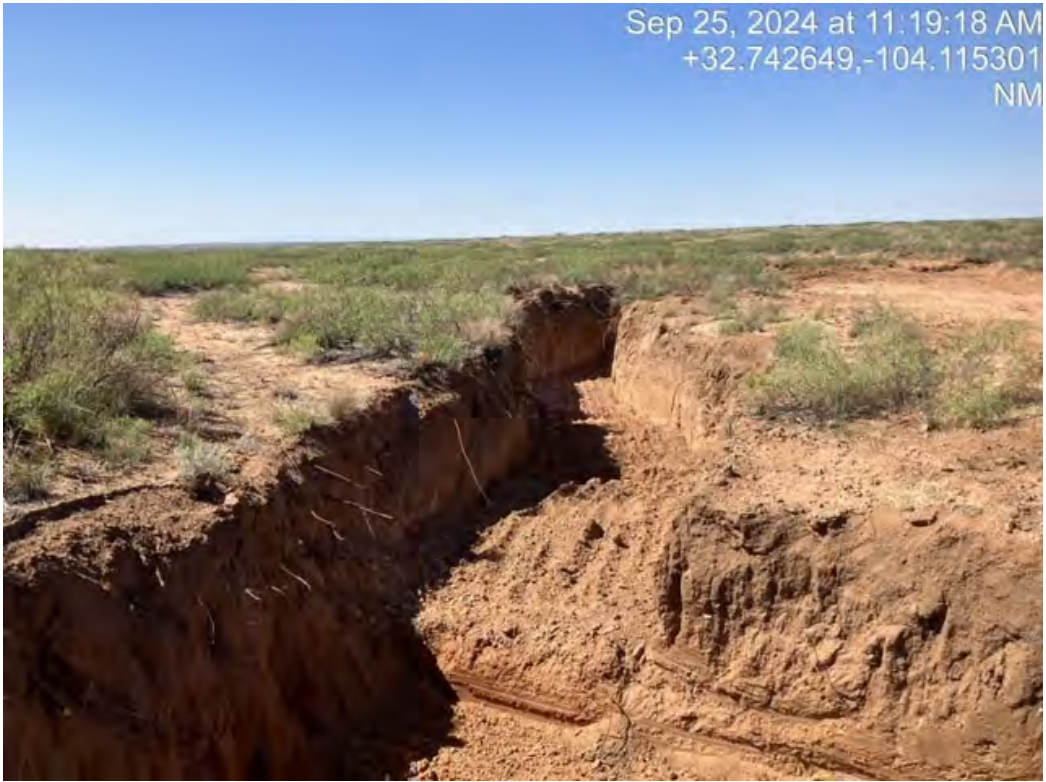
Photo Number: 13

<p>Sep 25, 2024 at 11:19:18 AM +32.742649,-104.115301 NM</p>
Photo Direction: South-Southwest	
Photo Description: View of the excavated area.

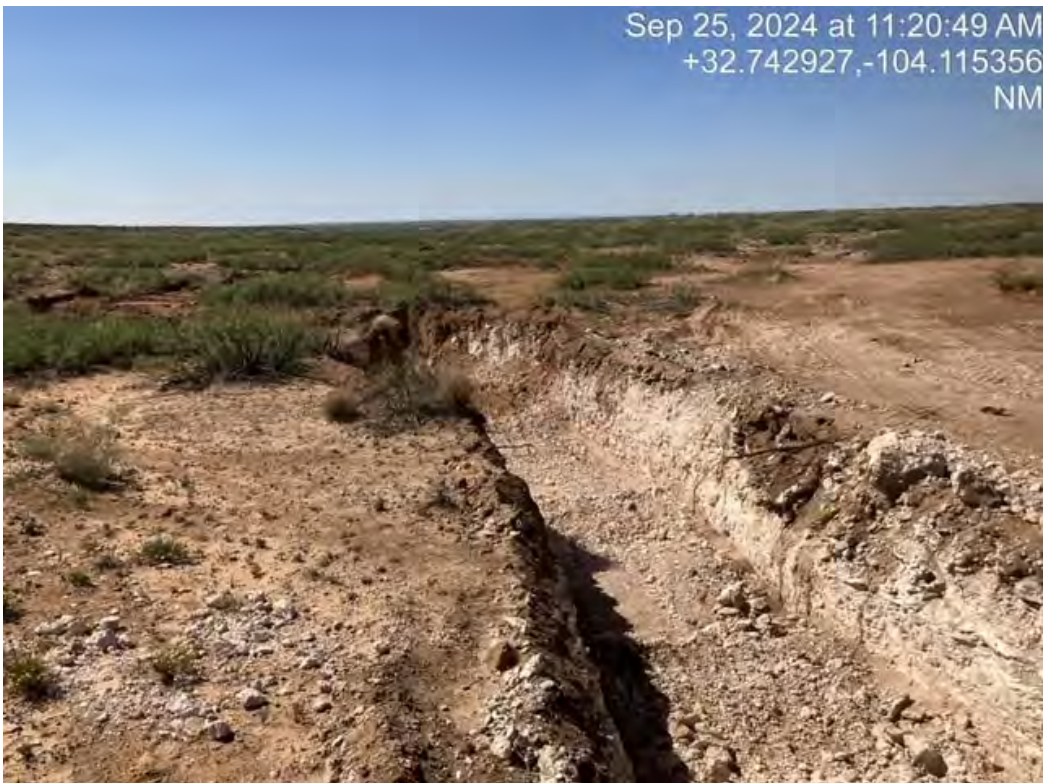
Photo Number: 14

<p>Sep 25, 2024 at 11:20:49 AM +32.742927,-104.115356 NM</p>
Photo Direction: South-Southwest	
Photo Description: View of the excavated area.

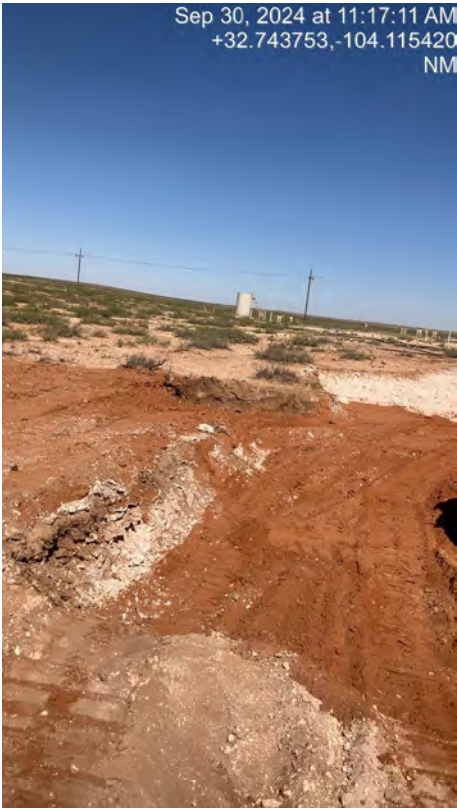
Photo Number: 16

Photo Direction: North-Northwest	
Photo Description: View of the remediated area during backfilling (showing topsoil thickness).

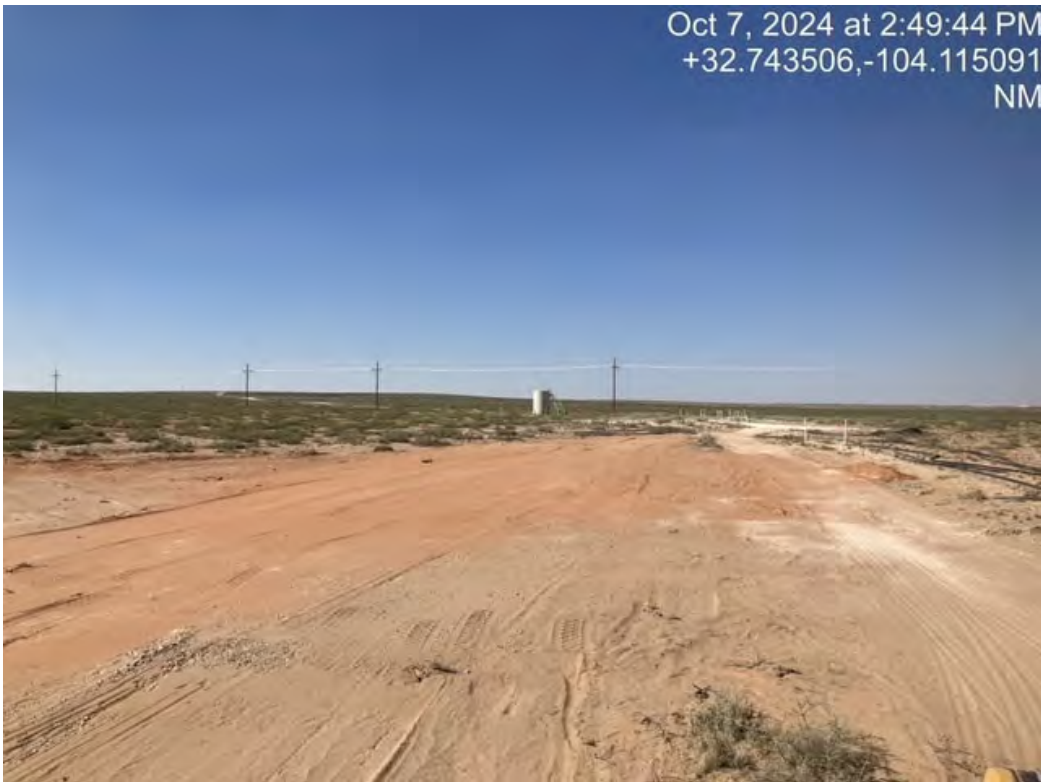
Photo Number: 17

<p>Oct 7, 2024 at 2:49:44 PM +32.743506,-104.115091 NM</p>
Photo Direction: North-Northwest	
Photo Description: View of the remediated area following backfill and regrading.

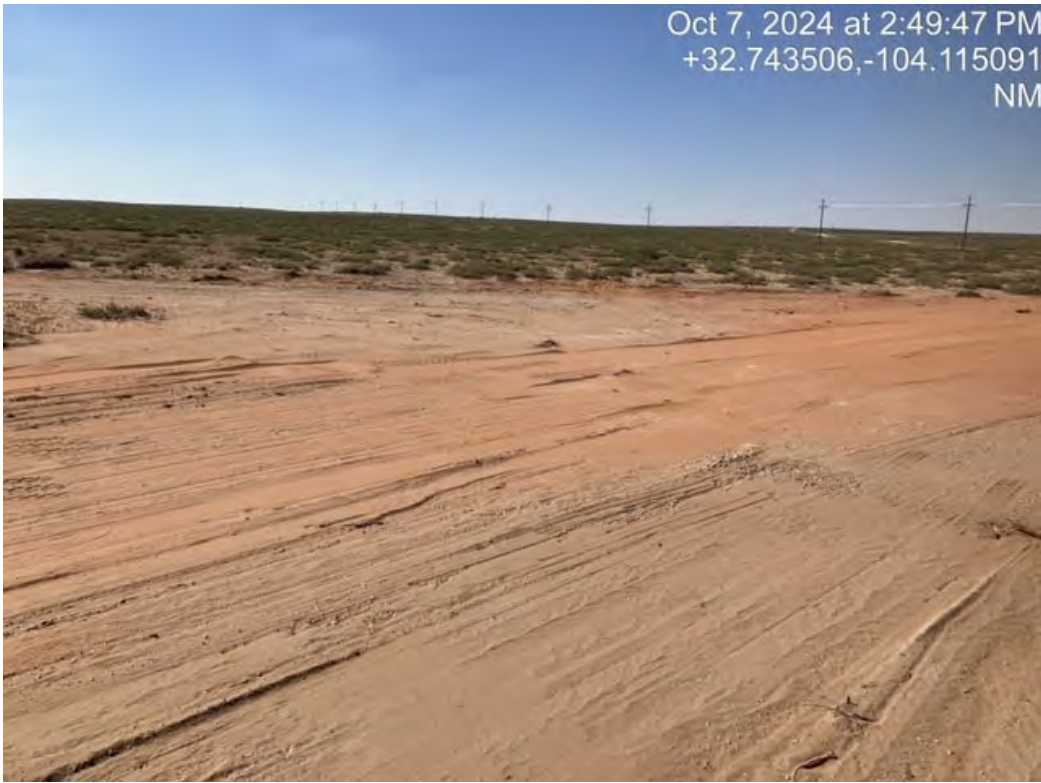
Photo Number: 18

<p>Oct 7, 2024 at 2:49:47 PM +32.743506,-104.115091 NM</p>
Photo Direction: Southeast	
Photo Description: View of the remediated area following backfill and regrading.

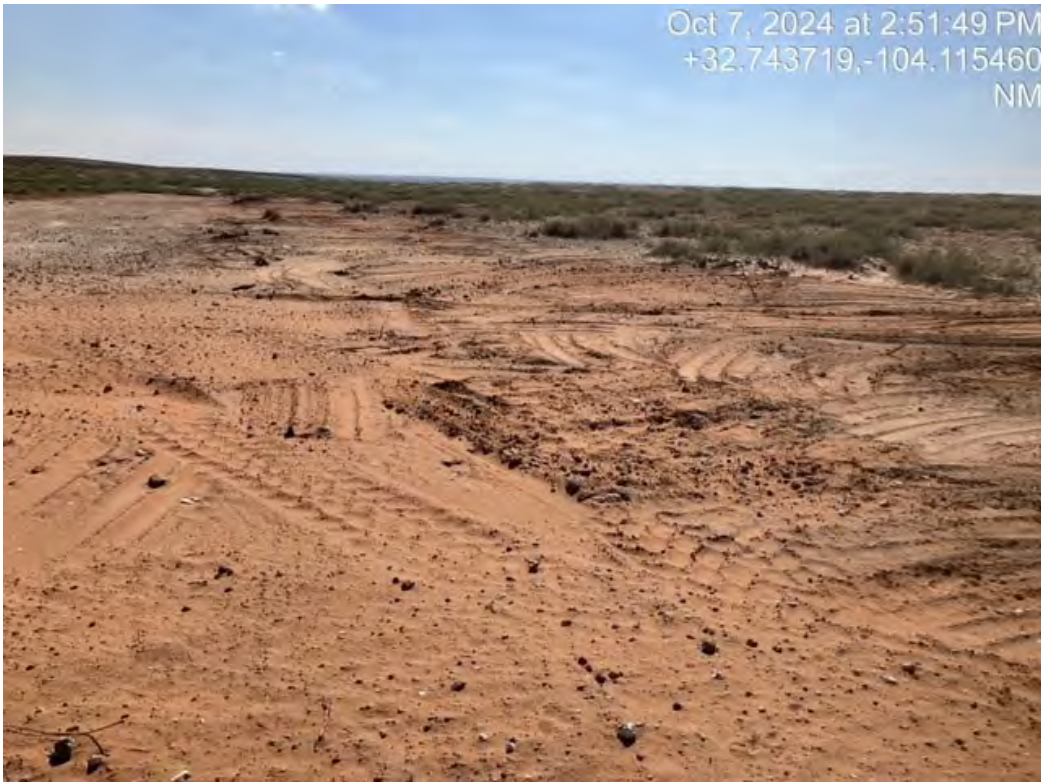
Photo Number: 19

<p>Oct 7, 2024 at 2:51:49 PM +32.743719,-104.115460 NM</p>
Photo Direction: South-Southwest	
Photo Description: View of the remediated area following backfill and regrading.

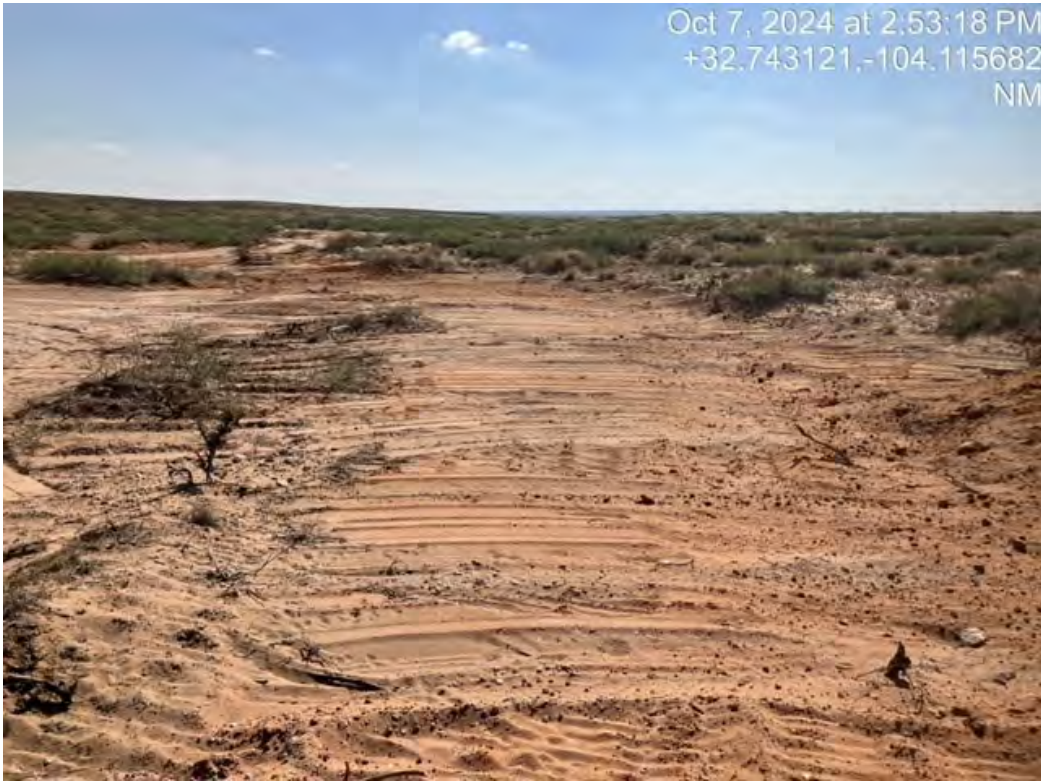
Photo Number: 20

<p>Oct 7, 2024 at 2:53:18 PM +32.743121,-104.115682 NM</p>
Photo Direction: South-Southwest	
Photo Description: View of the remediated area following backfill and regrading.

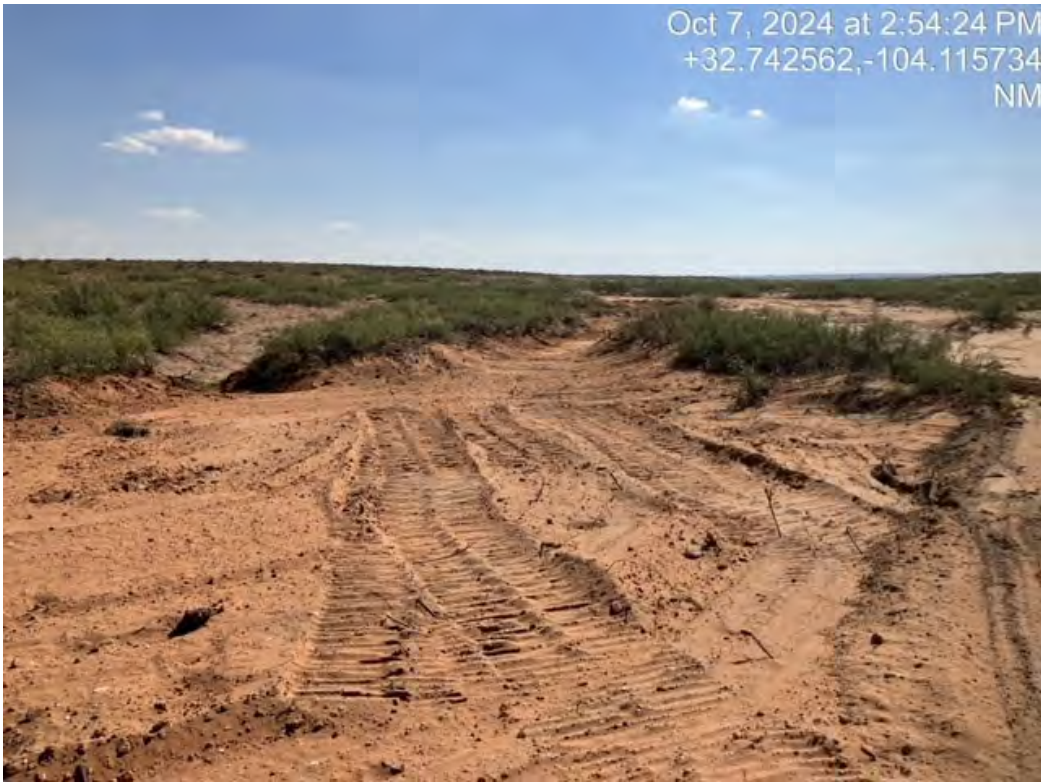
Photo Number: 21

<p>Oct 7, 2024 at 2:54:24 PM +32.742562,-104.115734 NM</p>
Photo Direction: South-Southwest	
Photo Description: View of the remediated area following backfill and regrading.

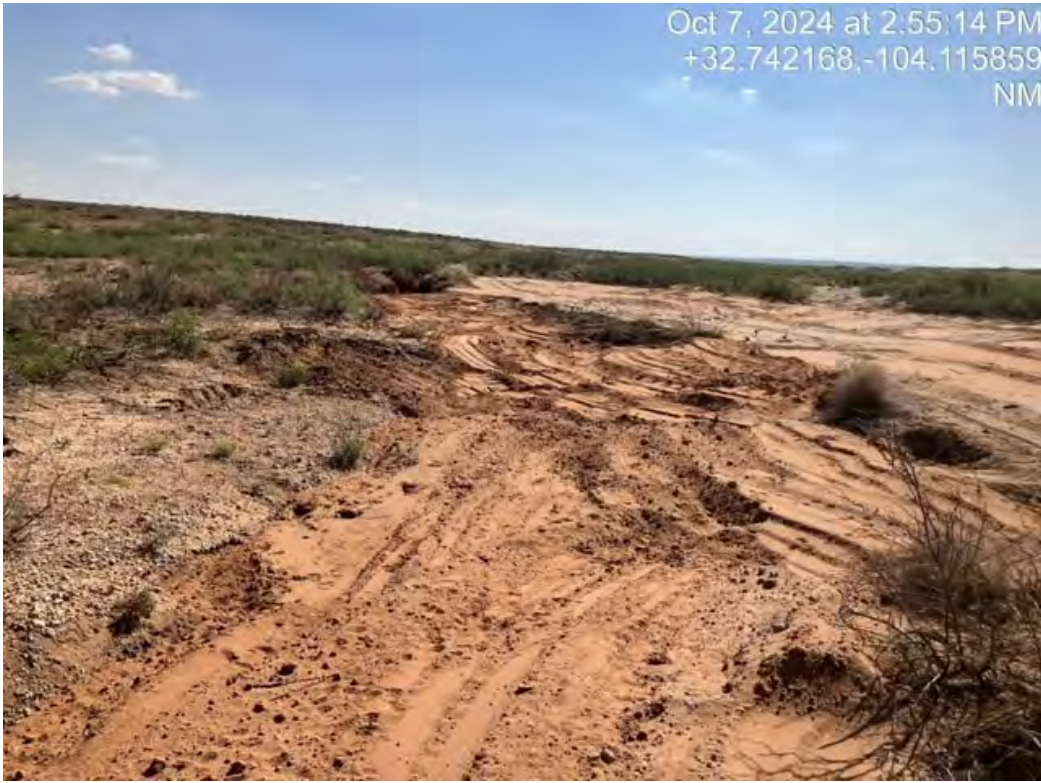
Photo Number: 22

<p>Oct 7, 2024 at 2:55:14 PM +32.742168,-104.115859 NM</p>
Photo Direction: South-Southwest	
Photo Description: View of the remediated area following backfill and regrading.

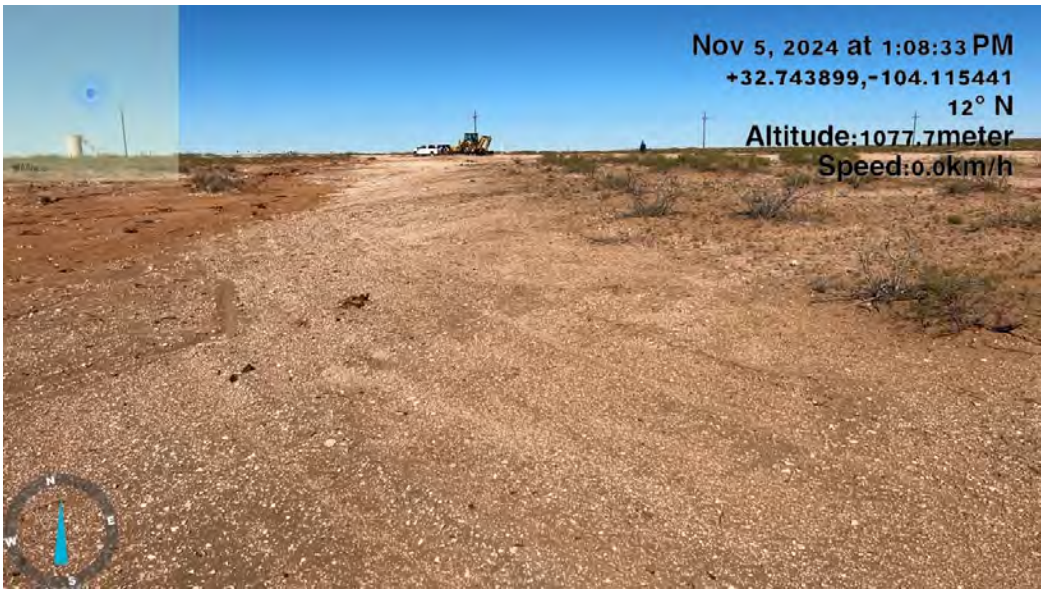
Photo Number: 24

Photo Direction: North-Northeast	
Photo Description: View of the remediated area during seeding event.

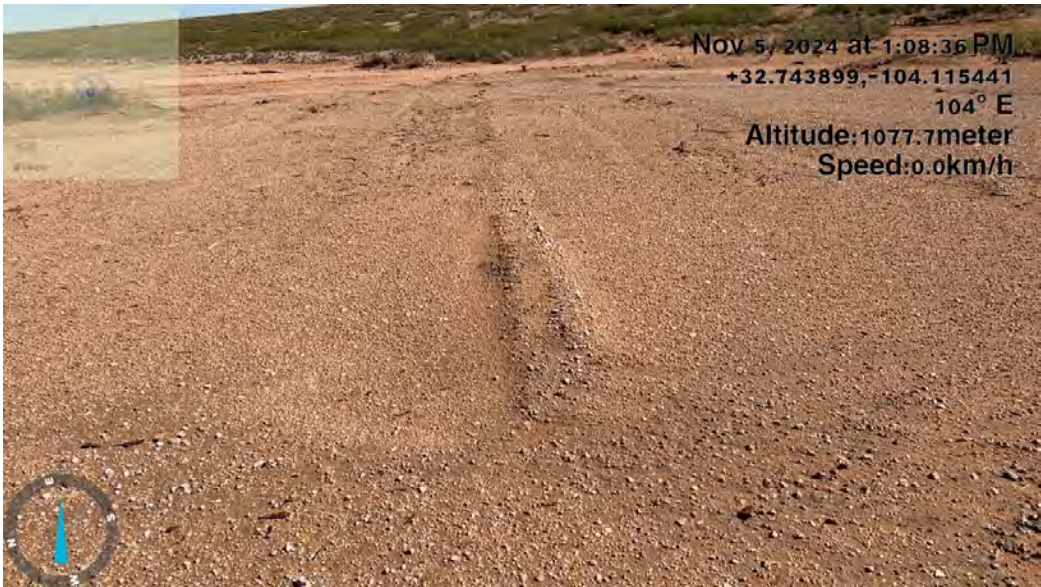
Photo Number: 25

Photo Direction: East-Southeast	
Photo Description: View of the remediated area during seeding event.

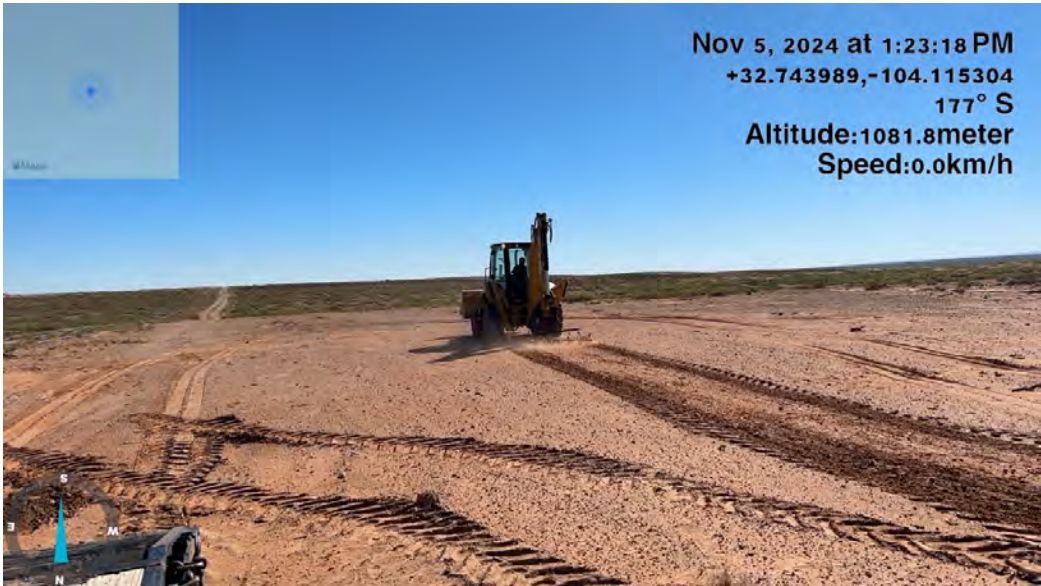
Photo Number: 26

Photo Direction: South	
Photo Description: View of the remediated area during seeding event.

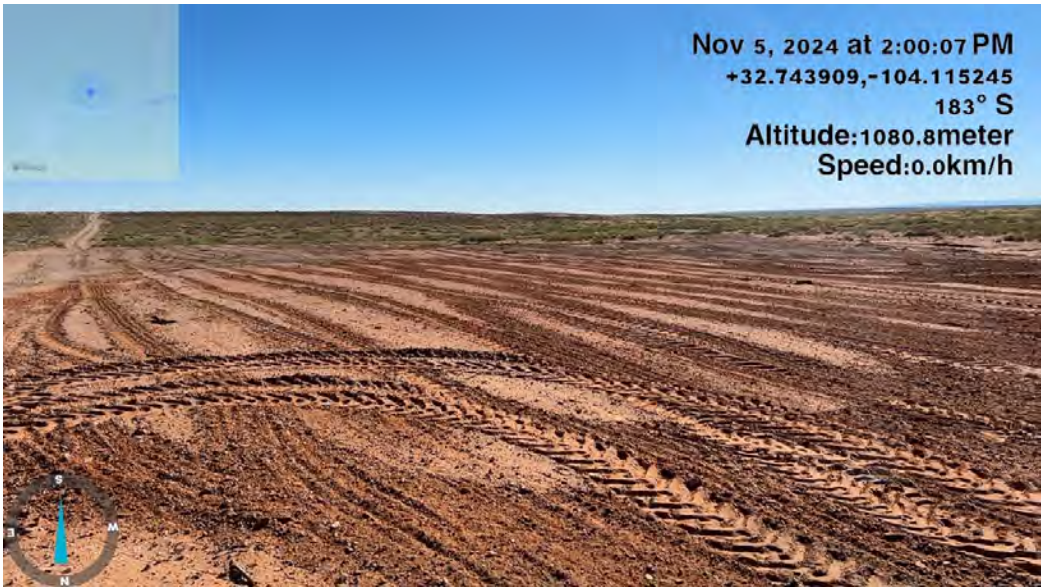
Photo Number: 27

Photo Direction: South	
Photo Description: View of the remediated area following seeding event.

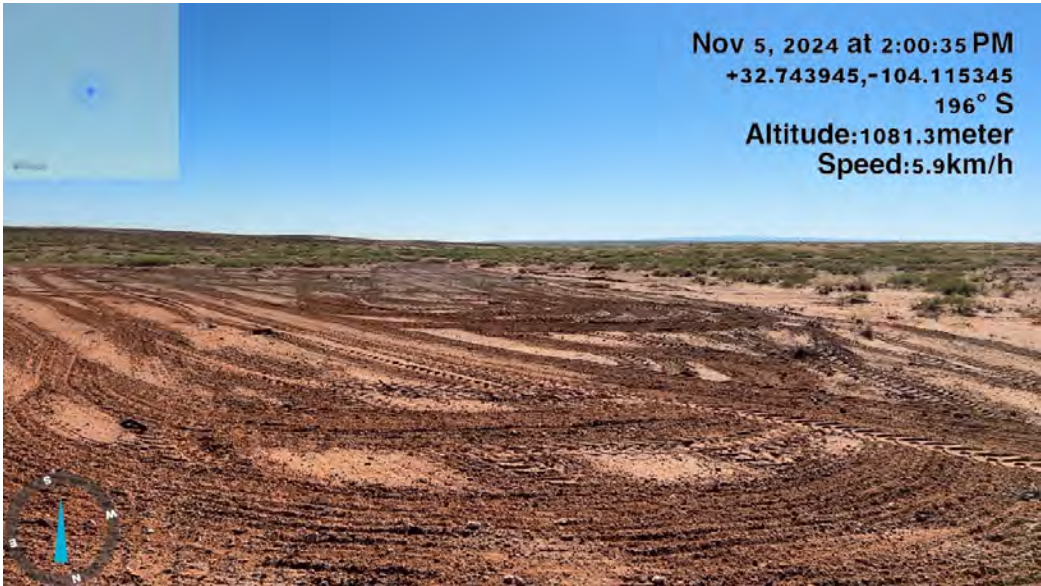
Photo Number: 28

Photo Direction: South-Southwest	
Photo Description: View of the remediated area following seeding event.

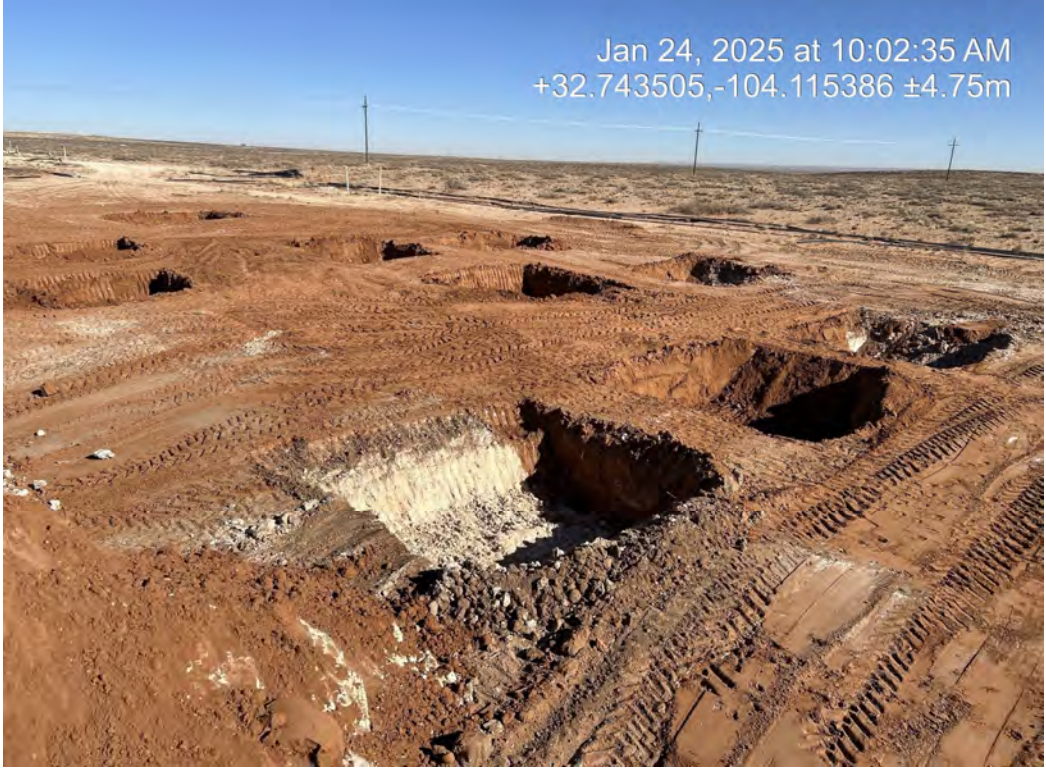
Photo Number: 29

Photo Direction: Northeast	
Photo Description: View of re-excavated areas.

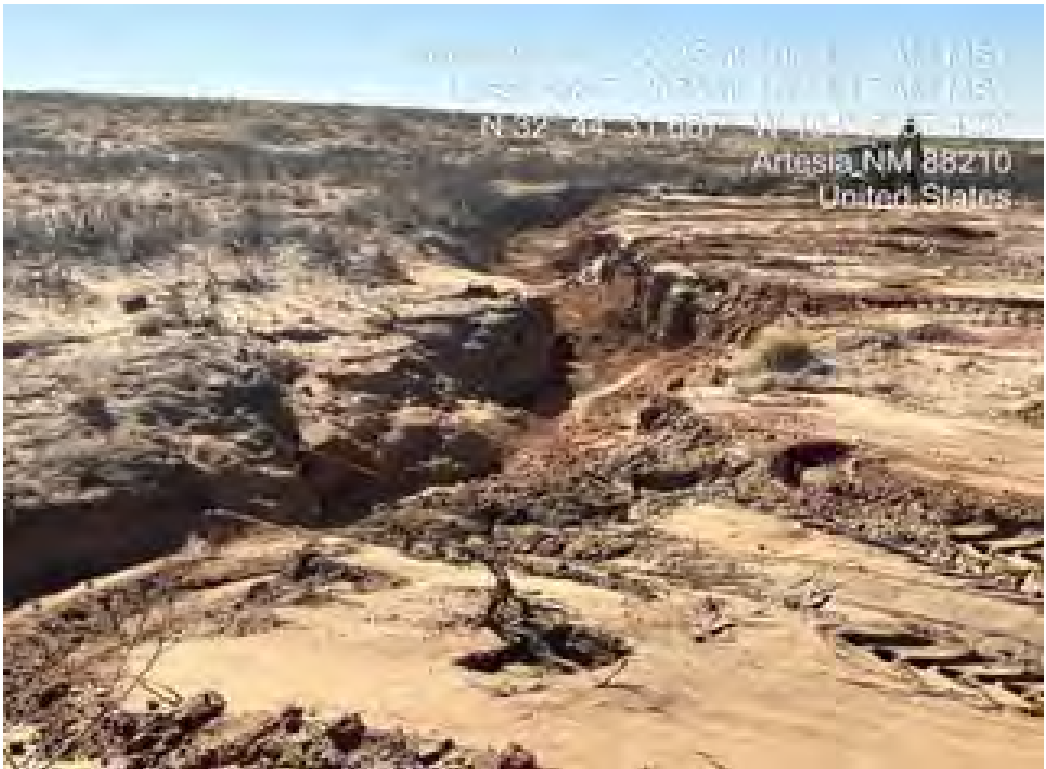
Photo Number: 30

Photo Direction: South	
Photo Description: View of re-excavated areas.

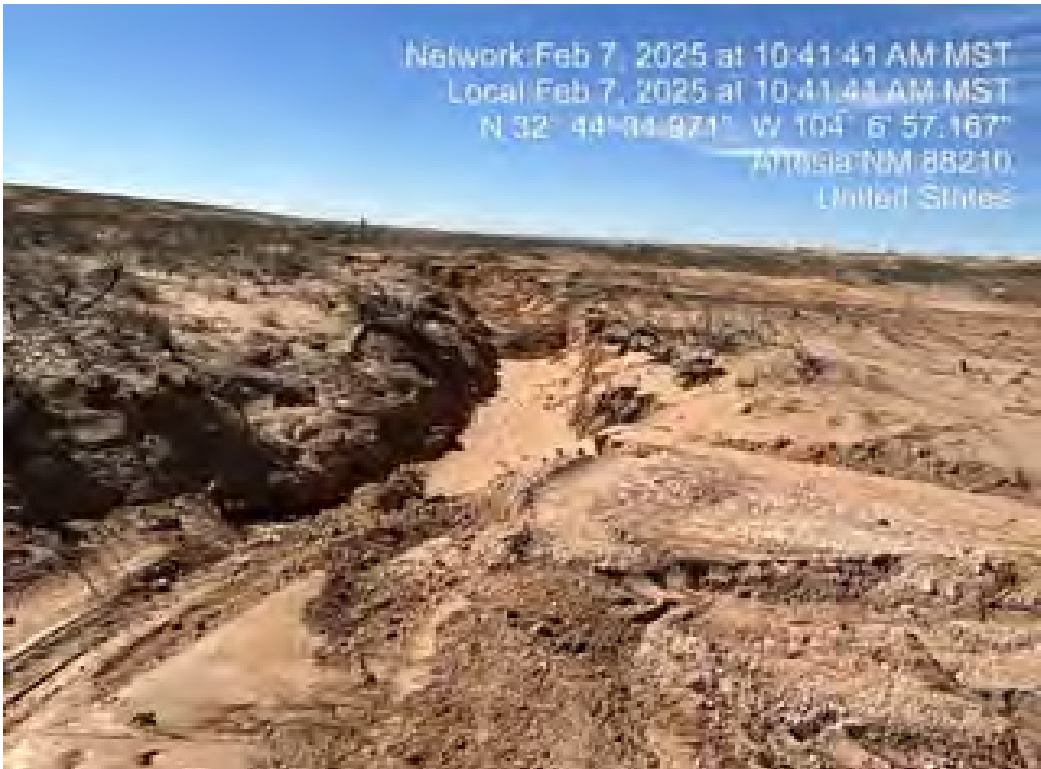
Photo Number: 31

<p>Network: Feb 7, 2025 at 10:41:41 AM MST Local: Feb 7, 2025 at 10:41:41 AM MST N 32° 44' 34.971" W 104° 6' 57.167" Artesia NM 88210 United States</p>
Photo Direction: South-Southeast	
Photo Description: View of re-excavated areas.

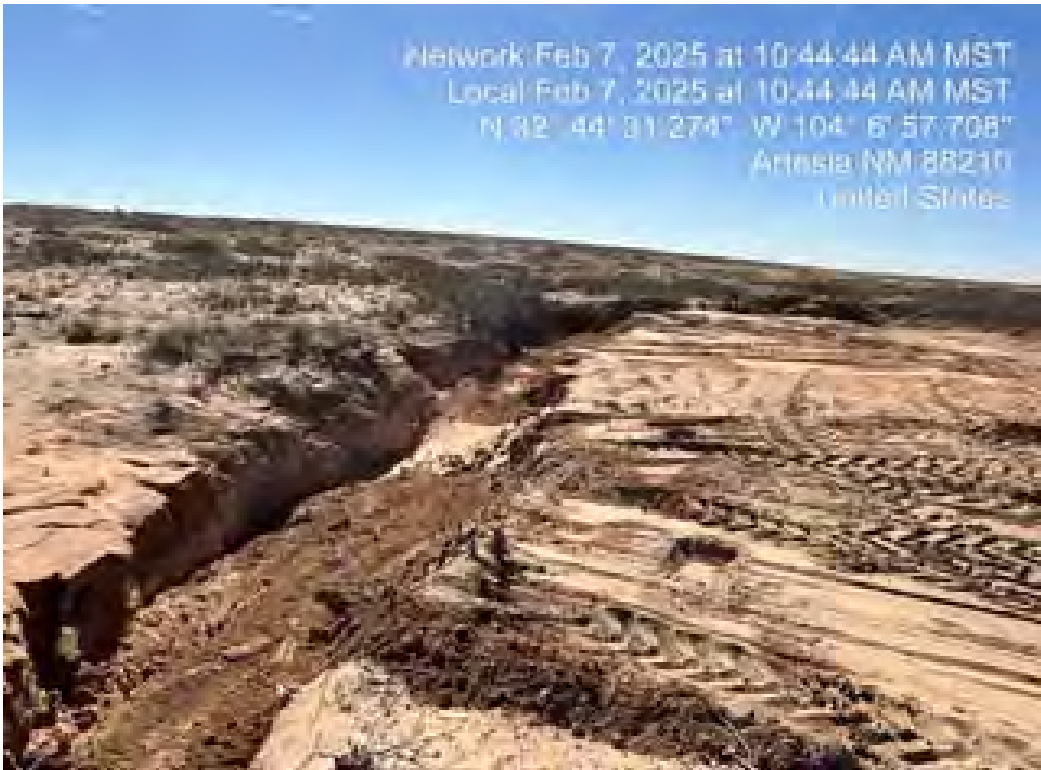
Photo Number: 32

<p>Network: Feb 7, 2025 at 10:44:44 AM MST Local: Feb 7, 2025 at 10:44:44 AM MST N 32° 44' 31.274" W 104° 6' 57.708" Artesia NM 88210 United States</p>
Photo Direction: South-Southwest	
Photo Description: View of re-excavated areas.
