Amended Remediation Summary & Soil Closure Request

Mewbourne Oil Company Pavo Frio to Westall SWD Line

Eddy County, New Mexico
Unit Letter "L", Section 18, Township 18 South, Range 29 East
Latitude 32.74355 North, Longitude 104.11546 West
NMOCD Reference No. nAPP2424249029

Etech Environmental & Safety Solutions, Inc.

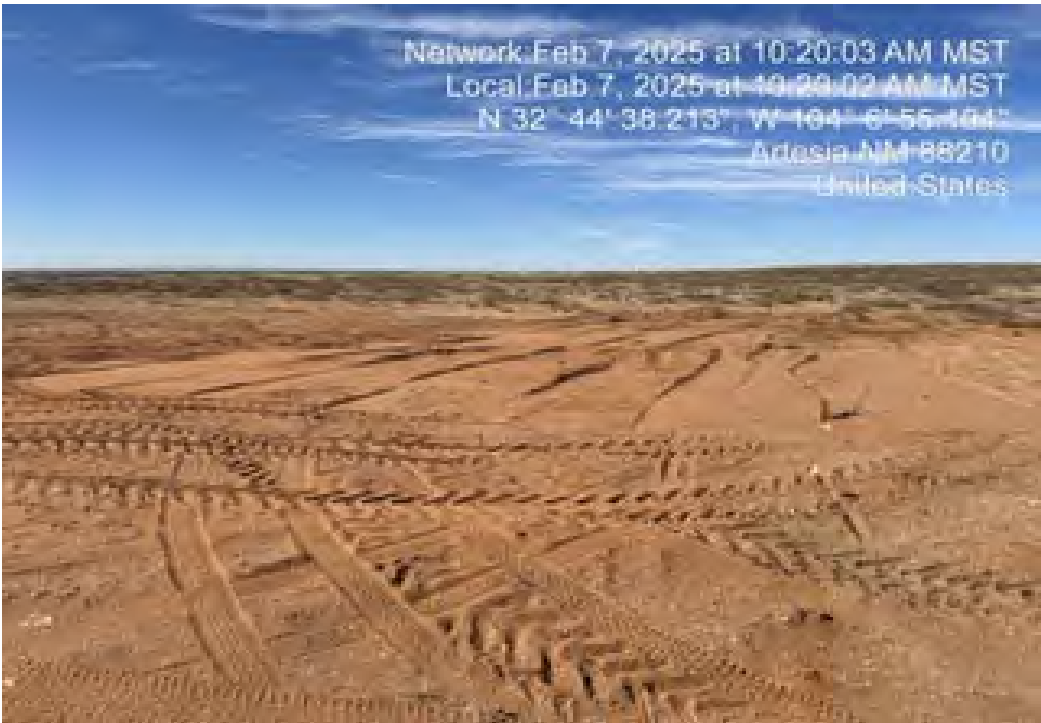
Photo Number: 33

<p>Network: Feb 7, 2025 at 10:20:03 AM MST Local: Feb 7, 2025 at 10:20:02 AM MST N 32° 44' 38.213", W 104° 6' 56.104" Artesia NM 88210 United States</p>
Photo Direction: West	
Photo Description: View of re-excavated areas after backfilling and regrading.

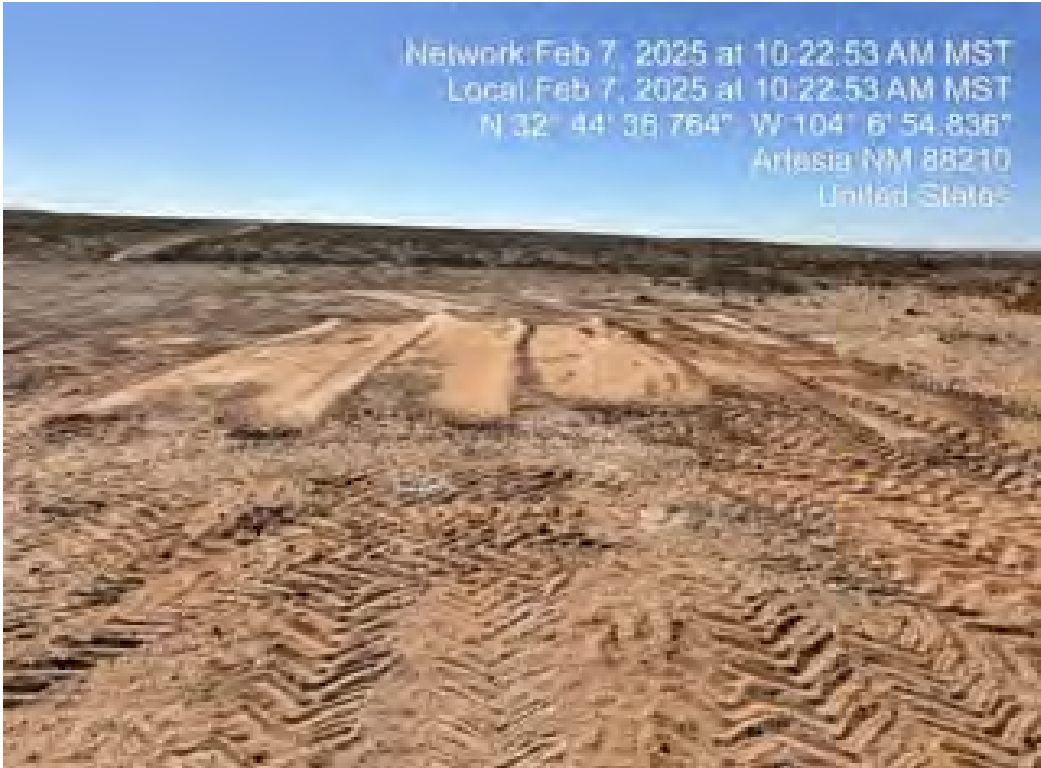
Photo Number: 34

<p>Network: Feb 7, 2025 at 10:22:53 AM MST Local: Feb 7, 2025 at 10:22:53 AM MST N 32° 44' 36.764", W 104° 6' 54.836" Artesia NM 88210 United States</p>
Photo Direction: West	
Photo Description: View of re-excavated areas after backfilling and regrading.
