## ADDENDUM

Location name: HAT MESA 31 STATE 001H

OCD Spill Number: nGRL1216655362

FIGURE: NM OSE POD LOCATION	
HAT MESA 31 STATE 1	
OCD INCIDENT nGRL1216655362	
32.535073° / -103.695685°	
drawn by: RDW	Date: 08/2025

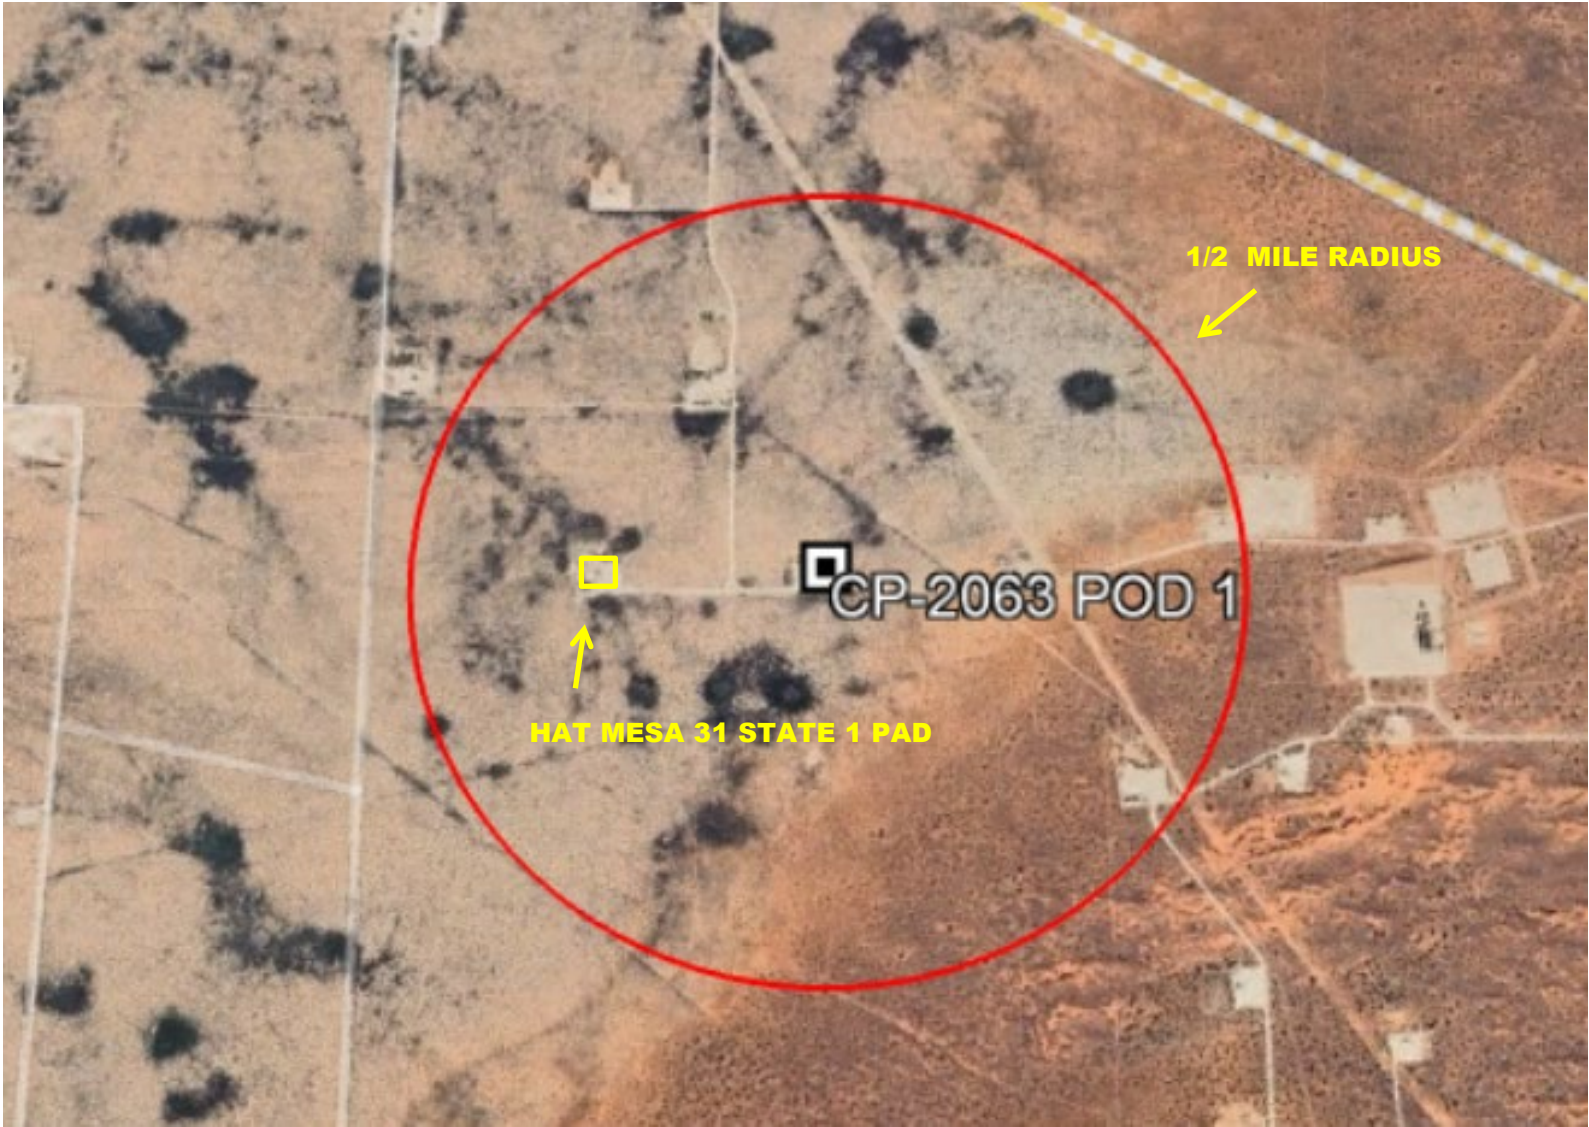
One pod location is within 0.5 miles of the location and is less than 25 years old. CP- 2063 POD 1 (installed in 2025) did not encounter groundwater at 105 feet and is 0.25 miles west of the location.

CP-2603 = 0.25 MILES FROM LOCATION  
(INSTALLED 6/2025)

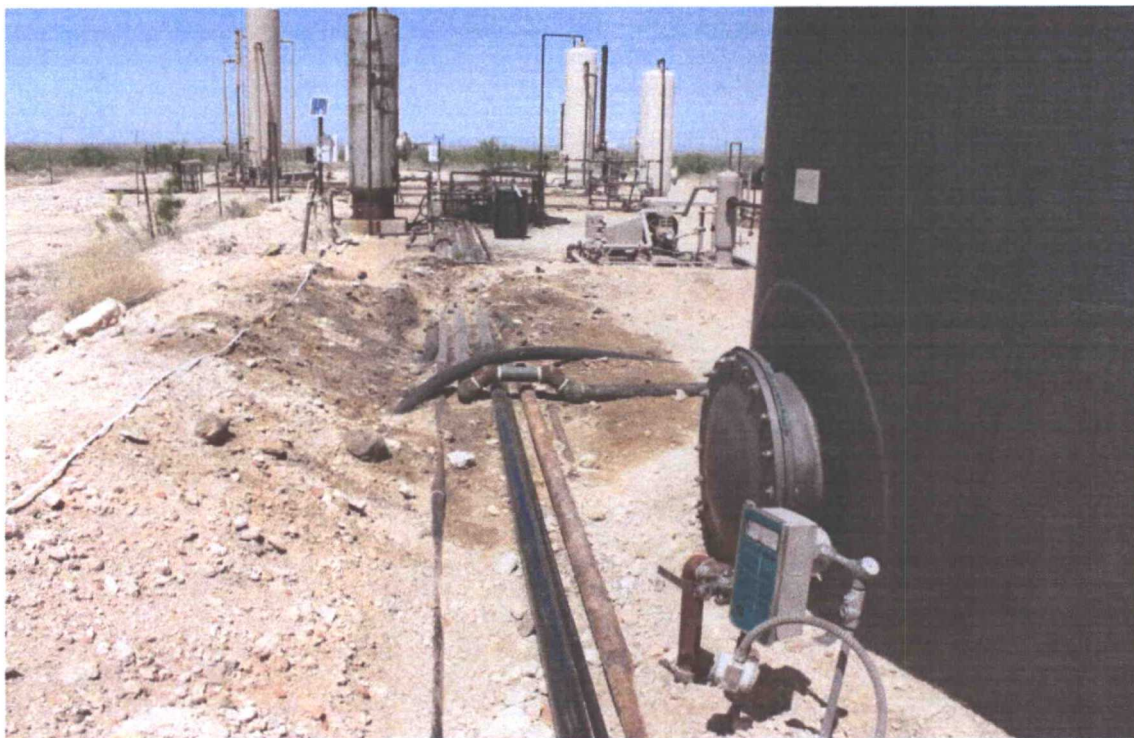
Hat Mesa State 31-32 Battery - Release Point (looking north)

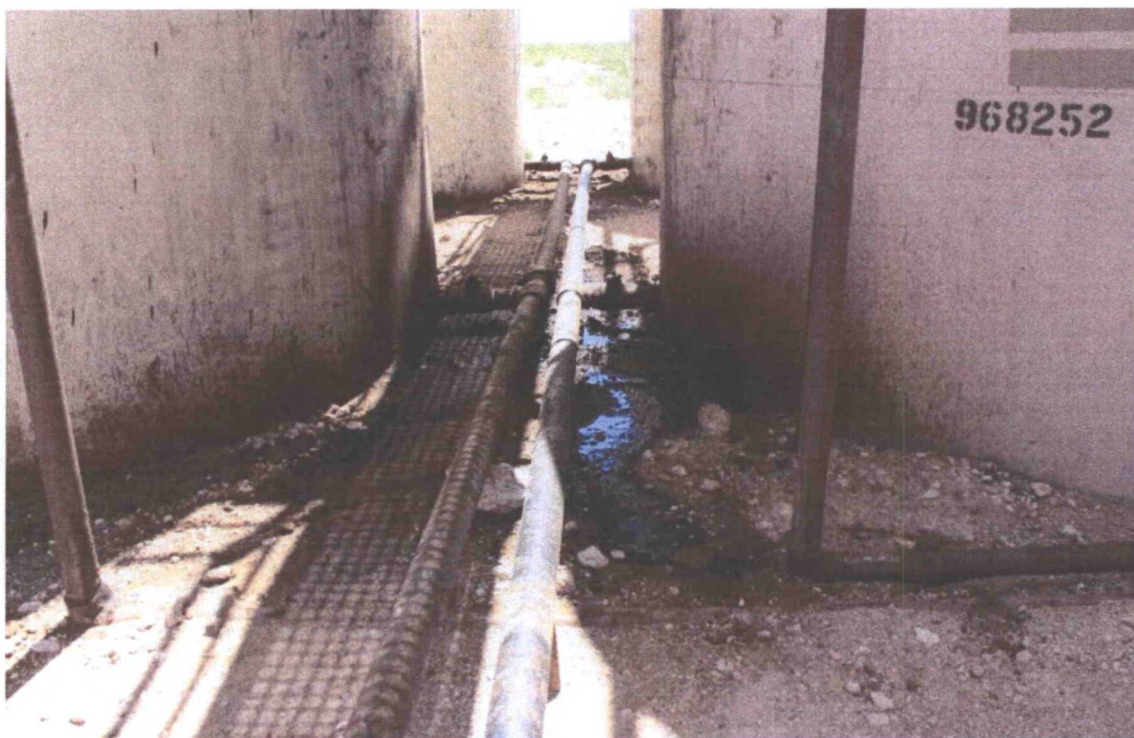
Hat Mesa State 31-32 Battery - Release Site

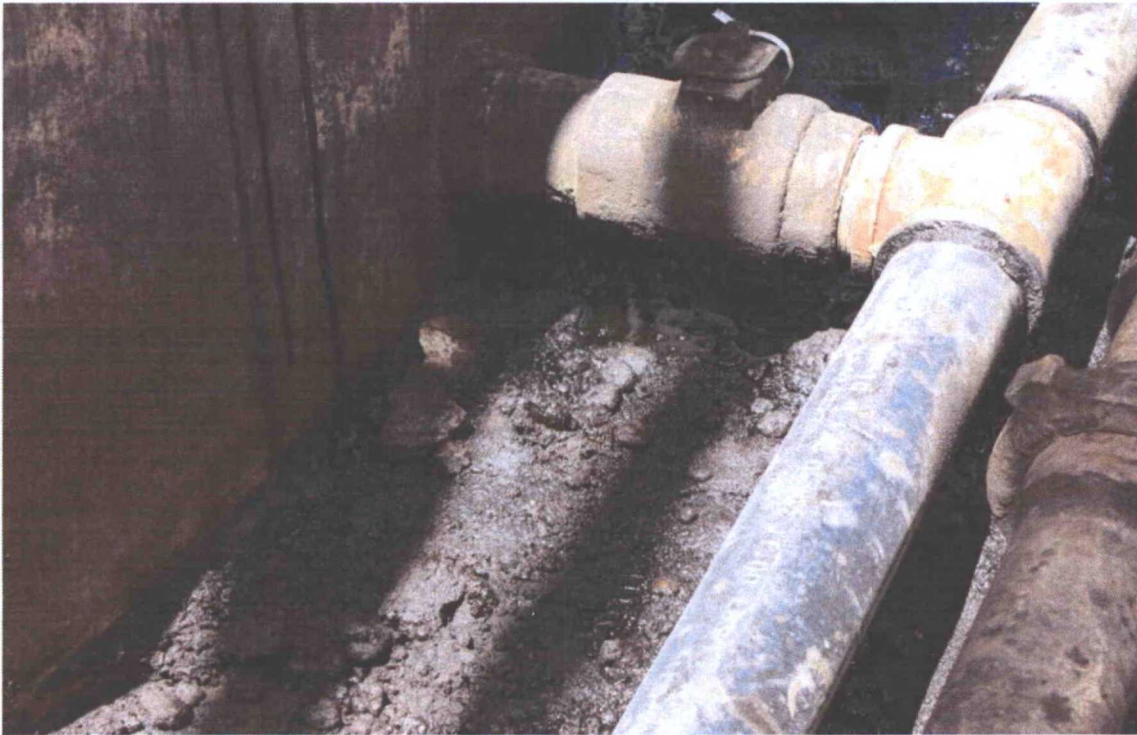
Hat Mesa State 31-32 Battery - Release Site

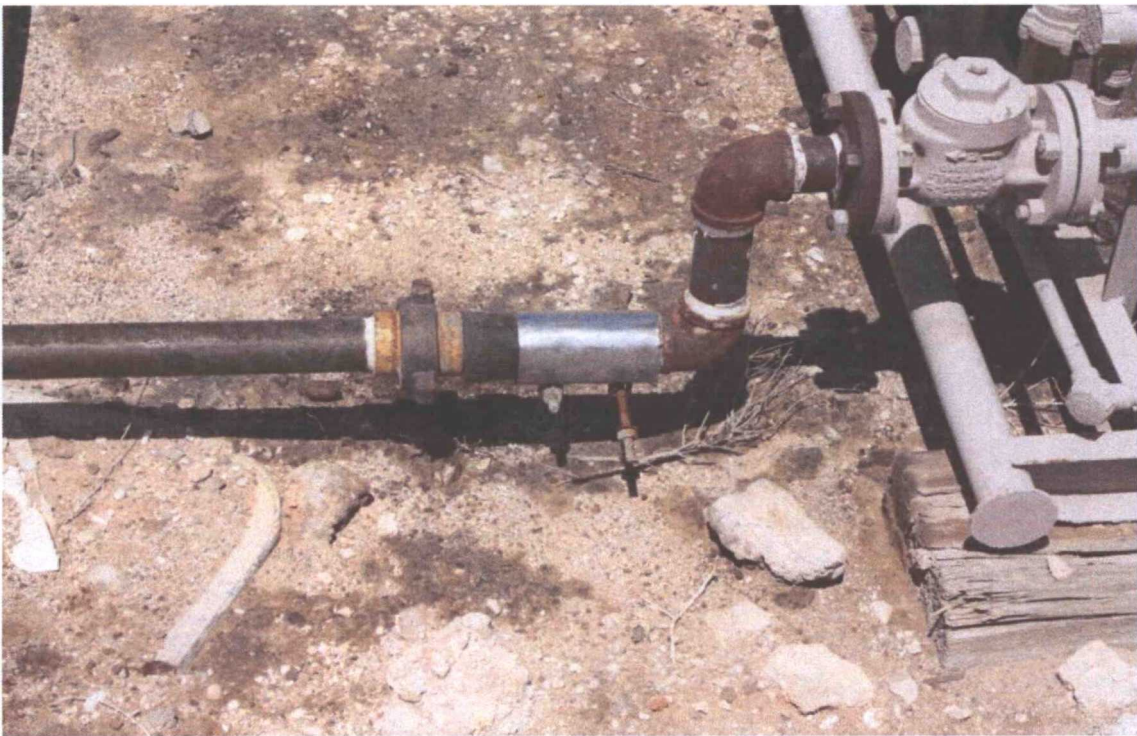
Hat Mesa State 31-32 Battery - Release Site

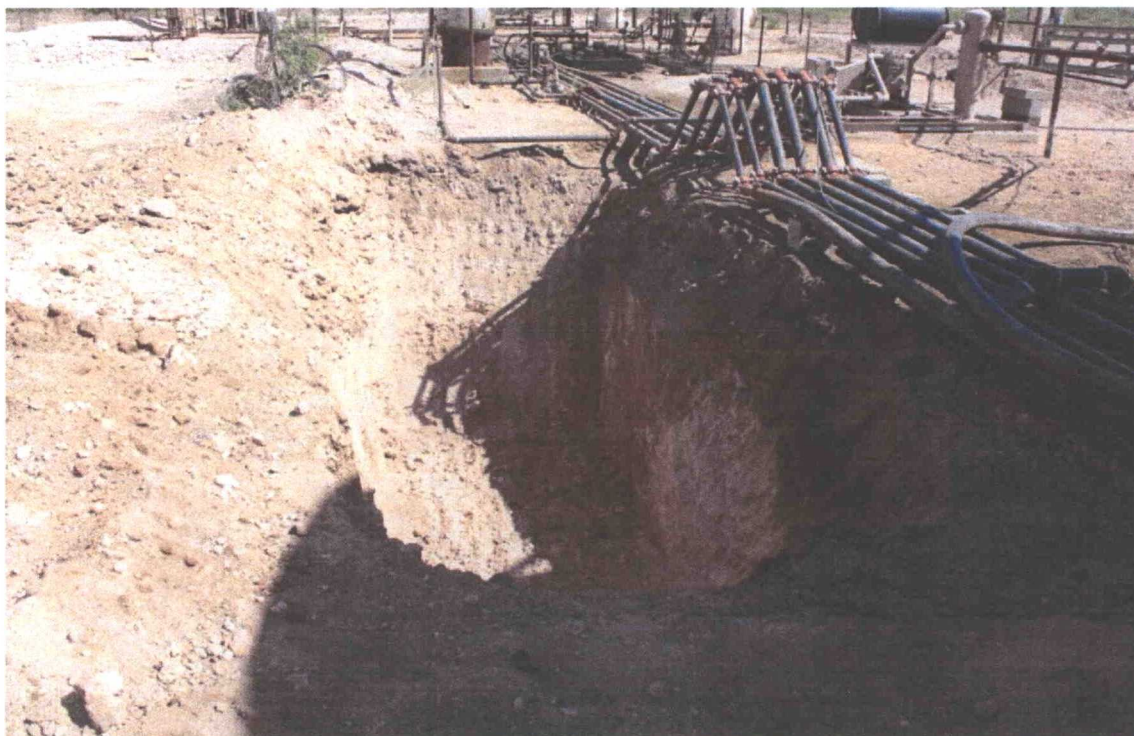
Hat Mesa State 31-32 Battery - North Excavation (looking north-northeast)

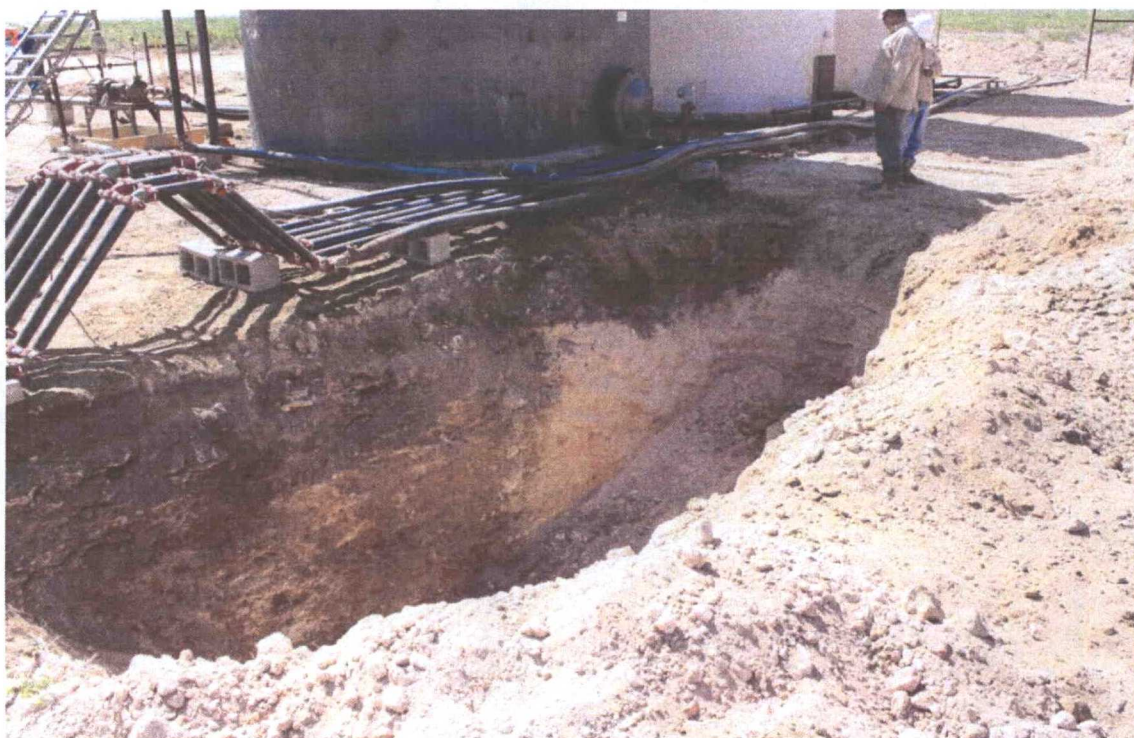
Hat Mesa State 31-32 Battery - North Excavation

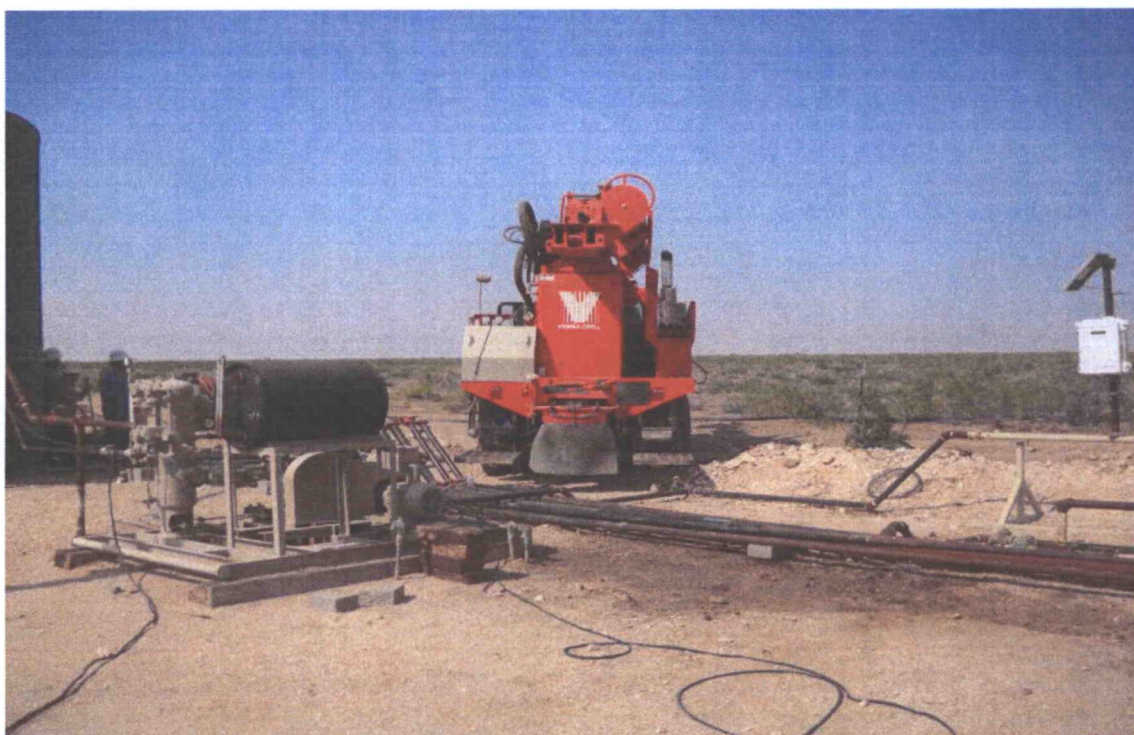
Hat Mesa State 31-32 Battery - Preparation for Advancement of Soil Boring SB-1

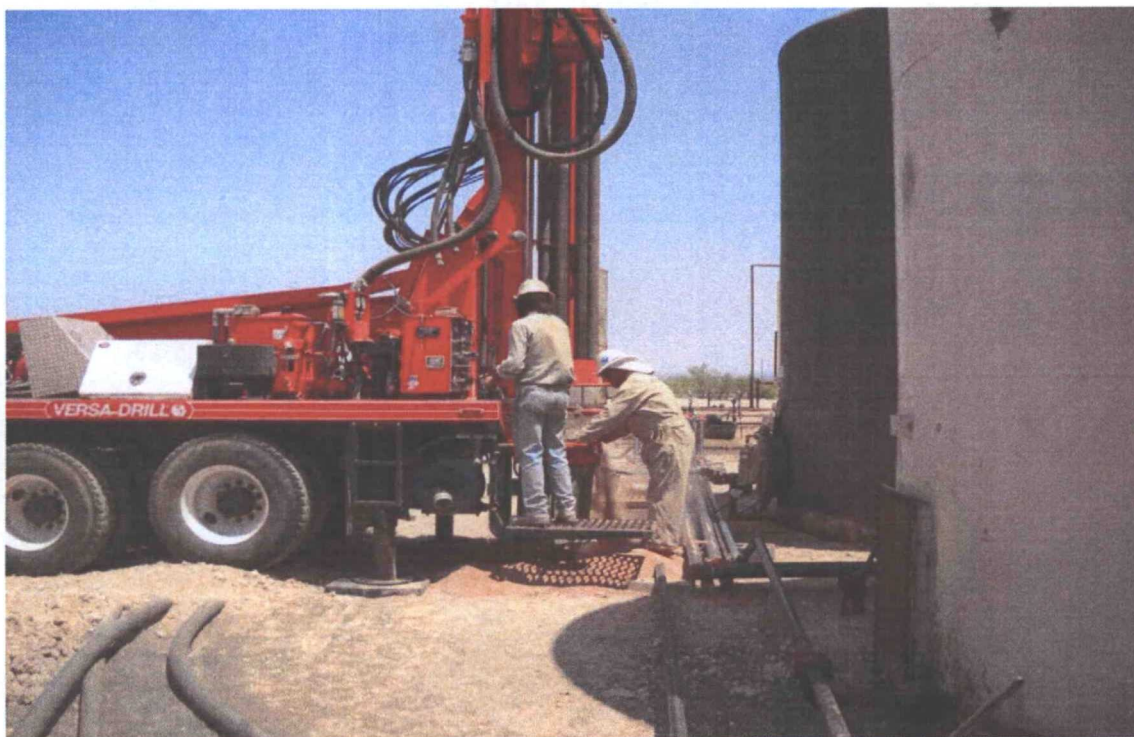
Hat Mesa State 31-32 Battery - Advancement of Soil Boring SB-2

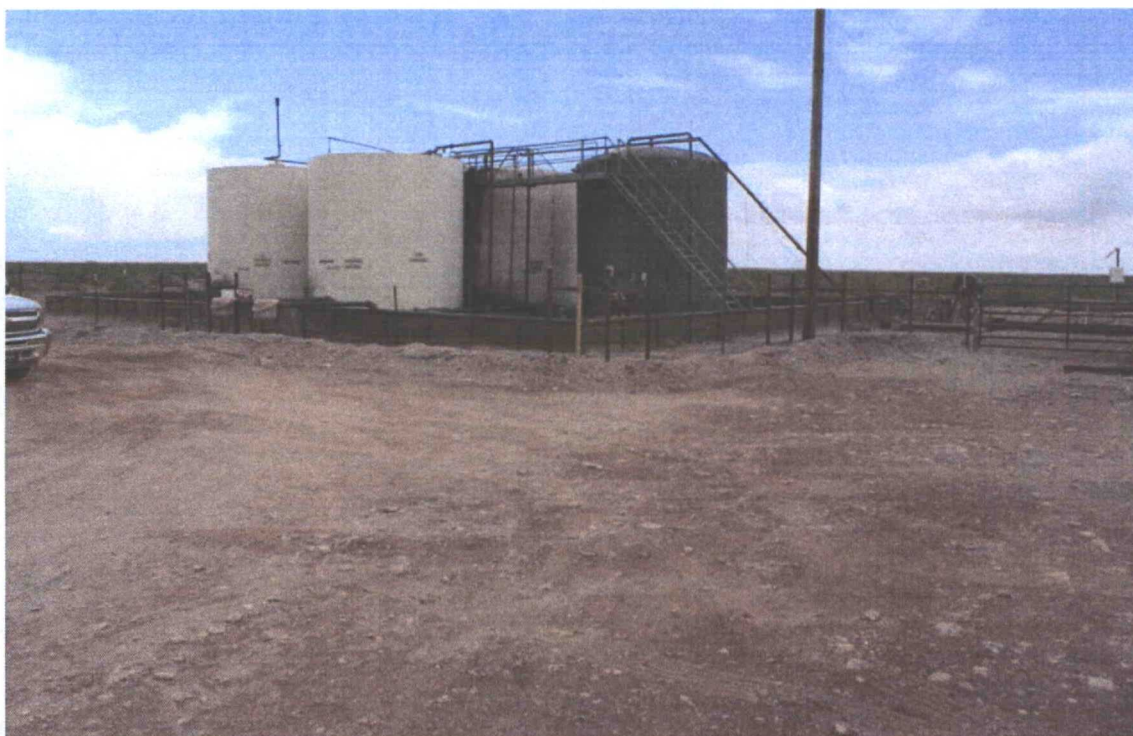
Hat Mesa State 31-32 Battery - Following Installation of Titan Liner (looking southwest)

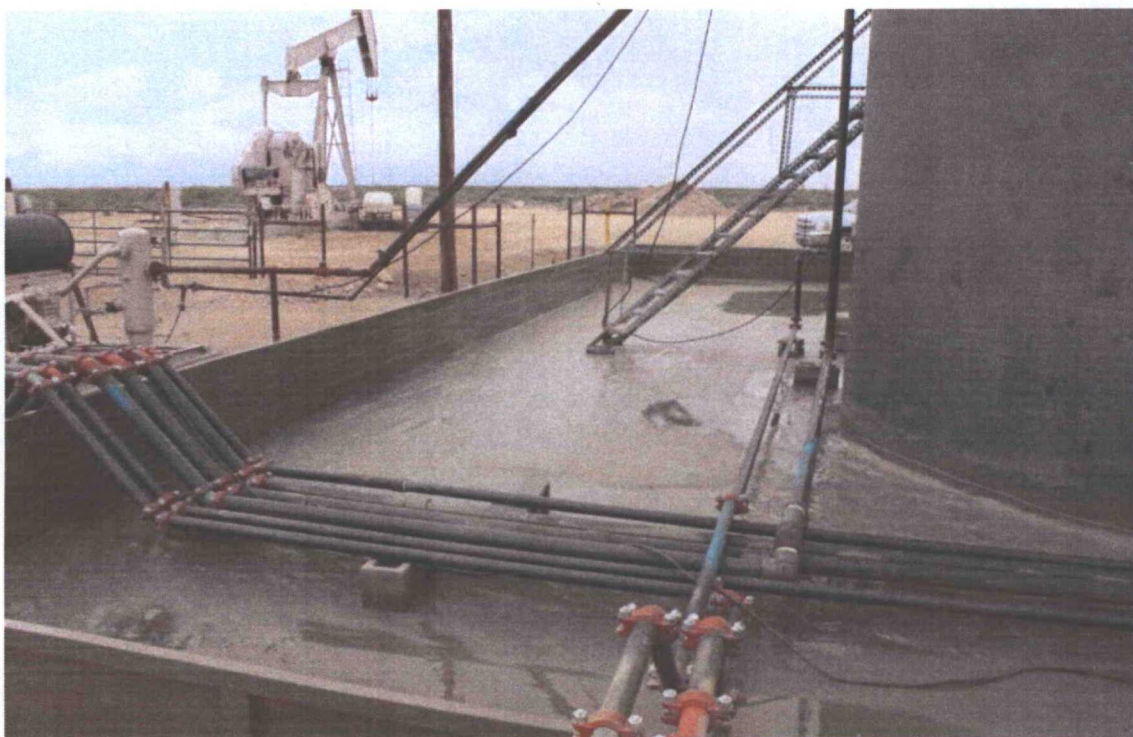
Hat Mesa State 31-32 Battery - North Excavation (following liner installation, looking east)

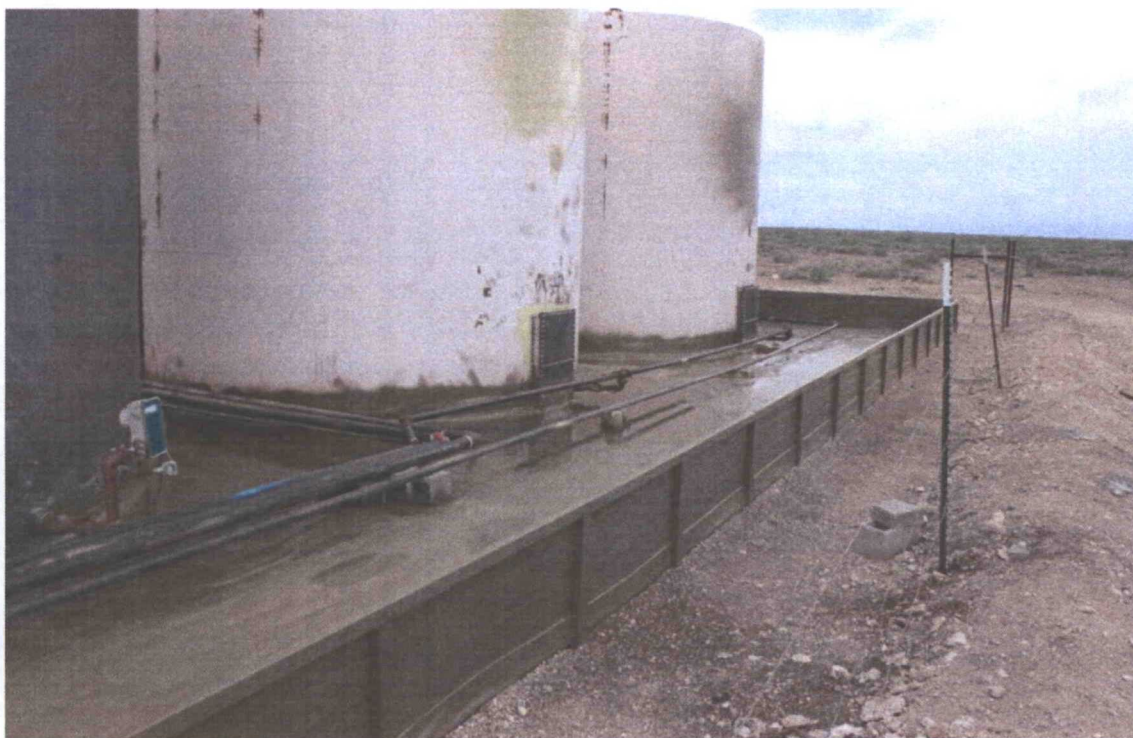
Hat Mesa State 31-32 Battery - Following Liner Installation (looking southeast)

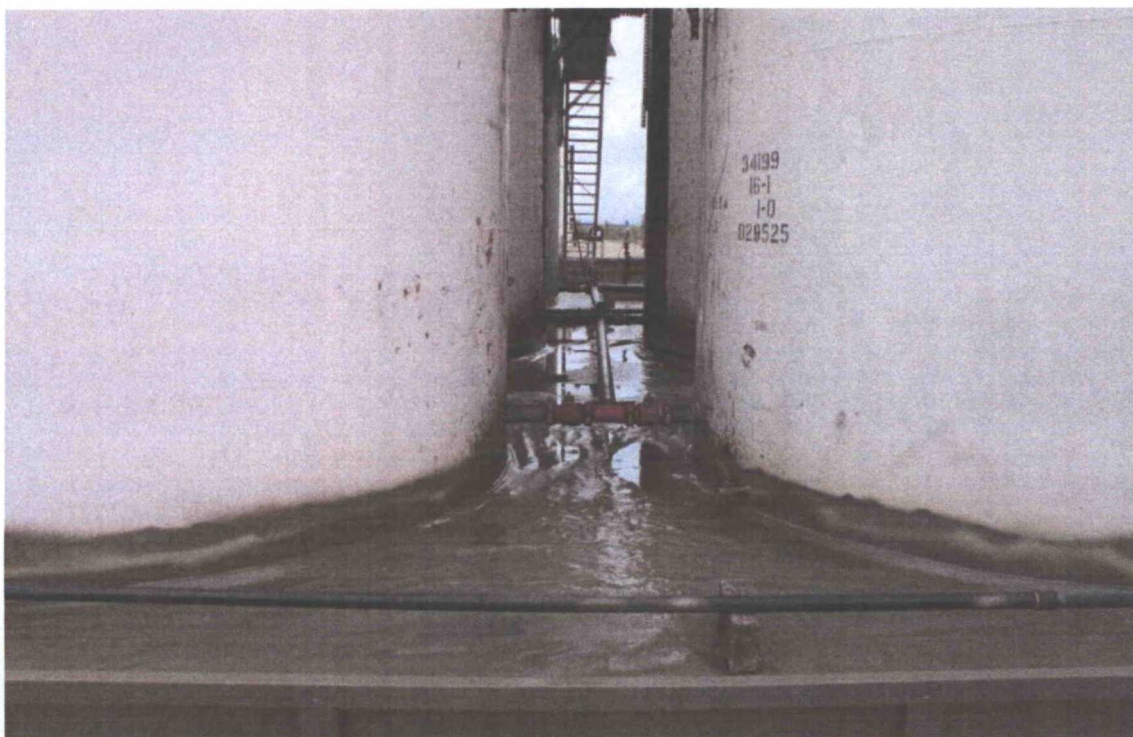
Hat Mesa State 31-32 Battery - Middle Excavation (following liner installation)
