**Re: Remediation Work Plan
MOC SWD SW Battery
Incident Number NAPP2315046261
API: 30-015-21669
Eddy County, New Mexico**

Oxy USA Inc.
Remediation Work Plan
MOC SWD SW Battery

Environmental Karst Study Report

Oxy MOC SWD SWBAT

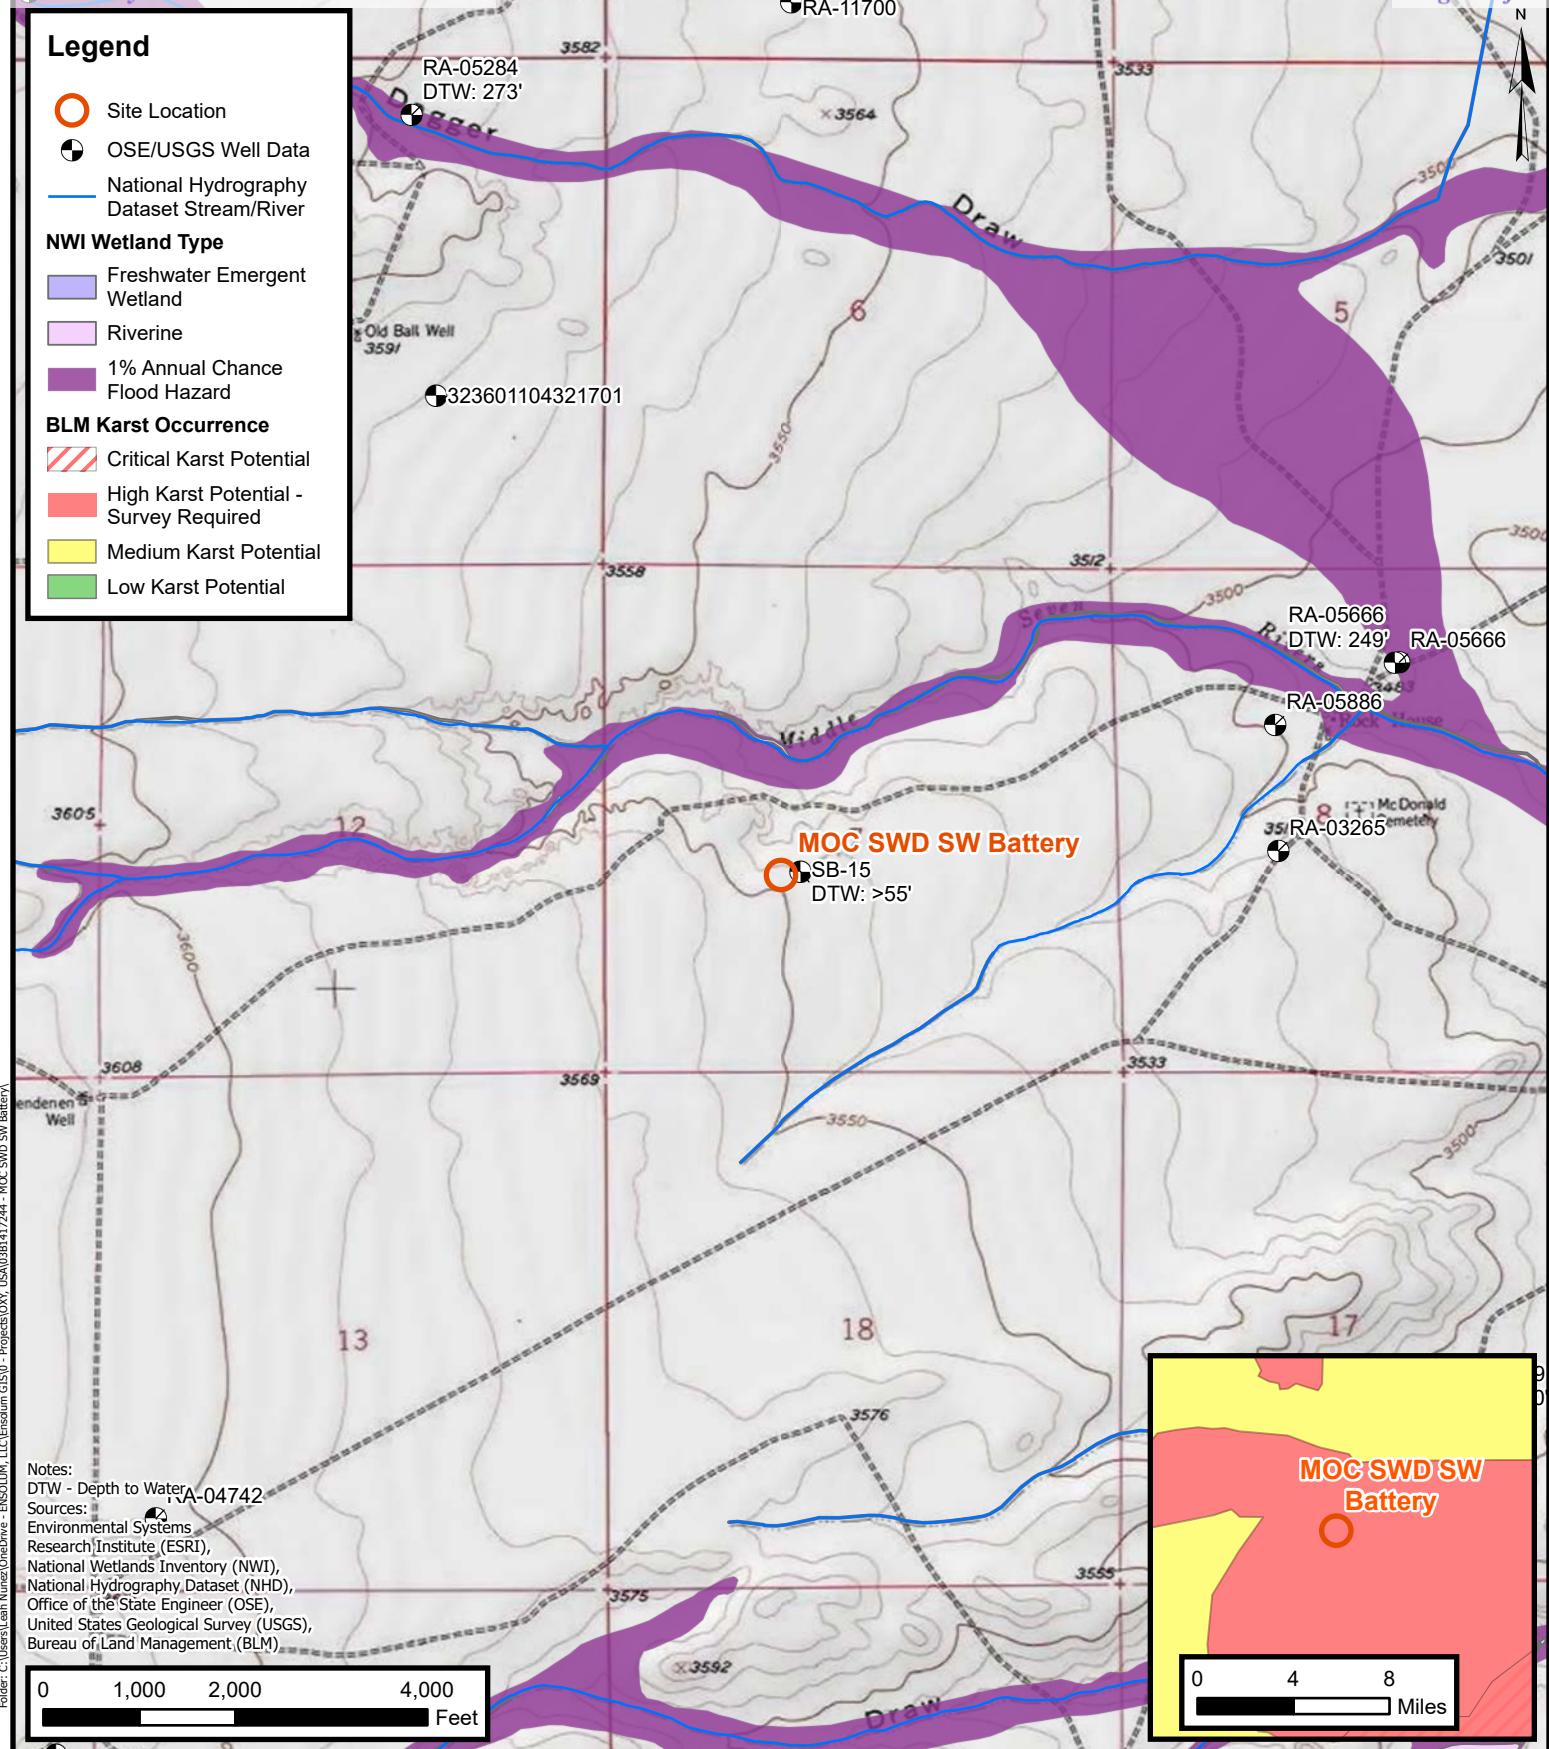
FIGURE
1

The Site was characterized to assess the applicability of Table I, Closure Criteria for Soils Impacted by a Release, of Title 19, Chapter 15, Part 29 (19.15.29) of the New Mexico Administrative Code (NMAC). Results from the characterization are summarized below and detailed in the NMOCD permitting portal Form C-141 Site Characterization section. Potential receptors are identified on Figure 1.

On March 20, 2024, a soil boring (SB-15) was advanced by Trinity Oilfield Services to a depth of 55 feet below ground surface (bgs) via hollow-stem auger drill rig. The soil boring was located approximately 190 feet northeast from the Site on the northeast corner of the well pad. No moisture or groundwater was encountered during drilling activities. The temporary well was left open for over 72 hours to allow for potential slow infill of groundwater. After the 72-hour waiting period without observing groundwater, it was confirmed that groundwater beneath the Site is greater than 55 feet bgs. The borehole was properly abandoned with drill cuttings and hydrated bentonite chips. The Well Record & Log is included in Appendix A. All wells used for depth to water determination are depicted on Figure 1.

Site Receptor Map

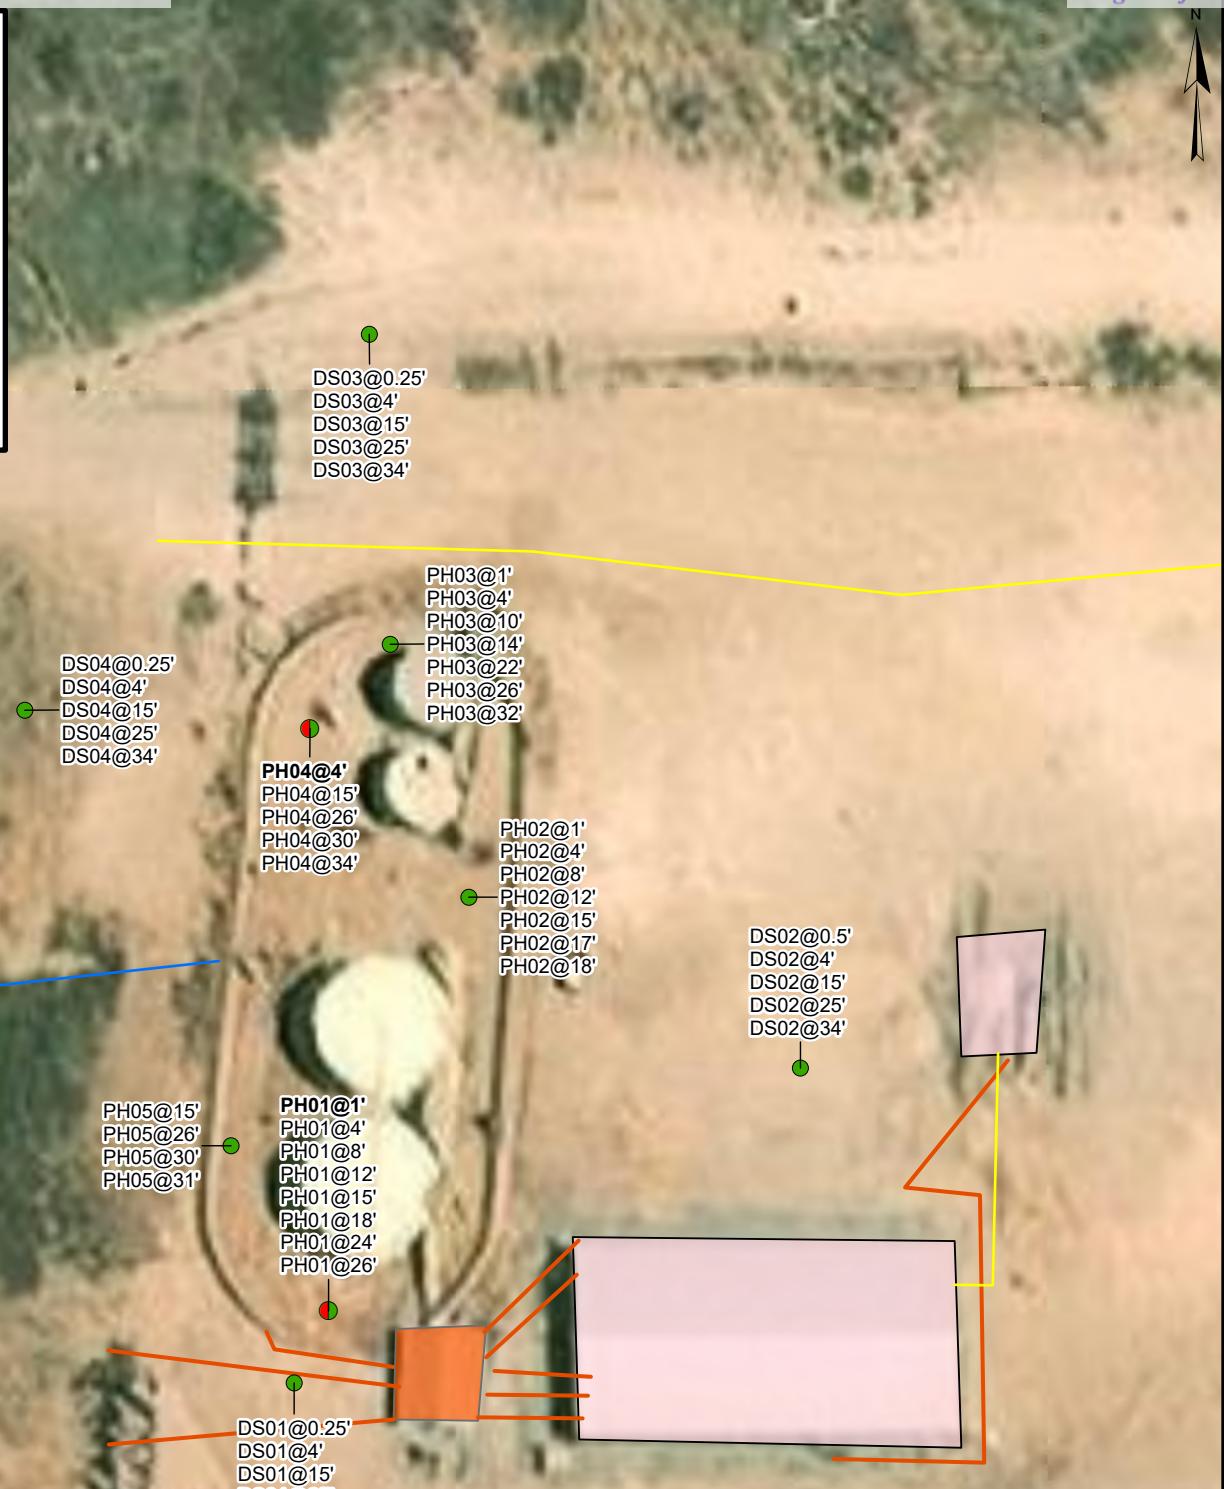
Delineation Soil Sample Locations

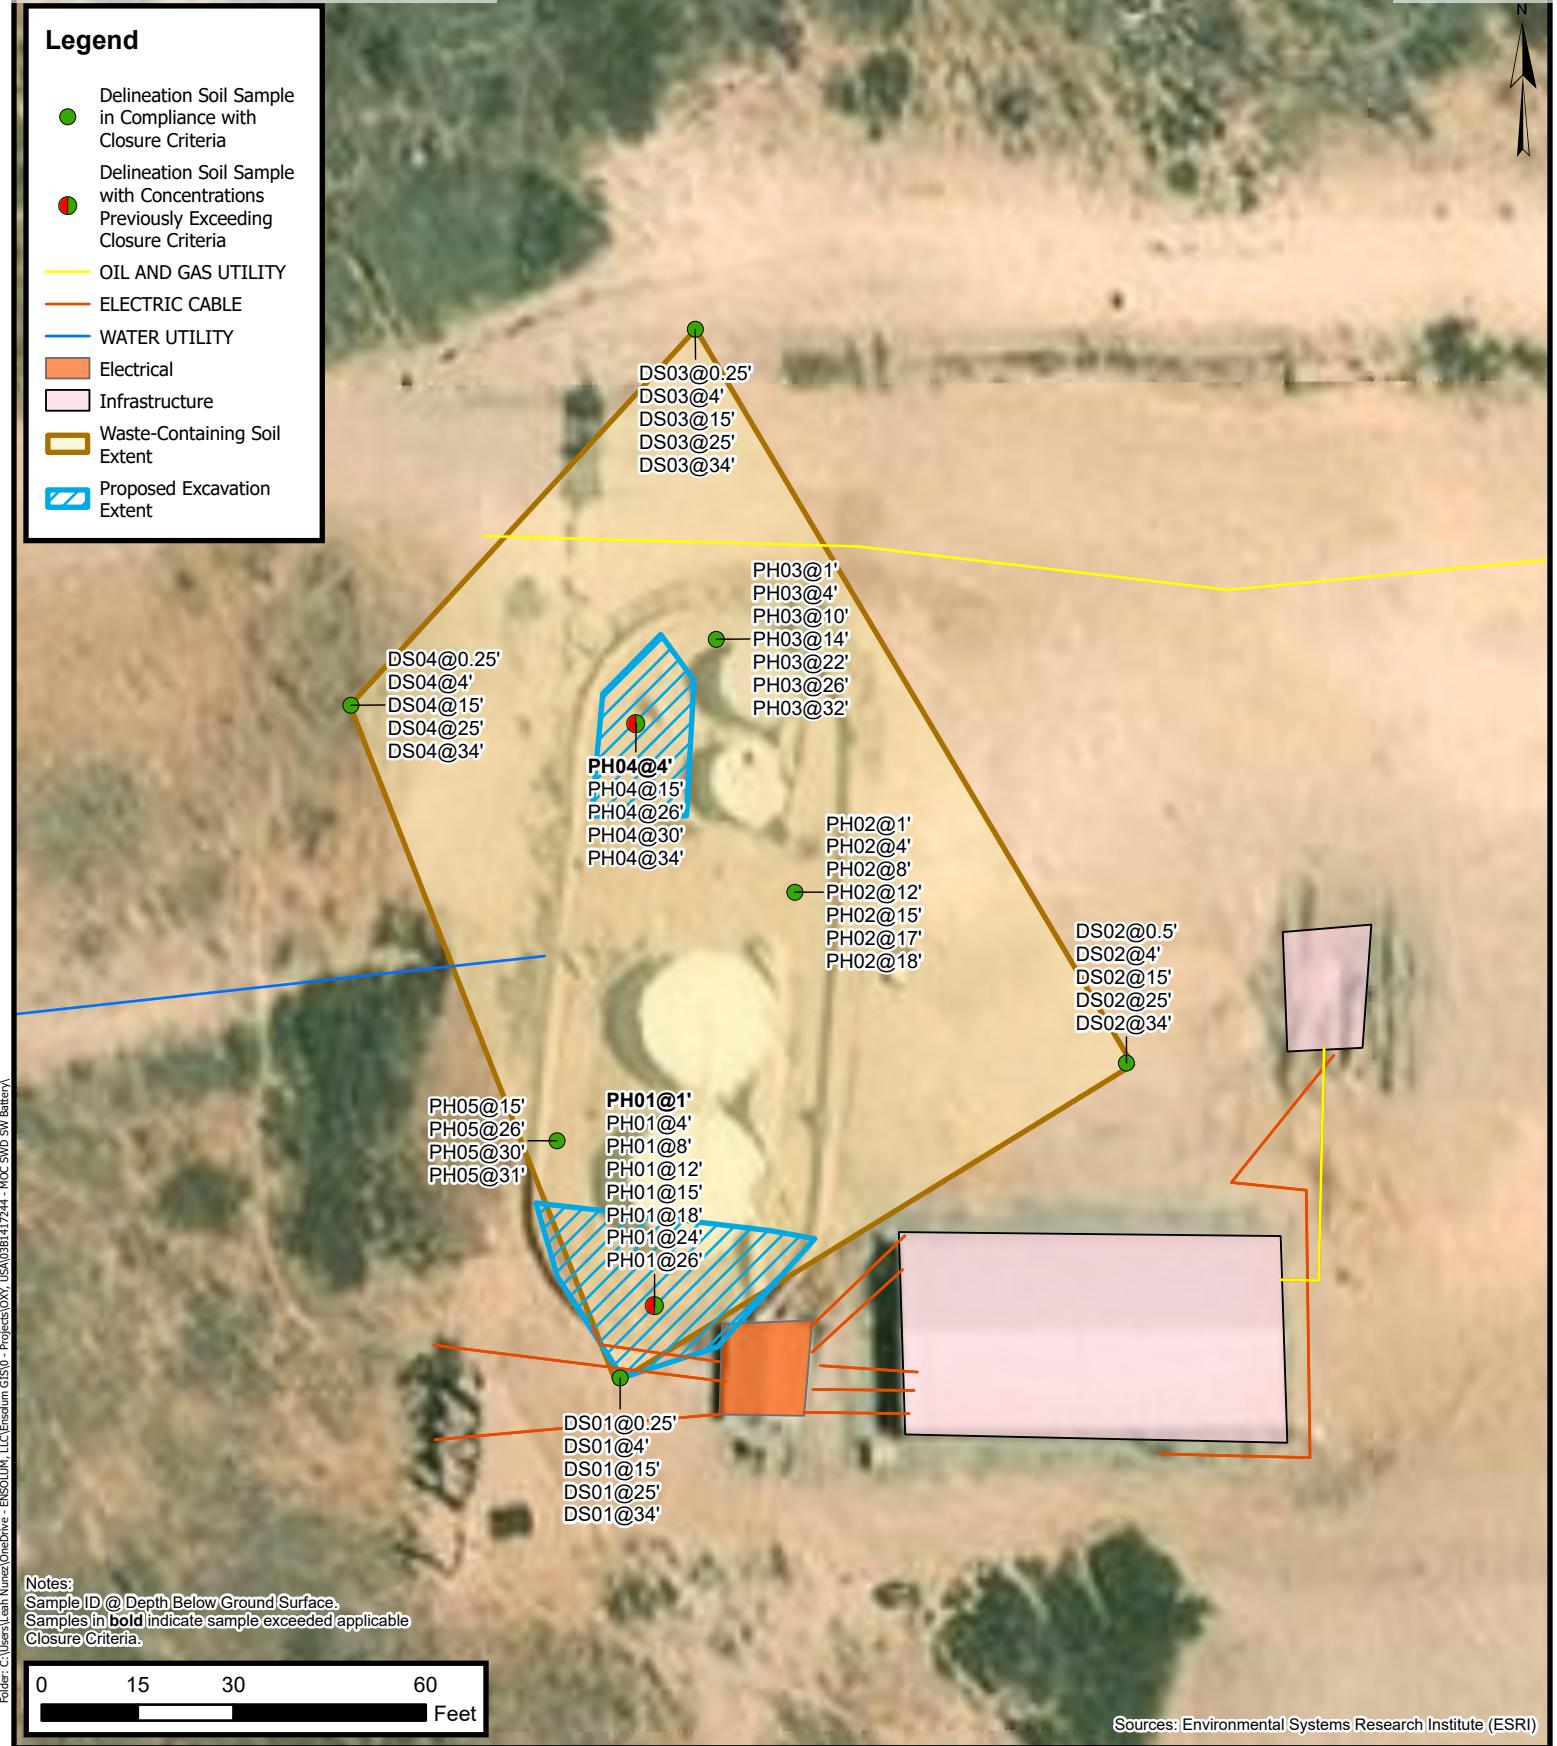
FIGURE
3

Proposed Excavation Map
Oxy, USA
MOC SWD SW Battery
Incident Number: NAPP2315046261
32.586619, -103.526978
Eddy County, New Mexico

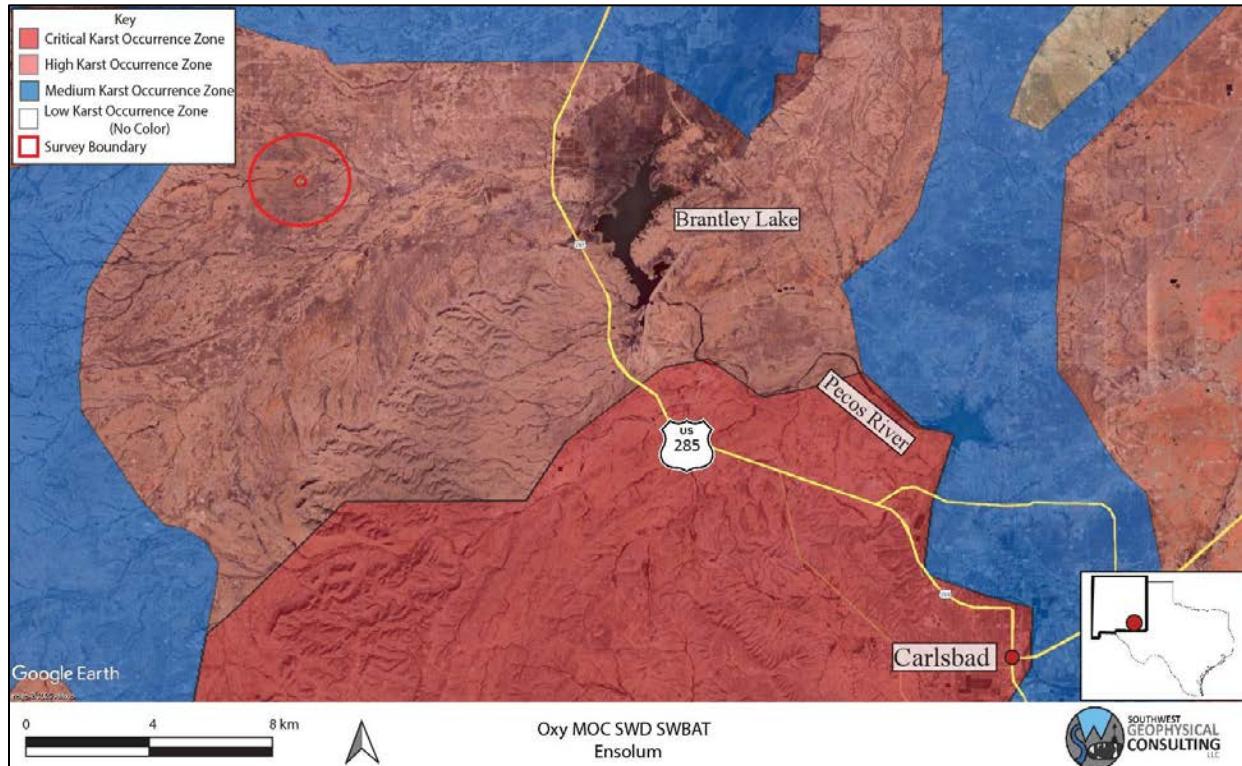
Figure 1: Karst occurrence zone overview. Background image credit: Google Earth. Image date: January 8, 2024. Image datum: WGS-84.

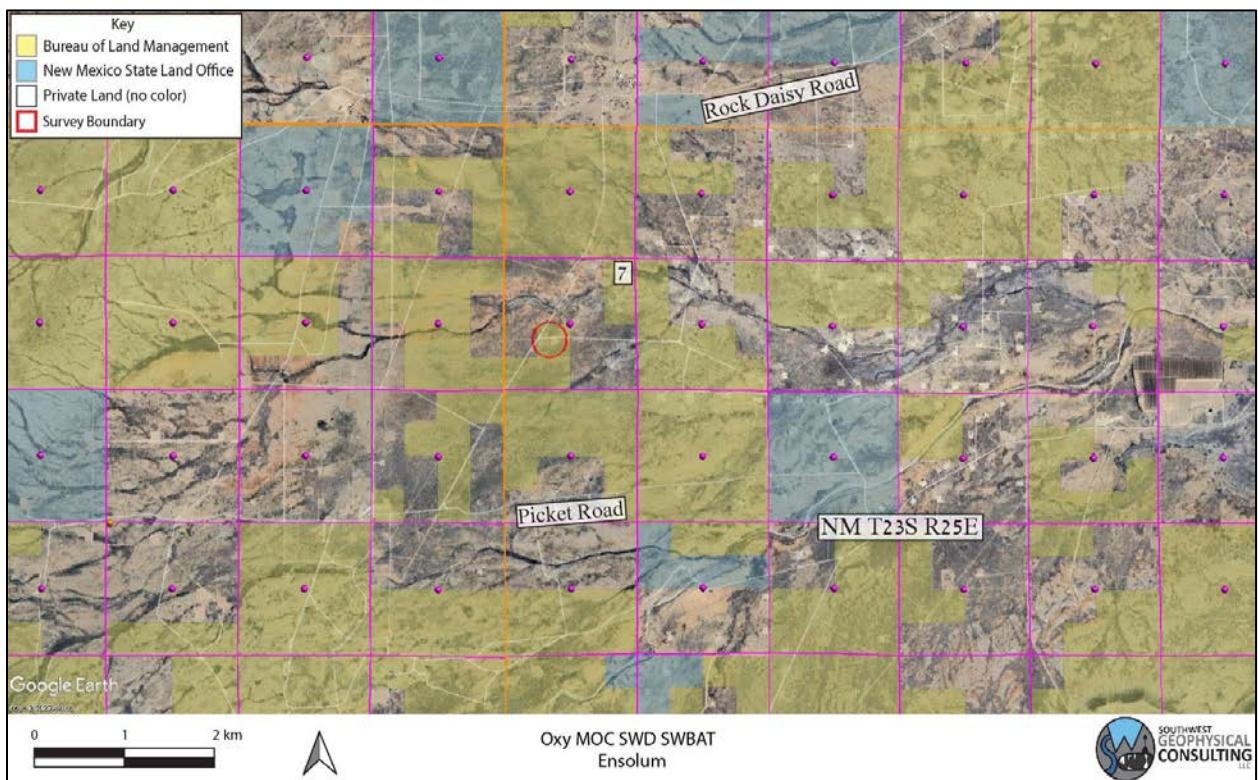
The site is located 33.7 kilometers (20.9 miles) northwest of Carlsbad, New Mexico, south of Rock Daisy Road and north of Picket Road. The release area is located within the SW $\frac{1}{4}$ section of section 7, NM T23S R25E^[6] (**Figure 1** and **Figure 2**). The region has rolling terrain with karstification occurring in the gypsite and caliche soils and underlying gypsum and dolomite bedrock^[7] (see section **2.2 Local Geology Summary** for further information). The climate in this area of southeast New Mexico is semi-arid with an average annual precipitation of approximately 13 inches, of which about two-thirds falls as rain during summer thunderstorms from June to October. Summers are hot and sunny while winters are generally mild, with an average maximum temperature of 96°F in July and an average minimum temperature of 28°F in January^[8]. This area is within the Chihuahuan Desert Thorns scrub as defined by the Southwestern Regional ReGAP Vegetation map^[9] and the vegetation consists mostly of areas of blue grama, nine-awned pappus grass, burro grass and low scrub including yucca. The spill delineation boundary is located within an HKOZ^[5] (**Figure 1**) and within BLM-CFO managed land^[10] (**Figure 2**).

Figure 2: Land ownership and PLSS overview. Background image credit: Google Earth. Image date: January 8, 2024. Image datum: WGS-84.

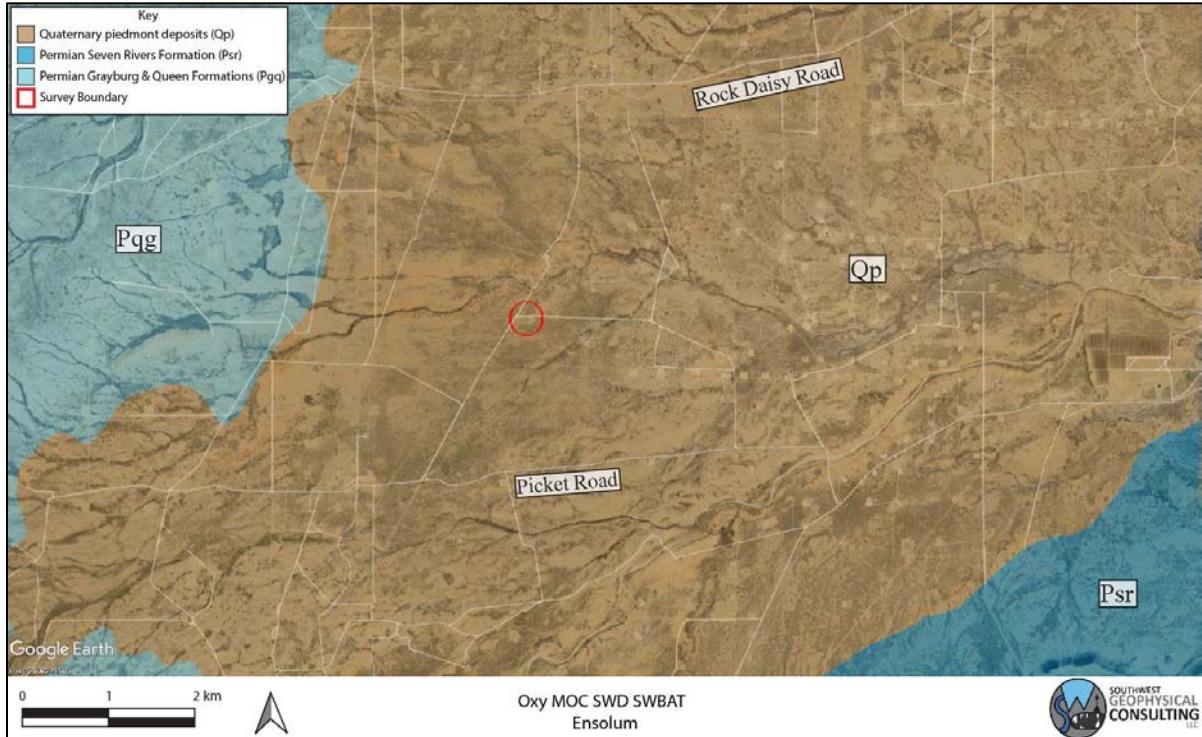
The Seven Rivers consists of interbeds of dolomite and gypsum with occasional sandstone lenses and thickly bedded anhydrite. Both the dolomite and gypsum/anhydrite are subject to karst formation. From north to south, the Seven Rivers transitions from an evaporite facies to a basin facies near the reef escarpment^[13]. The Seven Rivers overlies the Permian Queen Formation, a calcite rich siliciclastic unit^[12]. Beneath the Queen lies the Grayburg, a dolomitic limestone.

Figure 3: Geology overview. Geology map credit: The Digital Geologic Map of New Mexico in ARC/INFO Format. Background image credit: Google Earth. Image date: January 8, 2024. Image datum: WGS-84.

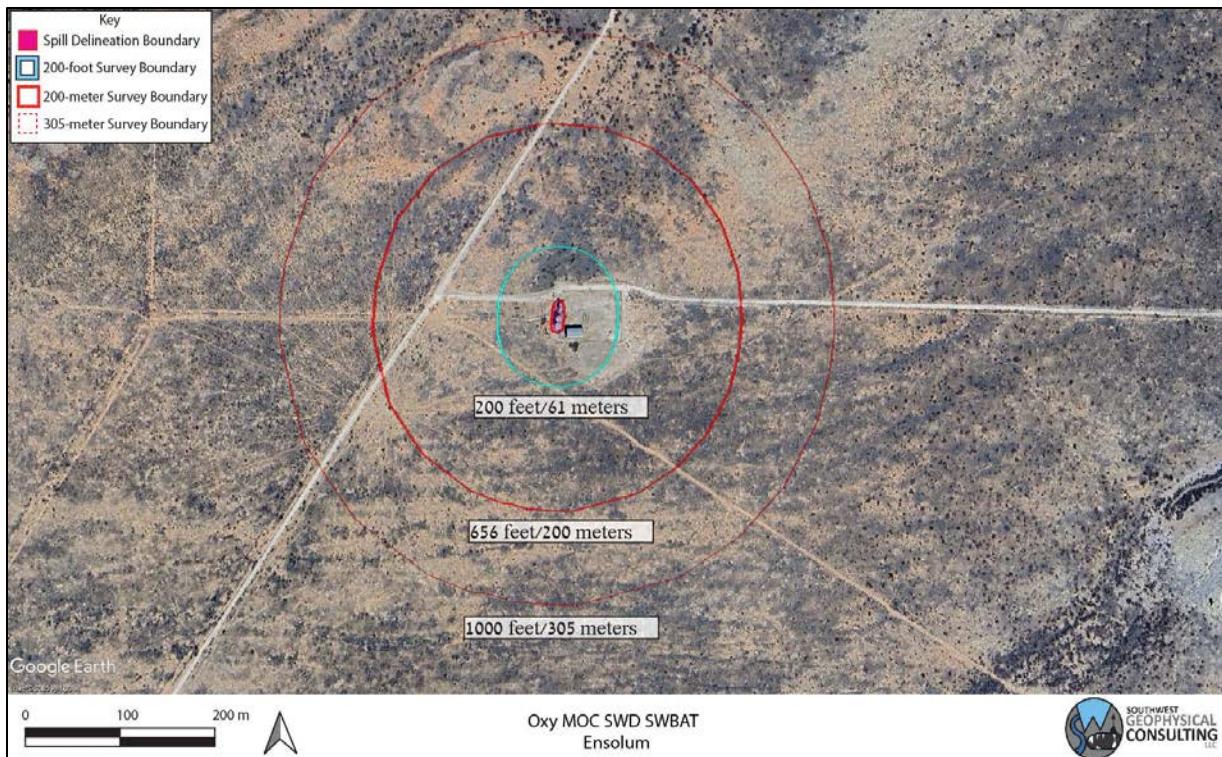
Surface karst surveys are conducted by sUAS at low elevation within 200 meters of the spill delineation boundary^[4] (**Figure 4**) following a preplanned raster pattern flightpath designed for the purpose of generating at least 75% imagery overlap. The collected high-resolution, georeferenced imagery is stitched together to develop orthomosaic imagery which is further developed into a digital elevation model (DEM); the DEM is then processed into a local relief model (LRM) (**Figure 6**). This LRM is color coded to enhance differences in elevation of as little as five centimeters. The orthoimagery, DEM, and LRM are uploaded to a server where they are analyzed by an experienced karst geologist. Finally, the data is reviewed by a senior karst geologist for quality assurance and downloaded into a table for inclusion in a written report^[16].

Figure 4: Surface survey overview. Background image credit: Google Earth. Image date: January 8, 2024. Datum: WGS-84.

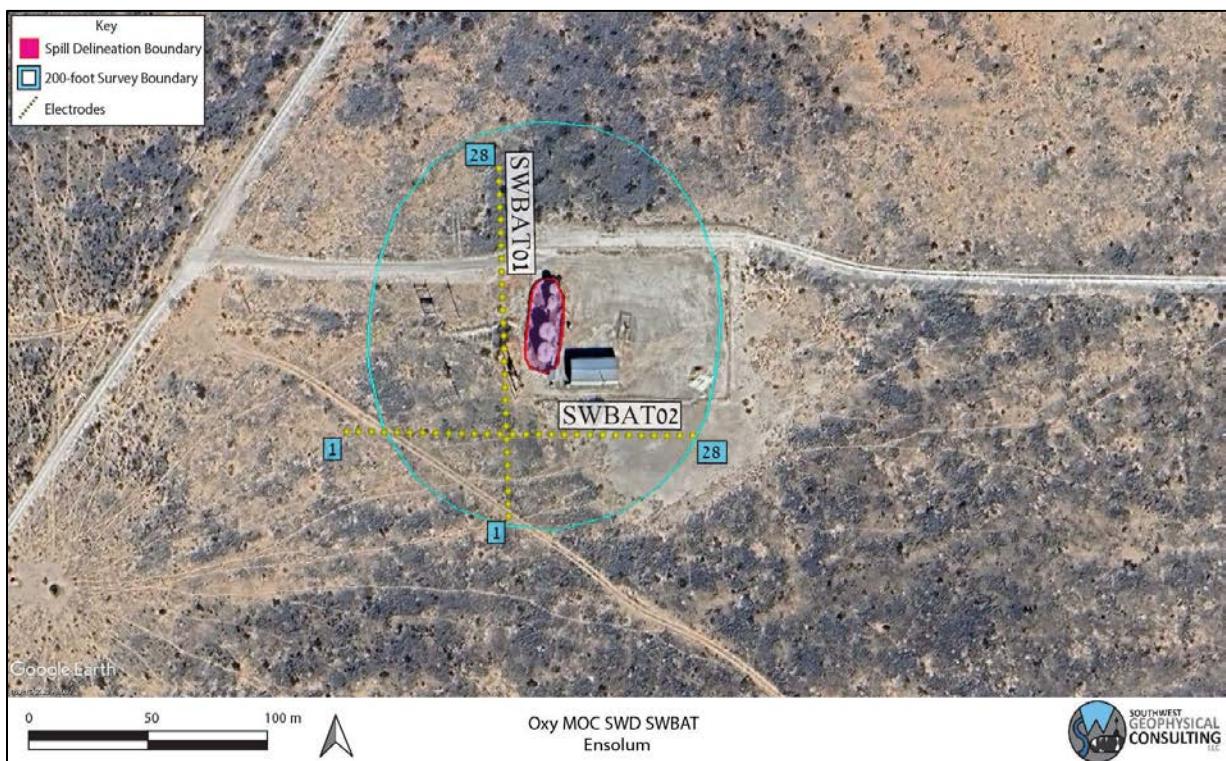
For this survey, a Guideline Geo Terrameter LS 2 and a 28-electrode array of 40-centimeter-long electrodes were used to image the subsurface. This survey consisted of two resistivity lines in a dipole-dipole configuration; line one is laid out south to north while line two is laid out west to east. Both lines consisted of 28 electrodes at 5-meter spacing, resulting in 135-meter-long arrays (**Figure 5, Table 1**). A preconfigured protocol file was used to run the data collection (DipoleDipole2x14). This electrode configuration provided a depth of investigation of 27 meters (89 feet) and a resolution of 2.5 to 3.0 meters (8.2 to 9.8 feet) within the first 5 to 8 meters (16 to 26 feet) from the surface. A Leica GS18 GPS was used to record electrode locations and elevations.

Figure 5: Geophysical survey overview. Two survey lines were conducted with 28 electrodes each at 5-meter spacing (yellow dots denoted with blue numbers). Background image credit: Google Earth. Image date: January 8, 2024. Image datum: WGS-84.

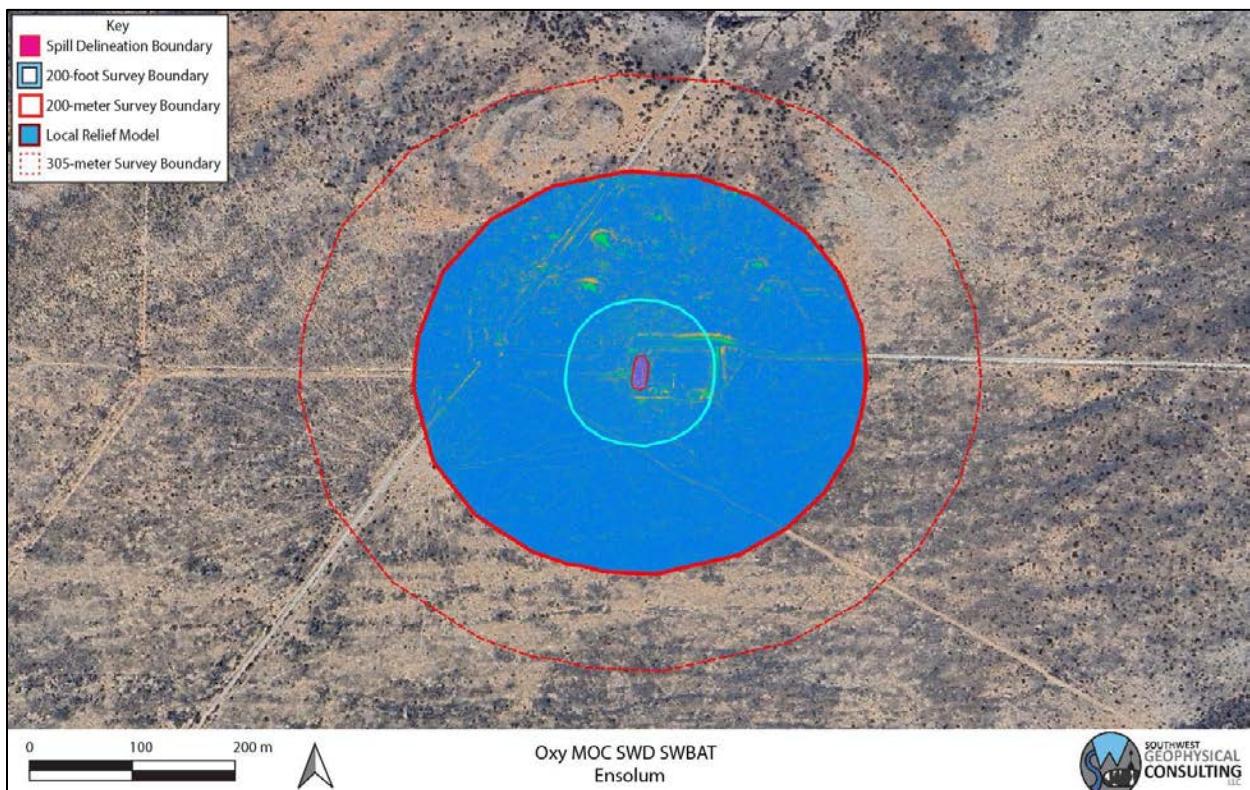
The desk study and surface karst survey showed no surface karst features located within the 200-foot (61-meter)^[1] survey area surrounding the spill delineation boundary (Figure 6).

No springs or other karst features exist within the 305-meter (1,000-foot)^[1] survey boundary (Figure 6).

Figure 6: Surface karst survey results. Background image credit: Google Earth. Image date: January 8, 2024. Image datum: WGS-84.

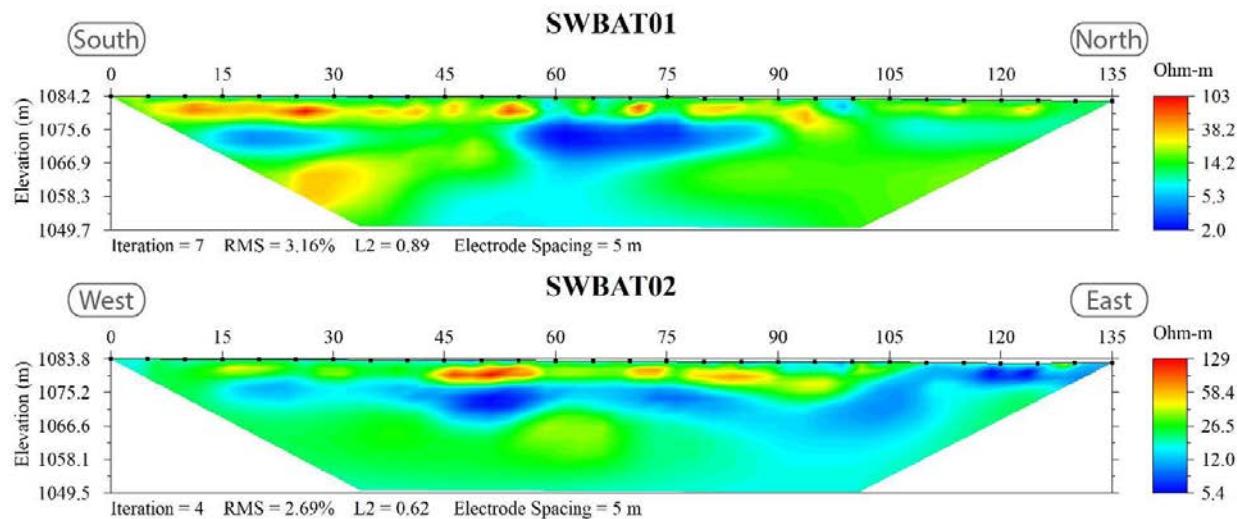
The results of this study indicate a well-layered geologic system with low resistivities between 2.0 and 129 Ohm-m (**Figure 7**). Please keep in mind when viewing the 2D inverted resistivity sections that color maps can be widely different for each view. Always check the color map located on the right side of the image when viewing the 2D images to ensure you understand the range of resistivities presented. Distances along the top and depths along the left side are in meters. The color map along the right side is in Ohm-m. Due to the nature of the survey, shallower zones have higher resolution between electrodes than deeper zones; therefore, small features at depth will not be visible.

Figure 7: 2D inverted resistivity section. Reds and oranges indicate higher resistivity values. Yellows and greens are medium-resistivity values. Blues are low-resistivity values. Please note that the color scale is relative.

Very low-resistivity areas between 2 – 10 Ohm-m may either represent fluid from the brine release, surface-to-subsurface hydrologic pathways, or a layer of either clays and halite lenses or moist to saturated layers within the Seven Rivers Formation (**Figure 7**).

No surface karst features and no anomalies consistent with air-filled subsurface voids are found within the SWBAT survey area. However, small solutionally enlarged voids or fractures at or near the resolution limit of the survey (2.5 – 3.0 meters) may be present. (**Figure 7** and **Figure 8**).

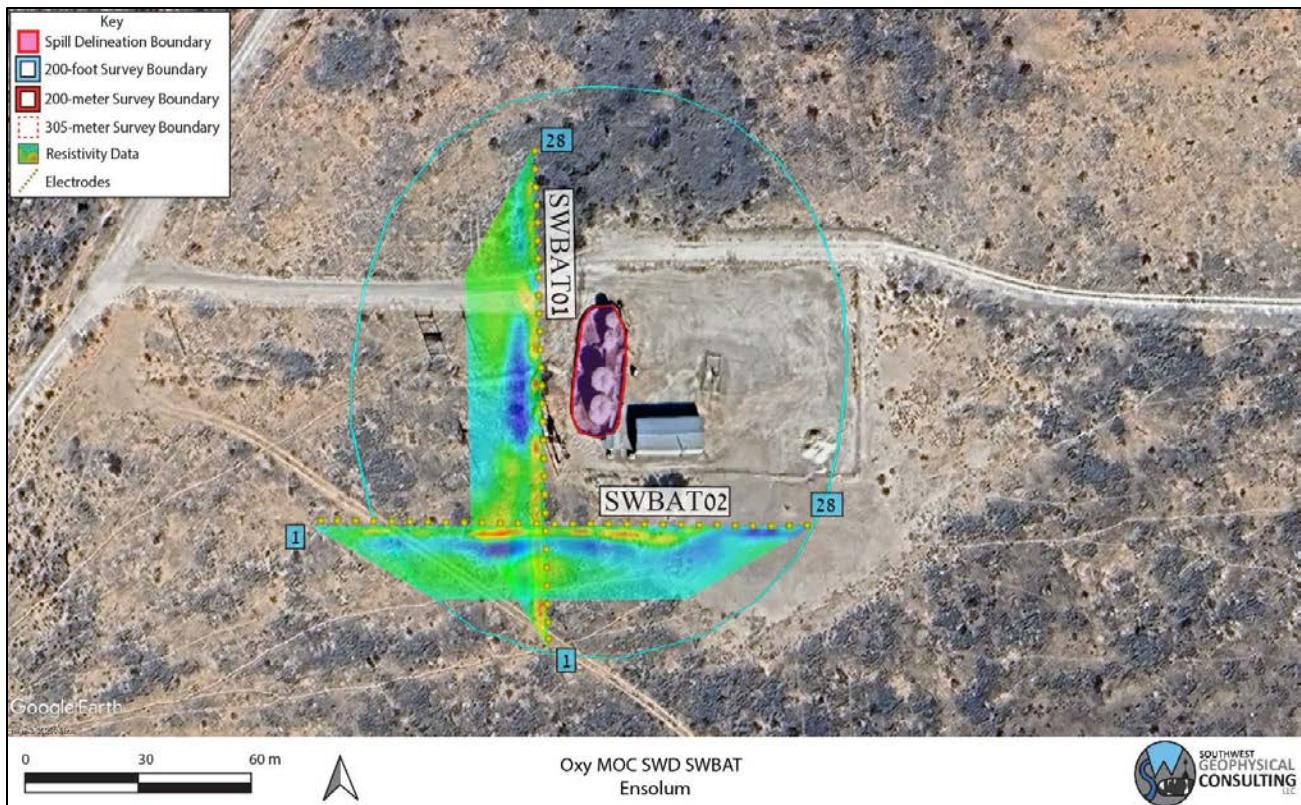
Figure 8: Data overlay. Colored trapezoids are the 2D inverted resistivity lines. Background image credit: Google Earth. Image date: January 8, 2024.

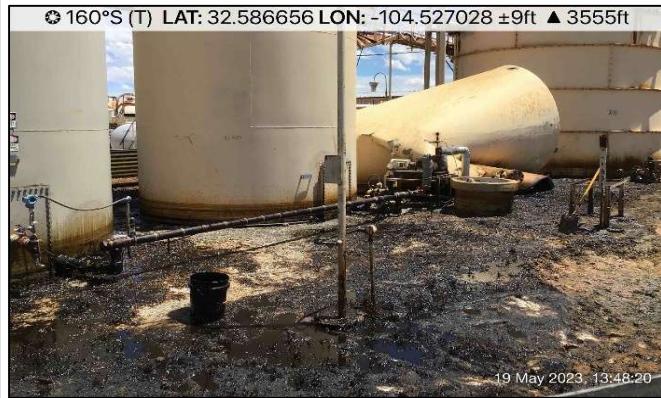
Photograph: 1 Date: 5/19/2023
Description: Soil staining in release footprint
View: South

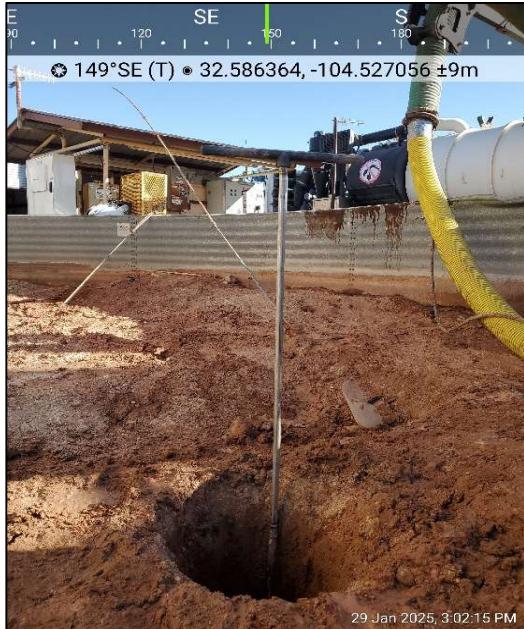
Photograph: 2 Date: 1/29/2025
Description: Delineation activities (PH01)
View: Southeast

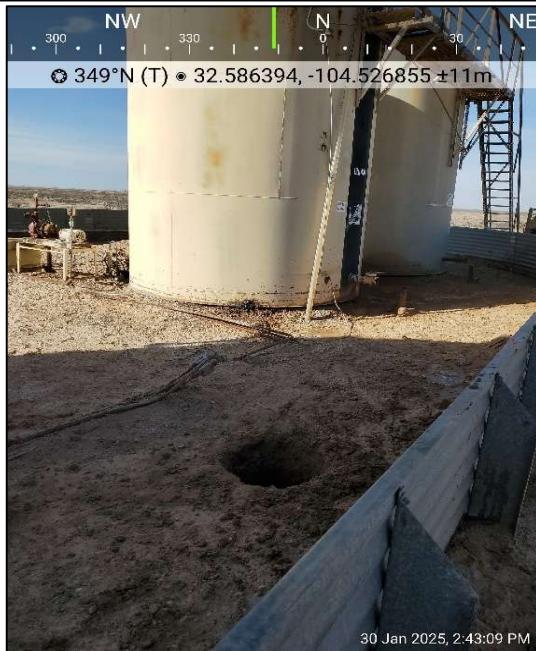
Photograph: 3 Date: 1/30/2025
Description: Delineation activities (PH02)
View: North

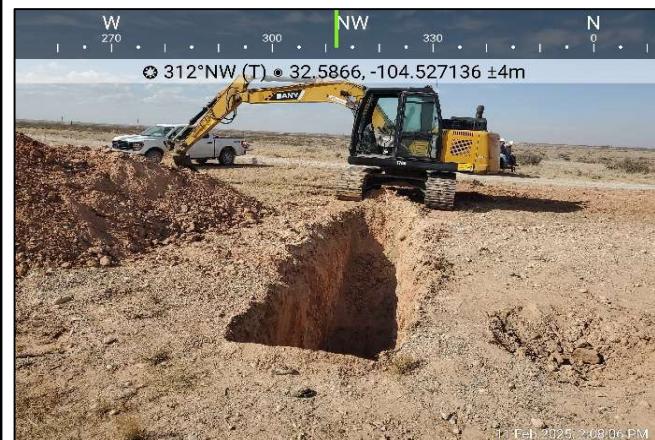
Photograph: 4 Date: 9/29/2022
Description: Delineation activities (DS-04)
View: Northwest

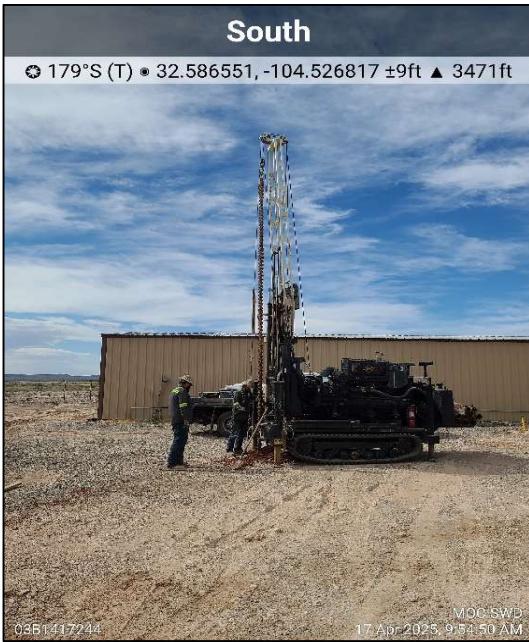
Photograph: 5 Date: 4/17/2025
Description: Delineation activities (DS-02)
View: South

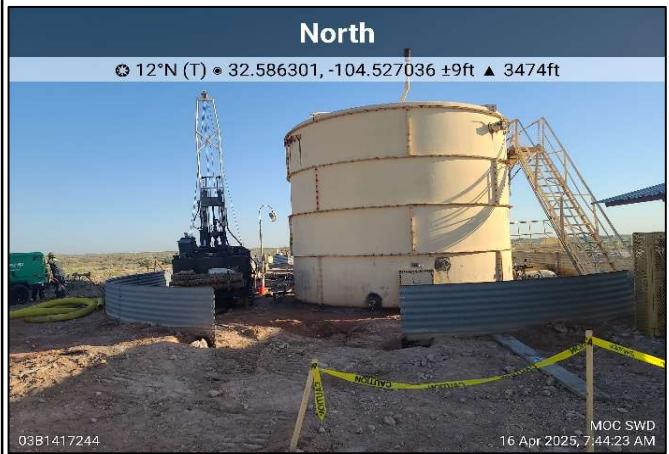
Photograph: 6 Date: 4/16/2025
Description: Delineation activities (PH05)
View: North

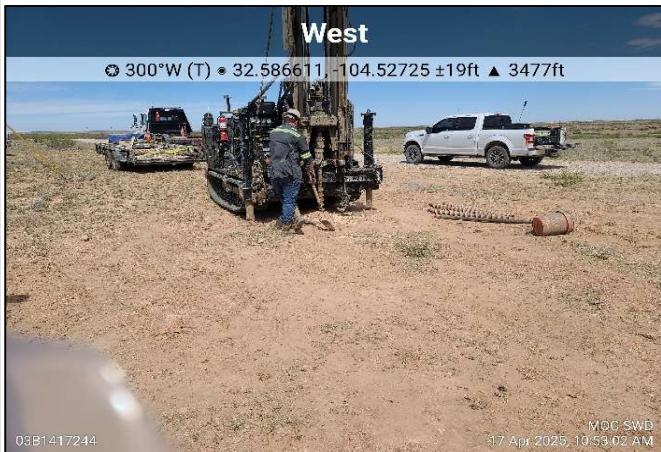
Photograph: 7 Date: 4/17/2025
Description: Delineation activities (DS-04)
View: West

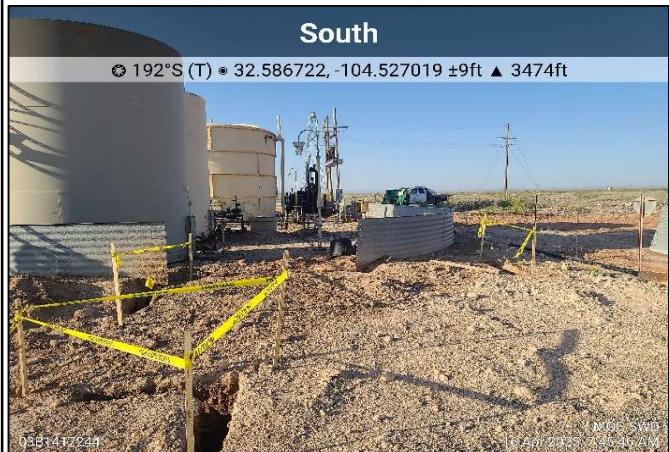
Photograph: 8 Date: 4/16/2025
Description: PH04 delineation location
View: South
