**Re: Remediation Work Plan
Tiger 14 CDP TB
Incident Number: nAPP2505726681
Eddy County, New Mexico**

Ensolum, LLC (Ensolum), on behalf of Matador Production Company (Matador), has prepared this *Remediation Work Plan (RWP)* to document assessment and soil sampling activities performed at the Tiger 14 CDP TB (Site). The purpose of the Site assessment and soil sampling activities was to address impacted and waste-containing soil resulting from a crude oil release. Matador is submitting this *RWP*, describing analytical results from soil sampling and karst survey activities associated with Incident Number nAPP2505726681 and proposing to address the current sensitive Site receptor (high karst potential) of the subject matter release prior to beginning excavation activities and prior to submitting a *Closure or Deferral Request*.

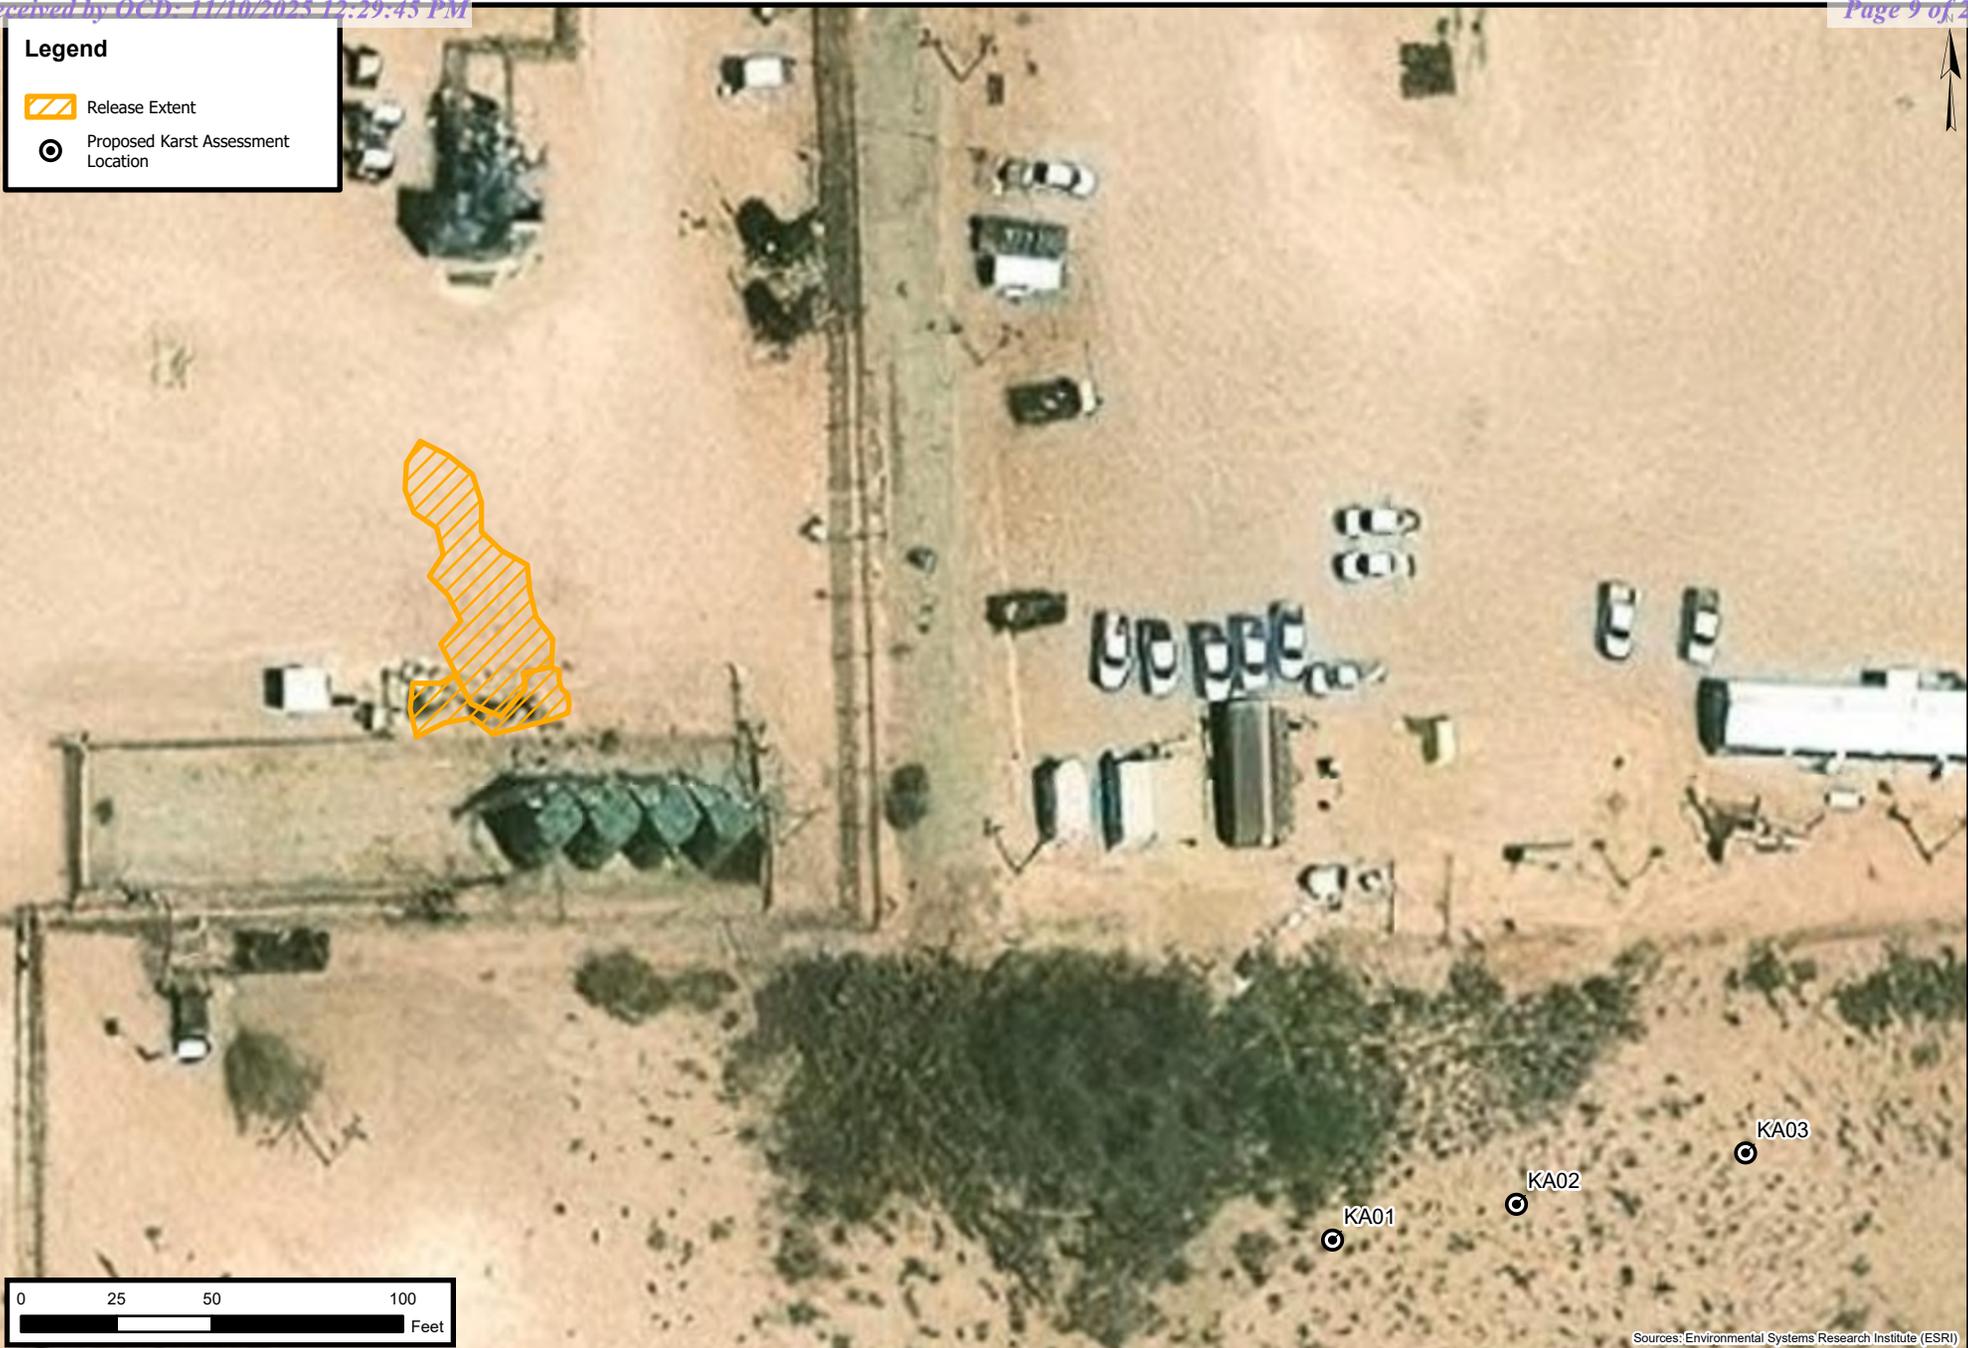
Proposed Karst Assessment Location

- Matador intends to complete unstable geology and karst assessment soil borings to establish the presence or absence of unstable geology and subsurface karst features at the Site. The soil borings will be advanced to a depth of approximately 44 feet bgs, which is the depth the off-site anomaly was observed in the ER survey. The proposed karst assessment soil boring locations are included on Figure 3.

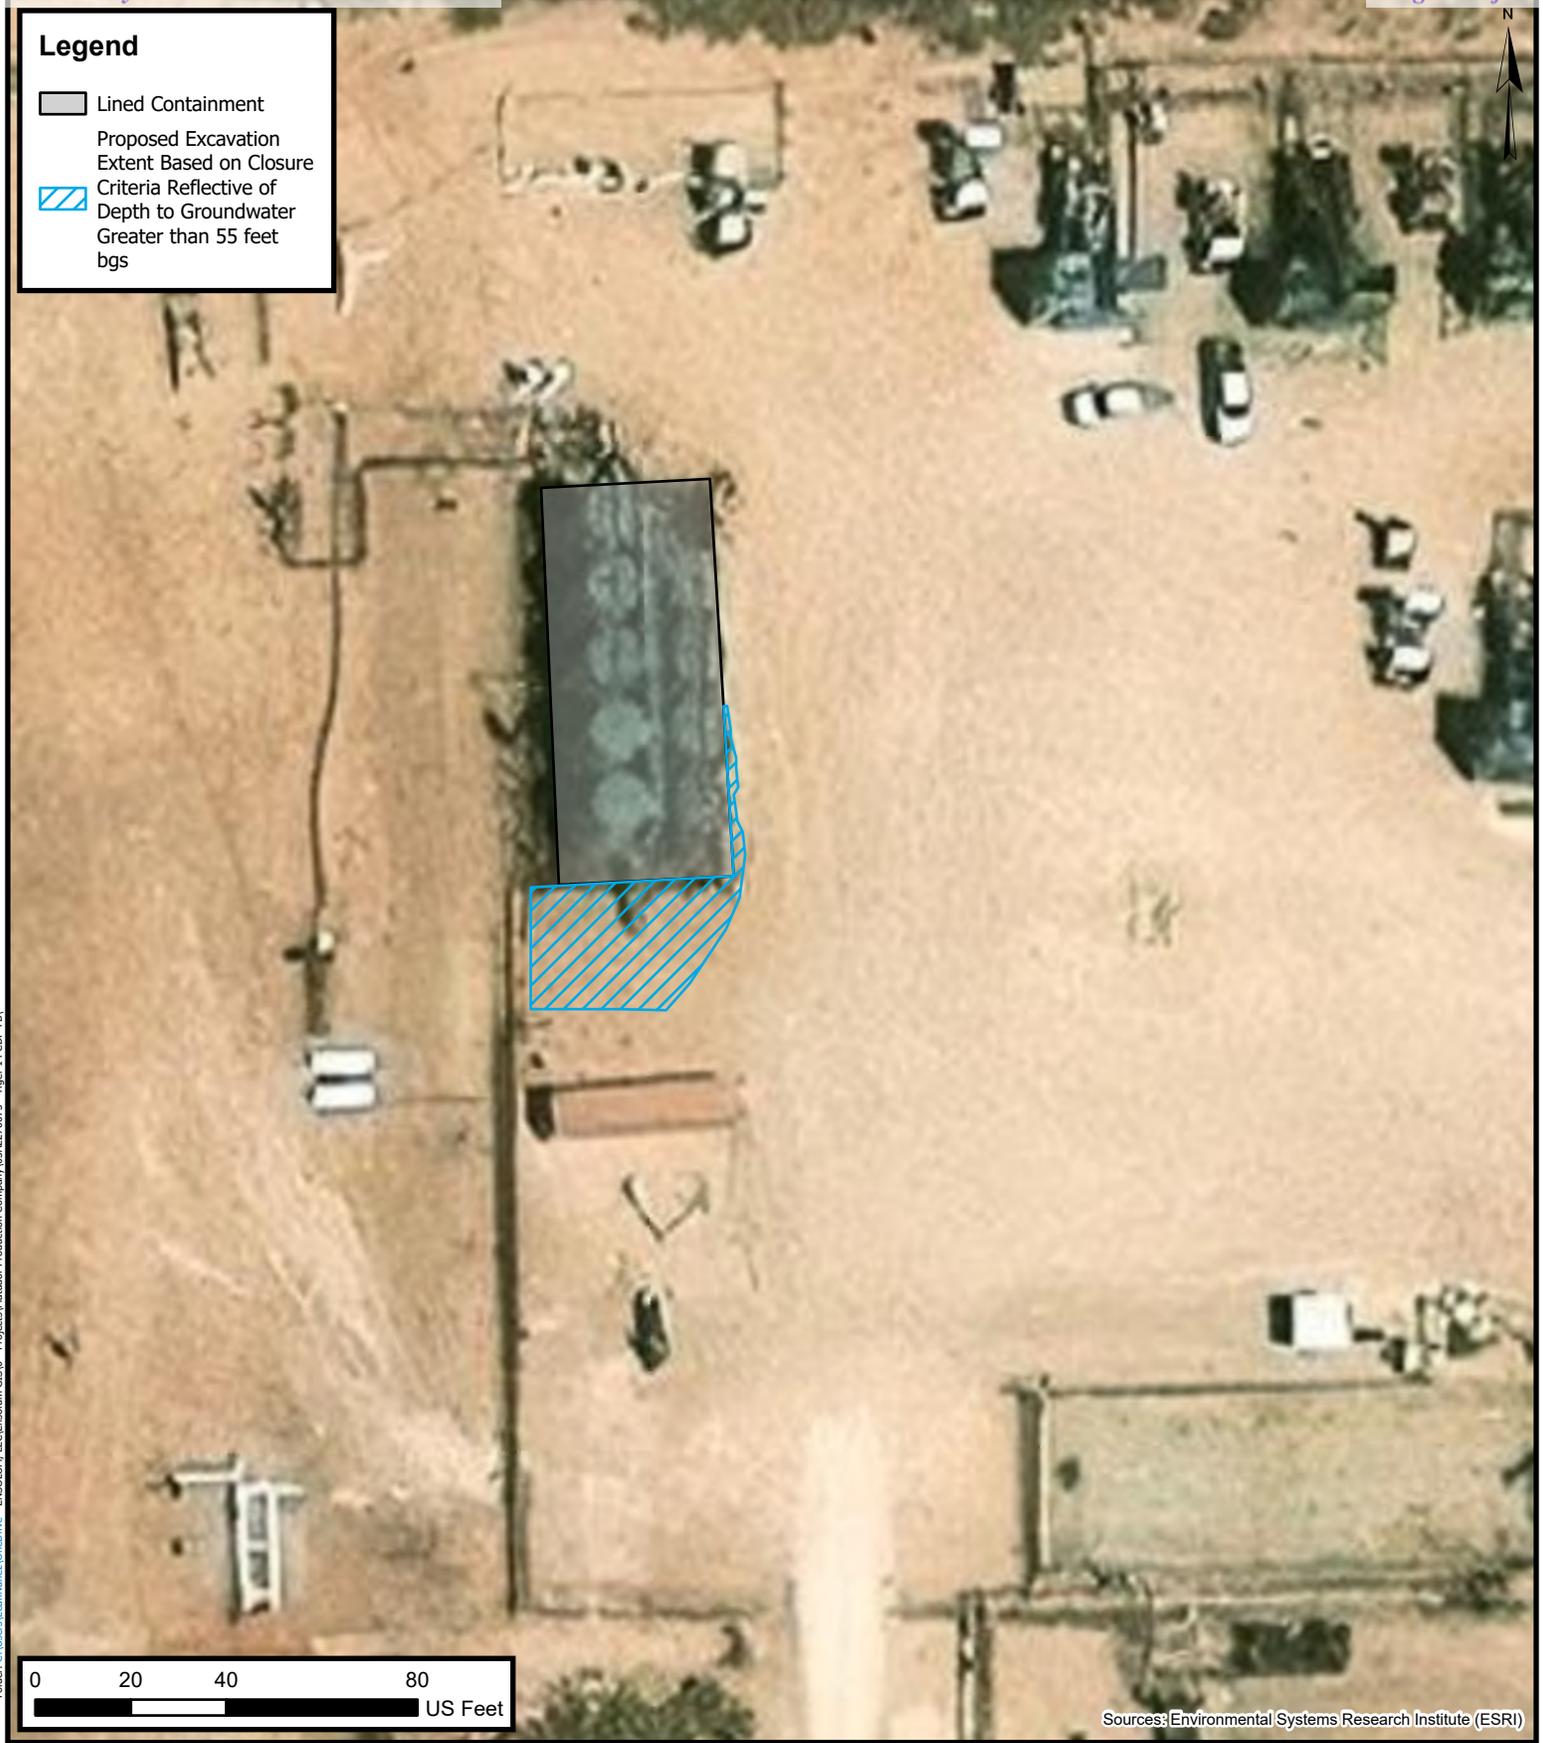
Criteria Reflective of Depth to Groundwater Greater than 55 feet bgs

- The excavation will be completed with mechanical equipment, and the proposed excavation extent are depicted on Figures 4a and 4b. Figure 4a depicts the proposed excavation extent if no sensitive Site receptors are associated with the Site and depth to groundwater is greater than 51 feet bgs. Figure 4b depicts the proposed excavation extent if sensitive Site receptors are found at the Site (unstable geology and/or karst features are present), utilizing the strictest Closure Criteria.

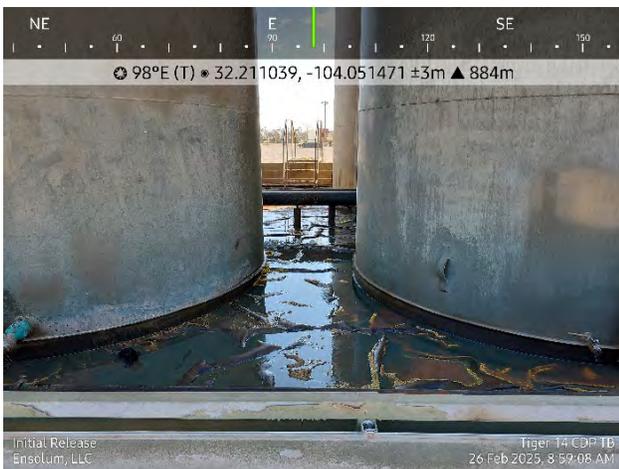
Photograph 3
Date: 2/26/2025
Description: Initial Release
View: East

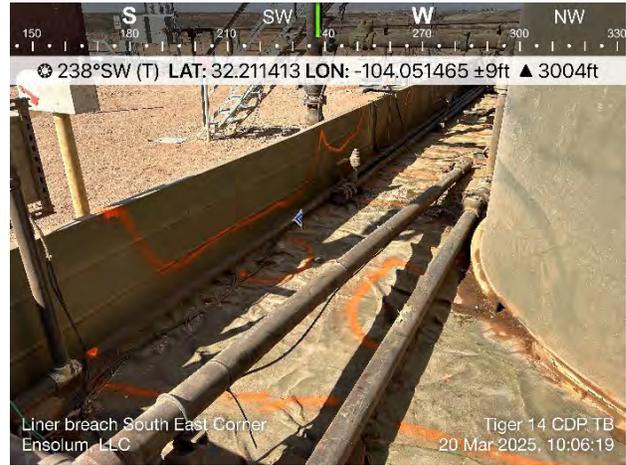
A liner integrity inspection was conducted on March 20, 2025, and the liner was found to be insufficient in containing the release. Boreholes BH01 through BH05 were advanced within the lined secondary containment area utilizing a hand auger and core drill to determine the vertical extent of impacted and waste containing soil beneath the containment area. Borehole BH01 was advanced to a depth of 12 feet bgs, borehole BH02 was advanced to a depth of 16 feet bgs, borehole BH03 was advanced to a depth of 2 feet bgs, borehole BH04 was advanced to a depth of 3 feet bgs, and borehole BH05 was advanced to a depth of 6 feet bgs. After the delineation inside the secondary containment area was completed, all holes were patched by Ensolum personnel and Dupree Energy LLC.

Photograph 6 Date: 3/20/2025
Description: Liner breach Southeast corner
View: Southwest

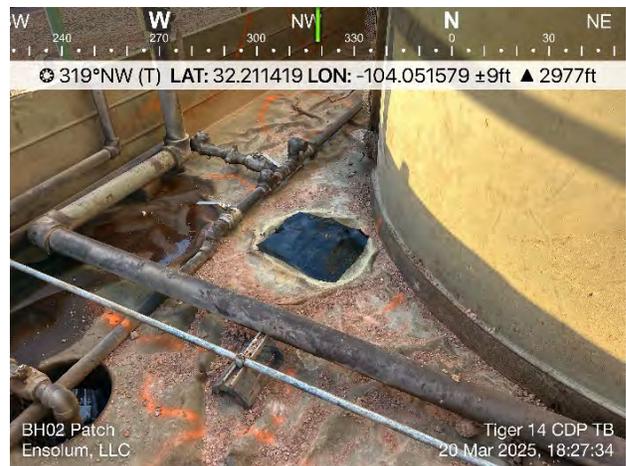
Photograph 16 Date:3/20/2025
Description: BH02 Patch
View: Northwest

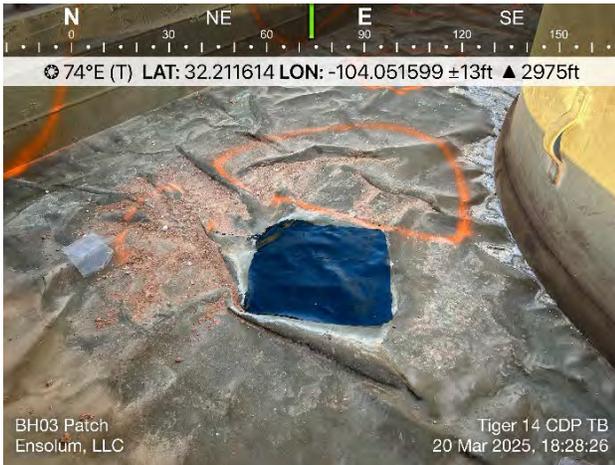
Photograph 17
Description: BH03 Patch
View: East

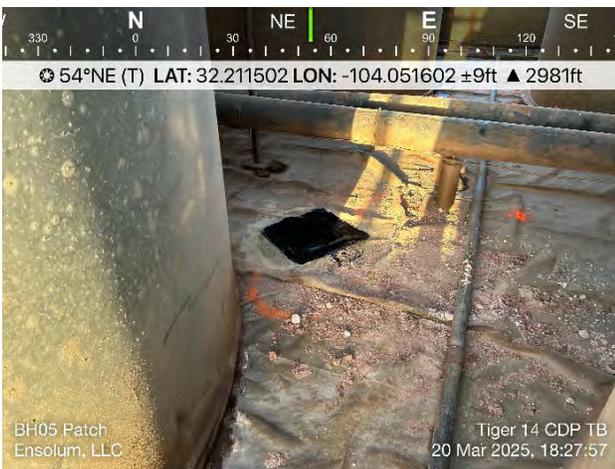
Photograph 19
Description: BH05 Patch
View: Northeast

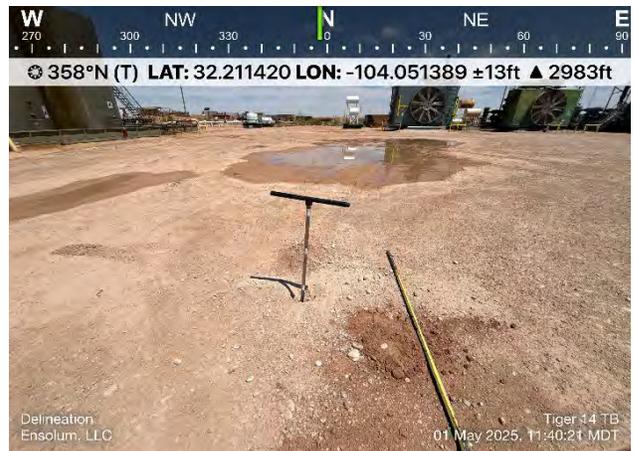
Photograph 28 Date: 5/1/2025
Description: Delineation (BH14); Water from previous rain event
View: North
