Incident Number: NAPP2513929022

Amended Release Assessment and Deferral

Corral Canyon 15 CVB

Release Assessment and Deferral
Corral Canyon 15 CVB
Section 22, Township 25 South, Range 29 East
County: Eddy

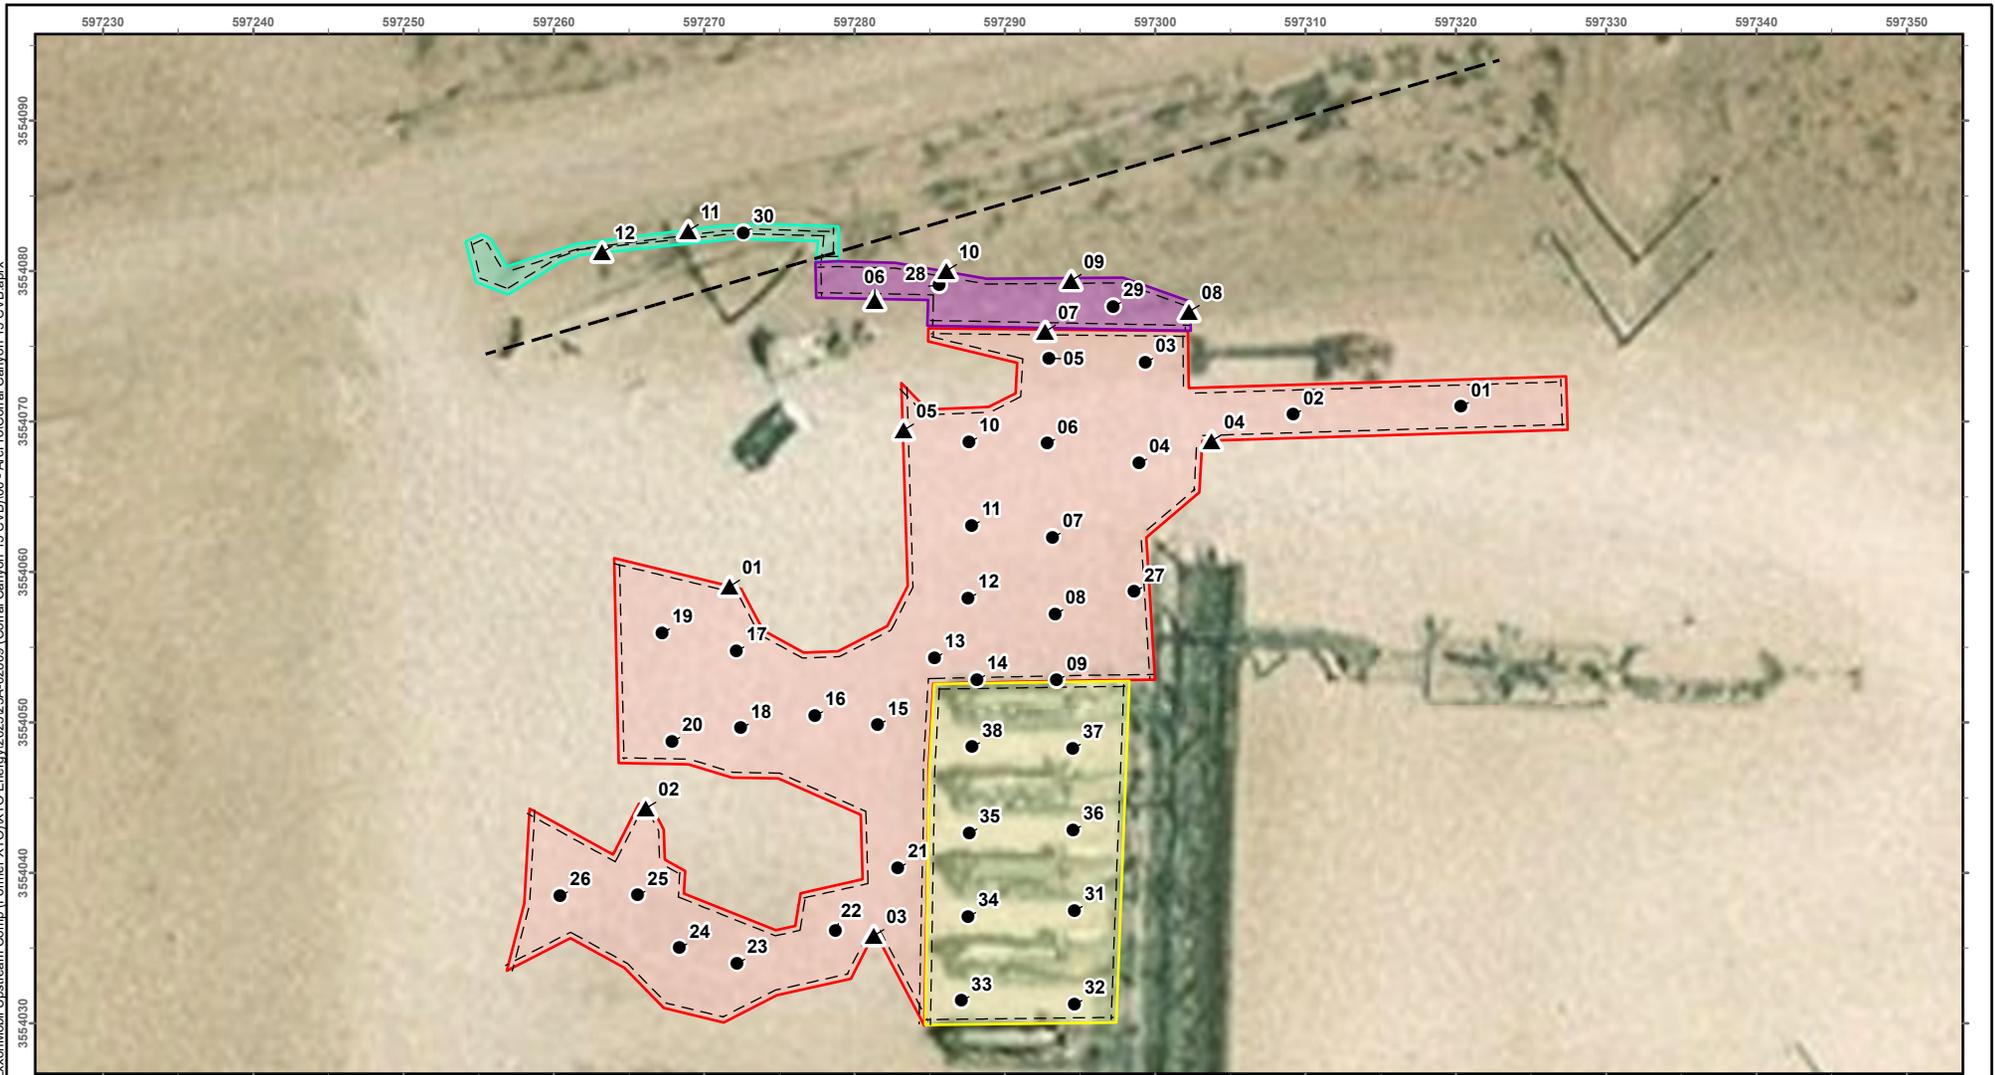
- Base Sample (Prefixed by "BS25-")
- ▲ Wall Sample (Prefixed by "WS25-")
- Pipeline (Aboveground)
- Excavation to 1' bgs (~ 10,063 sq.ft. | 977 ft.)
- Excavation to 2' bgs (~ 333 sq.ft. | 190 ft.)
- Excavation to 5' bgs (~ 792 sq.ft. | 184 ft.)
- Deferral Area (~3,156 sq.ft. | 233 ft.)

infrastructure and equipment and is deemed unsafe for mechanical excavation of contaminated materials. An initial attempt was made to hand dig the area; however, such action was unsuccessful at remediating the area. The required mechanical excavation is both unsafe and not feasible given the proximity to equipment and infrastructure.

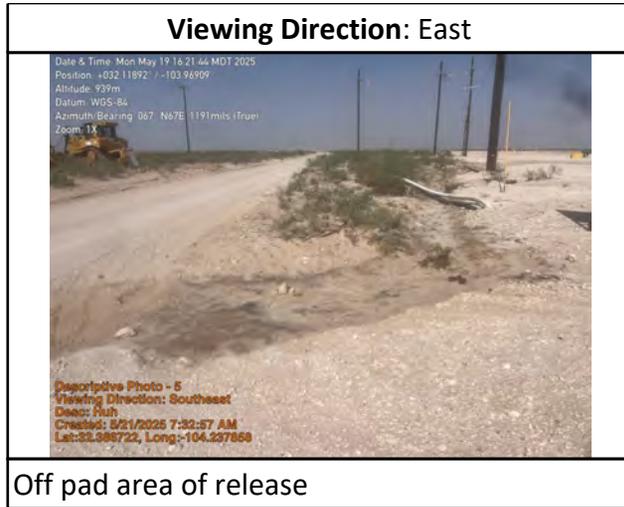
Off pad area of release

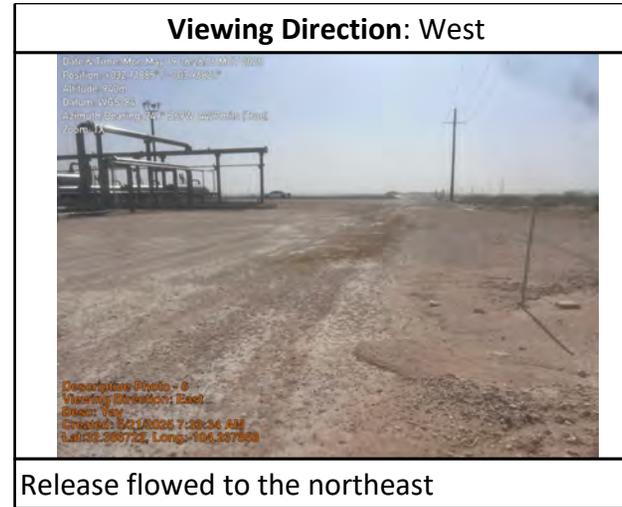
Release flowed to the northeast

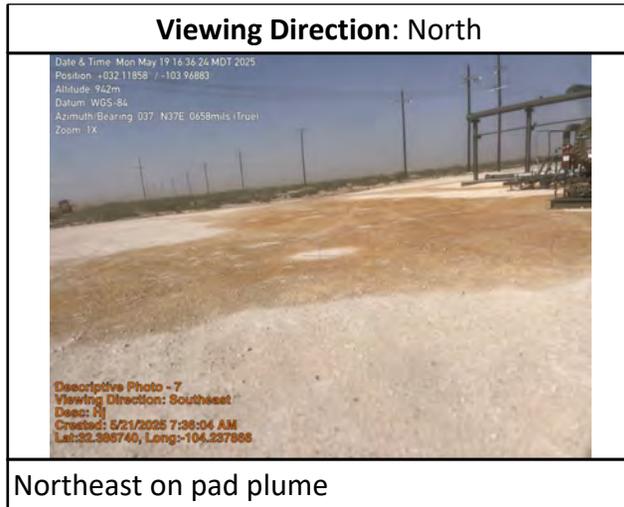
Northeast on pad plume

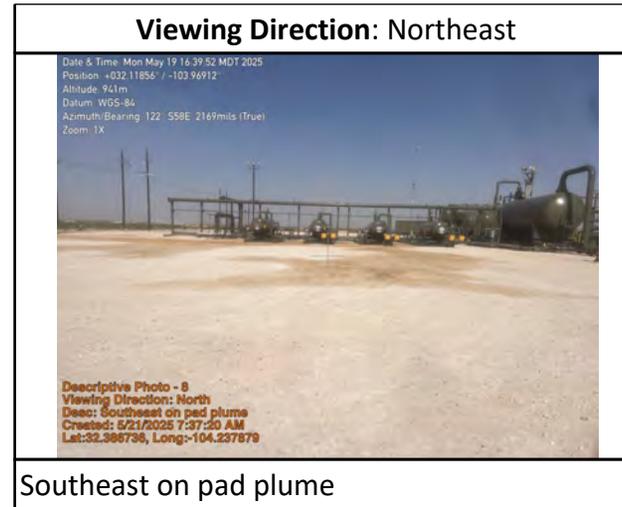
Southeast on pad plume

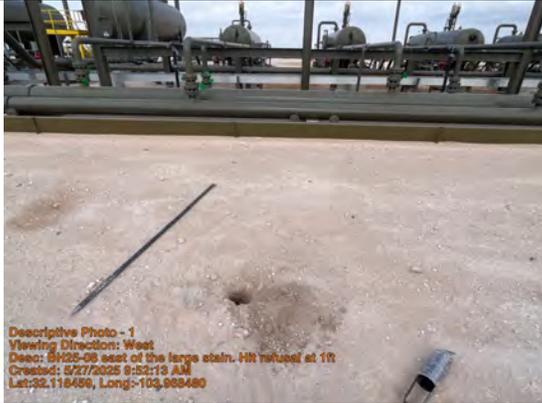
Descriptive Photo - 1
Viewing Direction: West
Desc: BH25-08 east of the large stain. Hit refusal at 1ft
Created: 5/27/2025 9:52:13 AM
Lat:32.118456, Long:-103.988480

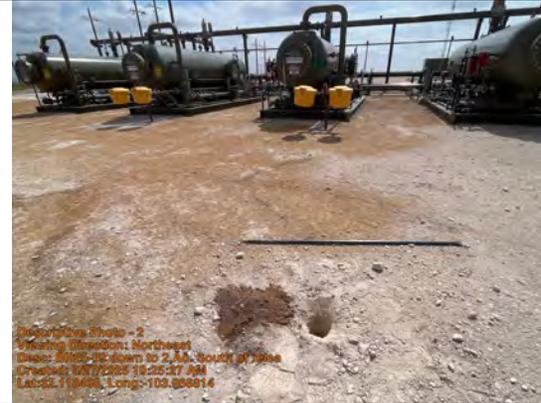
Descriptive Photo - 2
Viewing Direction: Northeast
Desc: BH25-09 down to 2'. South of release
Created: 5/27/2025 10:25:17 AM
Lat:32.118498, Long:-103.988814

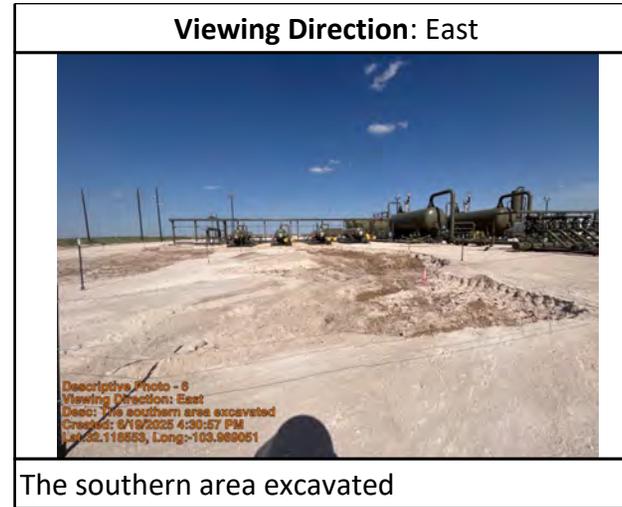
The southern area excavated

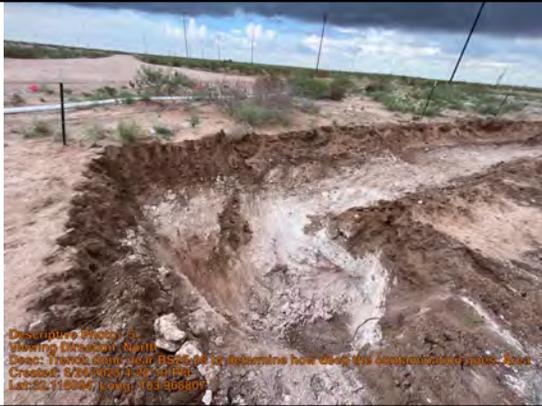
Trench done near BS25-28 to determine how deep the contamination goes. Area was not entered by people. Material was field screened ~1/ft

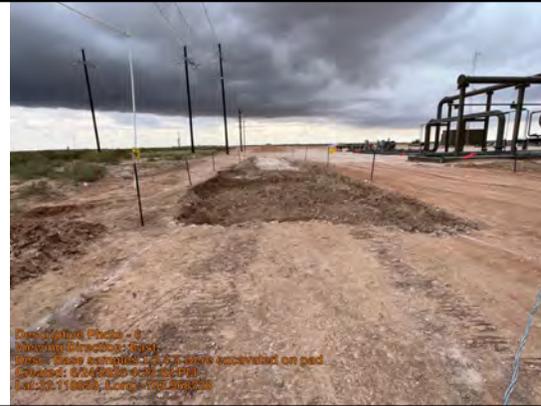
Base samples 1,2,4,5 were excavated on pad

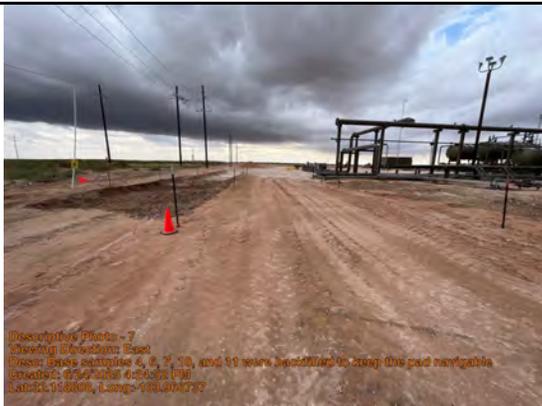
Base samples 4, 6, 7, 10, and 11 were backfilled to keep the pad navigable

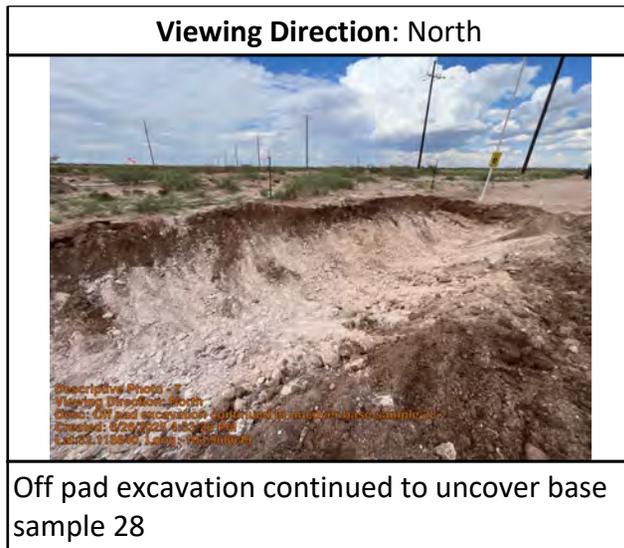
Off pad excavation continued to uncover base sample 28
