**Re: Re-Vegetation Closure Report
Golden Tyche CTB Release
BTA Oil Producers, LLC
Lea County, New Mexico
NMOCD Incident ID: nAPP2507652940
Project Location: 32.920603, -103.361783**

Re-Vegetation Closure Report
Golden Tyche CTB

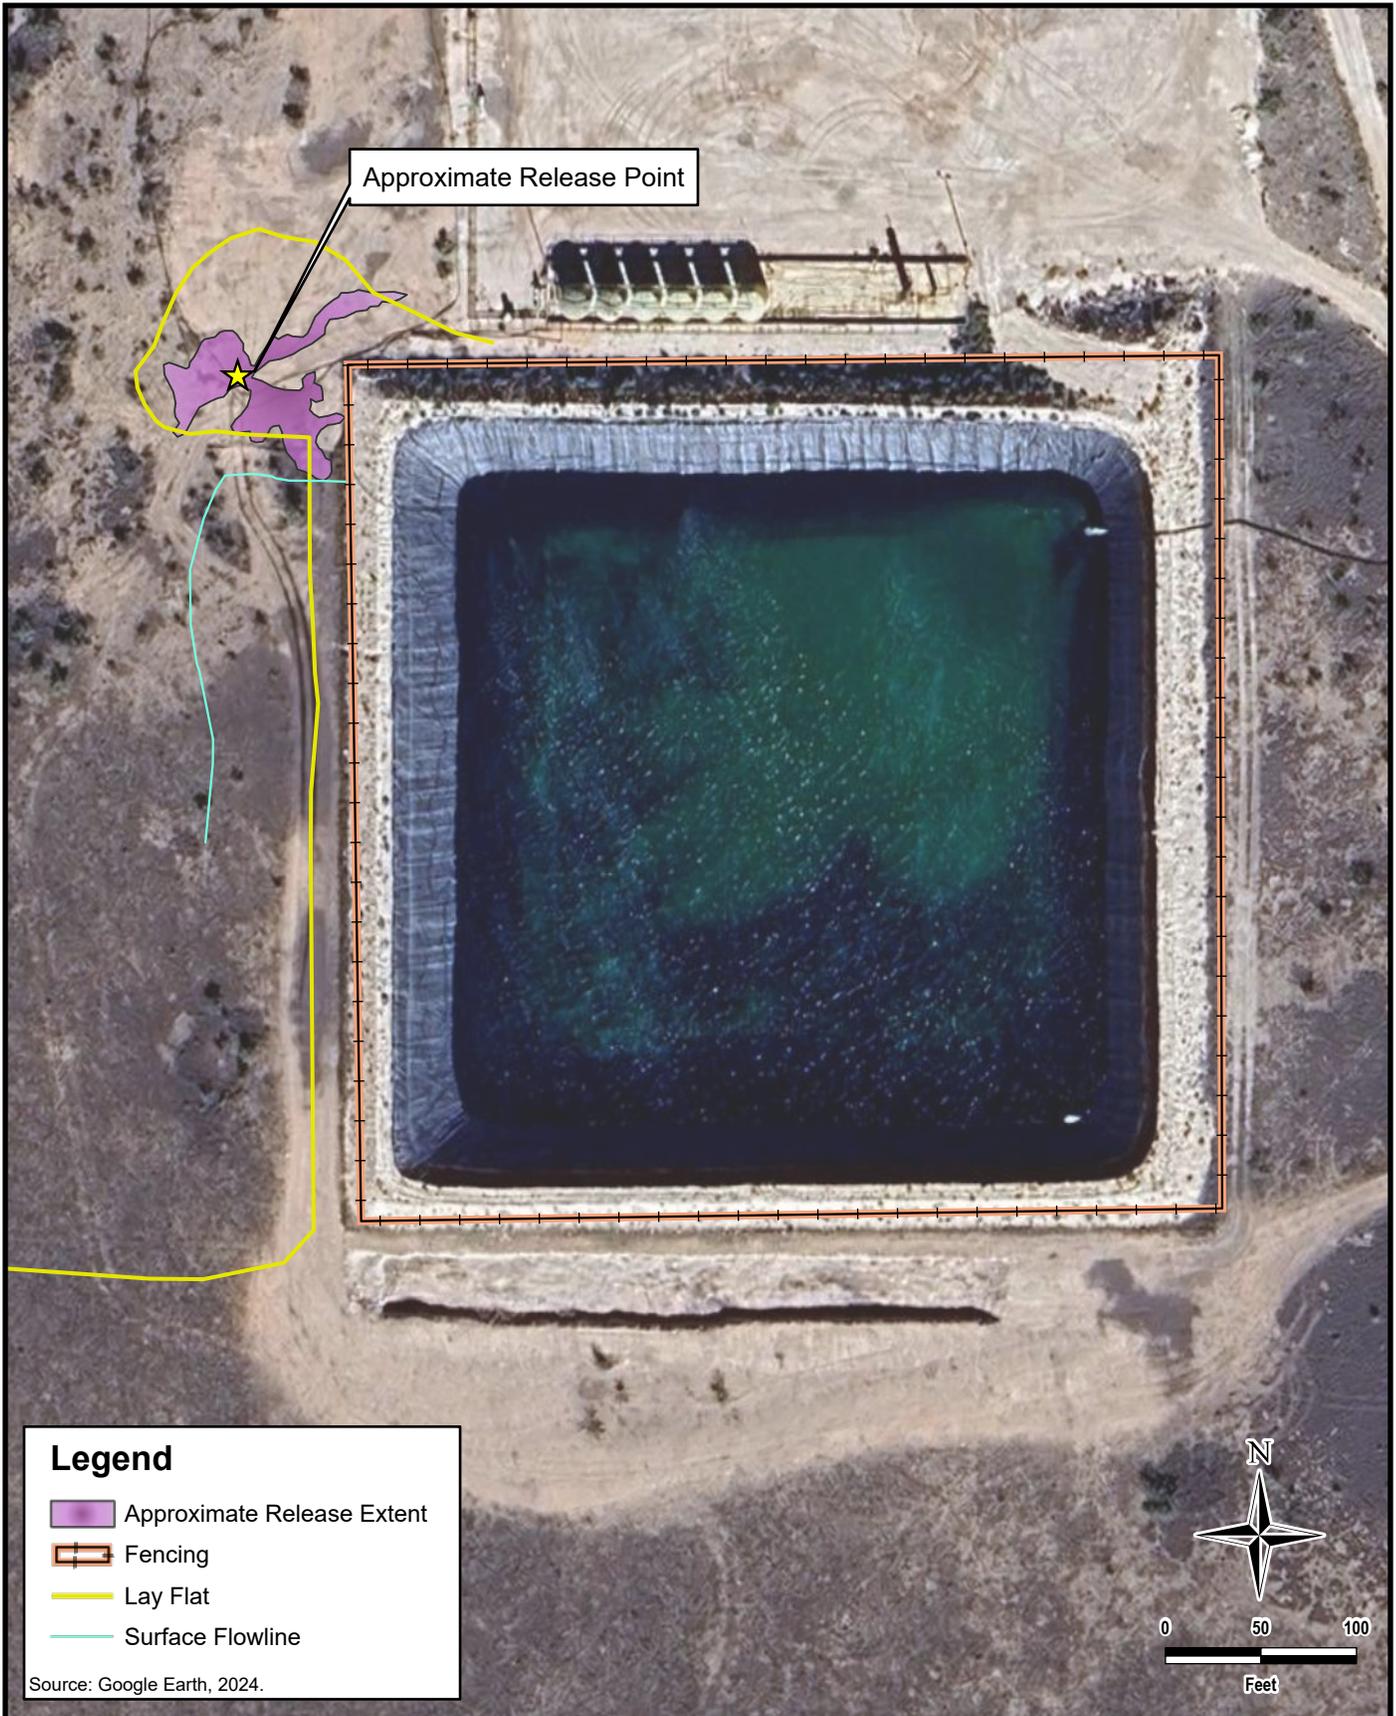
<p>TETRA TECH</p> <p>www.tetrattech.com</p> <p>901 West Wall Street, Suite 100 Midland, Texas 79701 Phone: (432) 682-4559 Fax: (432) 682-3946</p>	<p>BTA OIL PRODUCERS, LLC</p> <p>NAPP2507652940 (32.920550°, -103.361859°) LEA COUNTY, NEW MEXICO</p>	<p>PROJECT NO.: 212C-MD-03828</p> <p>DATE: NOVEMBER 19, 2025</p> <p>DESIGNED BY: LMV</p>
	<p>GOLDEN TYCHE CTB RELEASE APPROXIMATE RELEASE EXTENT</p>

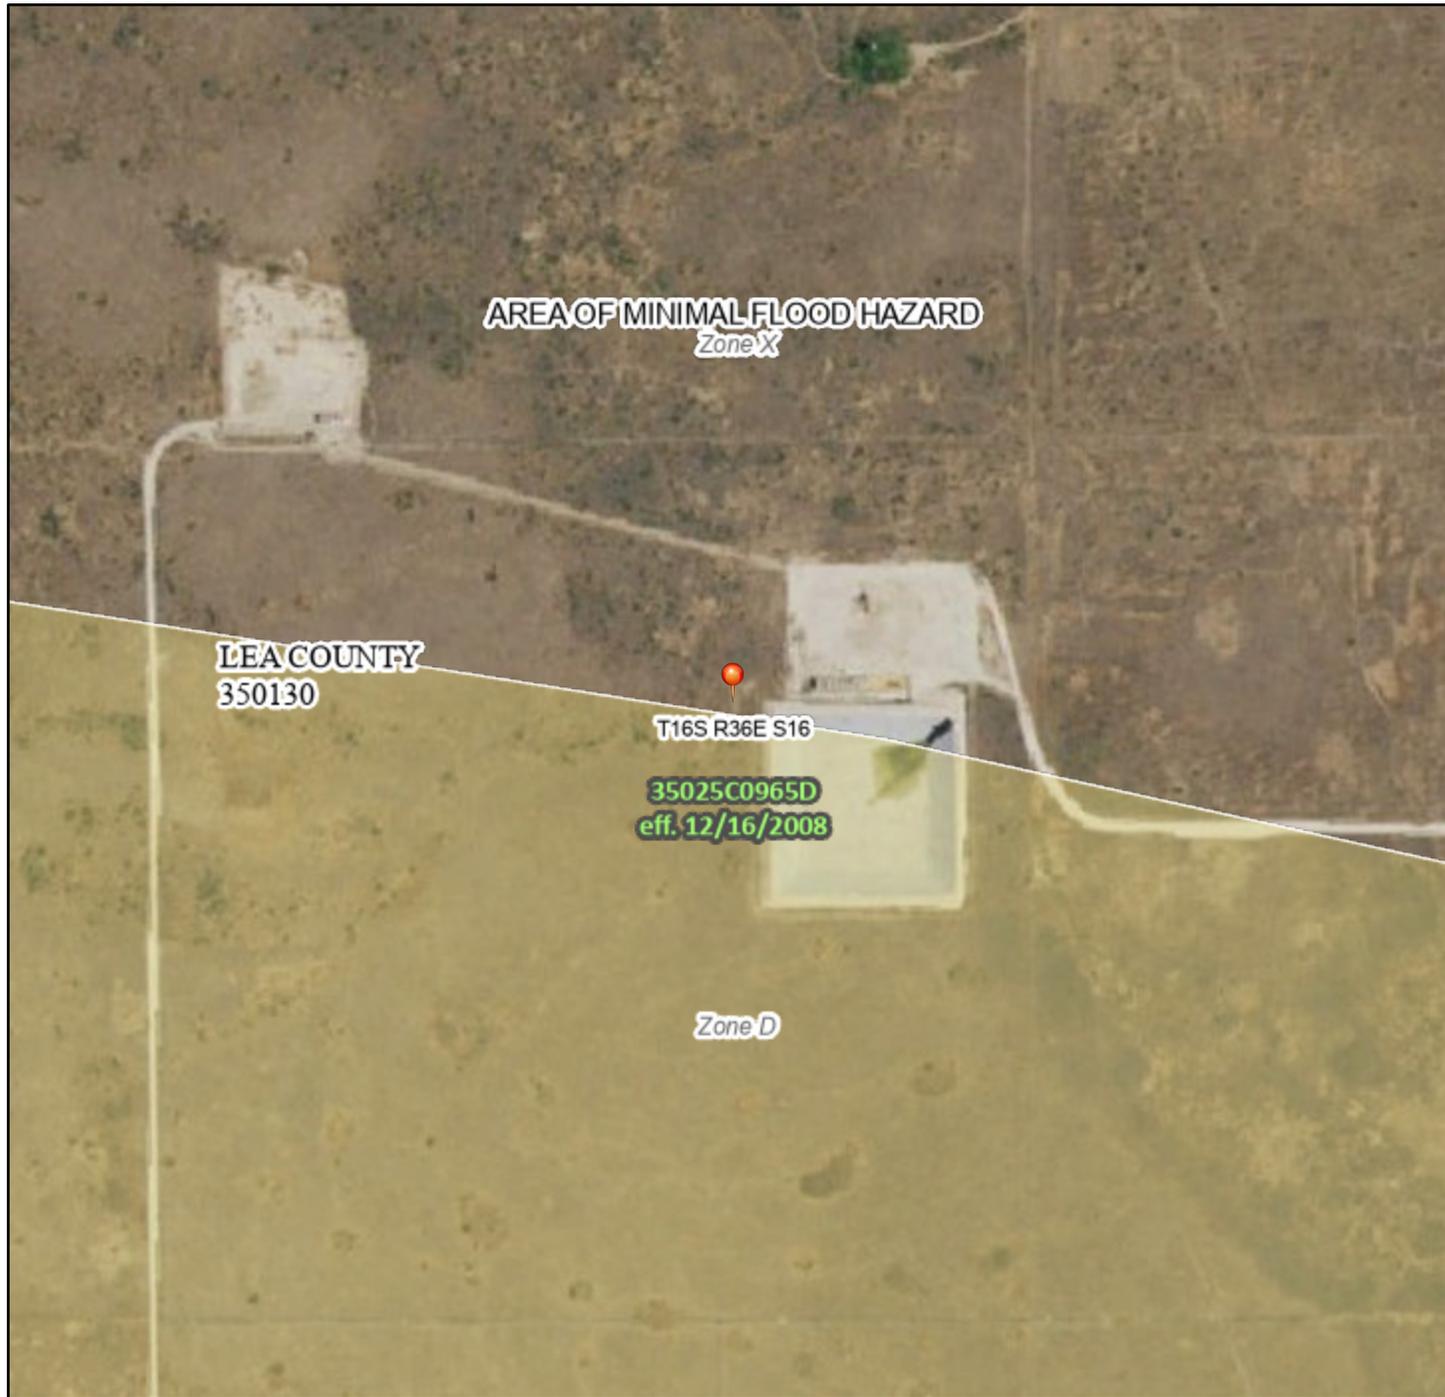
The flood hazard information is derived directly from the authoritative NFHL web services provided by FEMA. This map was exported on 11/7/2025 at 7:30 PM and does not reflect changes or amendments subsequent to this date and time. The NFHL and effective information may change or become superseded by new data over time.

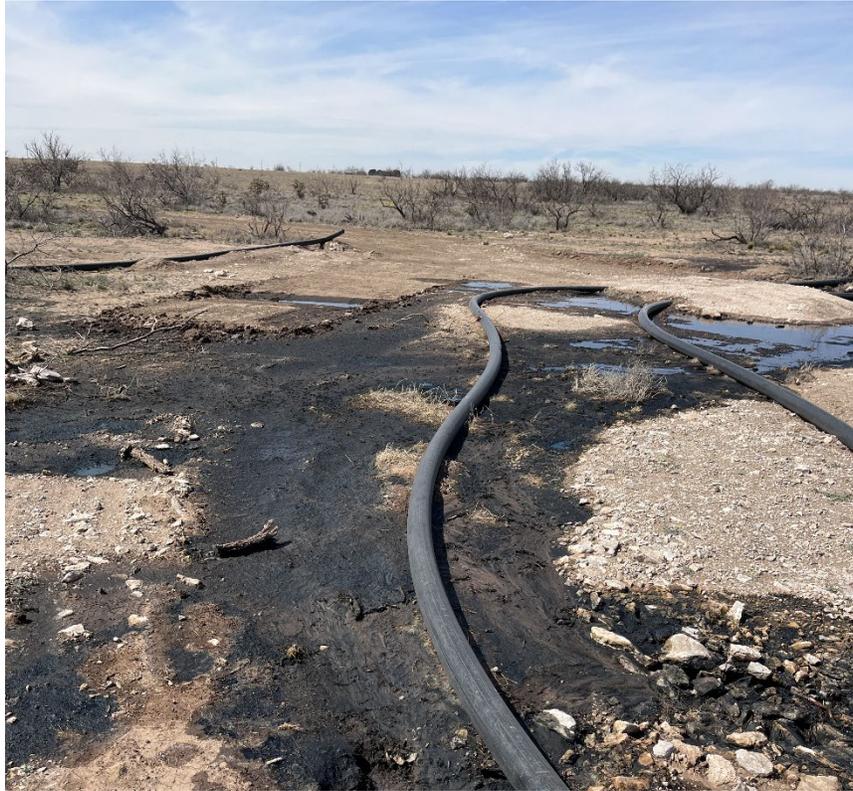
TETRA TECH, INC. PROJECT NO. 212C-MD-03828	DESCRIPTION	View of approximate release extent.	1
	SITE NAME	Golden Tyche CTB	N/A

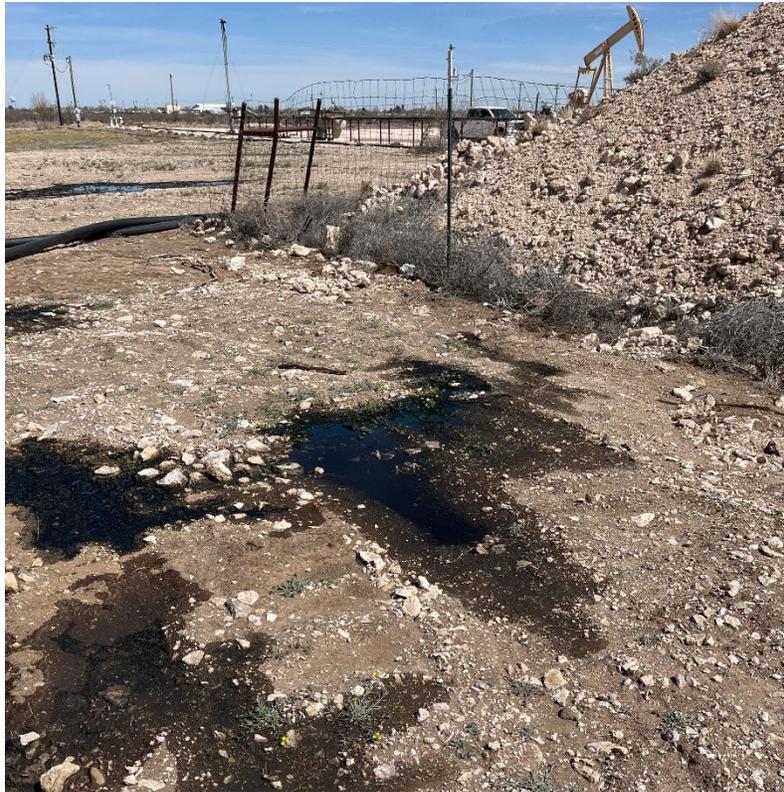
TETRA TECH, INC. PROJECT NO. 212C-MD-03828	DESCRIPTION	View of approximate release extent.	2
	SITE NAME	Golden Tyche CTB	N/A

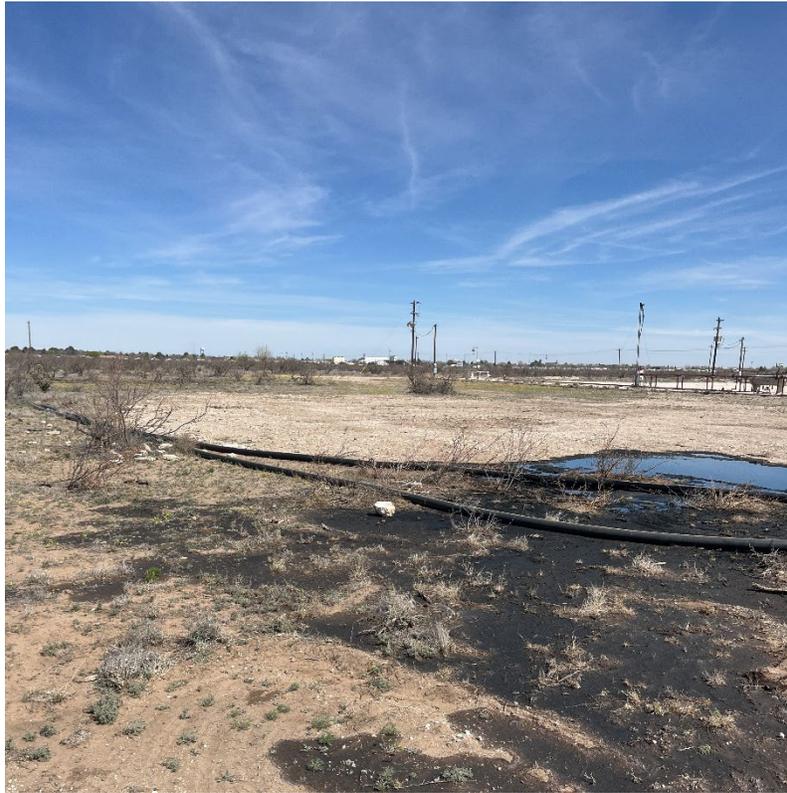
TETRA TECH, INC. PROJECT NO. 212C-MD-03828	DESCRIPTION	View of approximate release extent.	3
	SITE NAME	Golden Tyche CTB	N/A

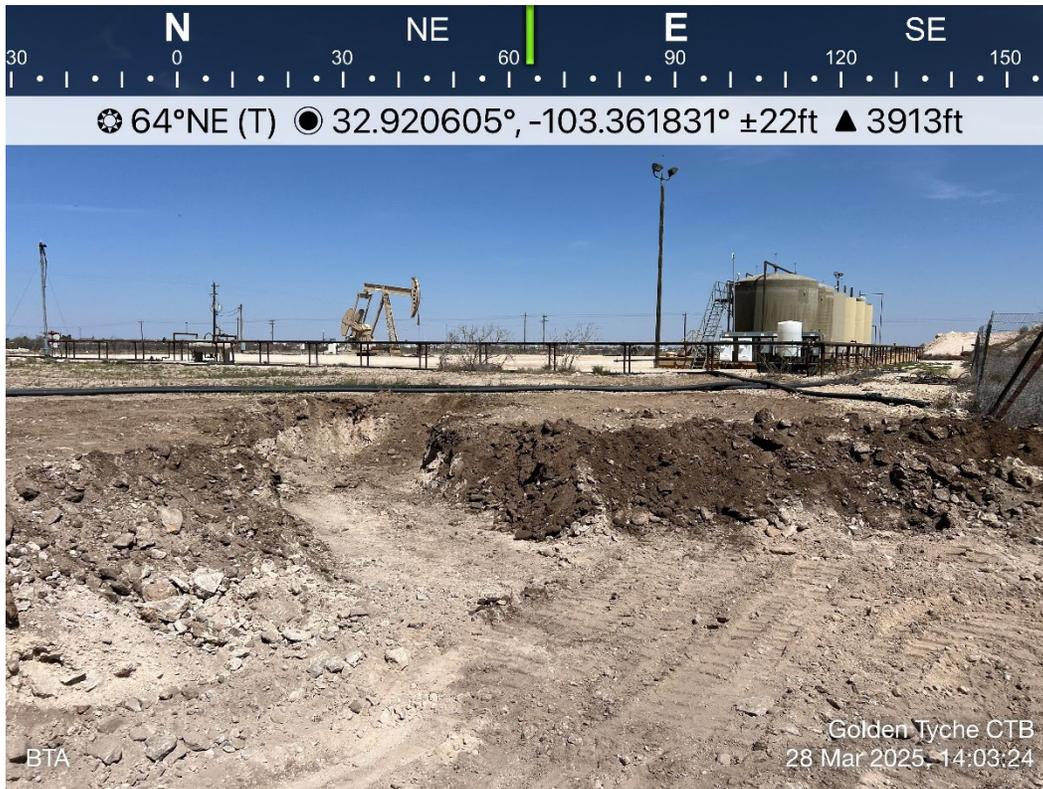
TETRA TECH, INC. PROJECT NO. 212C-MD-03828	DESCRIPTION	View east-northeast of excavation progress.	4
	SITE NAME	Golden Tyche CTB	3/28/2025

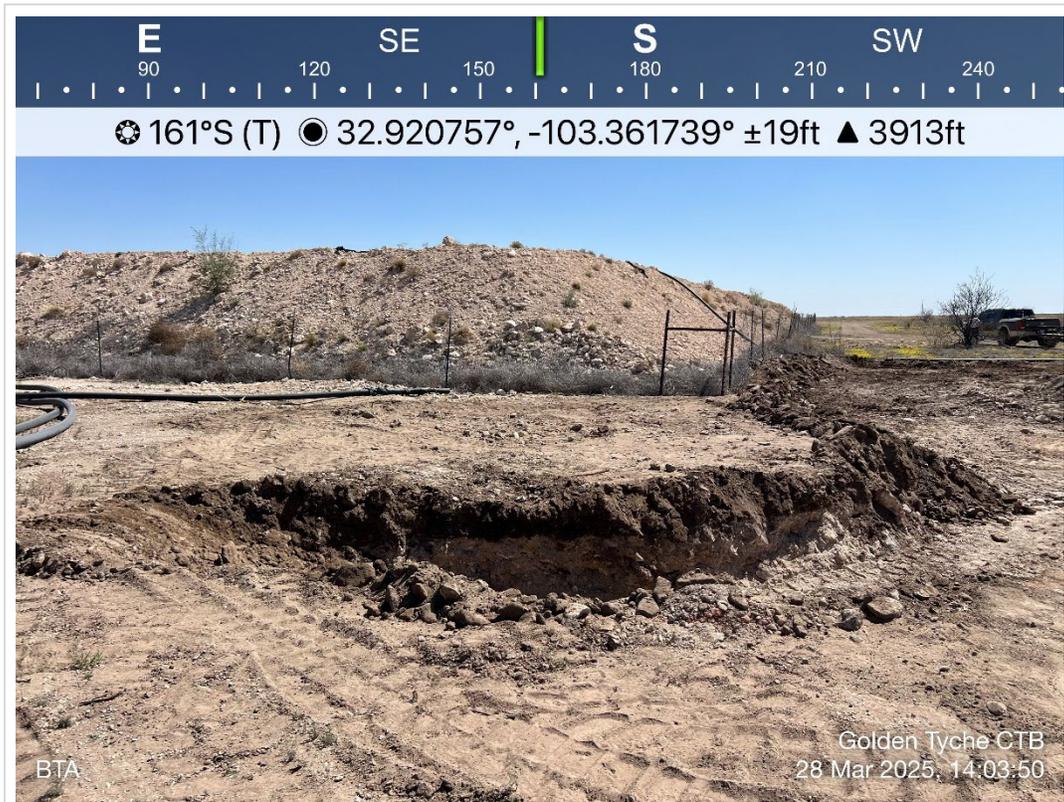
TETRA TECH, INC. PROJECT NO. 212C-MD-03828	DESCRIPTION	View south-southeast of excavation progress.	5
	SITE NAME	Golden Tyche CTB	3/28/2025

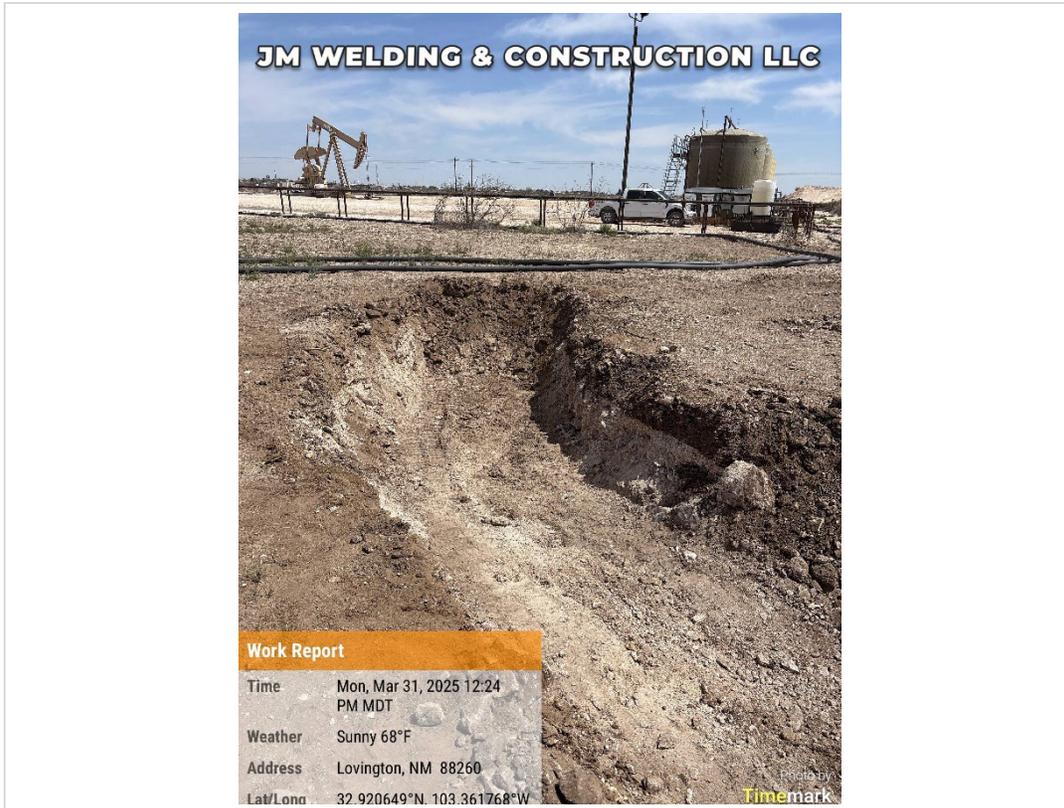
TETRA TECH, INC. PROJECT NO. 212C-MD-03828	DESCRIPTION	View of excavation progress.	6
	SITE NAME	Golden Tyche CTB	3/31/2025

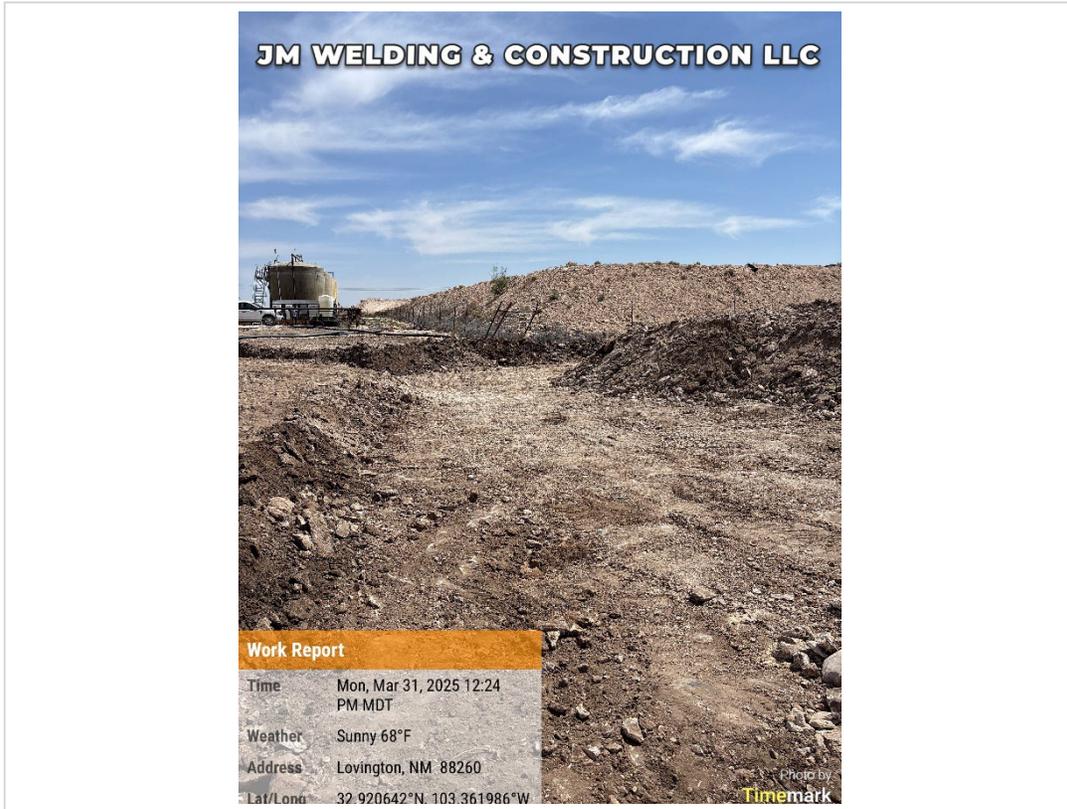
TETRA TECH, INC. PROJECT NO. 212C-MD-03828	DESCRIPTION	View of excavation progress.	7
	SITE NAME	Golden Tyche CTB	3/31/2025

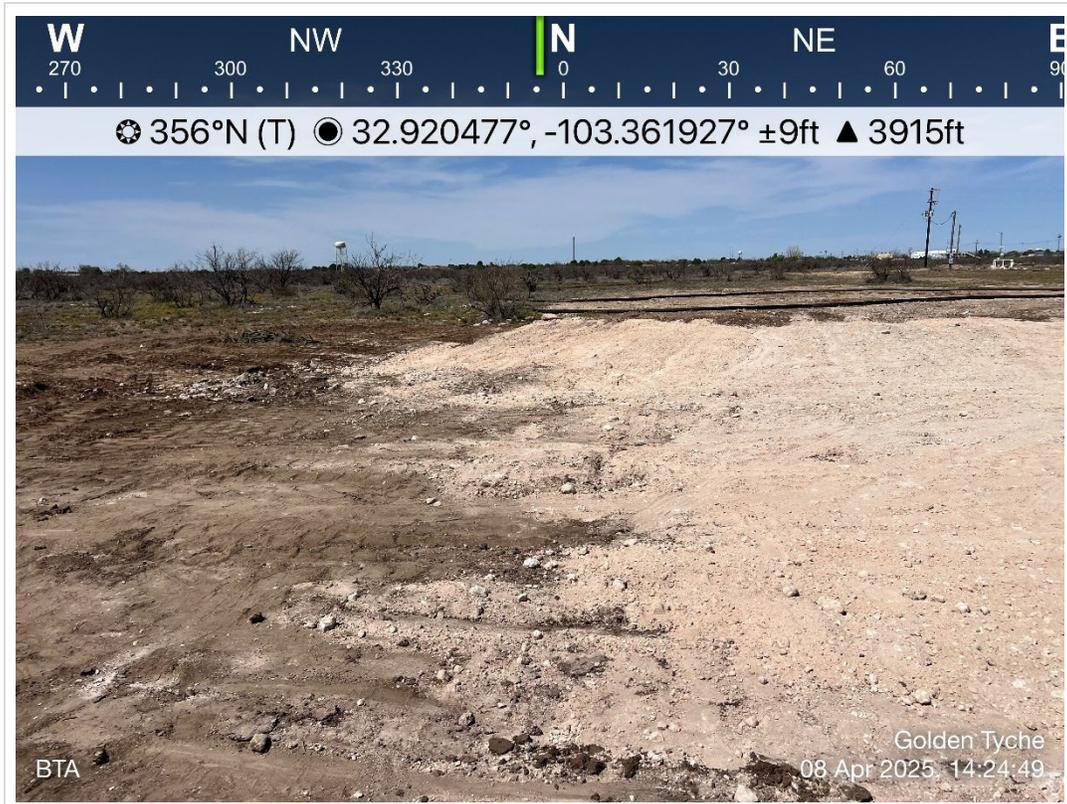
TETRA TECH, INC. PROJECT NO. 212C-MD-03828	DESCRIPTION	View north of backfilled excavation.	8
	SITE NAME	Golden Tyche CTB	4/8/2025

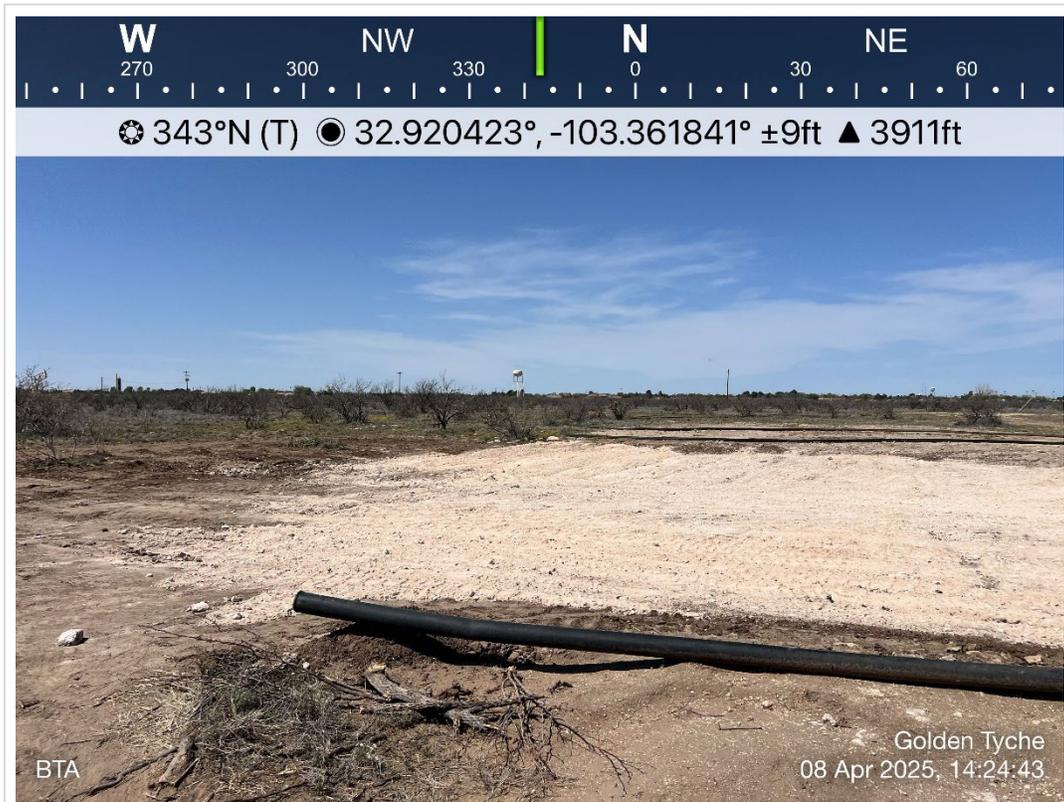
TETRA TECH, INC. PROJECT NO. 212C-MD-03828	DESCRIPTION	View north of backfilled excavation.	9
	SITE NAME	Golden Tyche CTB	4/8/2025

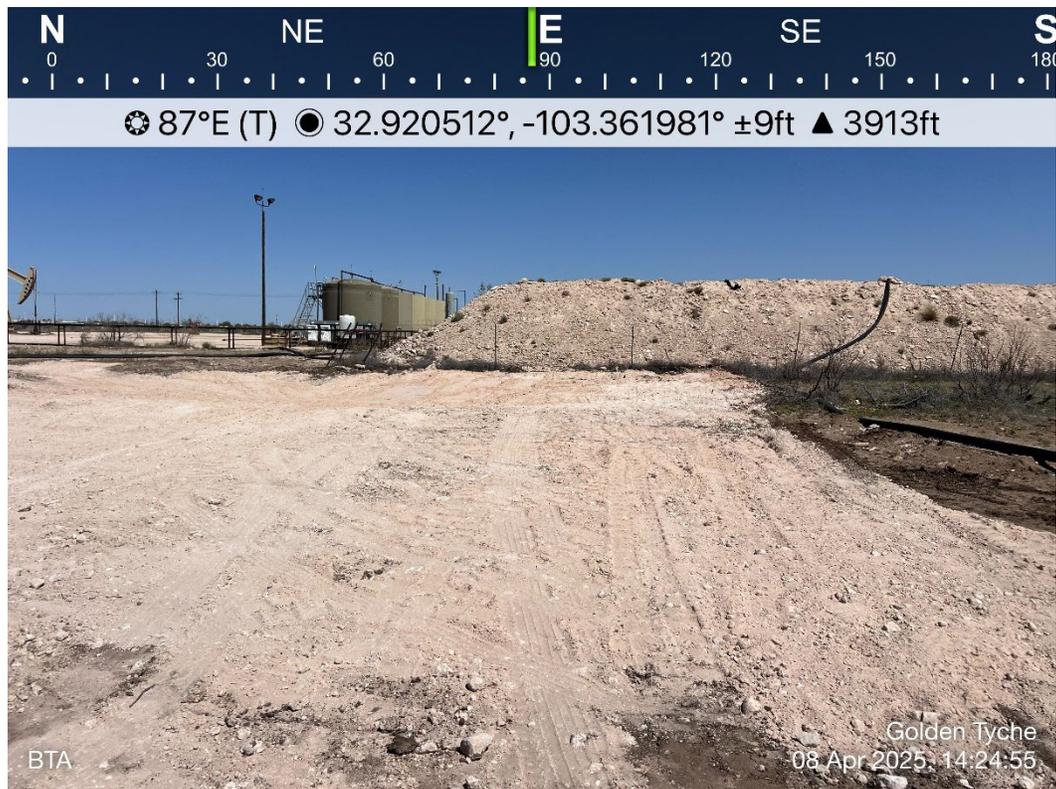
TETRA TECH, INC. PROJECT NO. 212C-MD-03828	DESCRIPTION	View east of backfilled excavation.	10
	SITE NAME	Golden Tyche CTB	4/8/2025

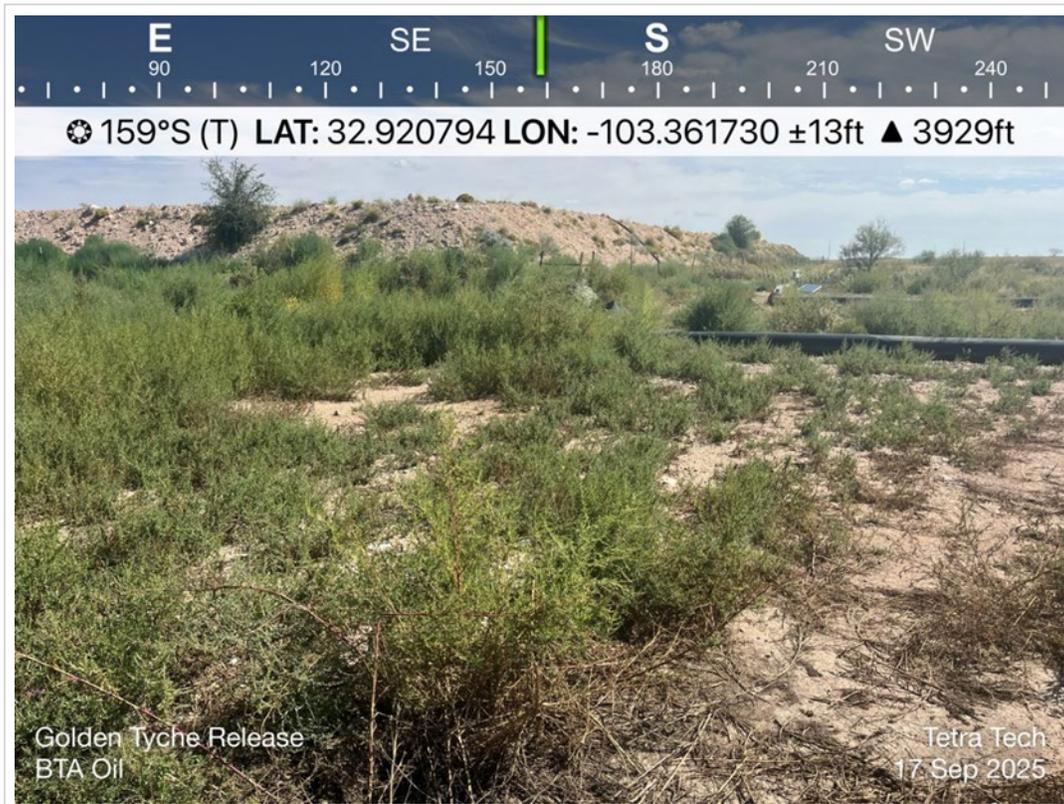
TETRA TECH, INC. PROJECT NO. 212C-MD-03828	DESCRIPTION	View south-southeast. Dense vegetation in previously remediated area.	11
	SITE NAME	Golden Tyche CTB	9/17/2025

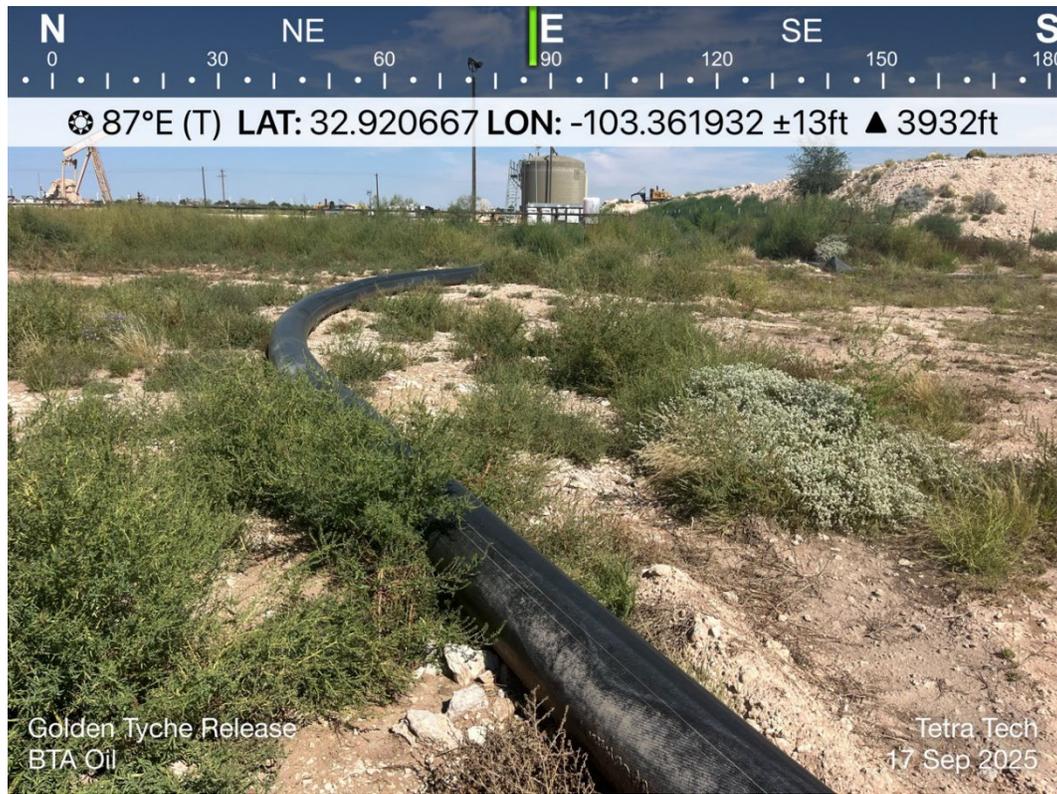
TETRA TECH, INC. PROJECT NO. 212C-MD-03828	DESCRIPTION	View east. Dense vegetation in previously remediated area.	12
	SITE NAME	Golden Tyche CTB	9/17/2025

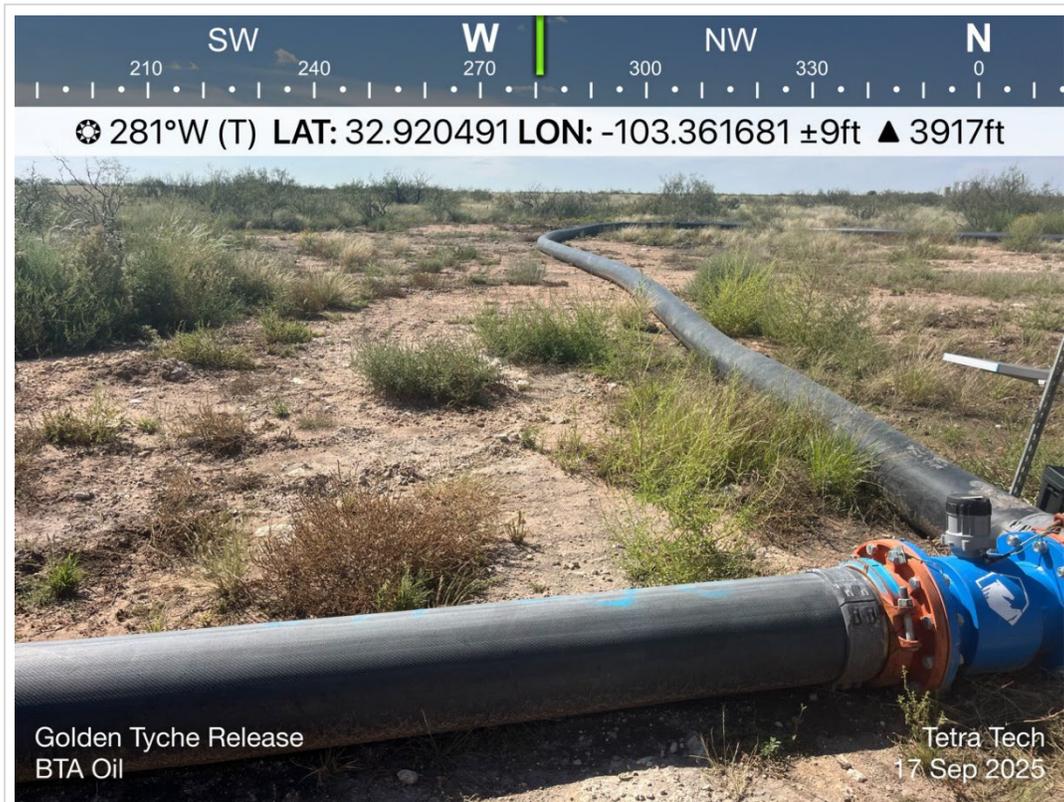
TETRA TECH, INC. PROJECT NO. 212C-MD-03828	DESCRIPTION	View west. Dense vegetation in previously remediated area.	13
	SITE NAME	Golden Tyche CTB	9/17/2025

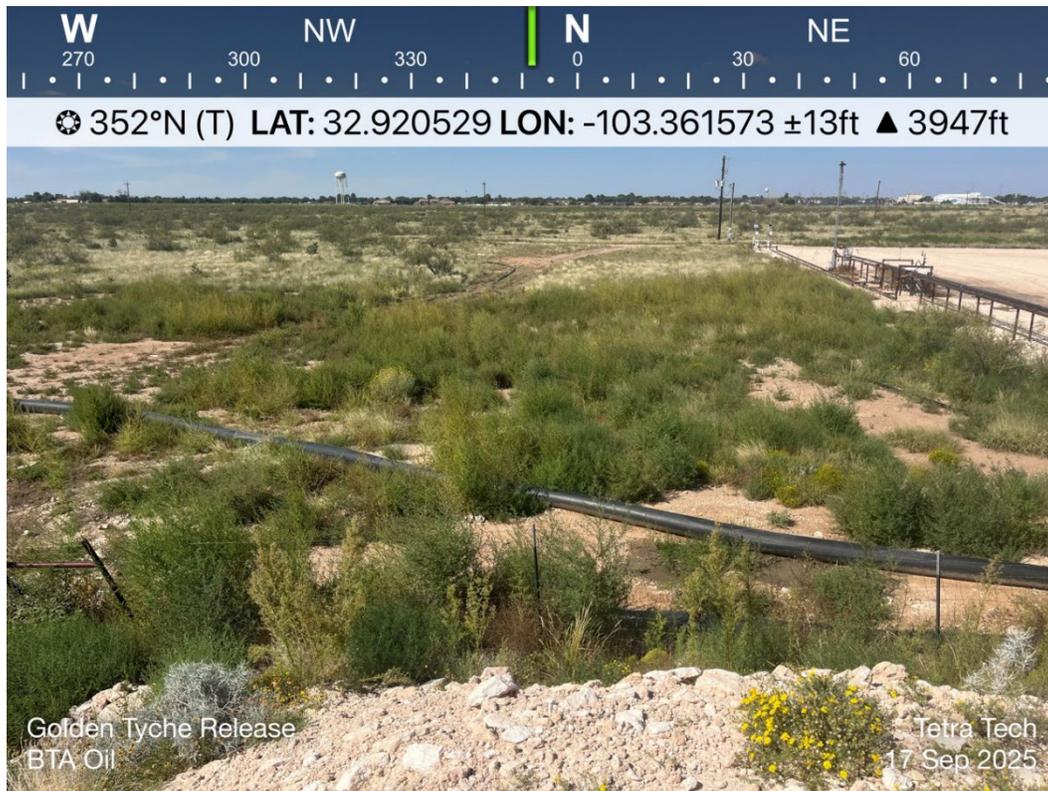
TETRA TECH, INC. PROJECT NO. 212C-MD-03828	DESCRIPTION	View north. Dense vegetation in previously remediated area.	14
	SITE NAME	Golden Tyche CTB	9/17/2025

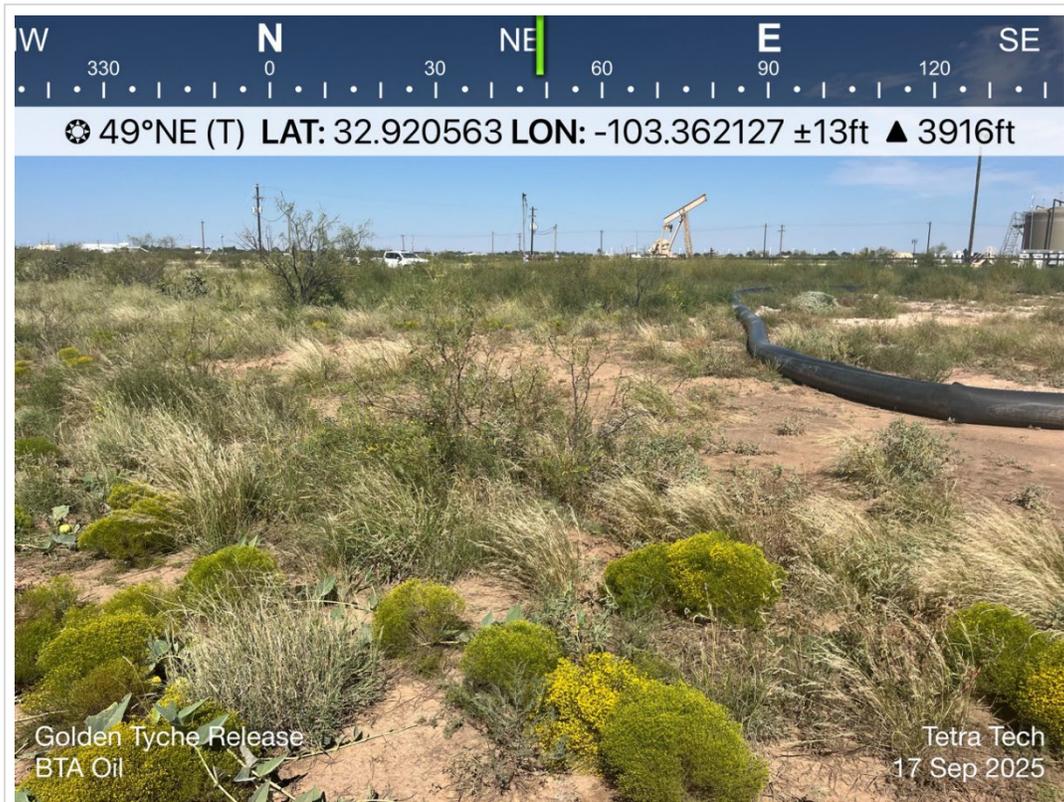
TETRA TECH, INC. PROJECT NO. 212C-MD-03828	DESCRIPTION	View northeast. Dense vegetation in previously remediated area.	15
	SITE NAME	Golden Tyche CTB	9/17/2025

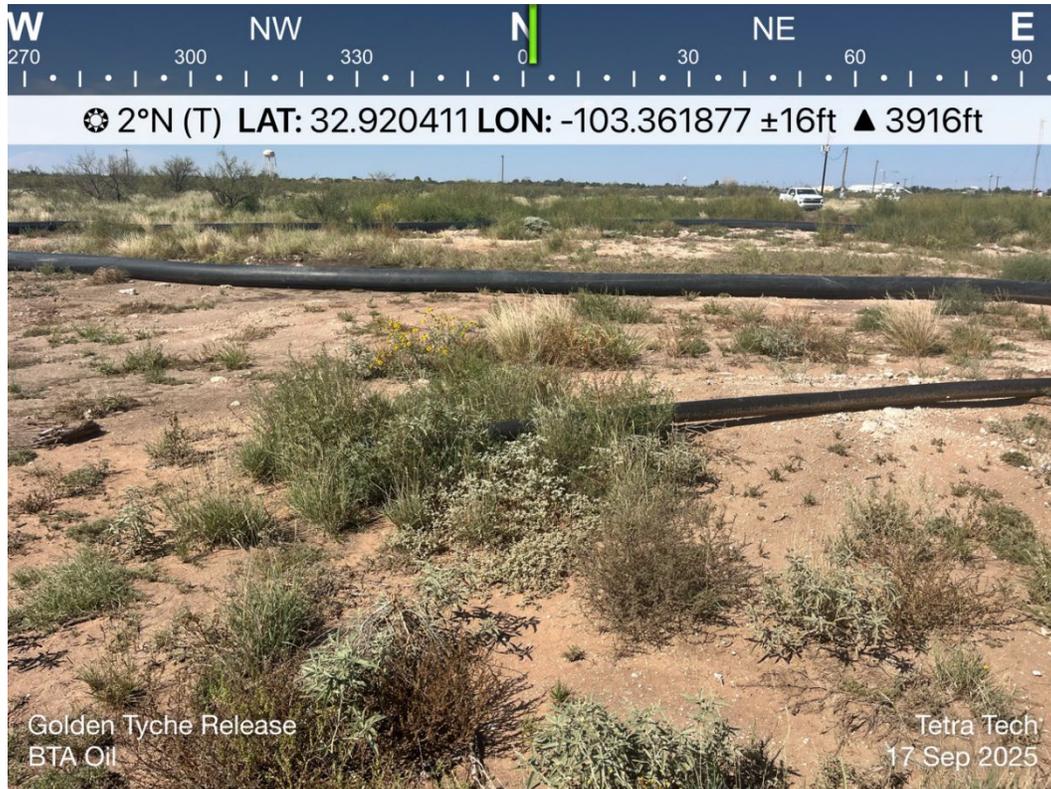
TETRA TECH, INC. PROJECT NO. 212C-MD-03828	DESCRIPTION	View north. Dense vegetation in previously remediated area.	16
	SITE NAME	Golden Tyche CTB	9/17/2025

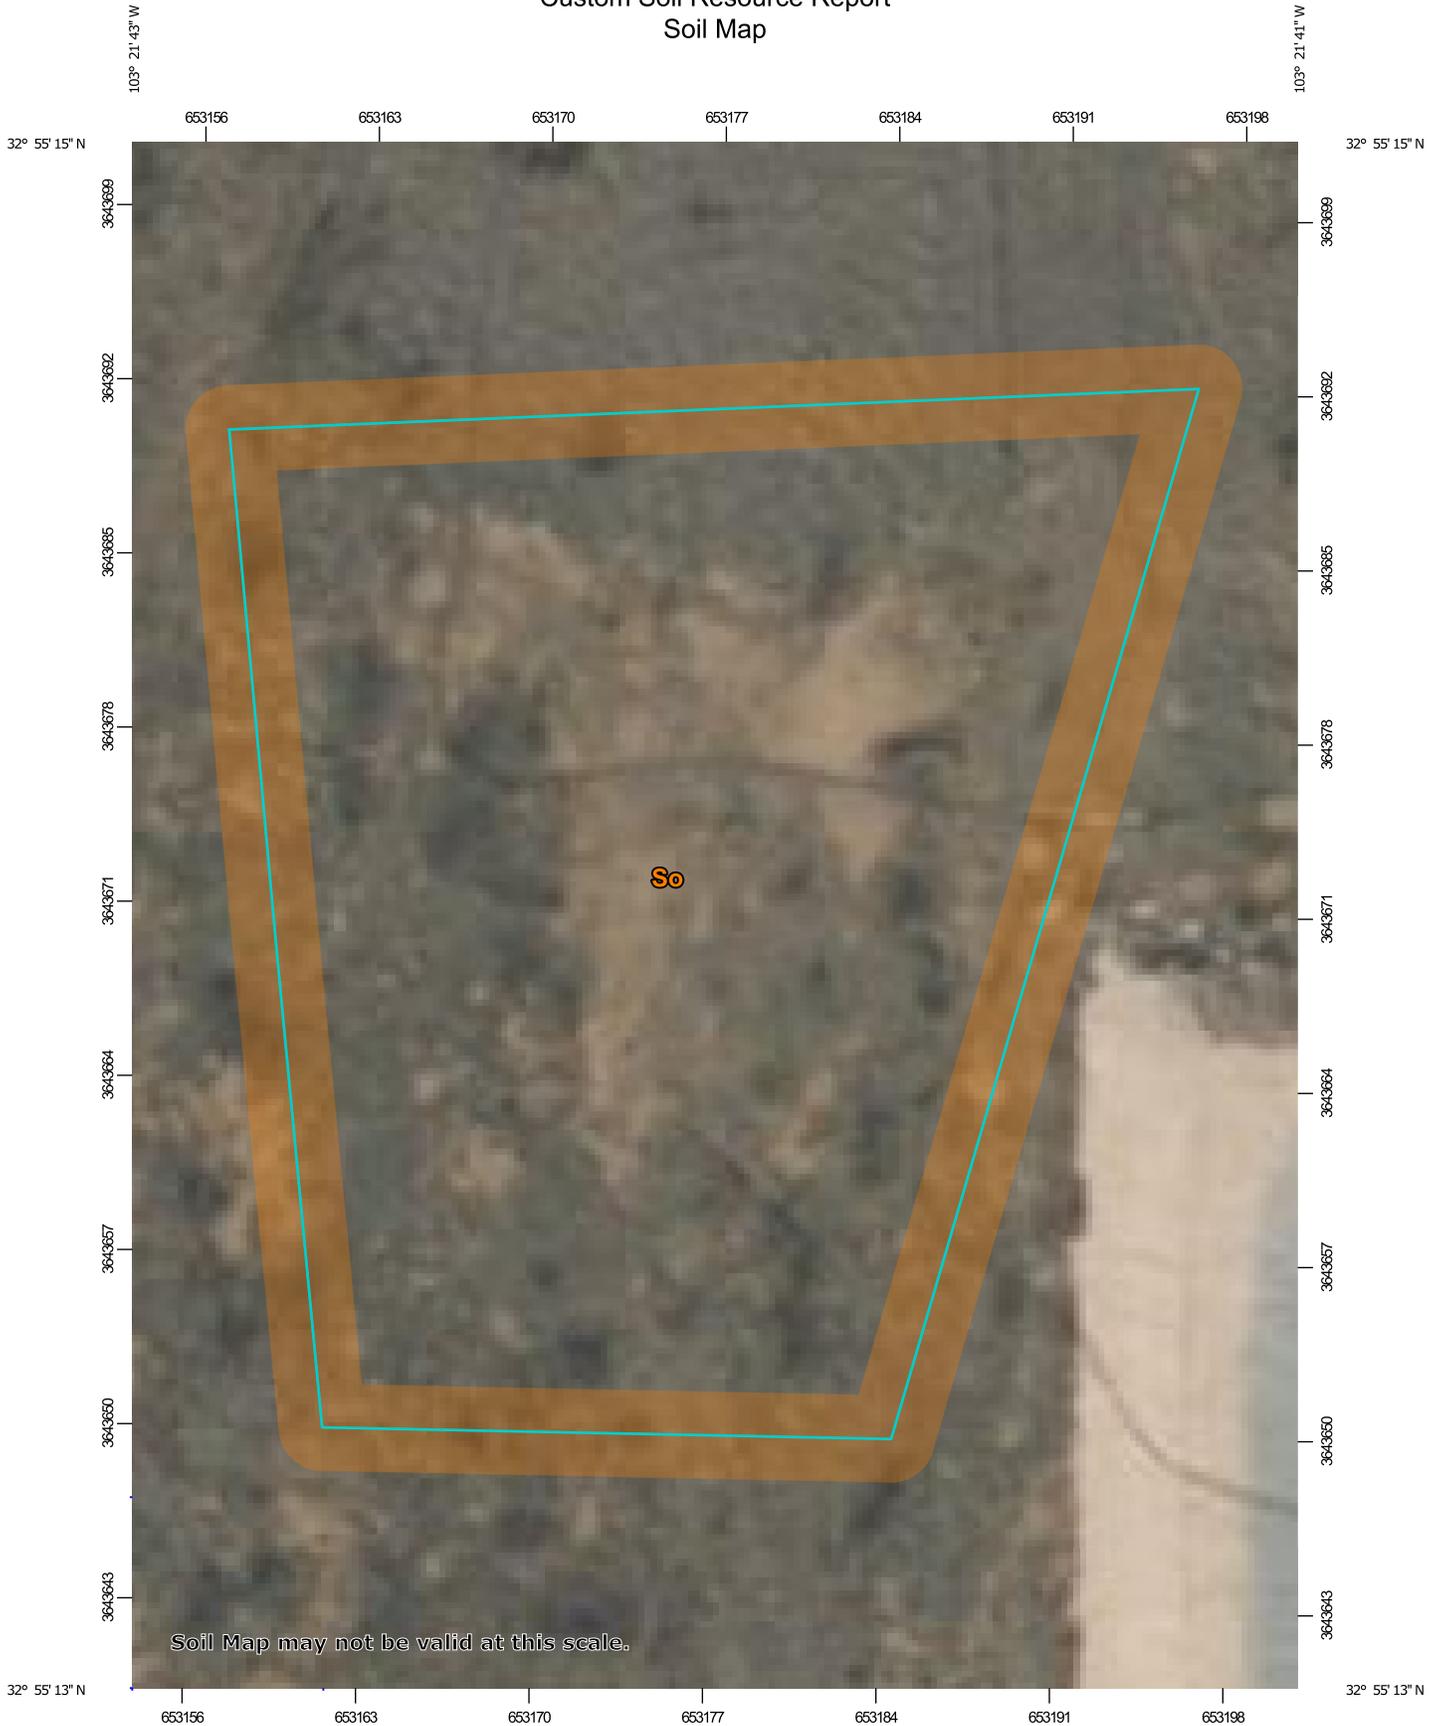
Custom Soil Resource Report Soil Map

The soil map section includes the soil map for the defined area of interest, a list of soil map units on the map and extent of each map unit, and cartographic symbols displayed on the map. Also presented are various metadata about data used to produce the map, and a description of each soil map unit.

Soil Map may not be valid at this scale.

Map Scale: 1:303 if printed on A portrait (8.5" x 11") sheet.
