Site Characterization & Remediation Plan

**Extex Operating Company
Indigo Federal #001
Eddy County, New Mexico
Unit L, Section 13, Township 20 South, Range 28 East
Latitude 32.570957° North, Longitude -104.137466° West
NMOCD Incident # nAPP2526247417**

Indigo Federal #001
Unit L, Section 13, Township 20 South,
Range 28 East
Eddy County, New Mexico
API: 30-015-26478
Incident: nAPP2526247417

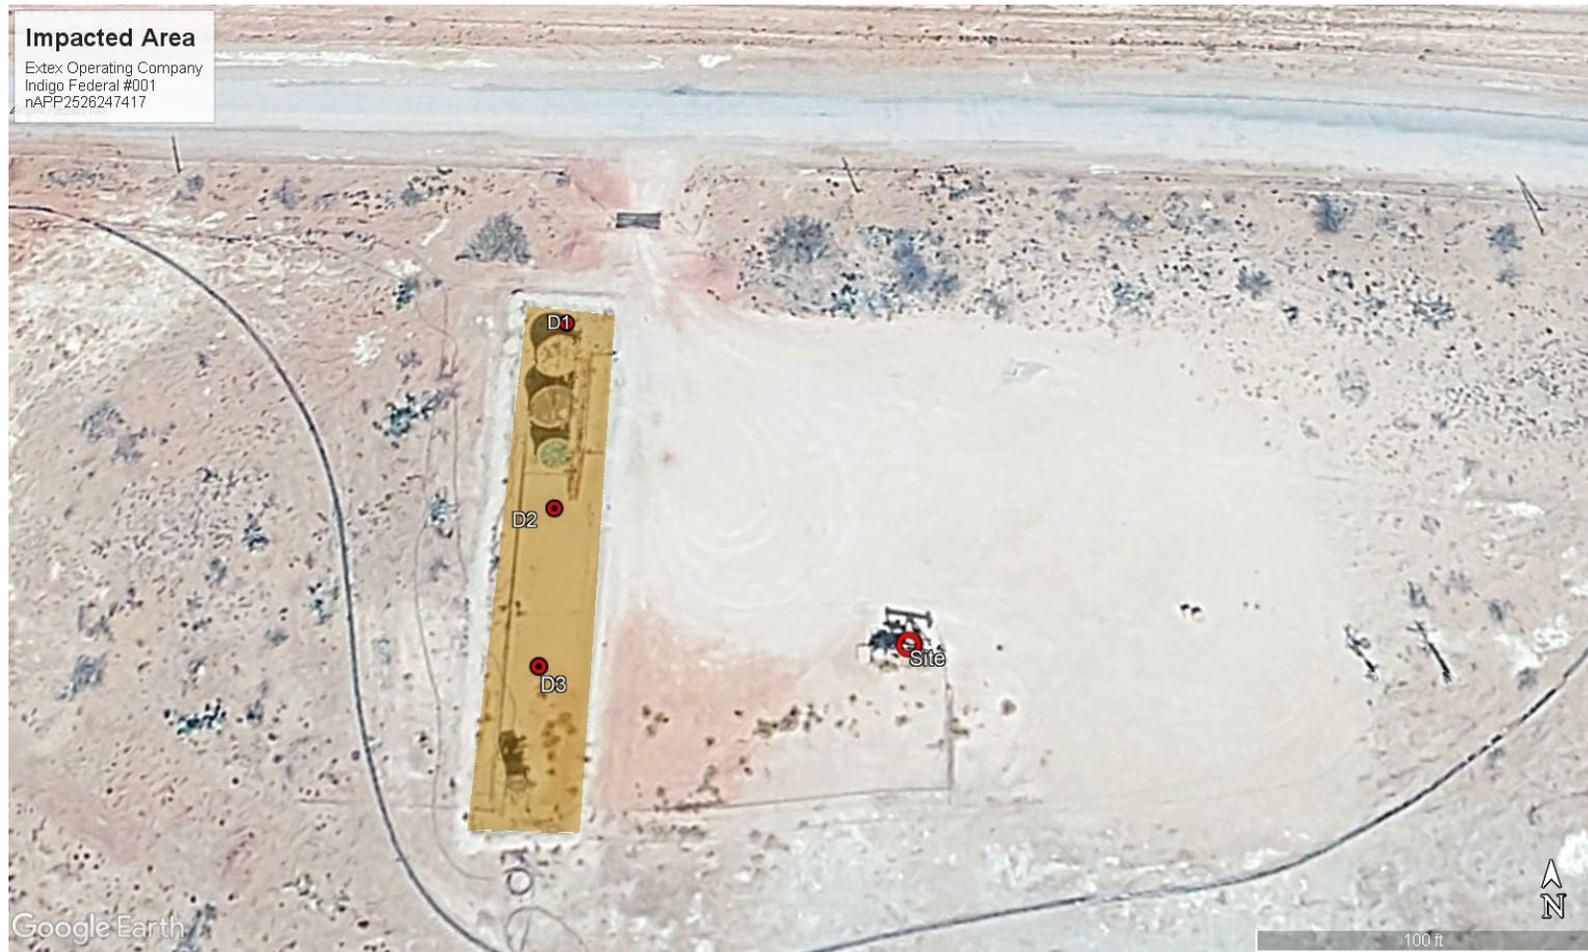
- (6) Grab soil samples were collected from the impacted area for assessment purposes.
- Delineation occurred at three sample points (D1, D2, D3) at depths of 1' and 2' bgs.

Showing the sampling grid for the Indigo Federal #001 delineation assessment samples collected on 10/22/2025

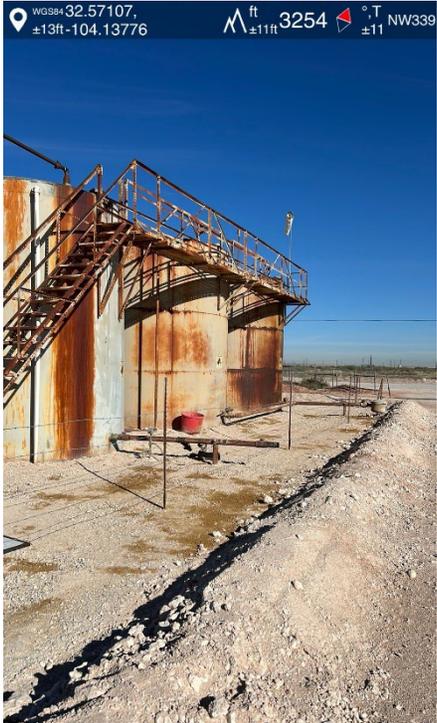
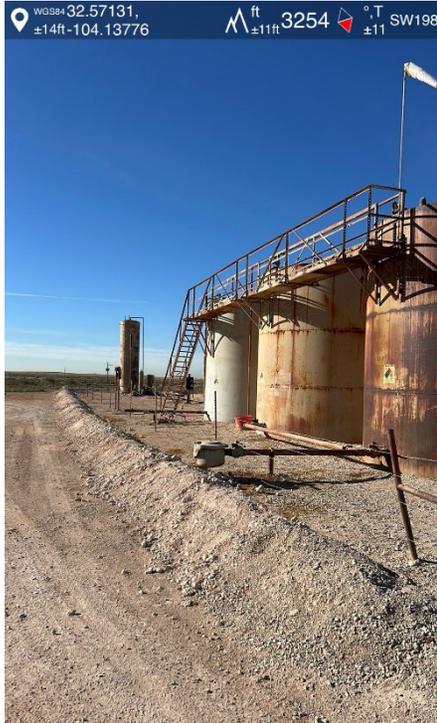
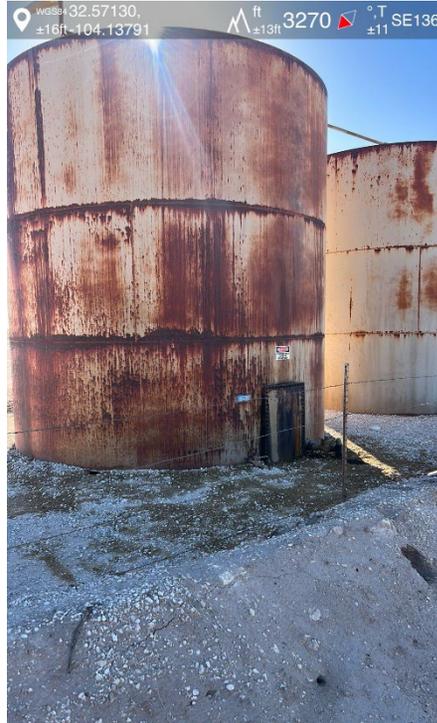
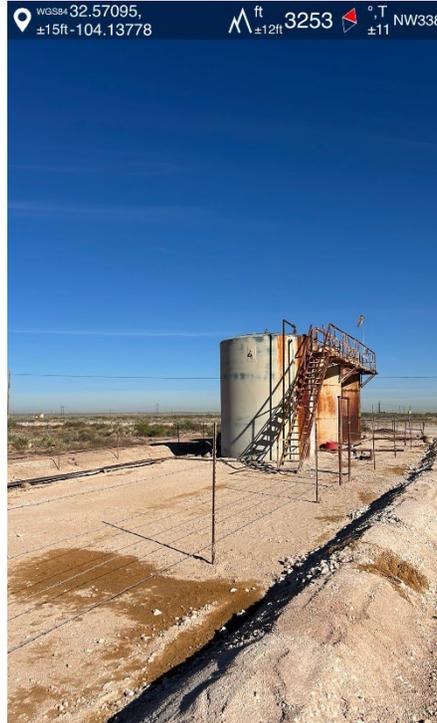
1	2	3	4

COMM Engineering arrived on location on 10/22/2025 to conduct a *Release & Site Assessment* in preparation for completing and submitting this *Site Characterization & Remediation Plan* for approval by the NMOCD. Measurements of the impacted area were recorded, and photographs were taken. Delineation samples were collected on 10/22/2025. Horizontally, the impacted area is 176' X 35', equaling 6,160 ft².

<p>22Oct25 09:25 Ad-hoc Burton Flats Rd, Carlsbad NM 88220, US © 22-Oct-25 09:25:11</p>
<p><i>Showing impacted area before excavation.</i></p>	<p><i>Showing impacted area before excavation.</i></p>	<p><i>Showing impacted area before excavation.</i></p>	<p><i>Showing impacted area before excavation.</i></p>

- Utilize heavy equipment and manual labor to excavate and remove contaminated soil from the site.
- The contaminated soil to be excavated is estimated to be **176' X 35' X 4' bgs**, equaling **6,160 ft², 24,640 ft³, 913 yd³**.

- Contaminated soil will be immediately transported to a licensed contaminated soil disposal facility.
- No contaminated soils will be stockpiled on location after excavation.

- After excavation, the impacted area will be sampled for confirmation that all remaining soils are under the strictest *Table I Closure Criteria for Soils Impacted by a Release*.

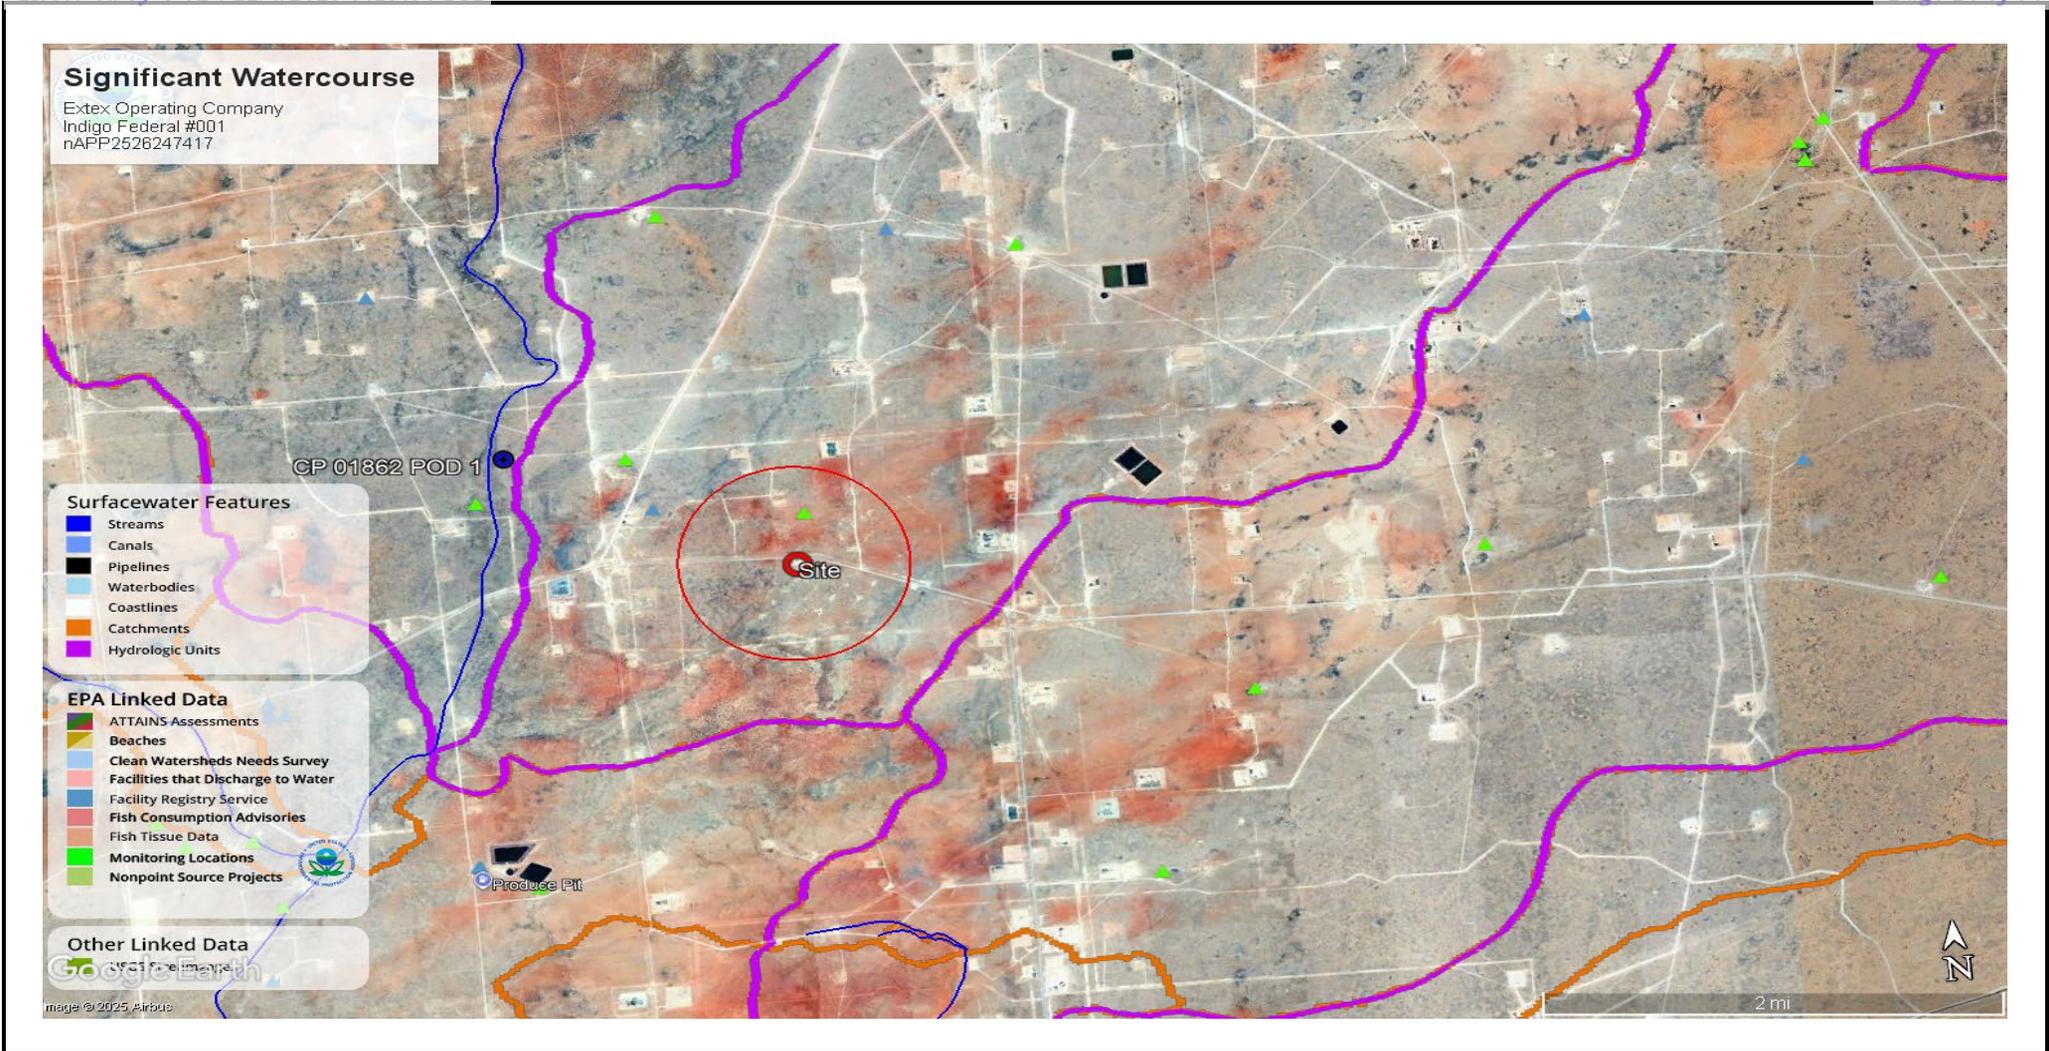
FIGURE
1

There is no surface water located on-site. The nearest significant watercourse, as defined in Subsection P of 19.15.17.7 NMAC, is Palmilla Draw, located 1.36 miles west of the site. There are no continuously flowing watercourses or significant watercourses, lakebeds, sinkholes, playa lakes, or other critical water or community features within range as outlined in Paragraph (4) of Subsection C of 19.15.29.12 NMAC. No site receptors exist per 19.15.29.12(C)(4) NMAC. The site is not within a 100-year floodplain and is in a high-risk karst area.

Significant Watercourse

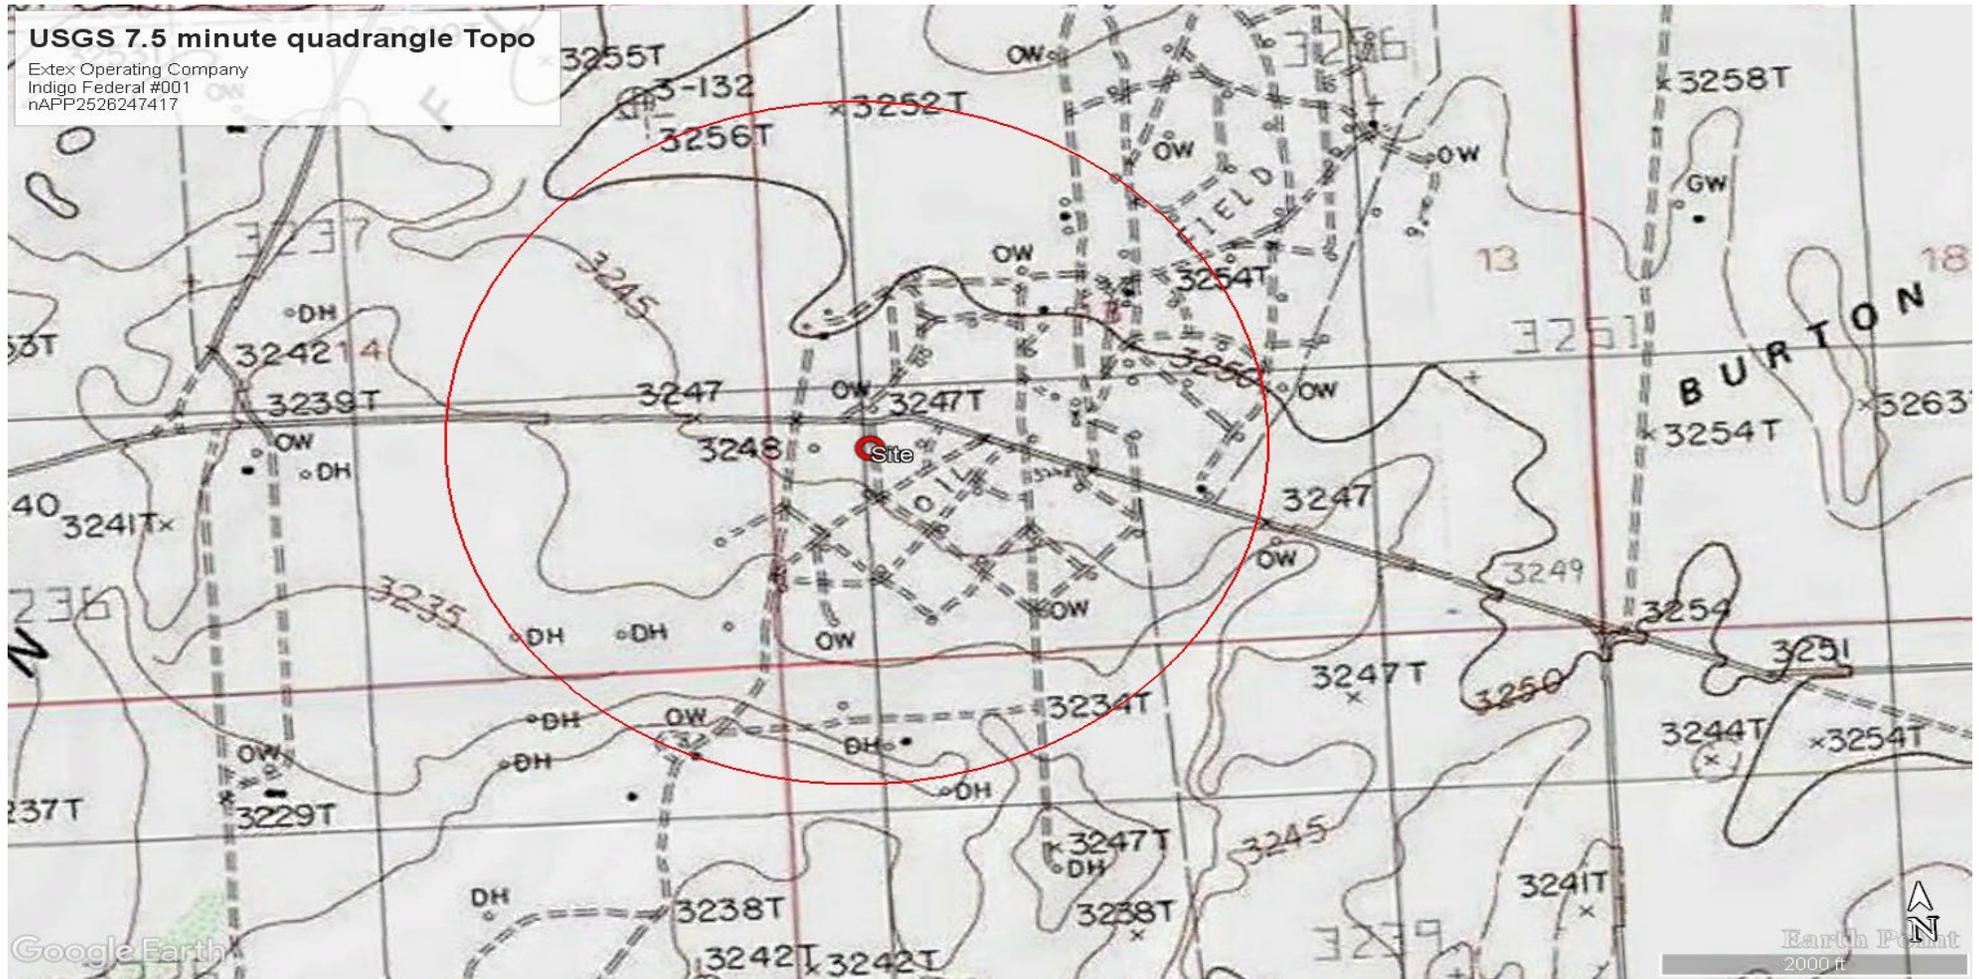
FIGURE

USGS 7.5-minute quadrangle Topo

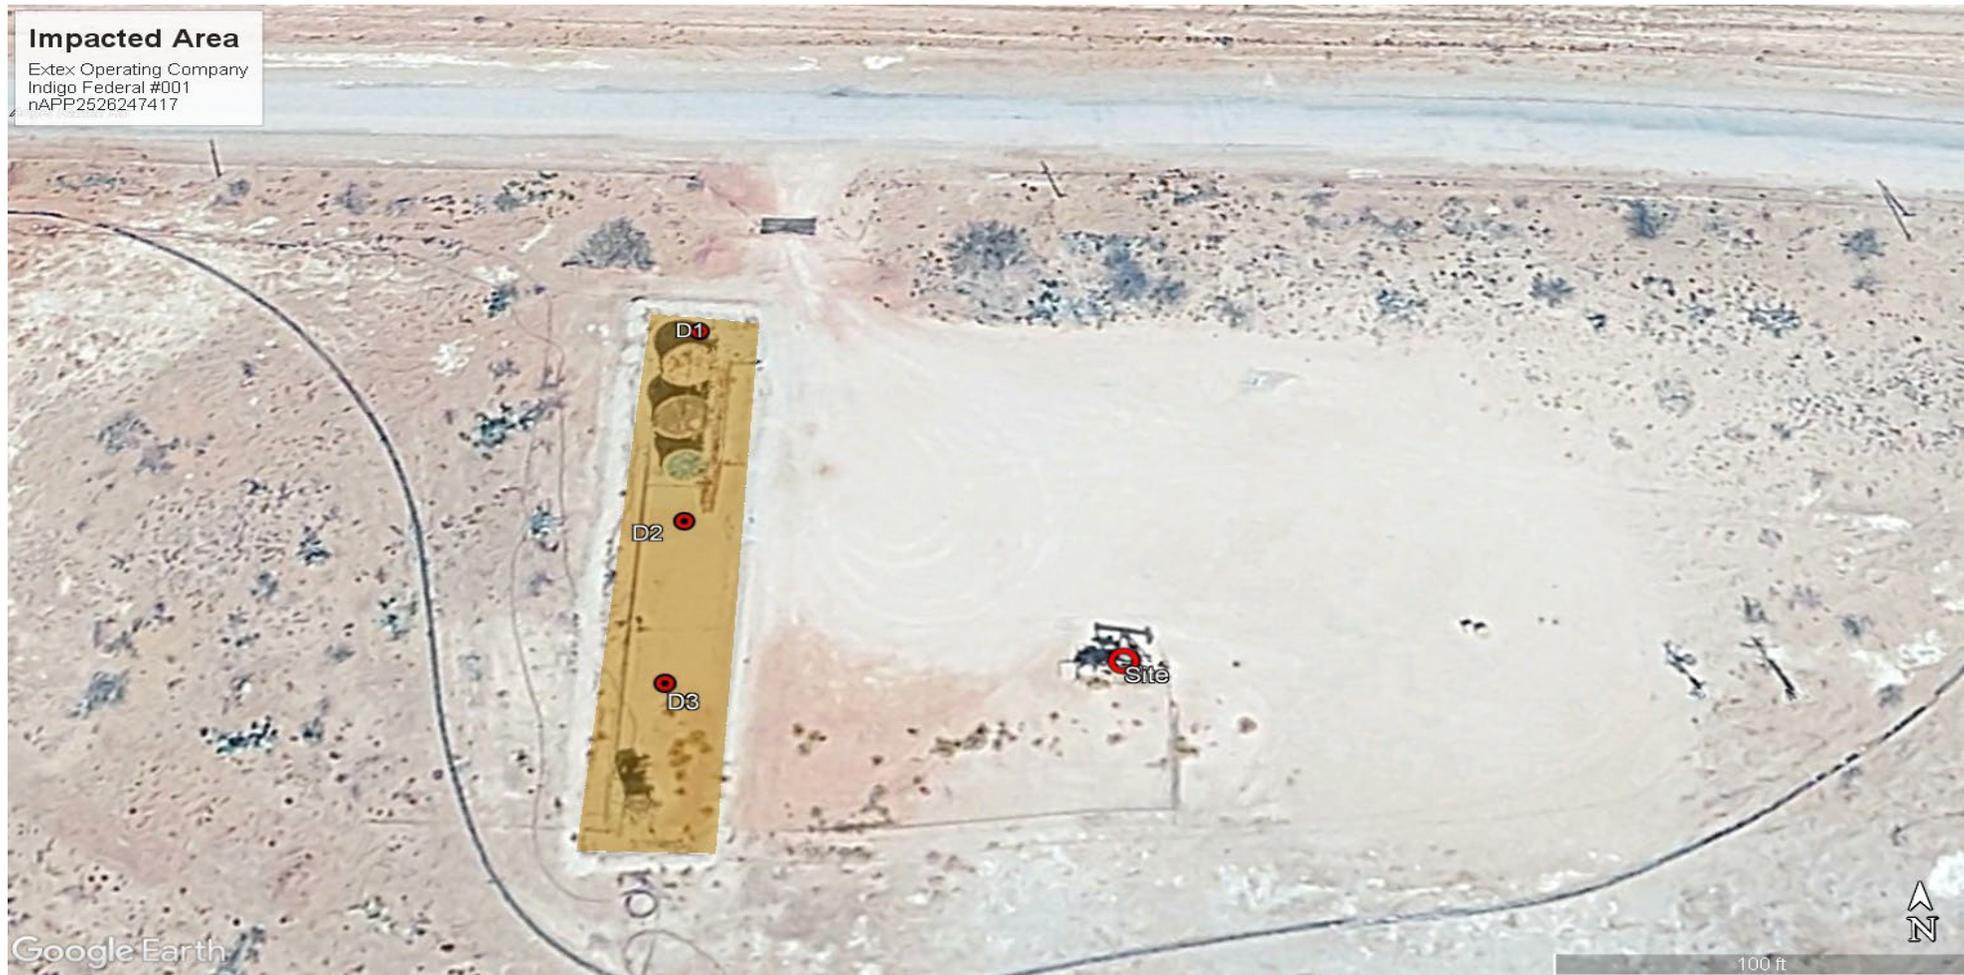
<p>Sample Points – 10.22.2025</p> <p>Extex Operating Company Indigo Federal #001 32.570957° North, -104.137466° West Unit L, Sec. 13, T20S, R28E Eddy County, New Mexico</p>	<p>FIGURE</p> <p>3</p>
---	---	--------------------------------------
