## Release Assessment and Deferral

Corral Canyon 15 CVB

Facility ID: fAPP2403725789

**Amended Release Assessment and Deferral**  
December 2025

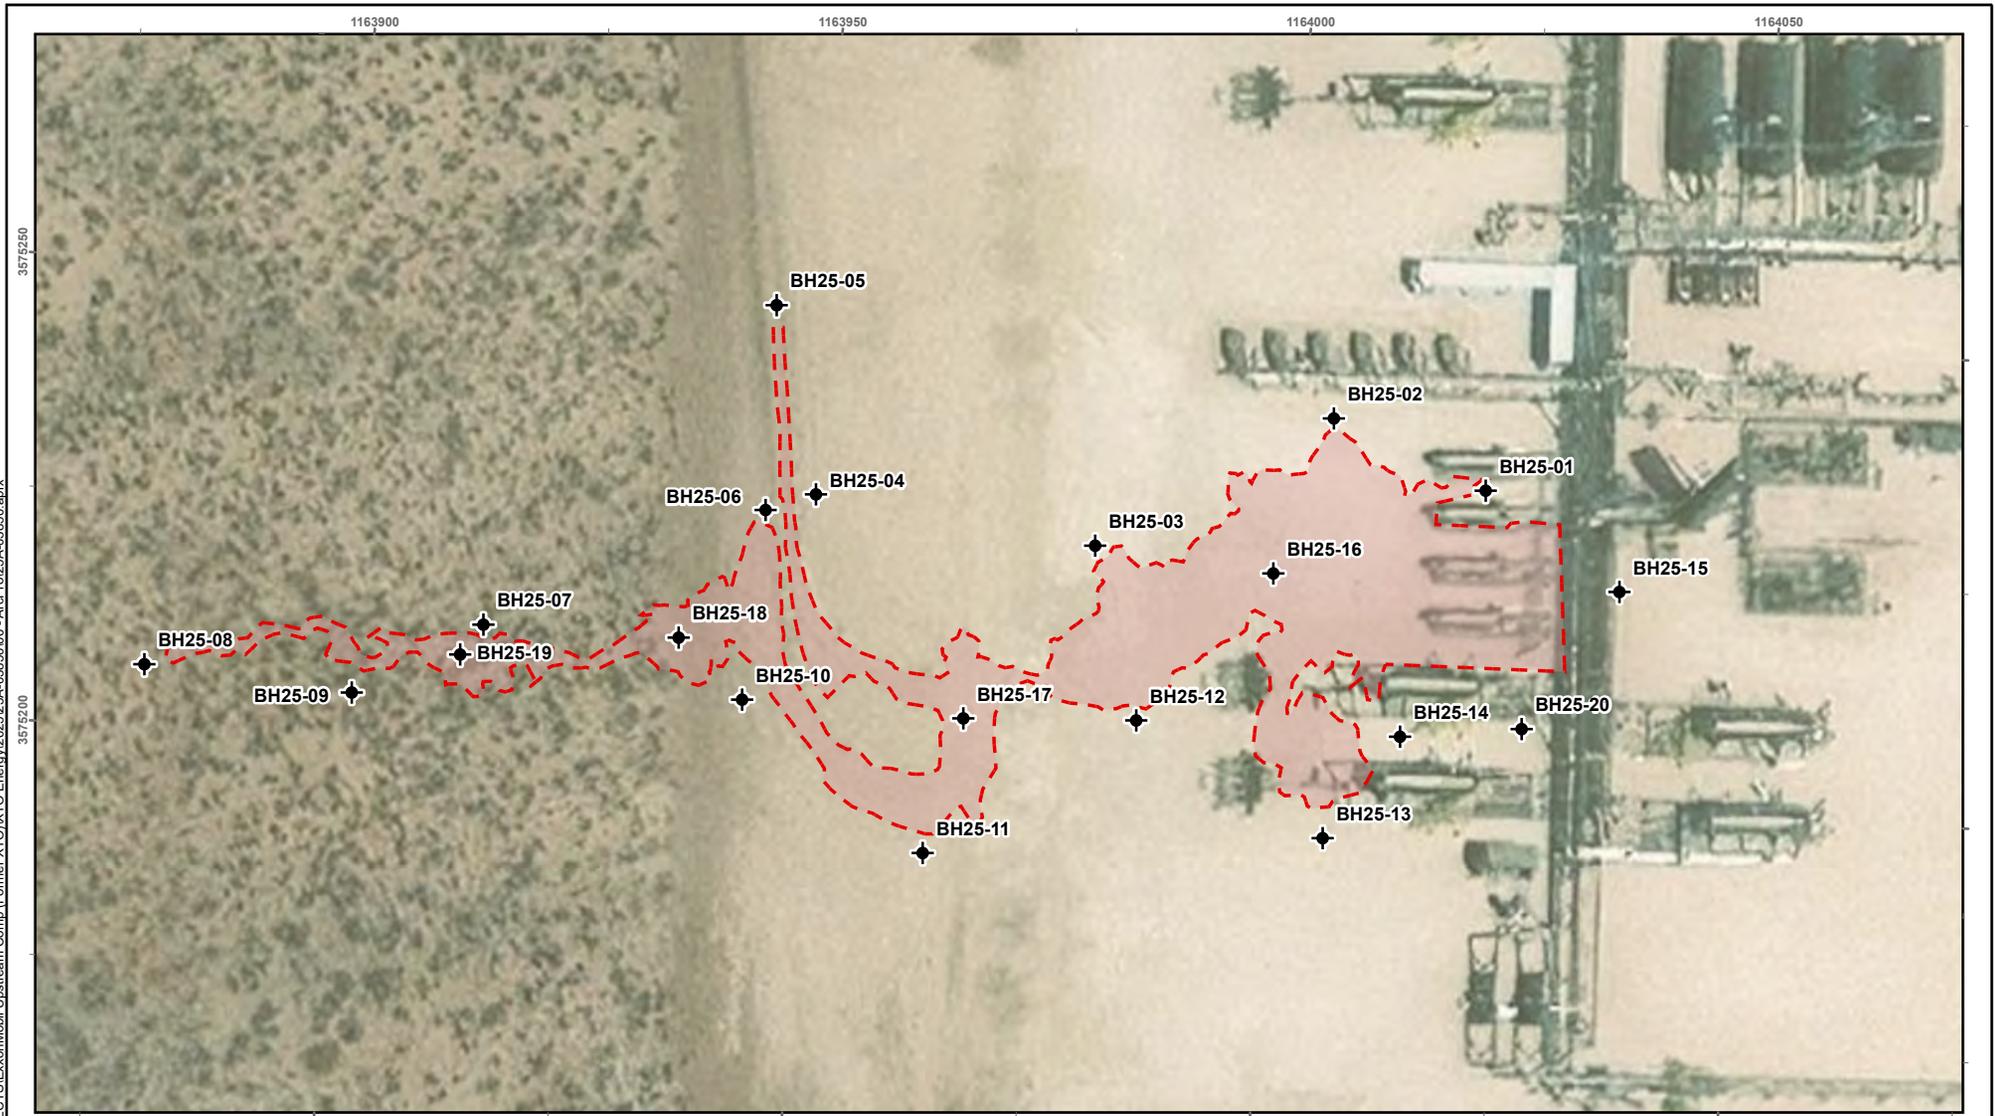
◆ Borehole  
 - - - - - Approximate Release Area (~17,204 sq.ft.)

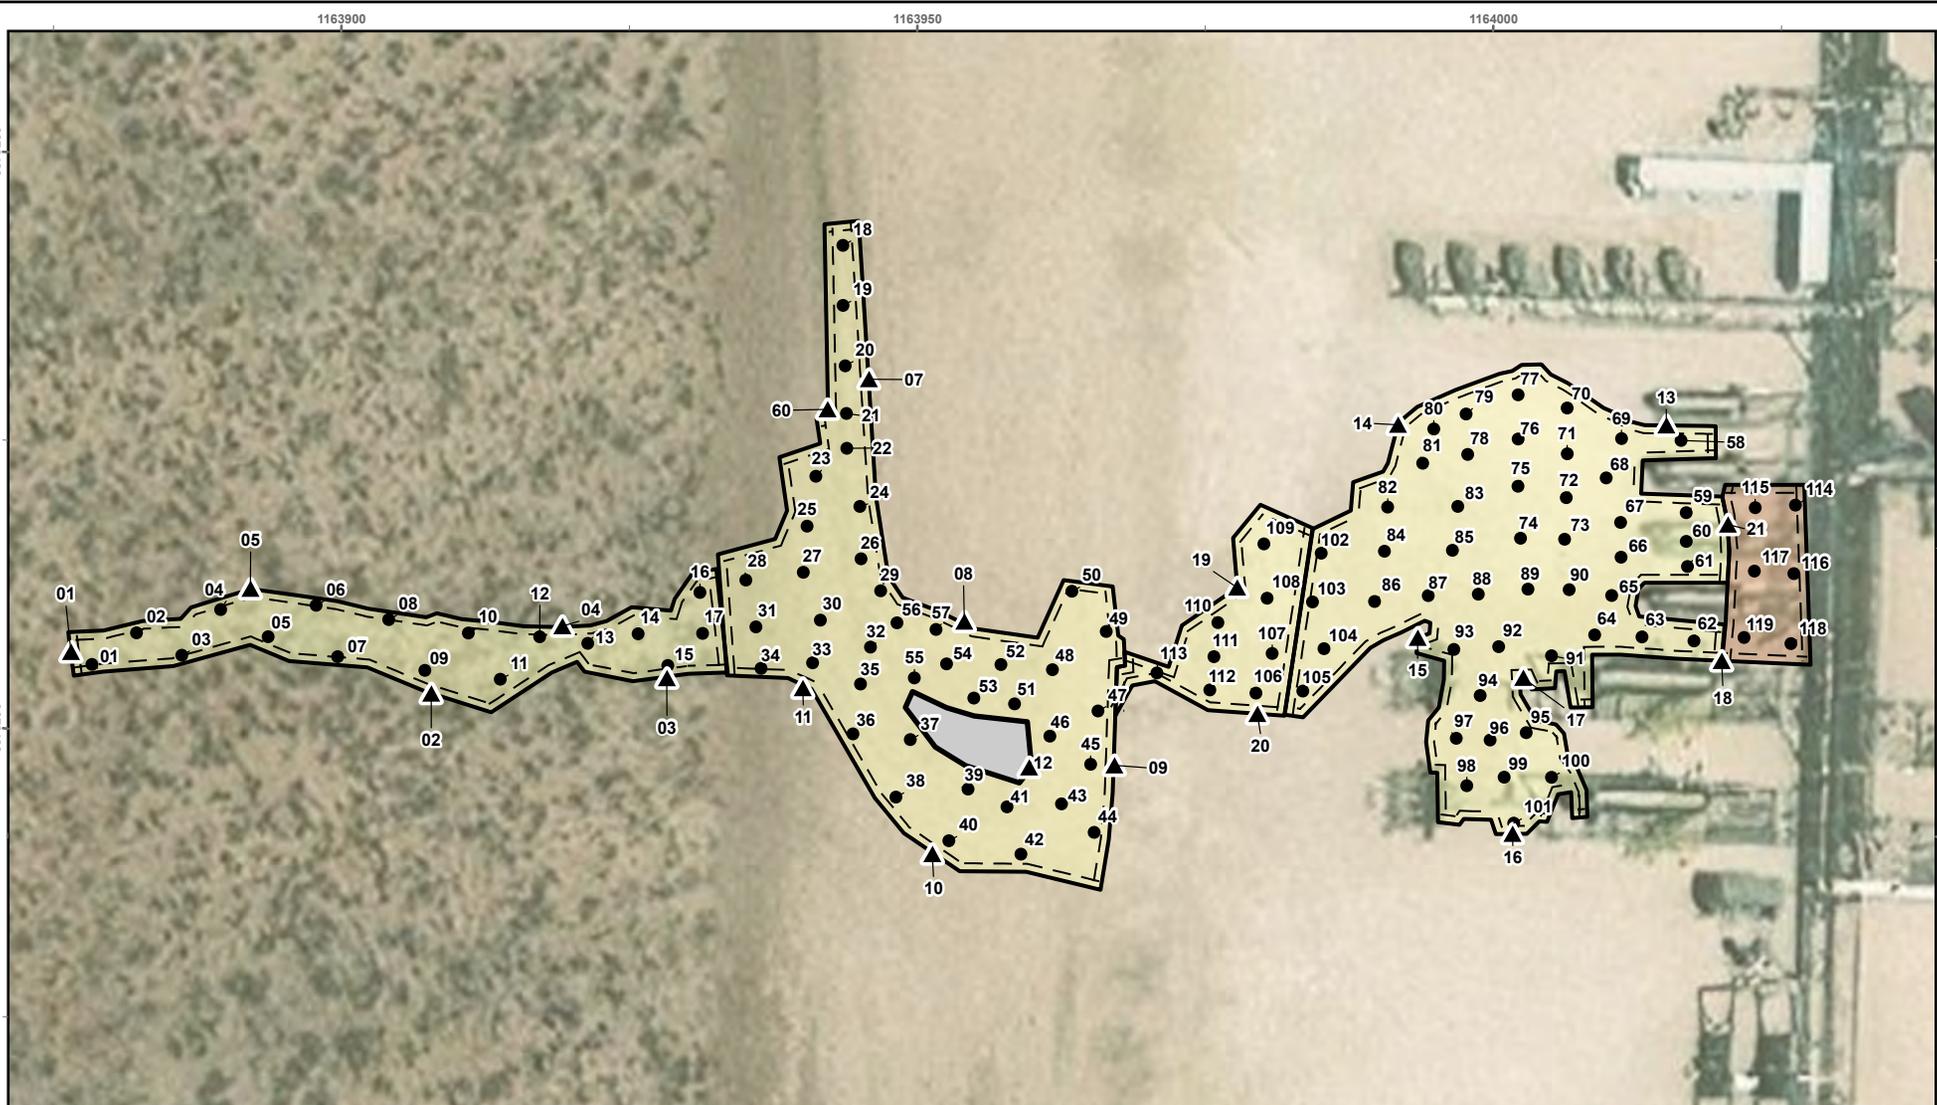
- Base Sample
- ▲ Wall Sample
- Undisturbed Island (~476 sq. ft. | 97 ft.)
- Excavation to 2' bgs (~22,657 sq.ft. | 1,876 ft.)
- Hand Dig Excavation to 6" bgs (~1,163 sq.ft. | 147 ft.)

The required mechanical excavation in this area is both unsafe and not feasible given the proximity to equipment and infrastructure. The areas are between separators, as identified by samples BS25-114 through BS25-119 (Figure 2), and are in proximity to electrical and fluid lines that run between the separators. Further attempts to excavate the area by hand digging were not successful due to the hard compacted caliche and were concluded after 2 days.

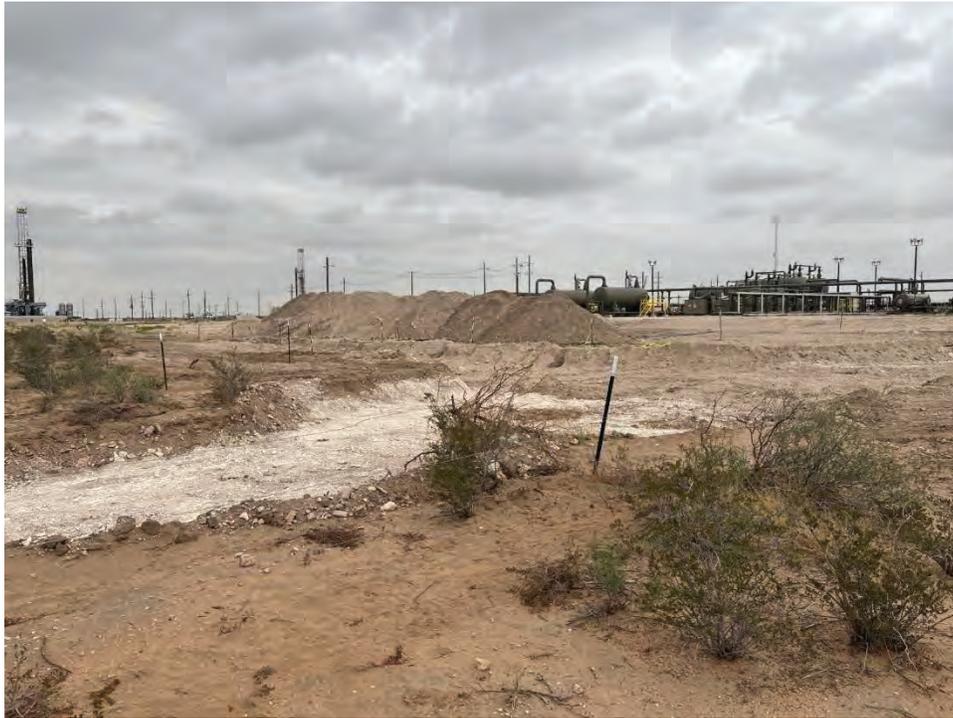
Figure 1. Corral Canyon 15 CVB facility and release delineation excavation

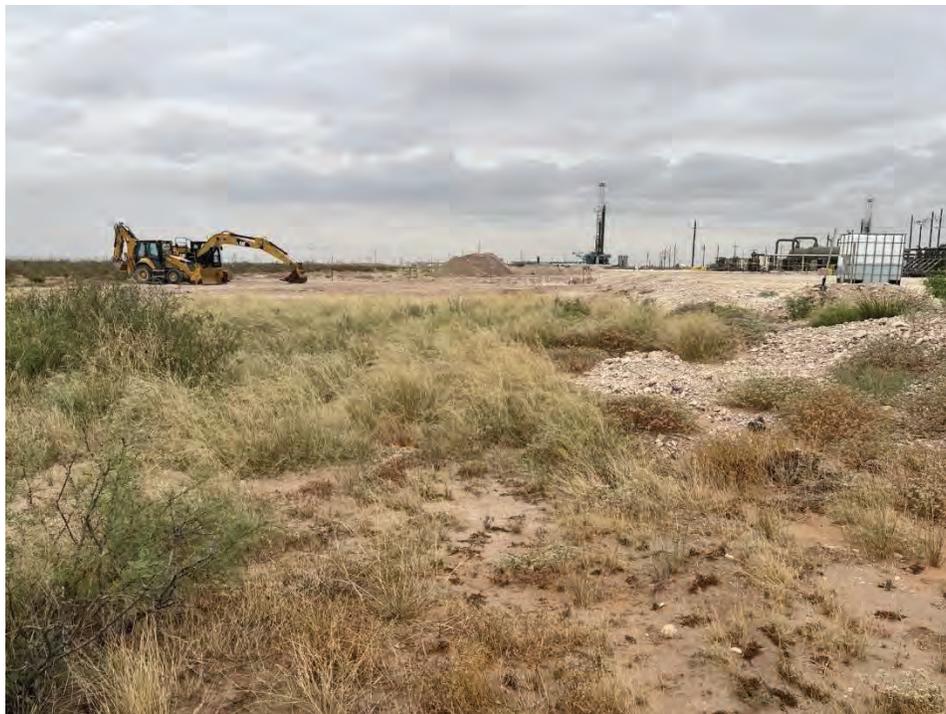
Figure 2. Corral Canyon 15 CVB and release excavation

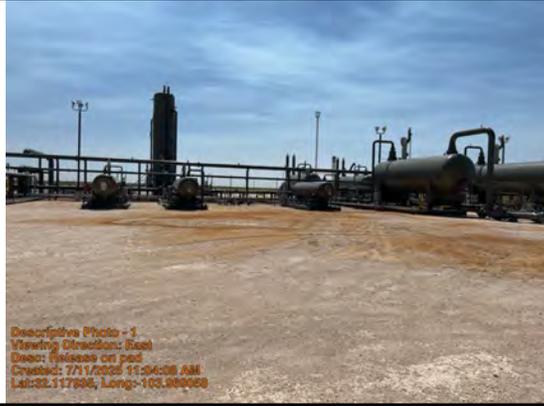
Descriptive Photo - 1  
Viewing Direction: East  
Desc: Release on pad  
Created: 7/11/2025 11:04:08 AM  
Lat:32.117898, Long:-103.989009

Release on pad

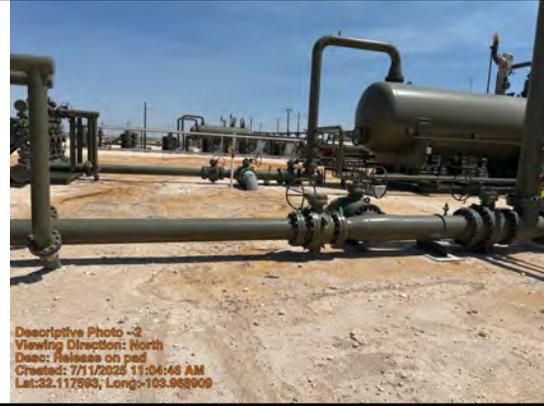
Descriptive Photo - 2  
Viewing Direction: North  
Desc: Release on pad  
Created: 7/11/2025 11:04:46 AM  
Lat:32.117893, Long:-103.989009

Release on pad

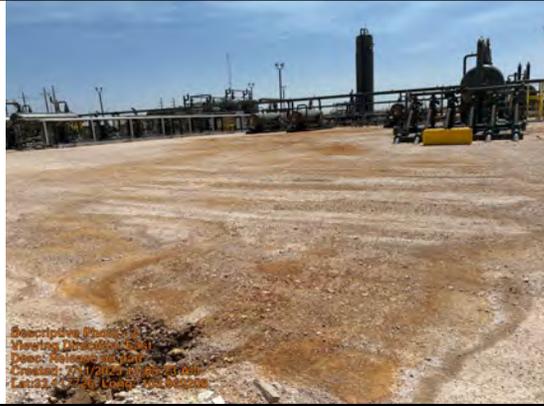
Descriptive Photo - 3  
Viewing Direction: East  
Desc: Release on pad  
Created: 7/11/2025 11:05:00 AM  
Lat:32.117898, Long:-103.989009

Release on pad

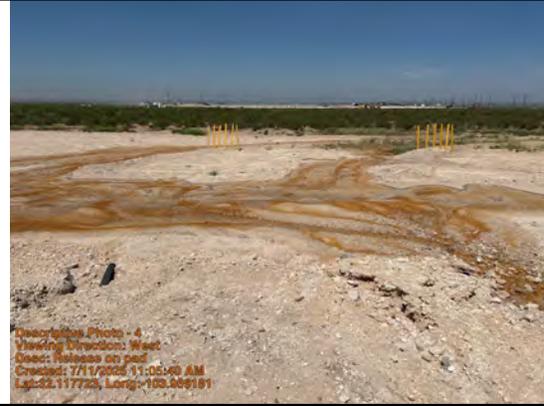
Descriptive Photo - 4  
Viewing Direction: West  
Desc: Release on pad  
Created: 7/11/2025 11:05:40 AM  
Lat:32.117723, Long:-103.989181

Release on pad

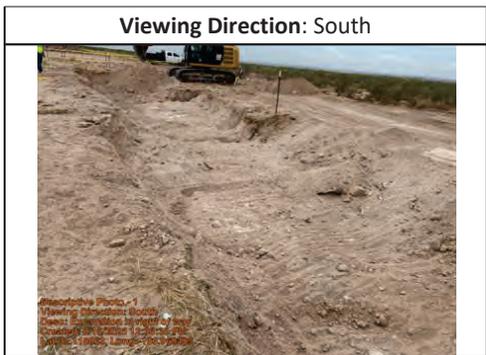
Excavation in right of way

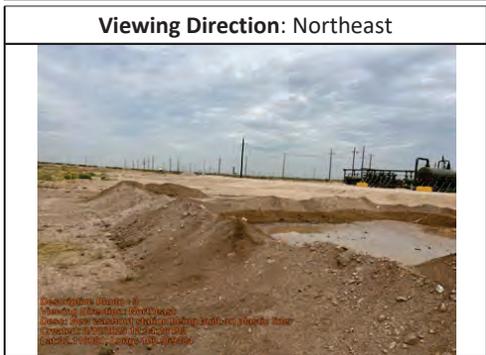
New washout station being built on plastic liner

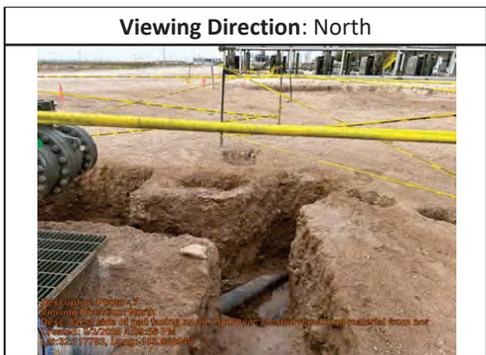
West side of pad facing north. Hydrovac cleared remaining material from north side of production equipment.

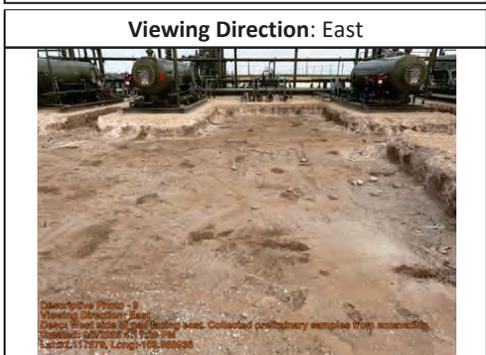
West side of pad facing east. Collected preliminary samples from excavation base.

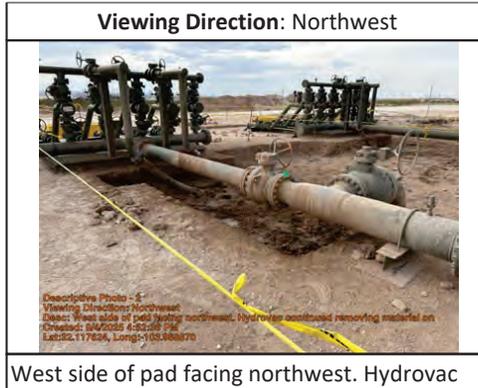
West side of pad facing northwest. Hydrovac continued removing material on south edge of equipment.

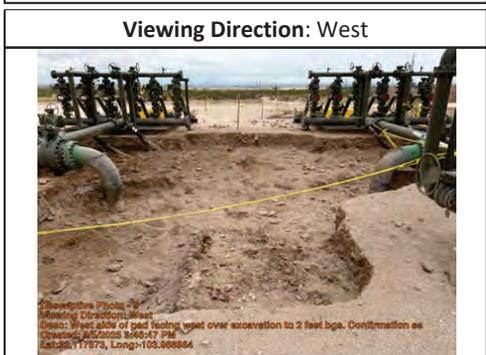
West side of pad facing west over excavation to 2 feet bgs. Confirmation samples collected.

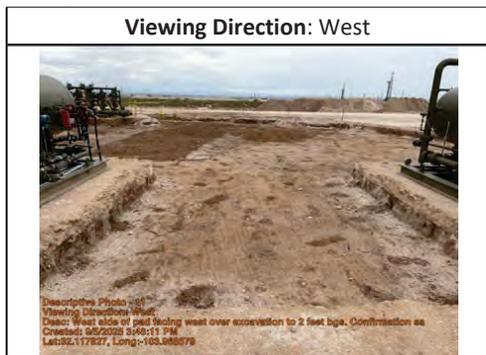
West side of pad facing west over excavation to 2 feet bgs. Confirmation samples collected.

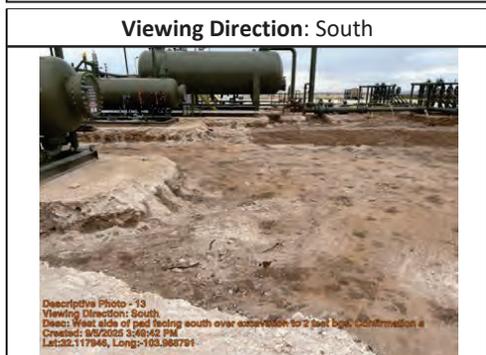
West side of pad facing south over excavation to 2 feet bgs. Confirmation samples collected.

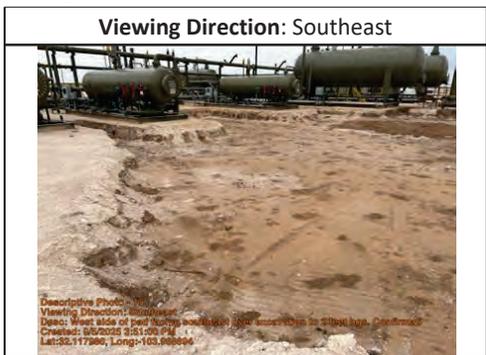
West side of pad facing southeast over excavation to 2 feet bgs. Confirmation samples collected.

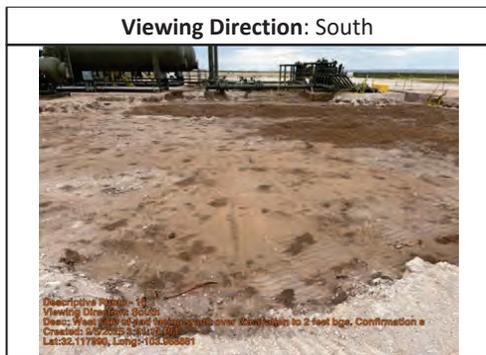
West side of pad facing south over excavation to 2 feet bgs. Confirmation samples collected.

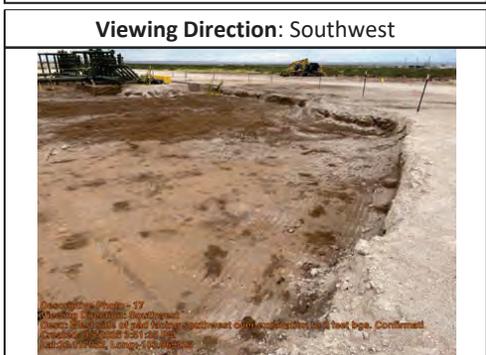
West side of pad facing southwest over excavation to 2 feet bgs. Confirmation samples collected.

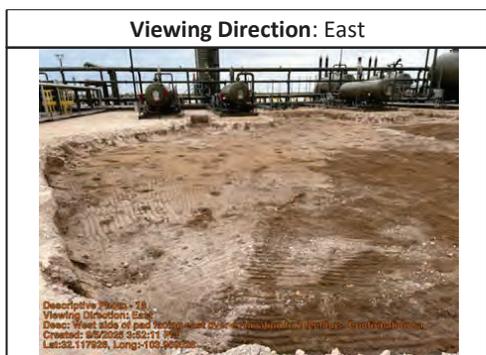
West side of pad facing east over excavation to 2 feet bgs. Confirmation samples collected.

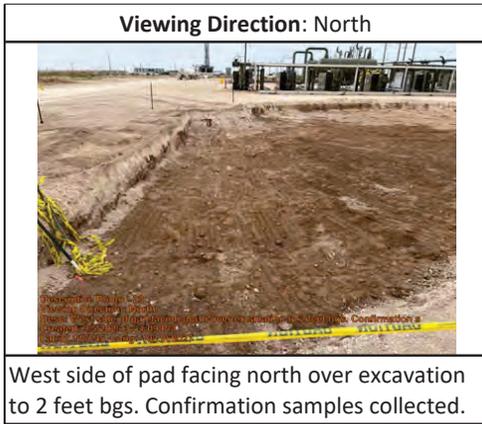
West side of pad facing north over excavation to 2 feet bgs. Confirmation samples collected.

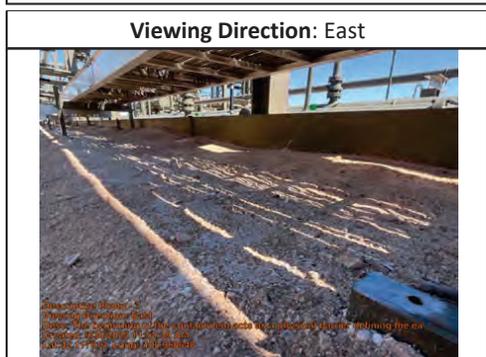
The beginning of the containment acts as a physical barrier defining the eastern side of the release area
