# RECLAMATION CLOSURE REPORT

Incident ID nAB1908044051

**Cotton Draw 13 Federal #1H**

API # 30-015-40385

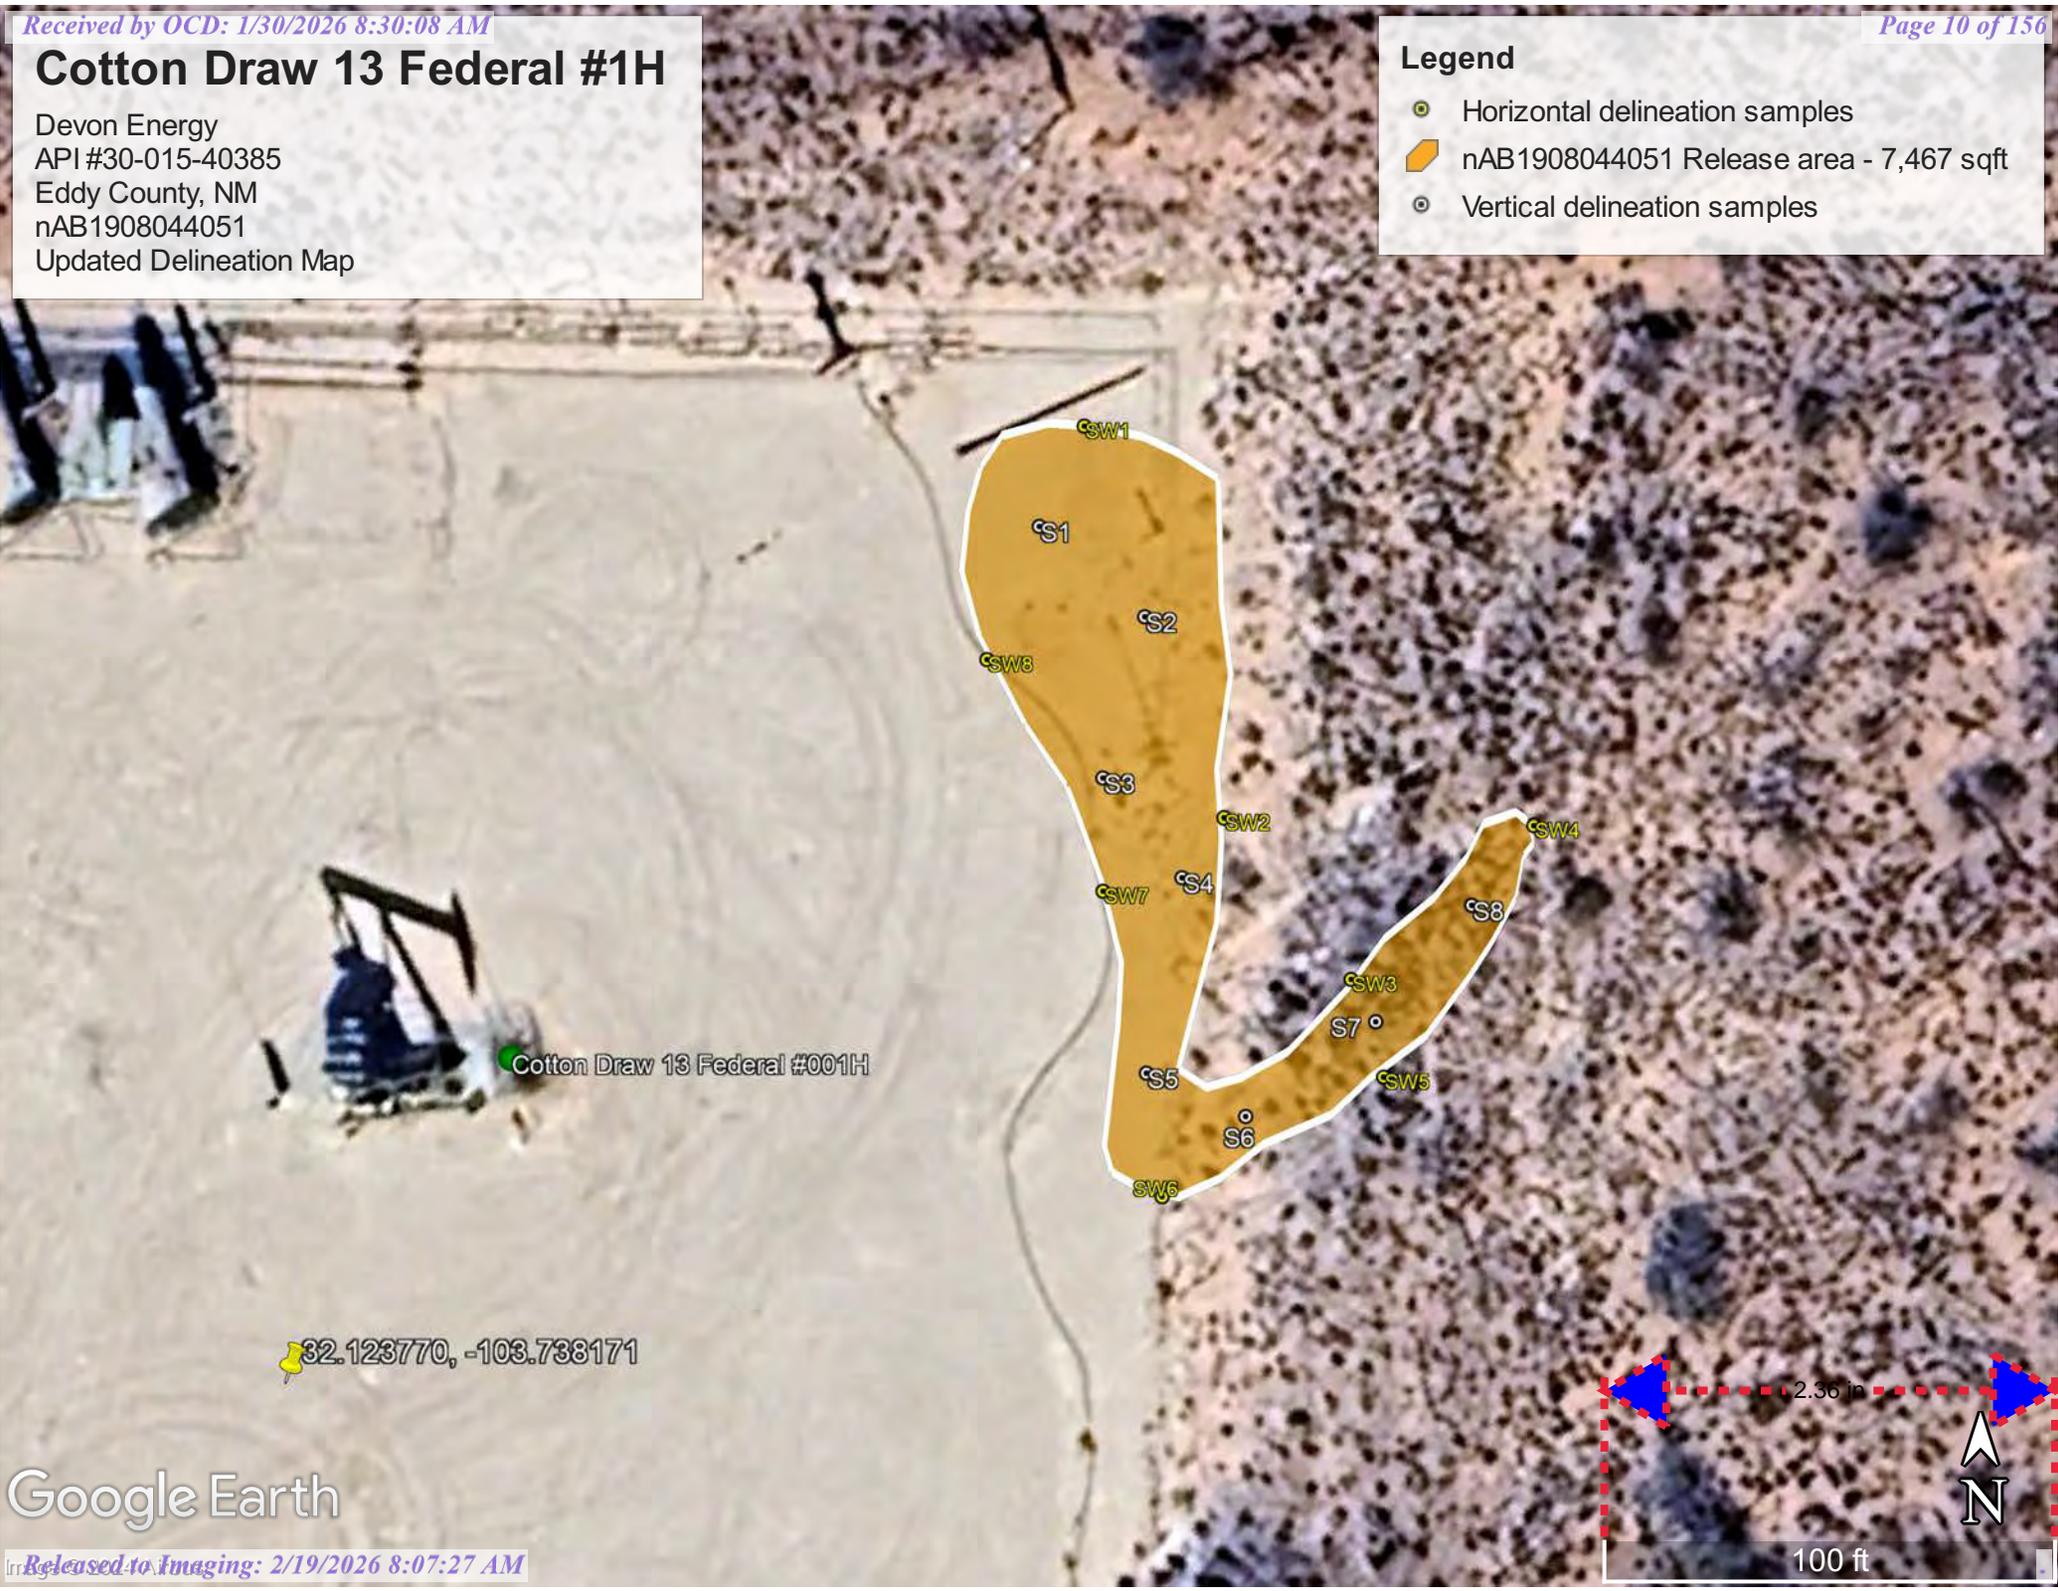
On May 10, 2023, Pima mobilized personnel and equipment to the site to reassess the release area and completely delineate vertically and horizontally. The impacted area measures approximately 3,766 square feet and remediation activities were performed in October and December of 2020, according the previously denied closure report located in the OCD Online: Permitting – Action Status, under the Application ID: 16106. Samples were collected from 5 different sample points on the pad from depth intervals of 1', 2', 3', and 4' bgs. Two of the sample points were advanced to 5' bgs. Samples were collected from 3 different sample points in the pasture from depth intervals of 1' and 2' bgs. Samples were then collected from 8 different sample points around the edge of the release area, which were each composite samples consisting of 0', 1', 2', 3', and 4' depths bgs. The samples were immediately put on ice, jarred, and delivered to Envirotech Labs for official testing. All samples were analyzed for all constituents listed on Table 1 19.15.29.12 NMAC. The results of this sampling event can be seen in the following data table. An Updated Delineation Map can be found in Figure 4.

With the depth to ground water at this release area being defined as less than 50 feet bgs, contamination over the regulatory limits was found at the S-3 sample point.

Vertical delineation samples

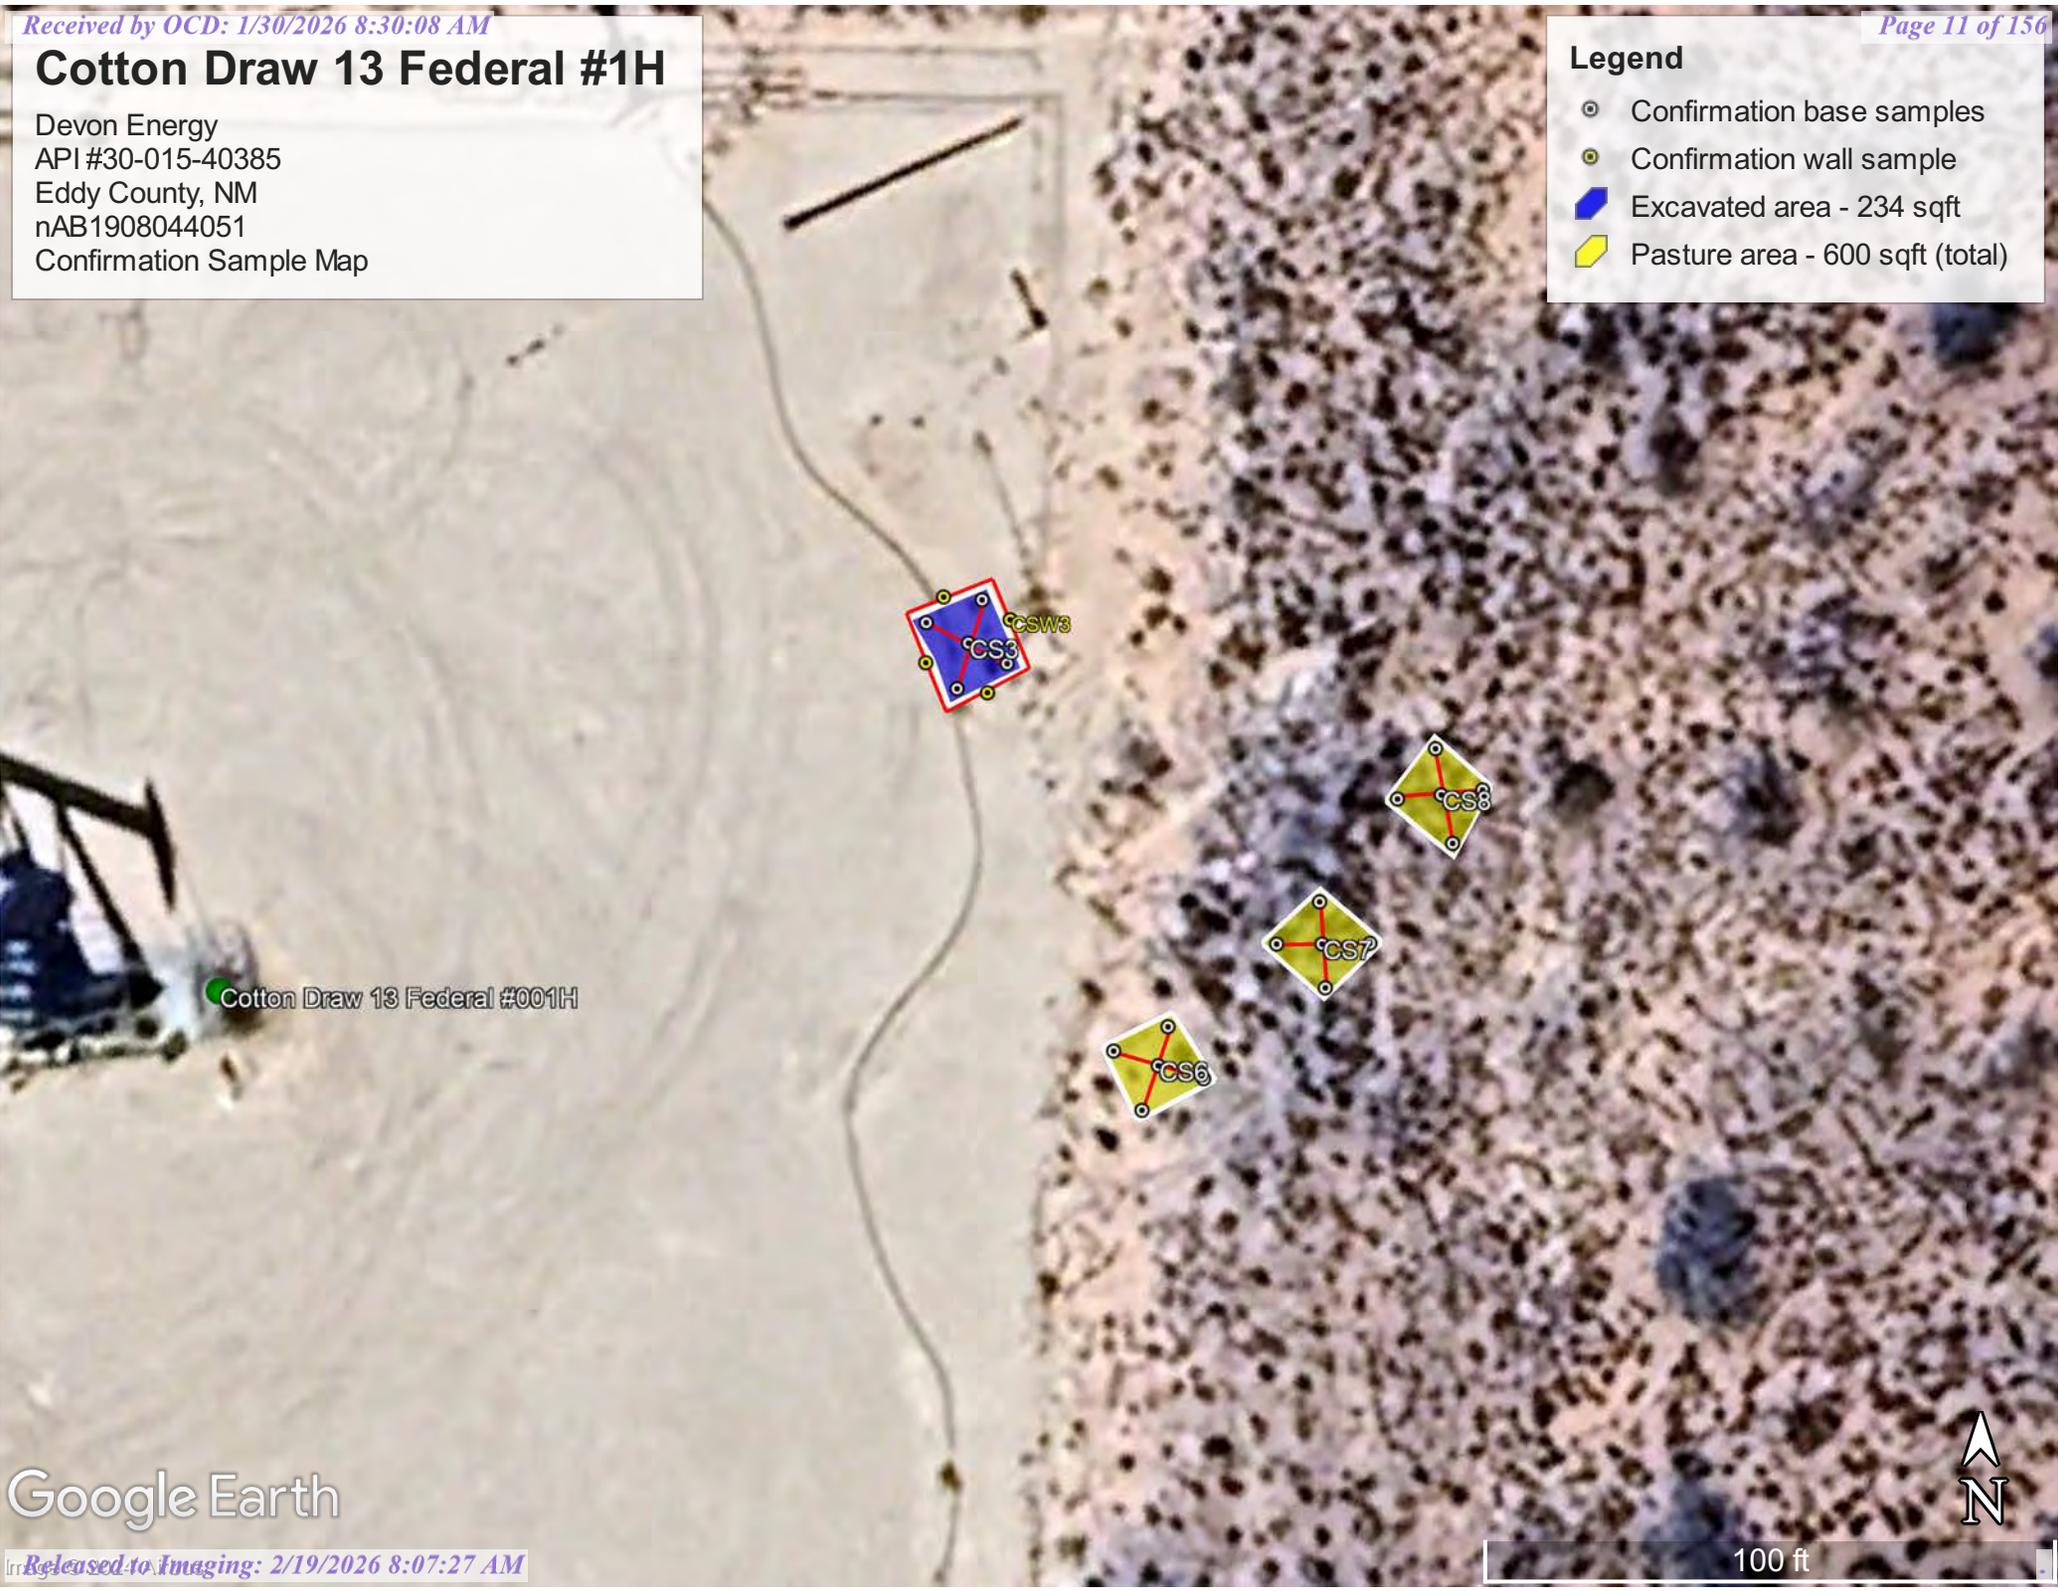
On June 28, 2024, Pima and the Devon construction department mobilized personnel and equipment to the site to excavate the area surrounding sample point S-3. An area measuring approximately 234 square feet was flagged then excavated utilizing mechanical excavation means to a depth of 3.5' bgs. After Devon submitted a 48-hour sampling notification, OCD Online: Permitting – Action Status, under the Application ID: 357729 (Appendix C), one confirmation composite base sample was collected from the base of the excavation and one confirmation composite wall sample was collected from the walls of the excavation. Furthermore, because the surface in the pasture has not been tested, 3 more confirmation composite samples were collected from the S-6, S-7, and S-8 sample points. After collection, each sample was immediately put on ice, jarred, and delivered to Envirotech Labs for official testing. All samples were analyzed for all constituents listed on Table 1 19.15.29.12 NMAC. The results of this sampling event can be seen in the following data table. A Confirmation Sample Map can be found in Figure 5.

- Confirmation base samples
- Confirmation wall sample
- Excavated area - 234 sqft
- Pasture area - 600 sqft (total)

Based on these lab results, the contaminant levels for all samples collected are under the regulatory limits according to the <50' depth to groundwater section of Table 1 19.15.29.12 NMAC. This excavation sufficiently removed all contaminated soil, which was hauled to R360, an NMOCD-approved disposal facility. Clean, fresh backfill material was brought in to backfill the excavation. The area was repacked and back dragged to match the surrounding pad.

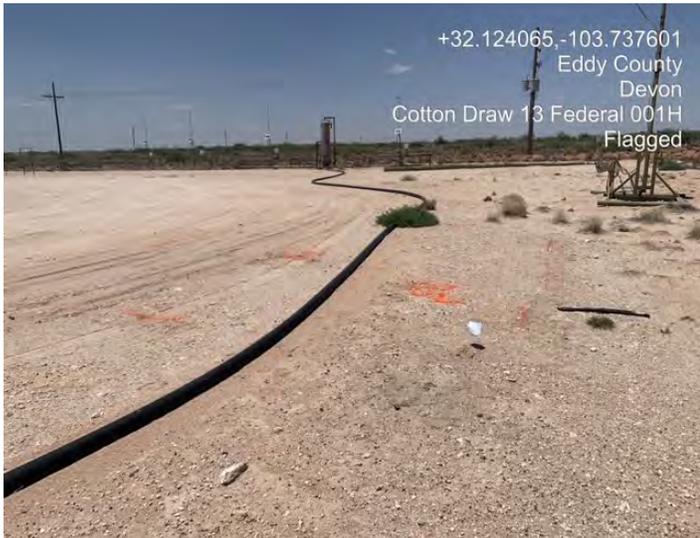
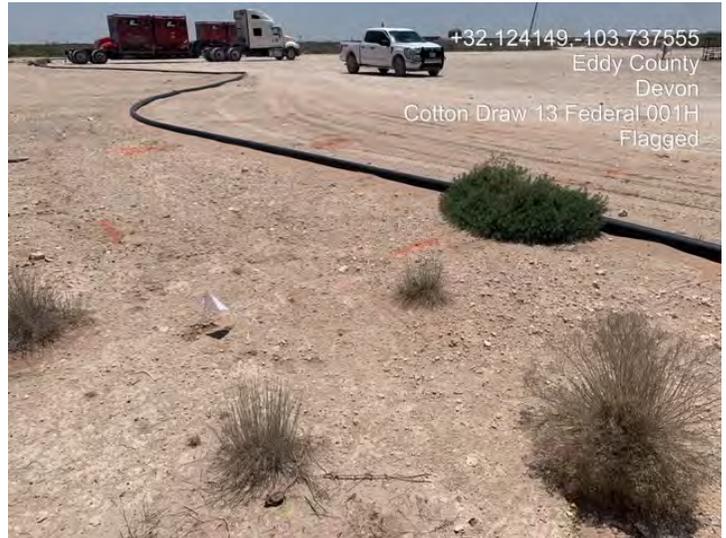
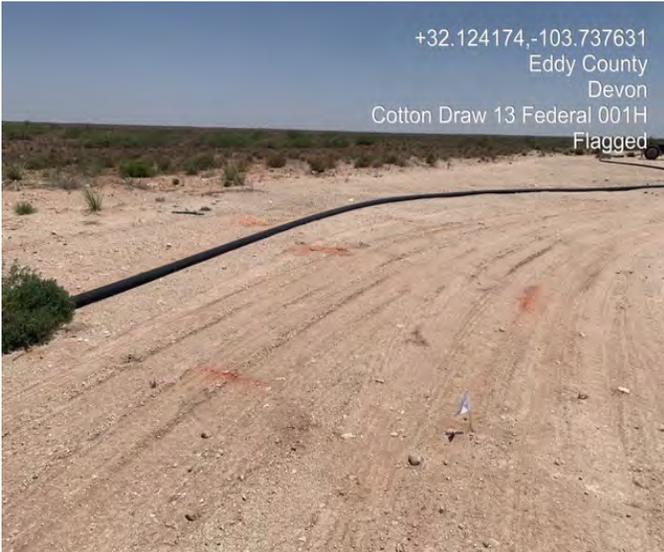
Flagging/Marking of S-3 Area

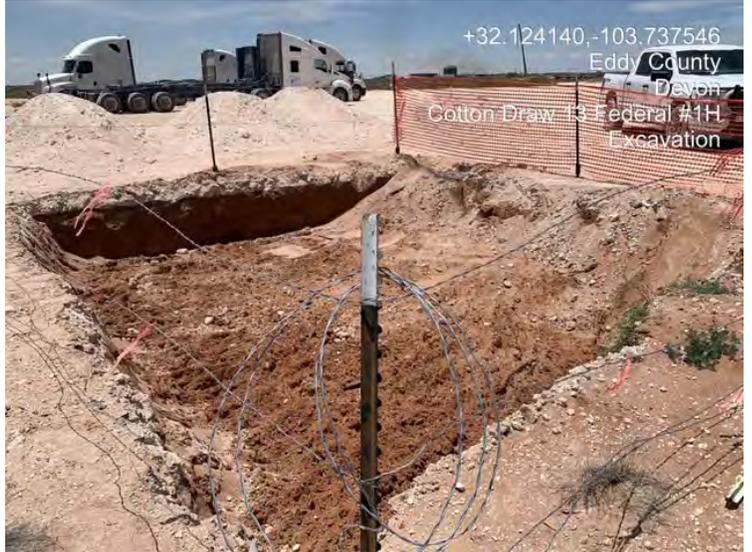
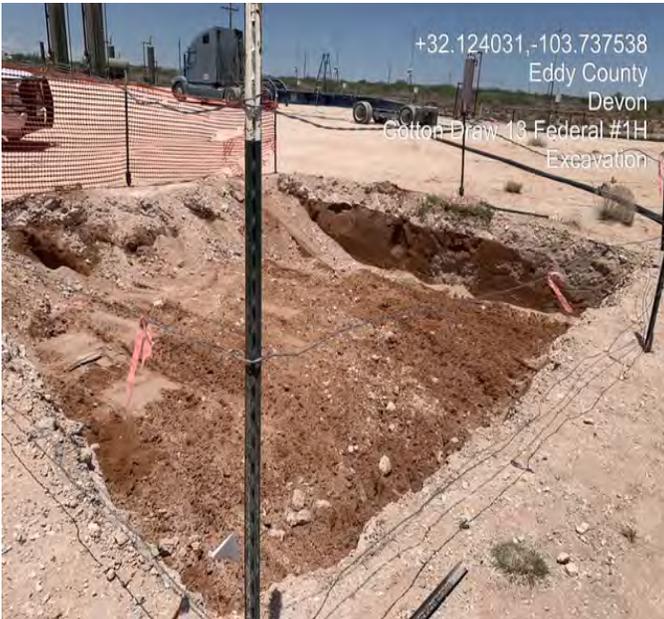
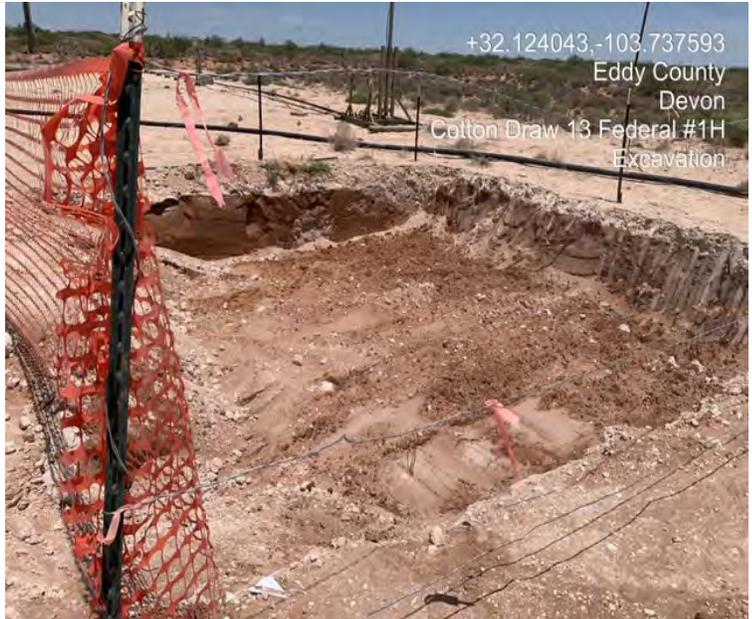
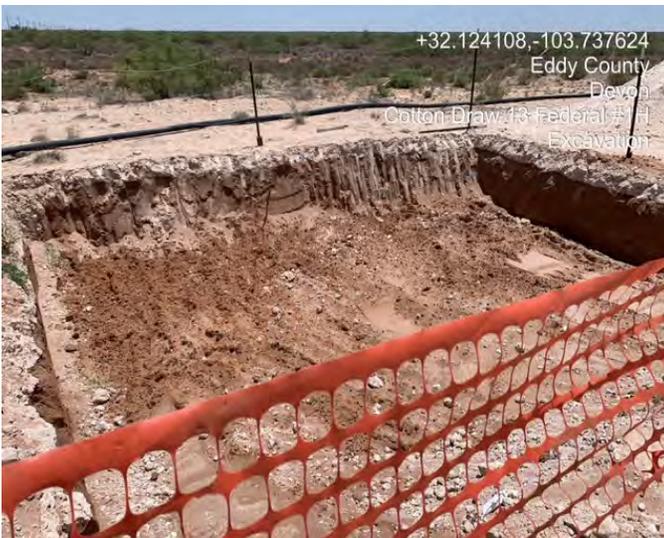
Excavation of S-3 Area

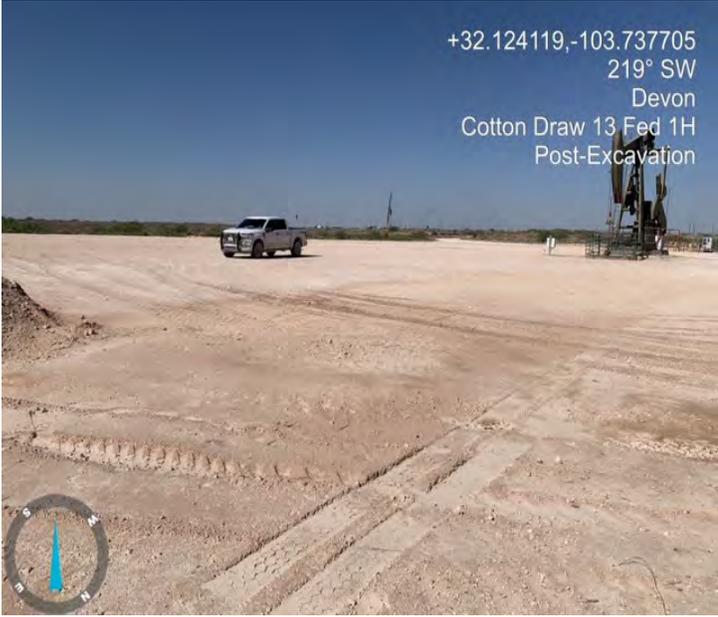
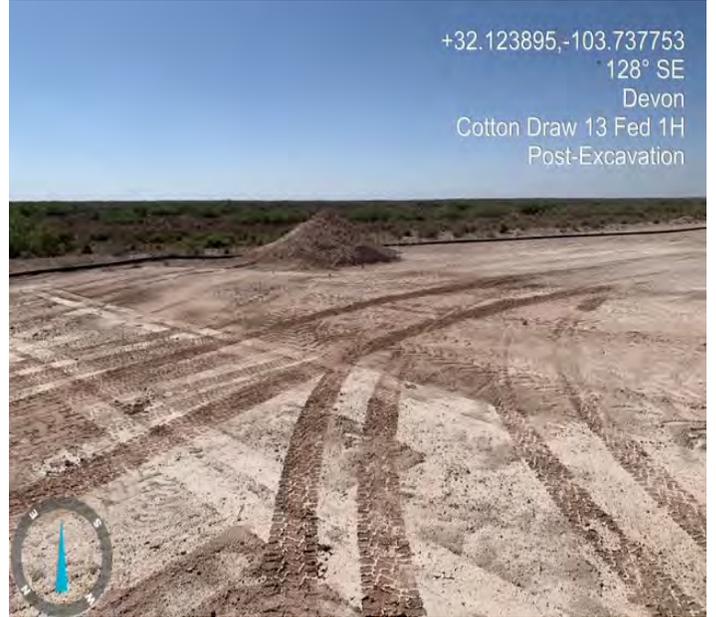
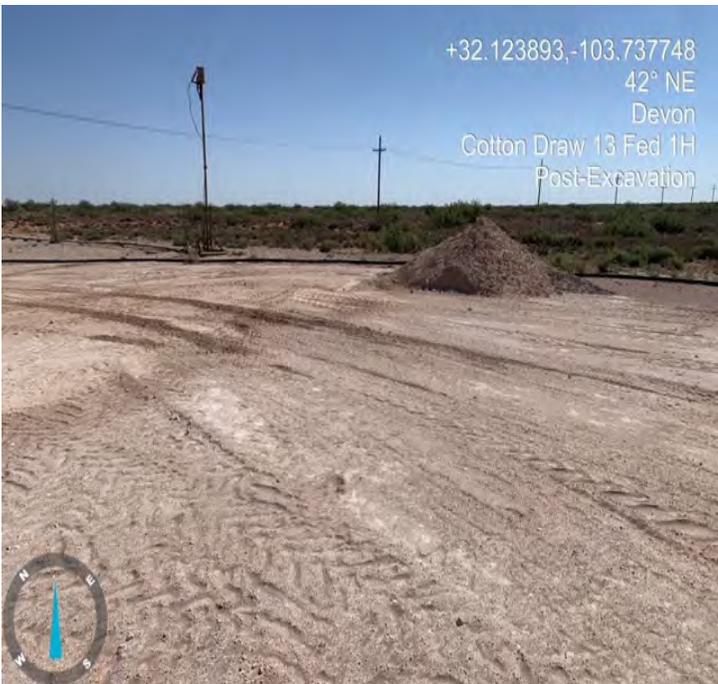
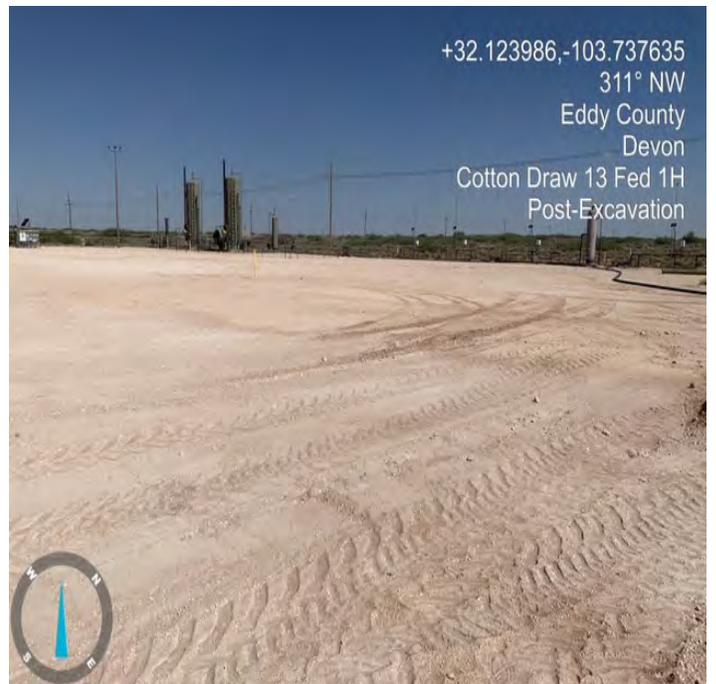
**Post Excavation Facing Southwest**

**Post Excavation Facing Southeast**

**Post Excavation Facing Northeast**

**Post Excavation Facing Northwest**
