G-8 LINE LEAK

Remediation Summary & Closure Report

NMOCD Incident No. nAPP2427125865
UL "M", Sec. 2, T17S, R34E
32.859457 -103.535844
Lea County, New Mexico

December 4, 2025

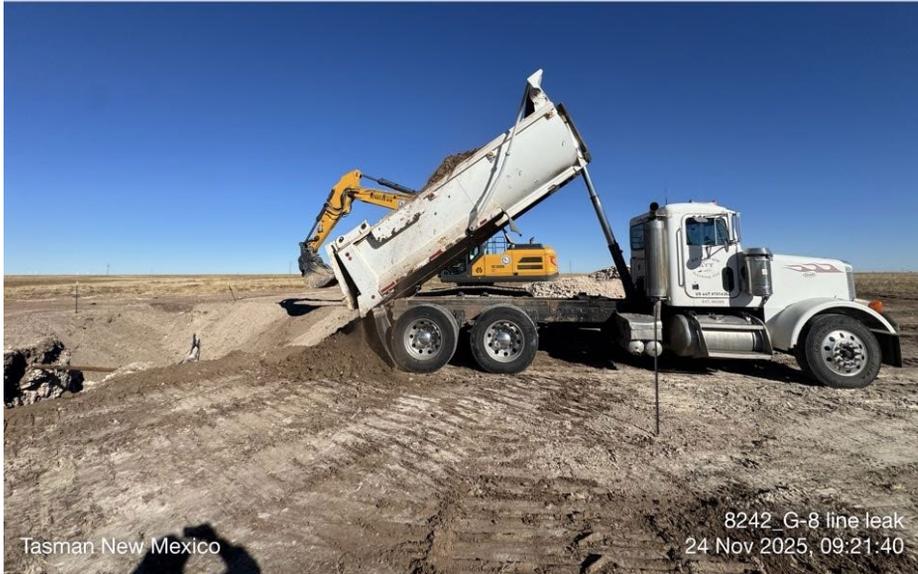
South Elevation

POS: 32.859332°, -103.535761° ±13ft

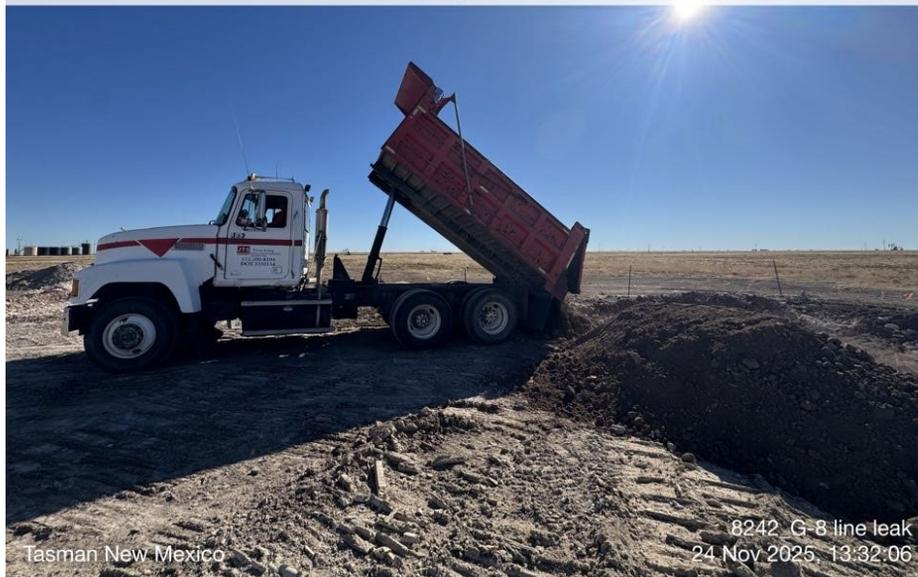
North Elevation

POS: 32.859379°, -103.535797° ±6ft

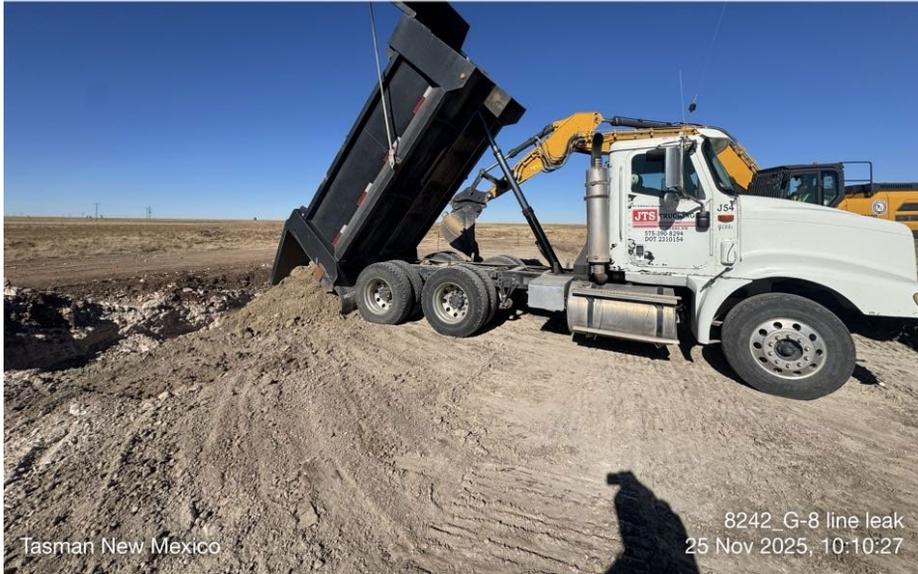
South East Elevation

POS: 32.859242°, -103.535623° ±45ft

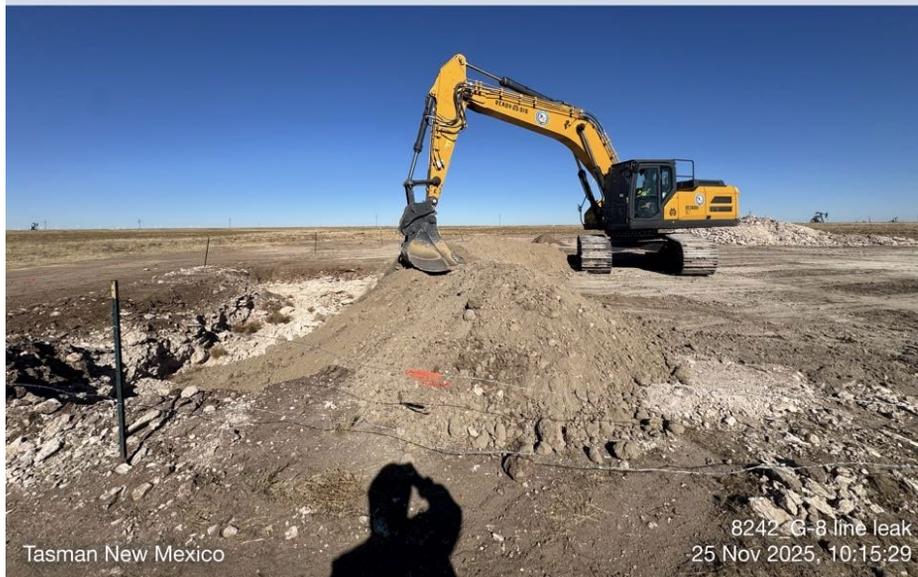
South Elevation

POS: 32.859239°, -103.535862° ±9ft
