RE: **RDU 67-68 Tank Battery - Closure Request Report**
Incident Number: nAPP2507627338
GPS: 32.01950°, -103.86710°
Eddy County, New Mexico
ESRR Project No. VP-122

Earth Systems Response & Restoration (ESRR), on behalf of WPX Energy Permian (WPX), presents the following Closure Request Report (CRR) detailing excavation activities and subsequent soil sampling events associated with an inadvertent release of produced water at the RDU 67-68 Tank Battery (Site). Based on completed remedial actions and laboratory analytical results from recent soil sampling events, WPX is requesting No Further Action (NFA) at the Site.

Environmental Karst Study Report RDU 67-68 Tank Battery Eddy County, New Mexico

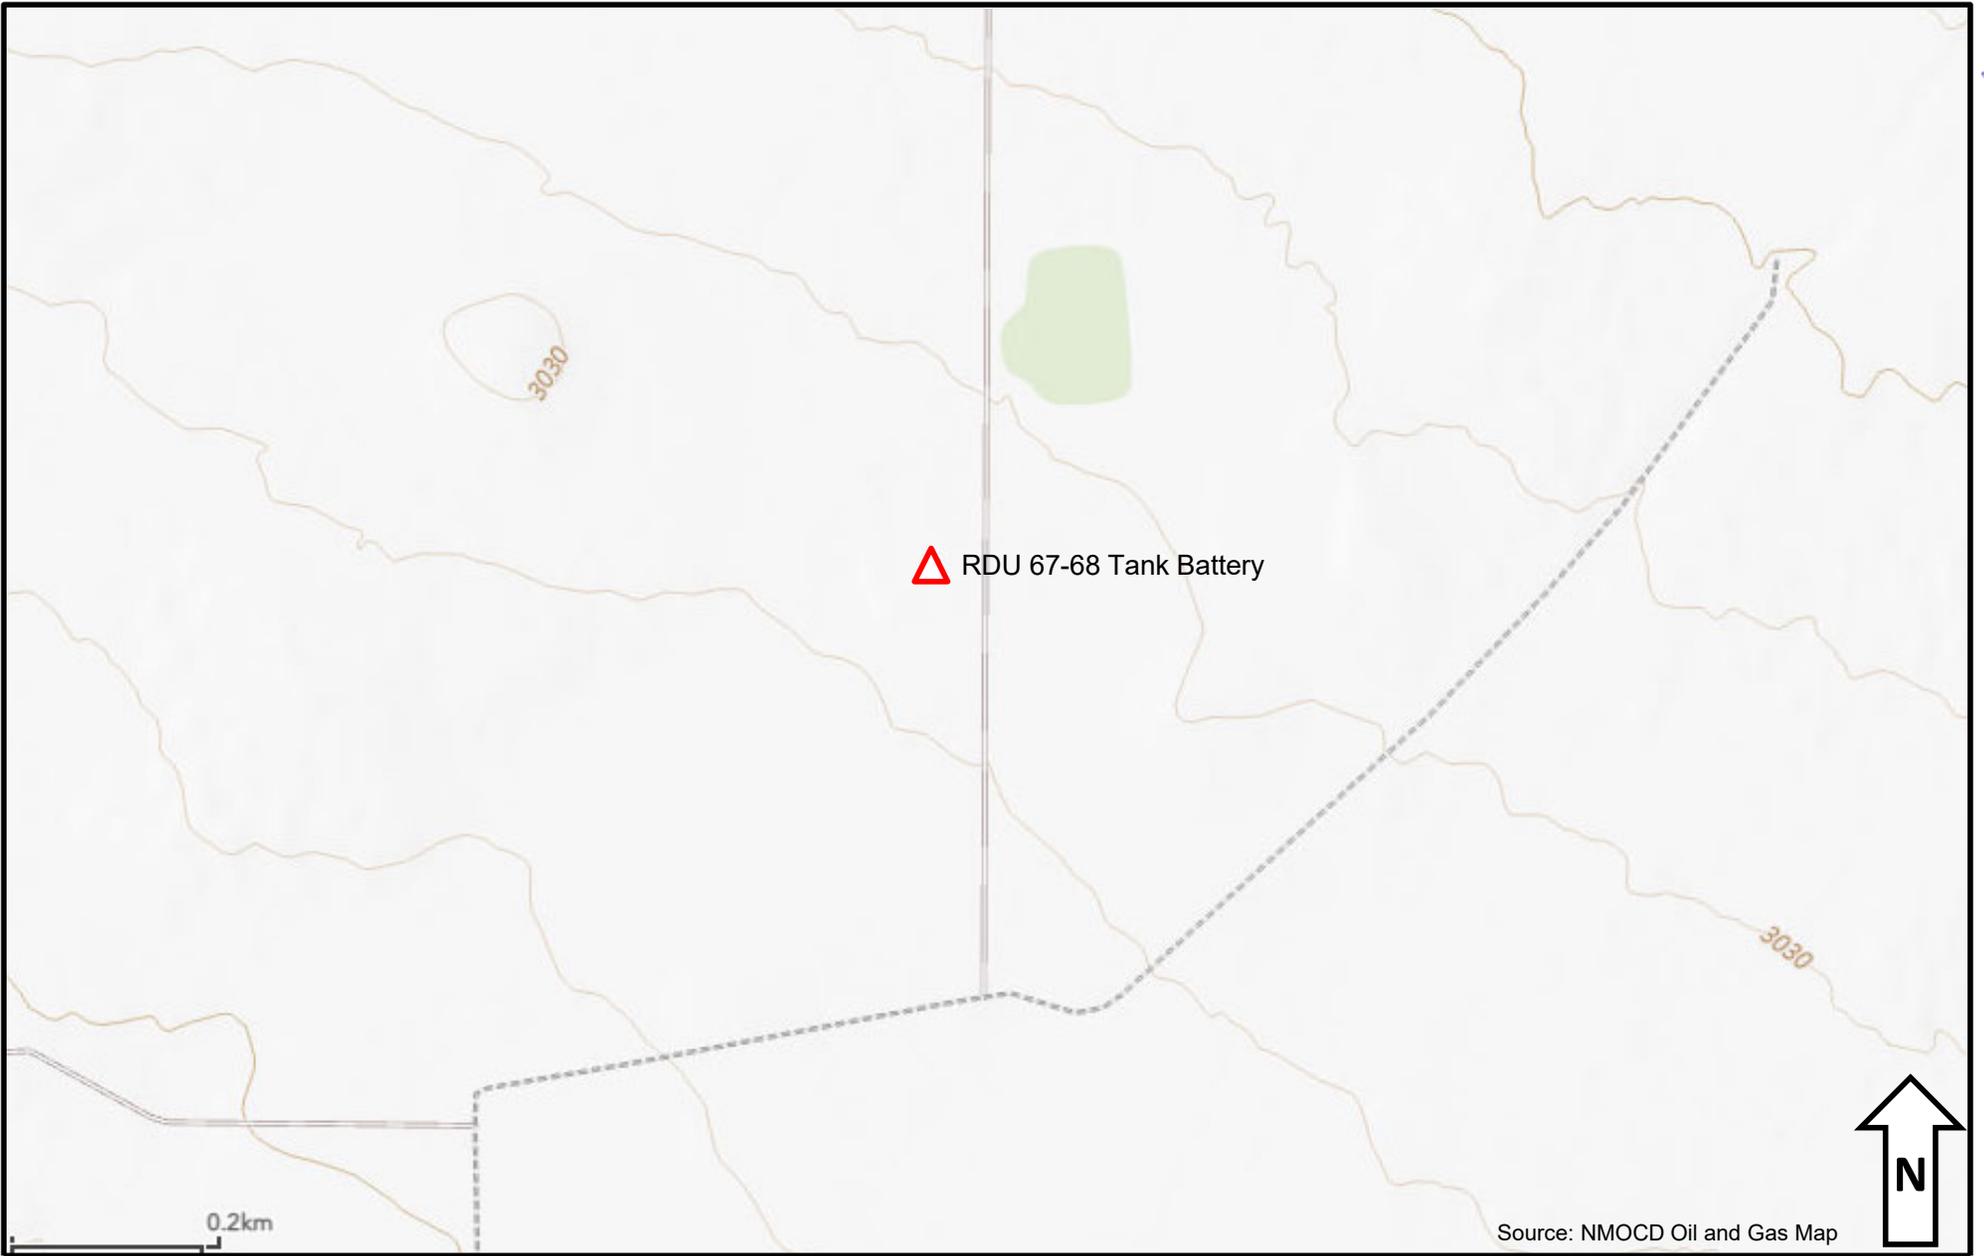
Figure 1 – Site Map

The Site is located in Unit B, Section 27, Township 26 South, Range 30 East, in Eddy County, New Mexico (32.01950°, -103.86710°) and is associated with oil and gas exploration and production operations on Federal Land managed by the Bureau of Land Management (BLM) (**Figure 1**).

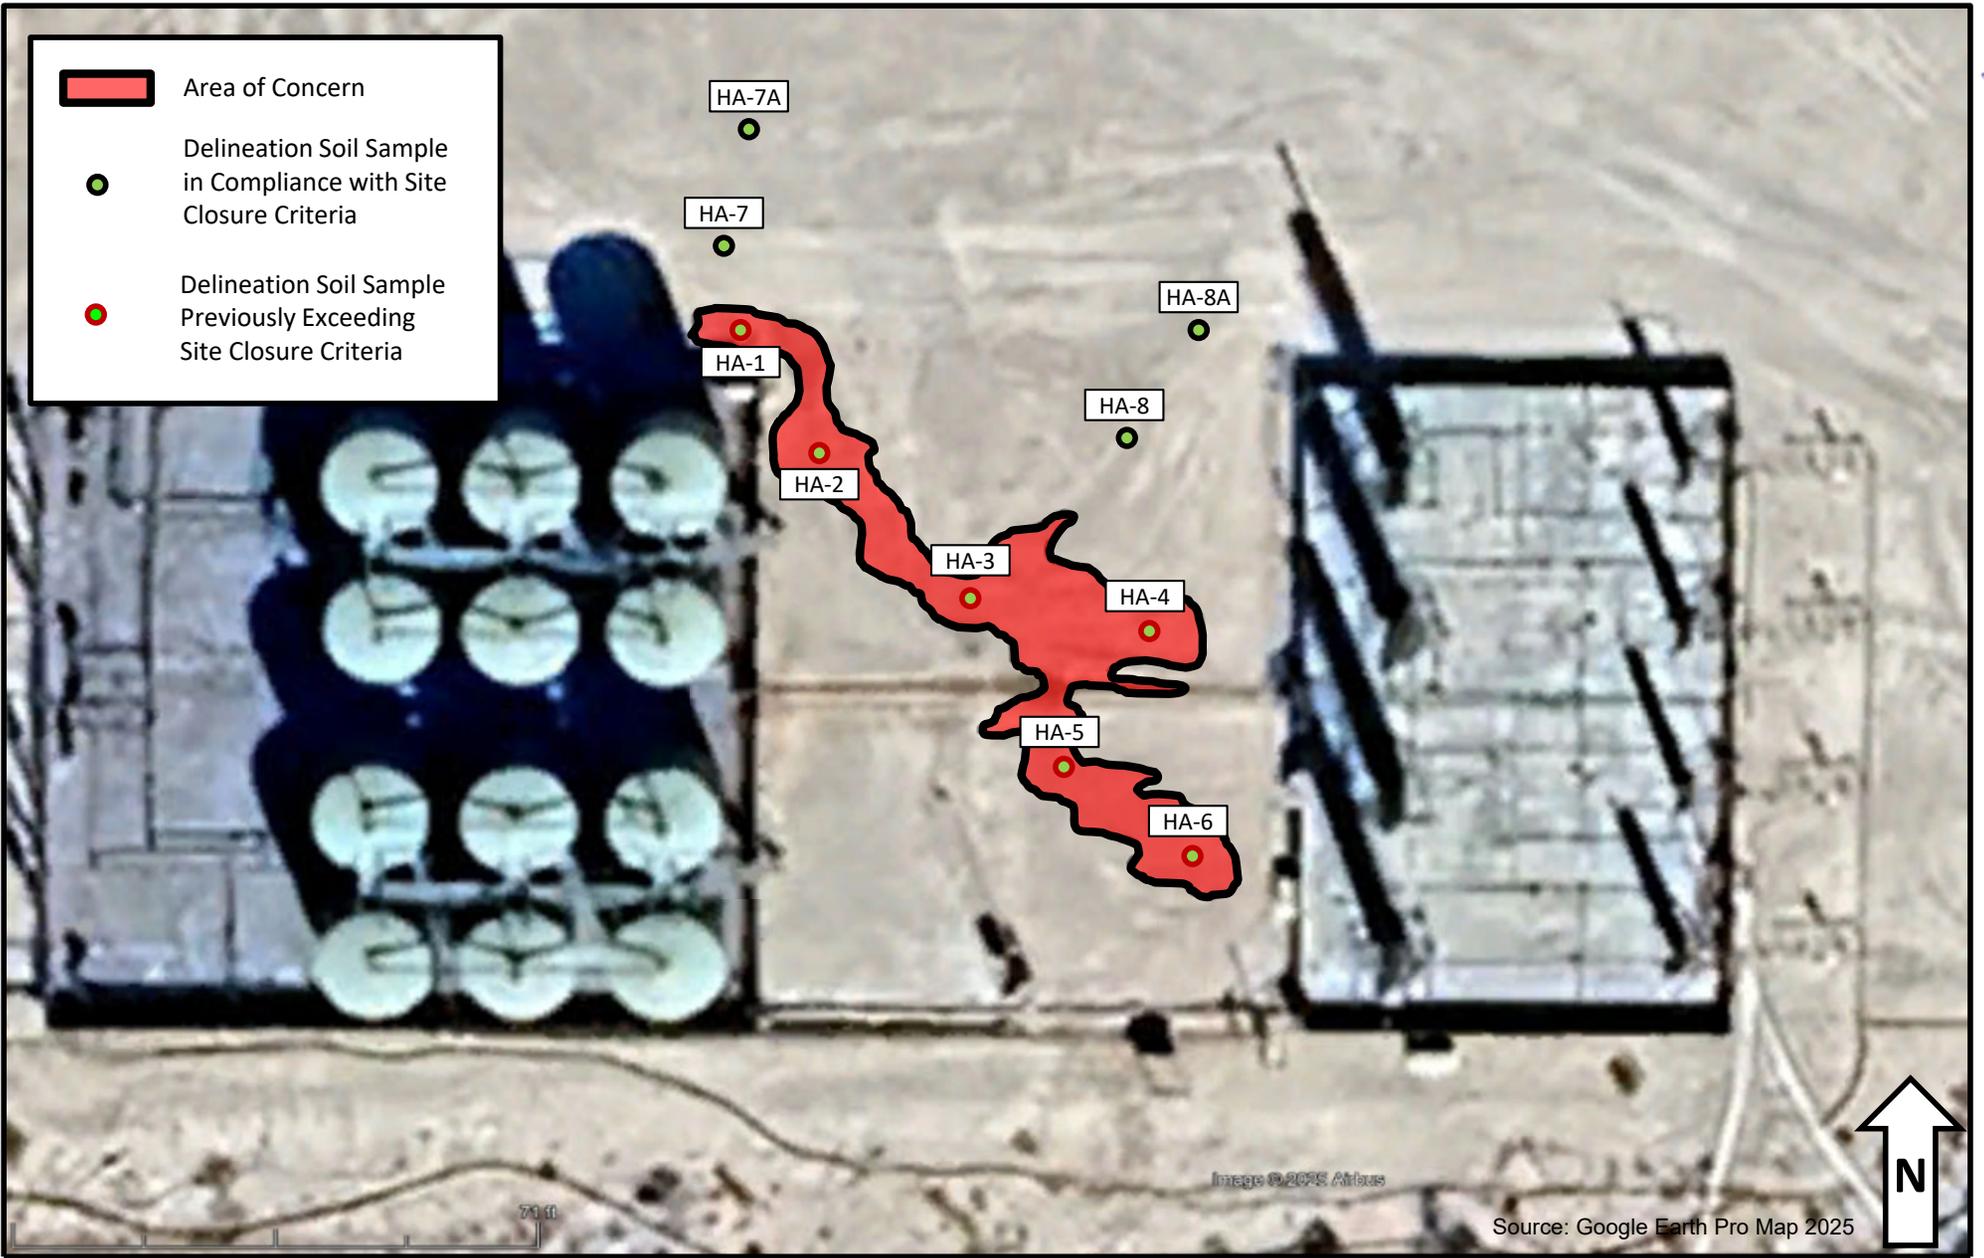
Figure 2 – Delineation Soil Sample Locations

On March 21, 2025, ESRR conducted delineation activities to assess the presence or absence of soil impacts associated with the AOC. Ten delineation boreholes (HA-1 through HA-8, HA-7A, and HA-8A) were advanced via hand auger within and surrounding the AOC. Delineation activities were driven by field screening soil for chloride utilizing QuanTab® test strips. A minimum of two soil samples were collected from each delineation borehole, representing the highest observed field screening concentrations and/or the greatest depth. Delineation soil samples were placed directly into lab-provided pre-cleaned jars, packed with minimal void space, labeled, and placed on ice. The delineation soil samples were transported under strict chain-of-custody procedures, to Eurofins in Carlsbad, New Mexico, for analysis of the COCs.

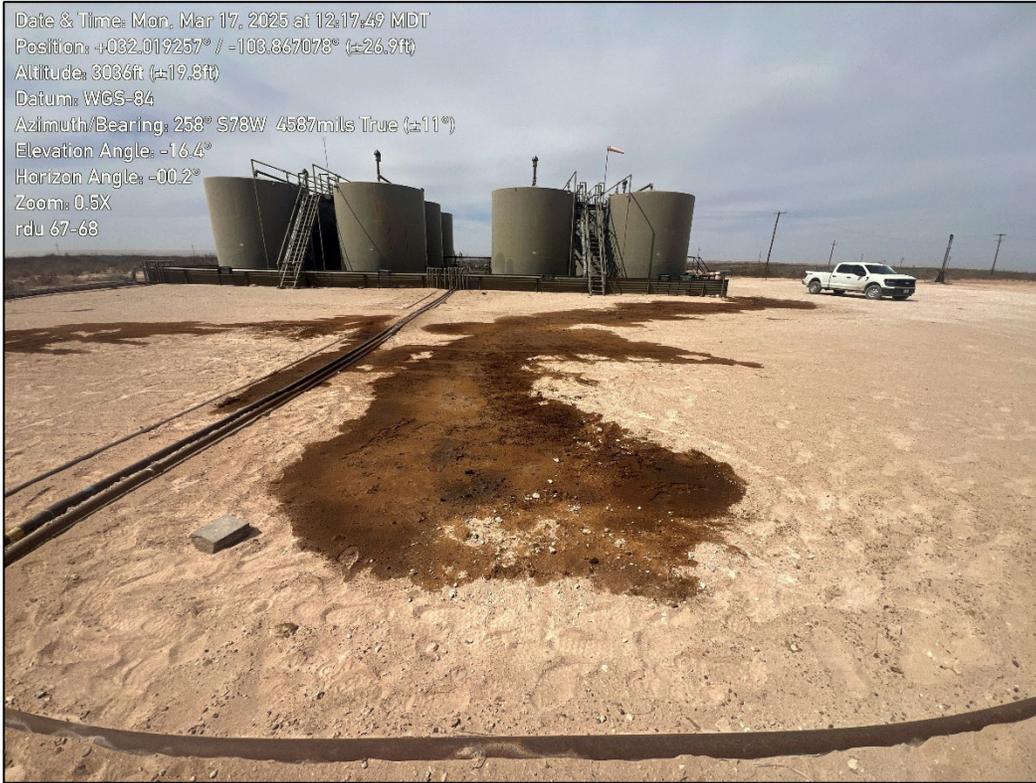
PHOTO 1: Southwestern view during initial site assessment. 03/17/2025

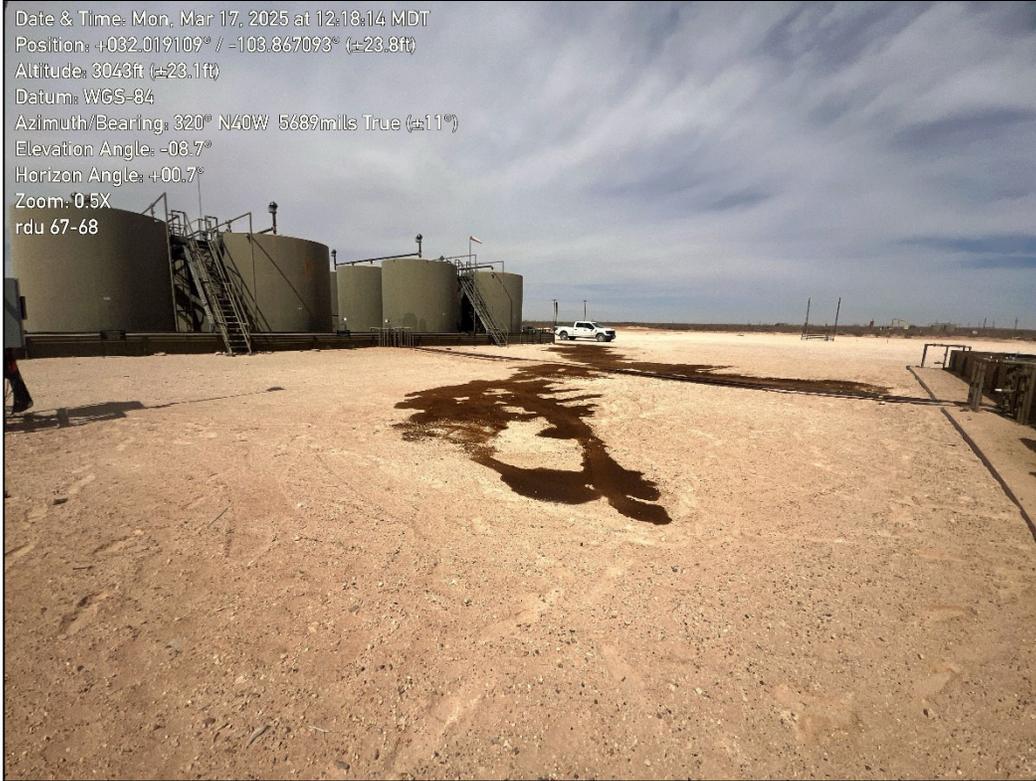
PHOTO 2: Northwestern view during initial site assessment. 03/17/2025

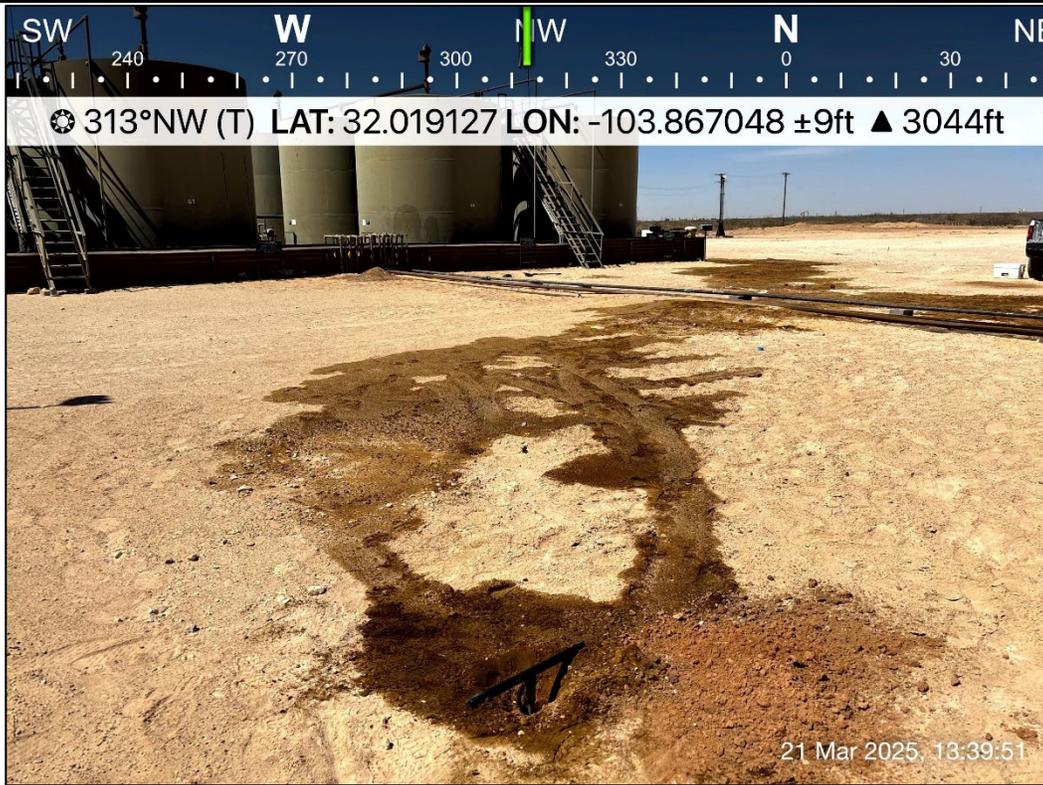
PHOTO 3: Northwestern view during delineation activities. 03/21/2025

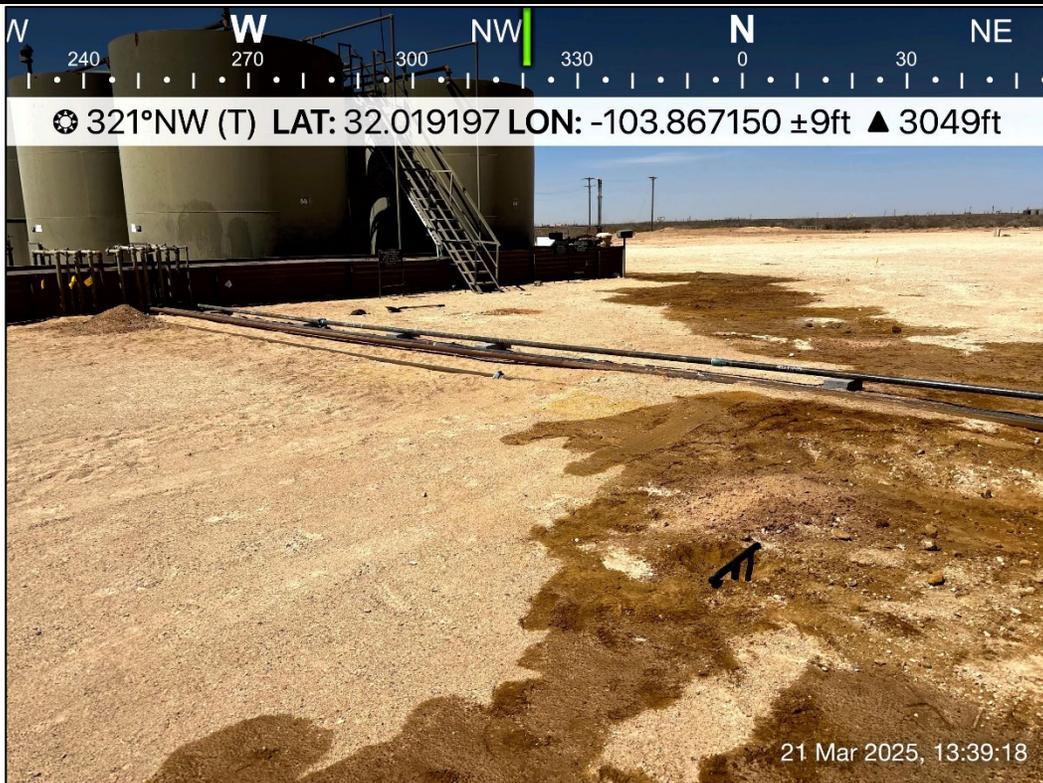
PHOTO 4: Northwestern view during delineation activities. 03/21/2025

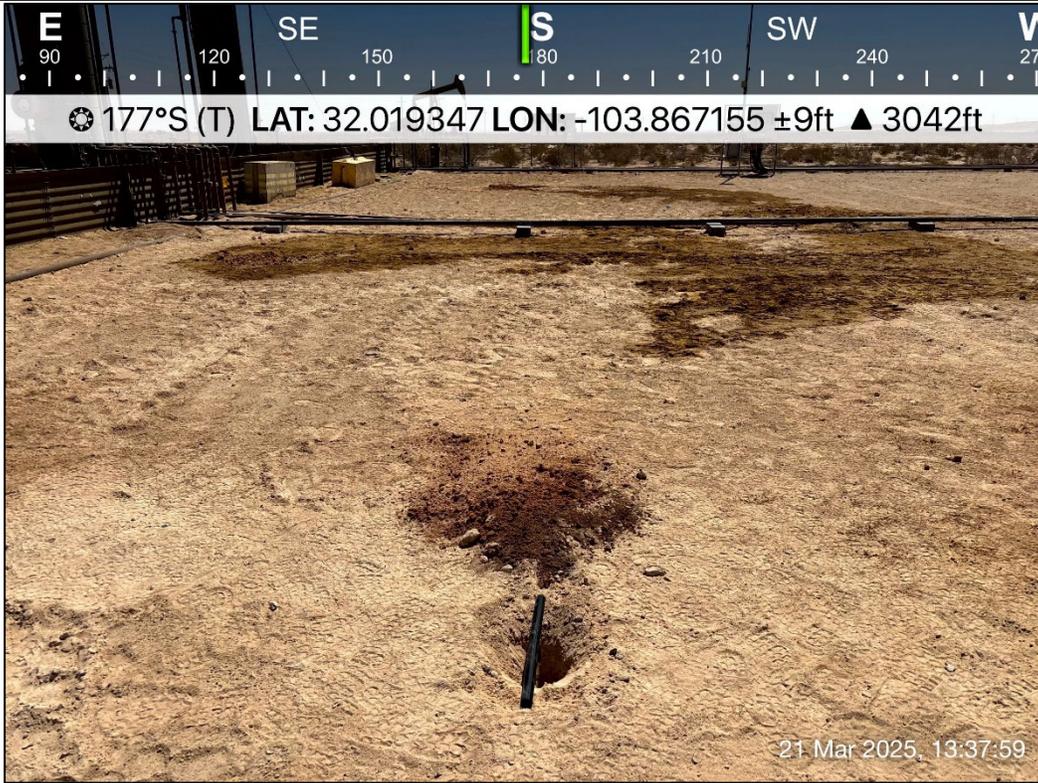
PHOTO 5: Southern view during delineation activities. 03/21/2025

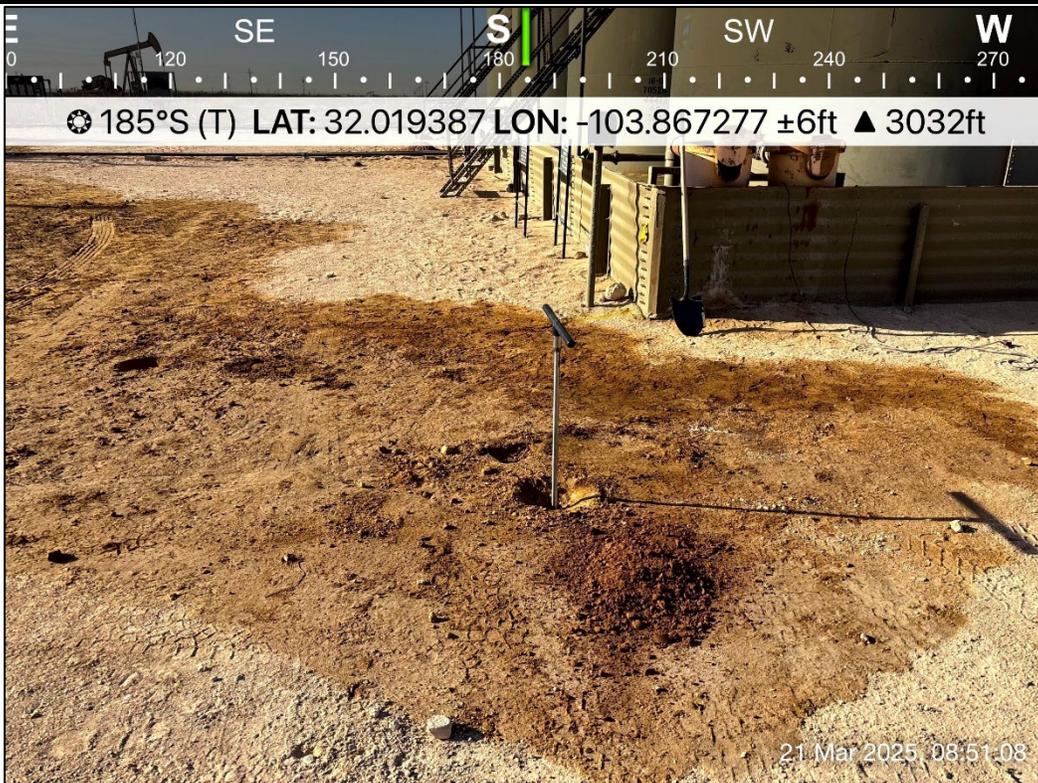
PHOTO 6: Southern view during delineation activities. 03/21/2025

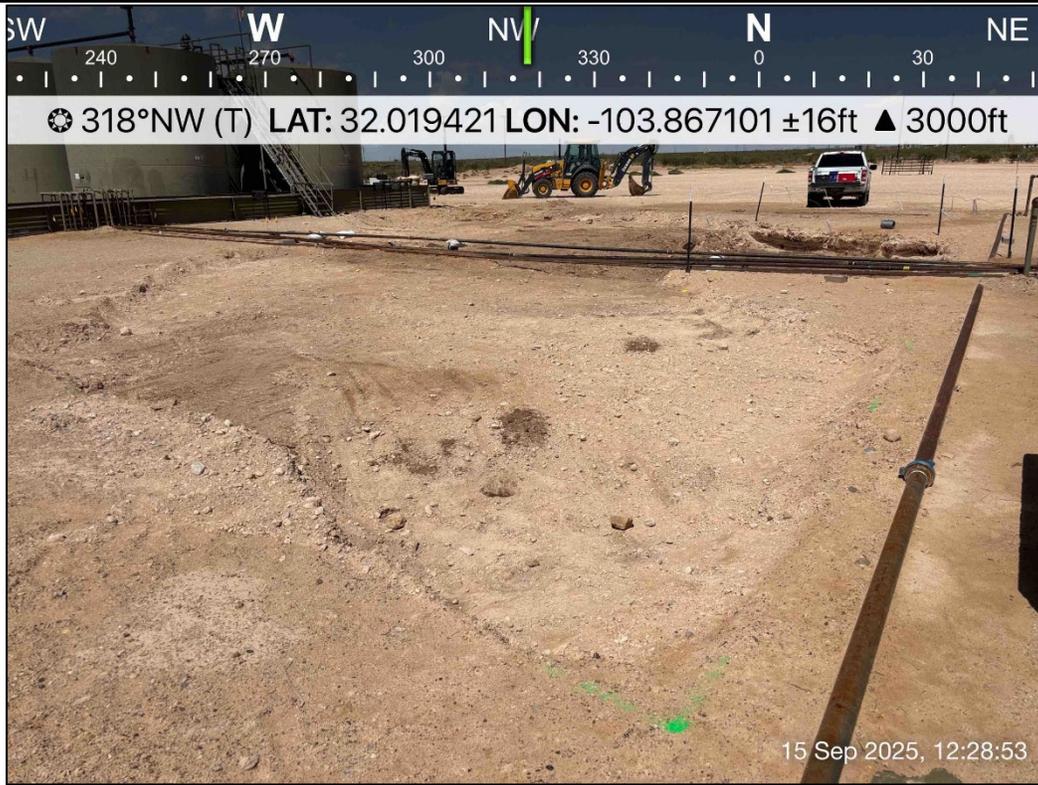
PHOTO 7: Northwestern view of the excavation extent. 09/15/2025

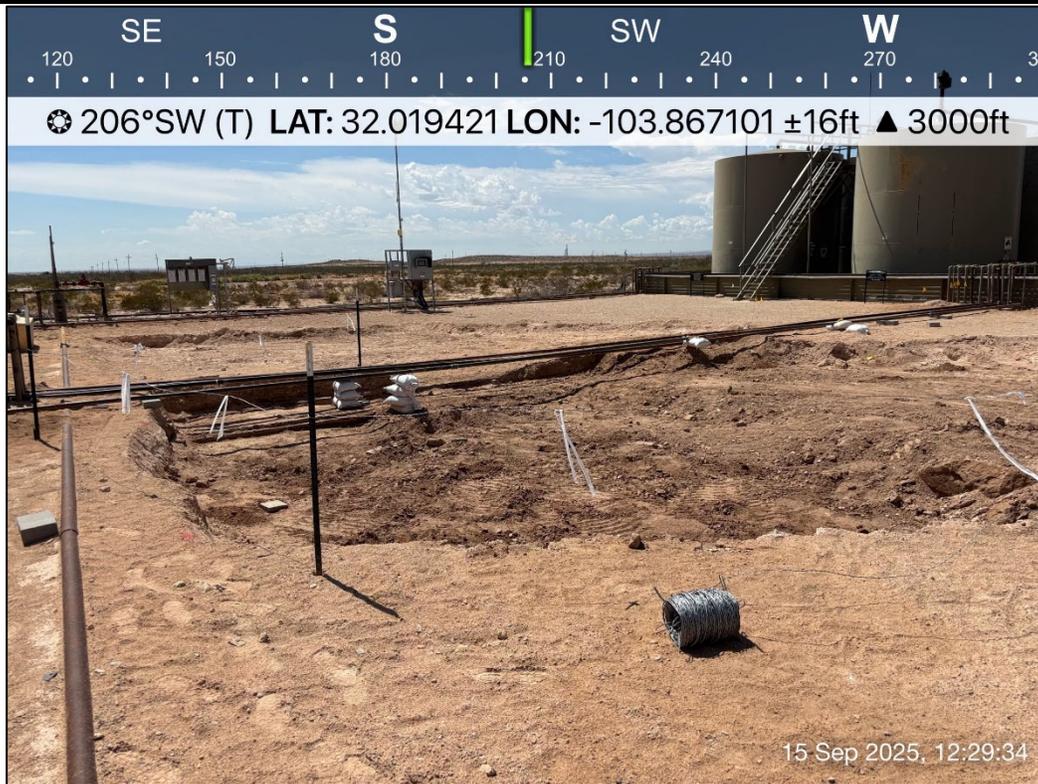
PHOTO 8: Southwestern view of the excavation extent. 09/15/2025

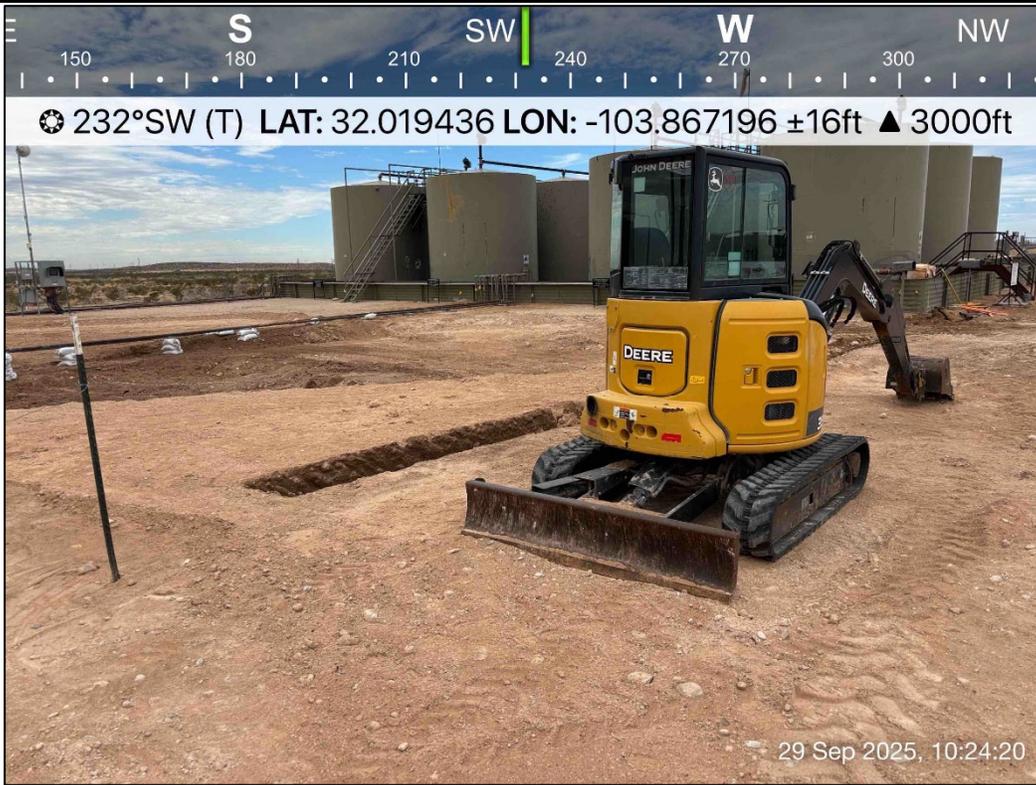
PHOTO 9: Southwestern view of the excavation extent. 09/29/2025

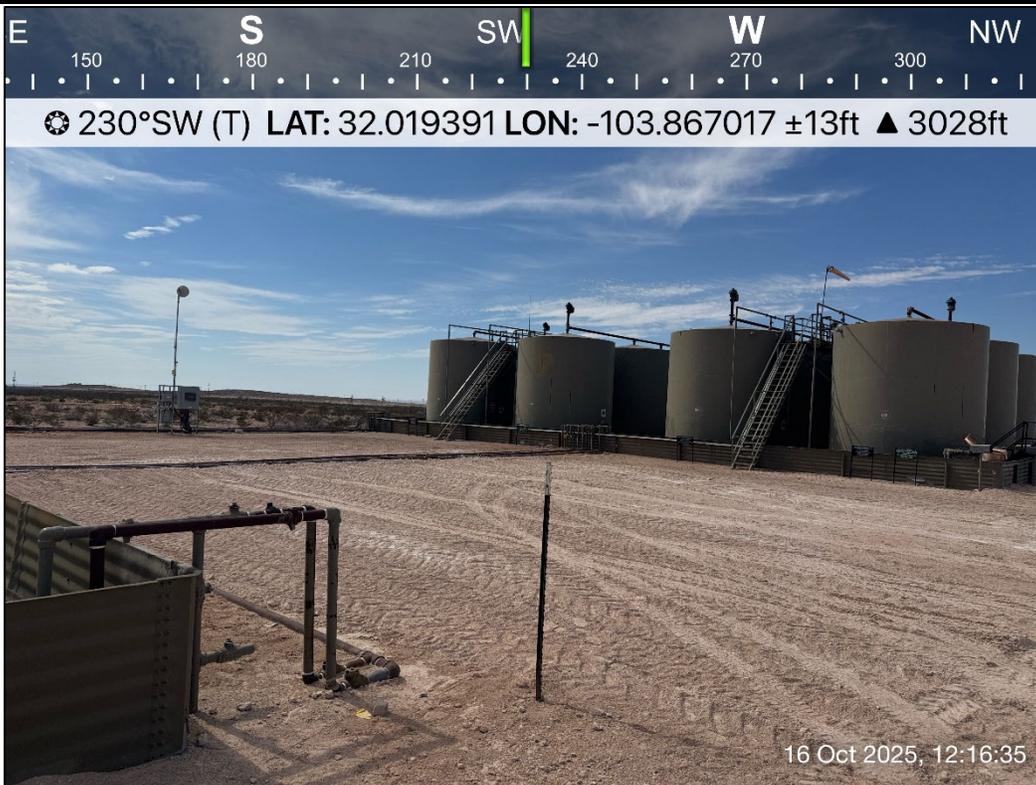
PHOTO 10: Southwestern view following restoration activities. 10/12/2025

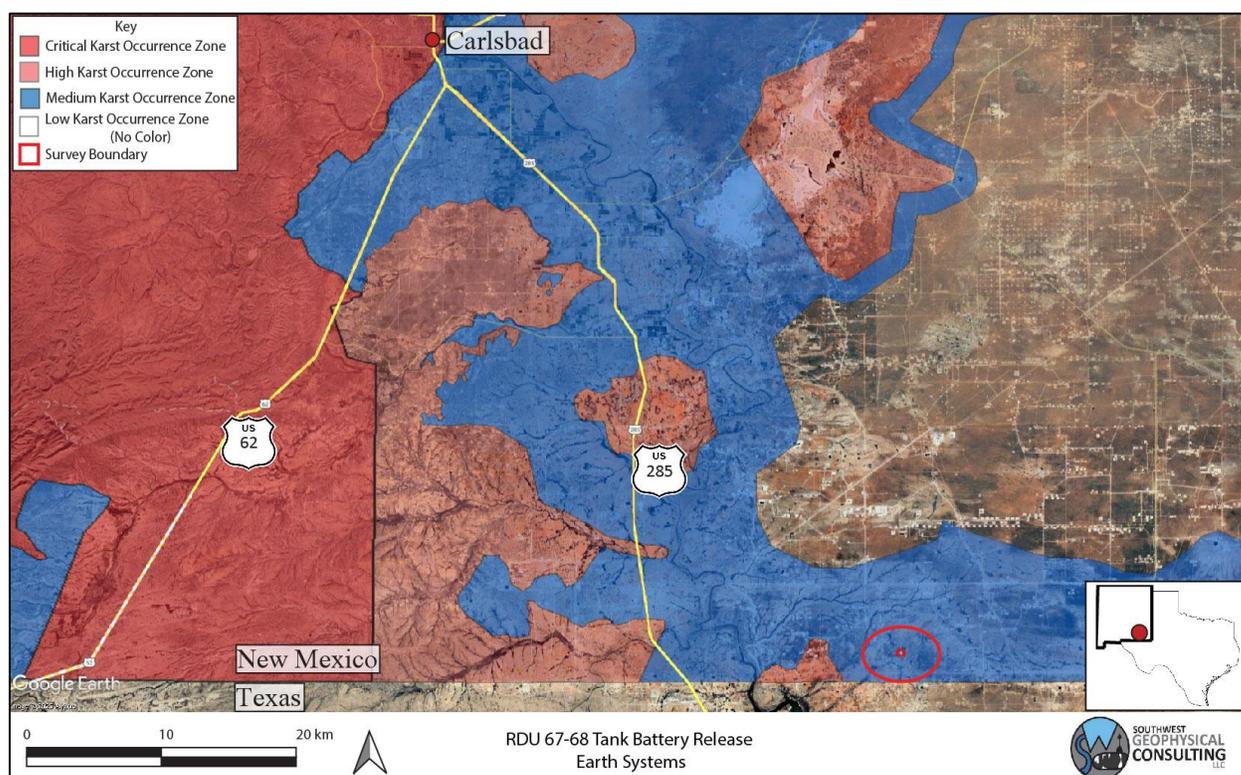
The Bureau of Land Management (BLM) categorizes all areas within the Carlsbad Field Office (CFO) zone of responsibility as having either low, medium, high, or critical cave potential based on geology, occurrence of known caves, density of karst features, and potential impacts to freshwater aquifers^[4]. These designations are also recognized by the New Mexico State Land Office (NMSLO). This project occurs within a **MEDIUM** karst occurrence zone (MKOZ)^[5] (**Figure 1**).

Figure 1: Karst occurrence zone overview. Background image credit: Google Earth. Image date: August 21, 2024. Image datum: WGS-84.

A medium karst occurrence zone is defined as an area in known soluble rock types that may have a shallow insoluble overburden. These areas may contain isolated karst features such as caves and sinkholes. Groundwater recharge may not be wholly dependent on karst features, but the karst features still provide the most rapid aquifer recharge in response to surface runoff^[4].

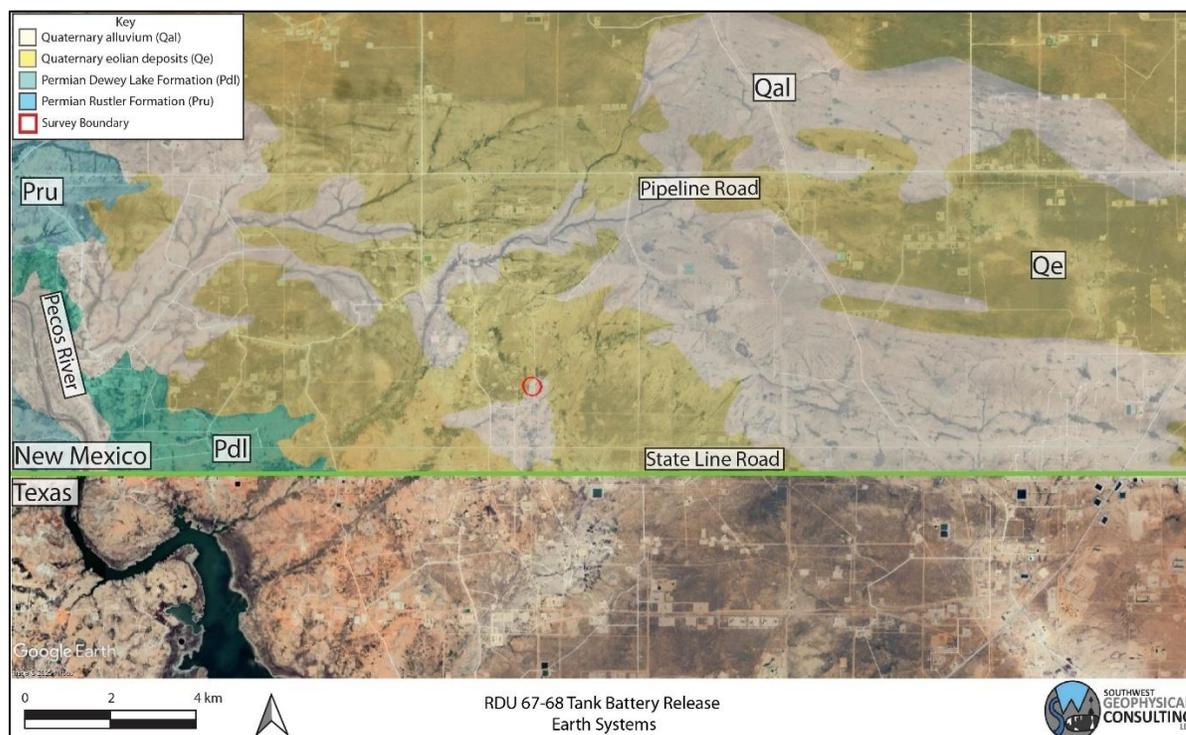
The site for the RD67 survey is located at an elevation of 924 meters (3,032 feet), \pm 2 meters (6.6 feet), and is located within a region entirely underlain by the Permian Dewey Lake (Pdl) and Rustler (Pru) Formations. The area is mantled by thin gypsiferous soils (gypsite), Quaternary alluvium (Qal) and eolian sands (Qe)^[11] up to 5 meters in depth (**Figure 3**).

Figure 3: Geology overview. Geology map credit: The Digital Geologic Map of New Mexico in ARC/INFO Format. Background image credit: Google Earth. Image date: December 31, 2023. Image datum: WGS-84.

The Dewey Lake Formation is composed of calcite-cemented, hematite-stained quartz sand grains^[12] and occasional gypsum lenses and can, in favorable conditions, form cavernous porosity within 30 meters of the top of the Rustler Formation^[13]. The Dewey Lake Formation is also known to be highly fractured near areas of heavy halite dissolution such as Nash Draw (approximately 25 kilometers north), and these fractures can act as hydrologic conduits.

The Rustler Formation is an evaporite facies and is composed mainly of thin siltstones and sandstones interbedded with claystones, dolomite and gypsum^[12], and contains both karst-forming strata (the Forty-niner and Tamarisk members) and two shallow aquifers (the Magenta and Culebra Dolomite members). The Forty-niner and Tamarisk members are known to have highly developed karst features including large voids and solution-enlarged fractures^[14].

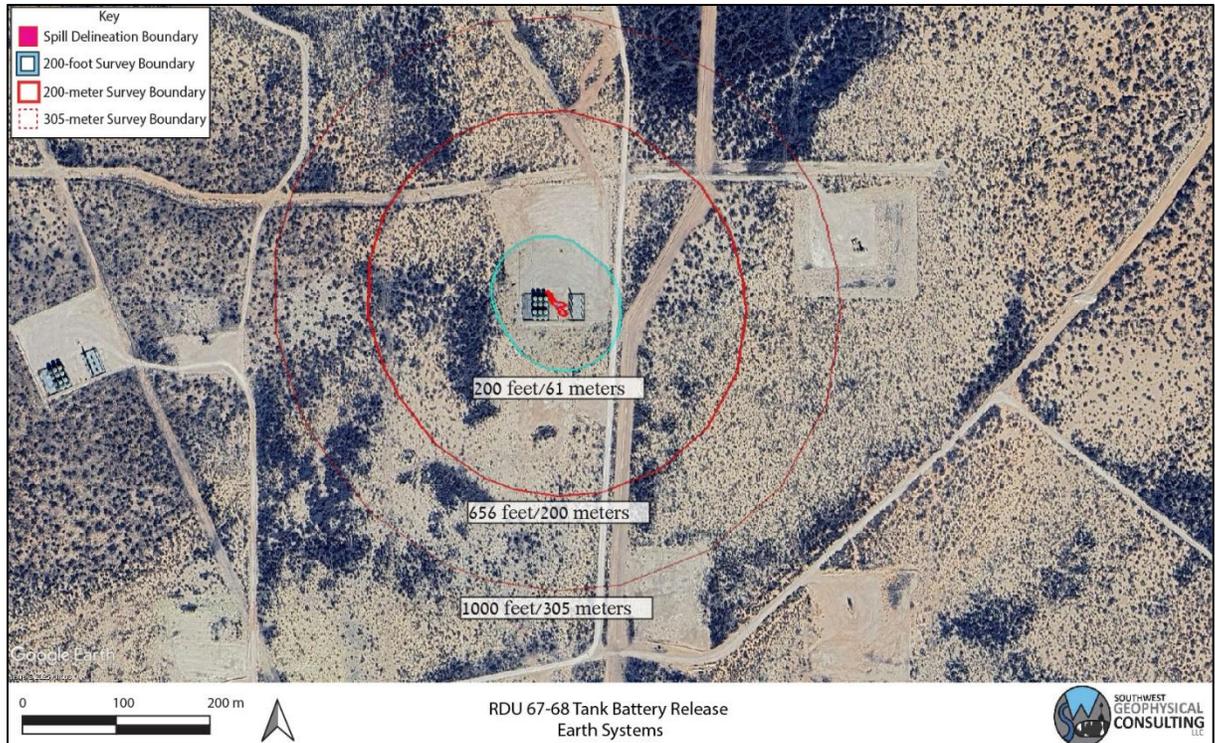
Surface karst surveys are conducted by sUAS at low elevation within 200 meters of the spill delineation boundary^[4] (**Figure 4**) following a preplanned raster pattern flightpath designed for the purpose of generating at least 75% imagery overlap. The collected high-resolution, georeferenced imagery is stitched together to develop orthomosaic imagery which is further developed into a digital elevation model (DEM); the DEM is then processed into a local relief model (LRM) (**Figure 6**). This LRM is color coded to enhance differences in elevation of as little as five centimeters. The orthoimagery, DEM, and LRM are uploaded to a server where they are analyzed by an experienced karst geologist. Finally, the data is reviewed by a senior karst geologist for quality assurance and downloaded into a table for inclusion in a written report^[17].

Figure 4: Surface survey overview. Background image credit: Google Earth. Image date: December 31, 2023. Datum: WGS-84.

The resolution of the orthoimagery is clear enough that features as small as 10 centimeters can be positively identified in most circumstances. Occasionally there are ambiguous features identified during an aerial survey that will need to be checked in the field if they are impacted by the proposed remediation efforts. Specifically, it is difficult to tell the difference between solution tubes, abandoned uncased well bores, and some burrows in drone imagery. If an ambiguous feature is located during imagery analysis, it is marked with a yellow dot in **Figure 6**. If a feature of any likelihood is subsequently verified in the field prior to publication of the report, the dot will be changed to a red triangle if confirmed as a karst feature or deleted if not.

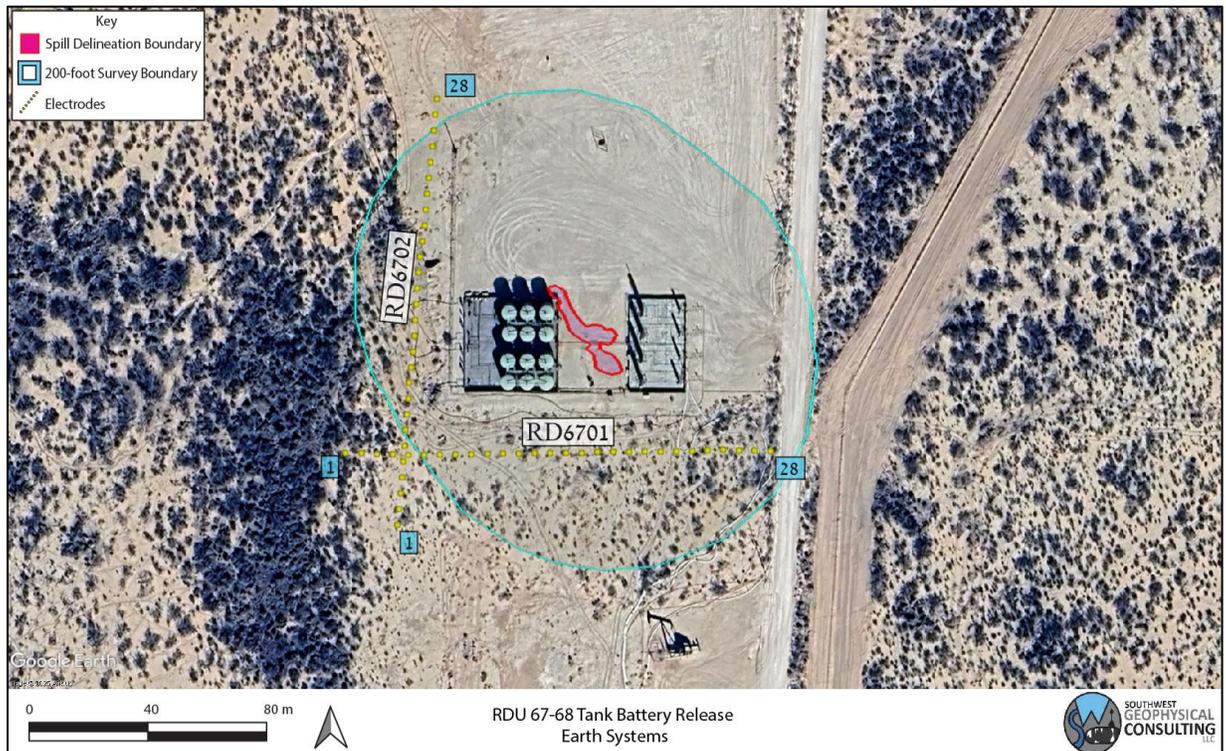
For this survey, an Advanced Geosciences Inc. (AGI) SuperSting™ Wifi R8 with a multi-electrode switchbox, a 28-electrode array of 40-centimeter-long electrodes, and a tablet controller were used to image the subsurface. This survey consisted of two orthogonal resistivity lines in a dipole-dipole configuration; line RD6701 is laid out west to east while line RD6702 is laid out south to north. Both lines consisted of 28 electrodes at 5-meter spacing, resulting in 135-meter-long arrays (**Figure 5, Table 1**). A preconfigured command file was used to run the data collection (DiDi28). This electrode configuration provided a depth of investigation of 27 meters (89 feet) and a resolution of 2.5 to 3.0 meters (8.2 to 9.8 feet) within the first 5 to 8 meters (16 to 26 feet) from the surface. A Leica GS18 GPS was used to record electrode locations and elevations.

Figure 5: Geophysical survey overview. Two survey lines were conducted with 28 electrodes (yellow dots denoted with blue numbers). Background image credit: Google Earth. Image date: December 31, 2023. Image datum: WGS-84.

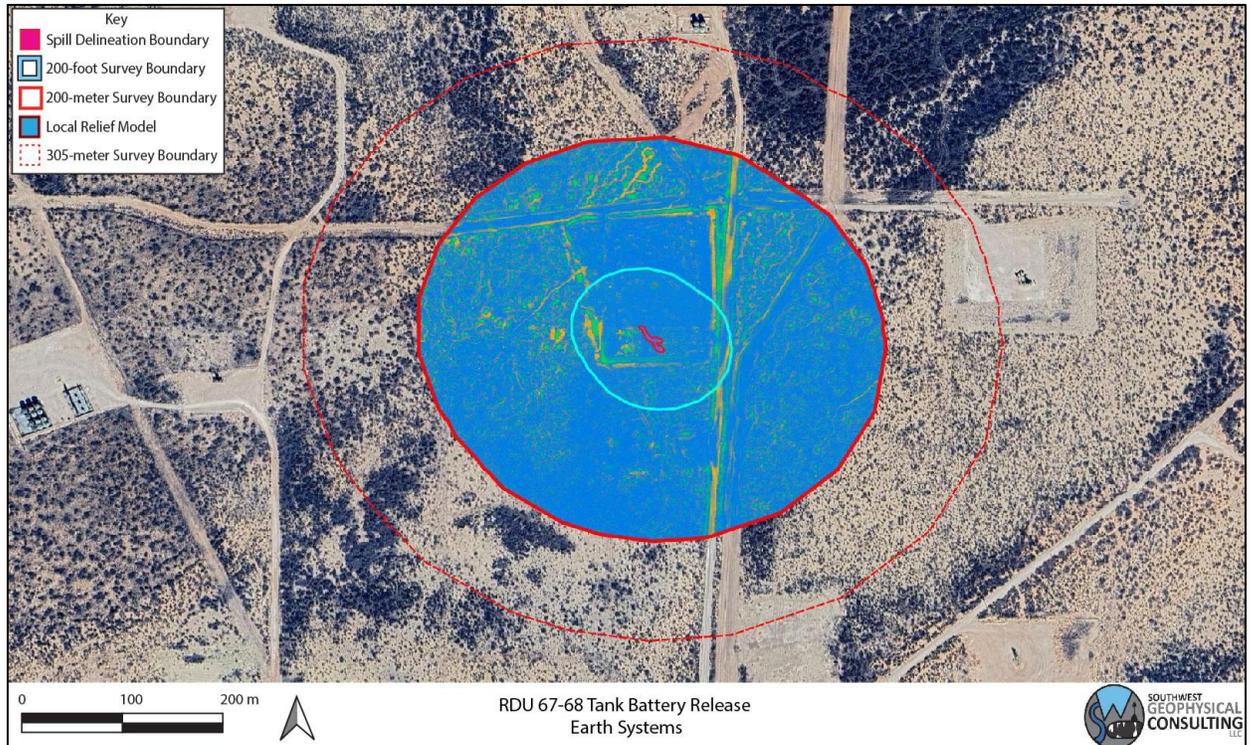
The desk study and surface karst survey showed no surface karst features within the 200-foot (61-meter)^[1] karst survey boundary (Figure 6).

Figure 6: Surface karst survey results. Background image credit: Google Earth. Image date: December 31, 2023. Image datum: WGS-84.

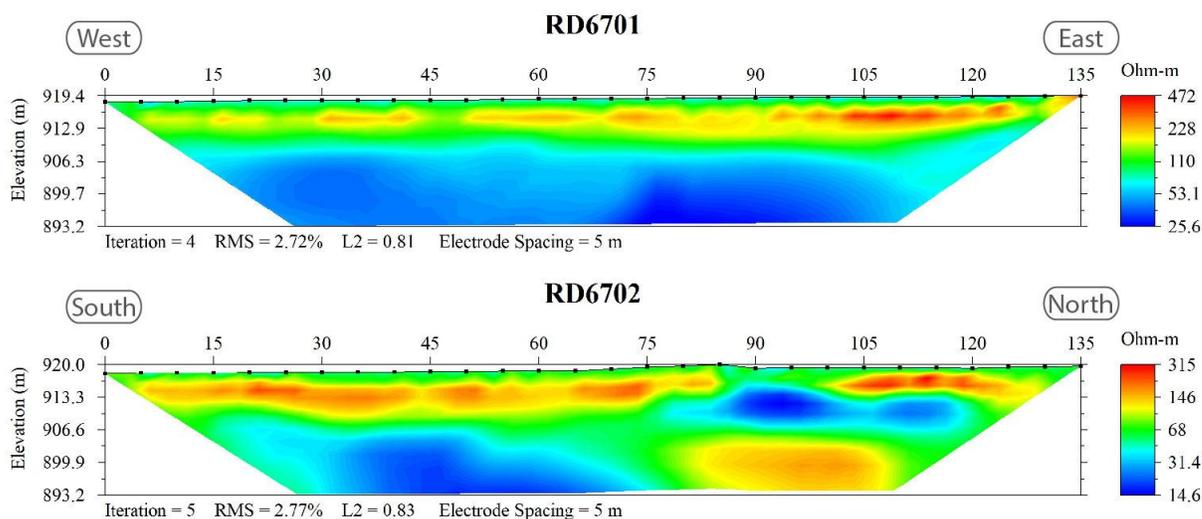
The results of this study indicate a well-layered geologic system with resistivities between 14.6 and 472 Ohm-m (**Figure 7**). Please keep in mind when viewing the 2D inverted resistivity sections that color maps can be widely different for each view. Always check the color map located on the right side of the image when viewing the 2D images to ensure you understand the range of resistivities presented. Distances along the top and depths along the left side are in meters. The color map along the right side is in Ohm-m. Due to the nature of the survey, shallower zones have higher resolution between electrodes than deeper zones; therefore, small features at depth will not be visible.

Figure 7: 2D inverted resistivity sections. Reds and oranges indicate higher resistivity values. Yellows and greens are medium-resistivity values. Blues are low-resistivity values. Please note that the color scale is relative.

No surface karst features and no anomalies consistent with air-filled subsurface voids are found within the RD67 survey area. However, small solutionally enlarged voids or fractures at or near the resolution limit of the survey (2.5 – 3.0 meters) may be present. Slightly higher-than-average resistivity areas less than 10 meters beneath the surface are interpreted as sand, caliche, or gypsite soils. Due to their much lower resistivity values when compared with significant subsurface voids, these features should not be a concern during remediation efforts. Areas of moderate resistivity (yellows, and greens) near the surface are interpreted as sand, caliche, or sandstone of the Dewey Lake Formation; or dry caliche soils and gypsum or dolomite bedrock Rustler Formation^[18] (**Figure 7** and **Figure 8**).

The low-resistivity area between 14.6 – 25 Ohm-m on line RD6702 may either represent fluid from the brine release or surface-to-subsurface hydrologic pathways. The low-resistivity area at a depth of 15 meters beneath the surface across both lines is likely a layer of either clay and halite lenses or moist or saturated layers within the Dewey Lake or Rustler Formations. (**Figure 7**).

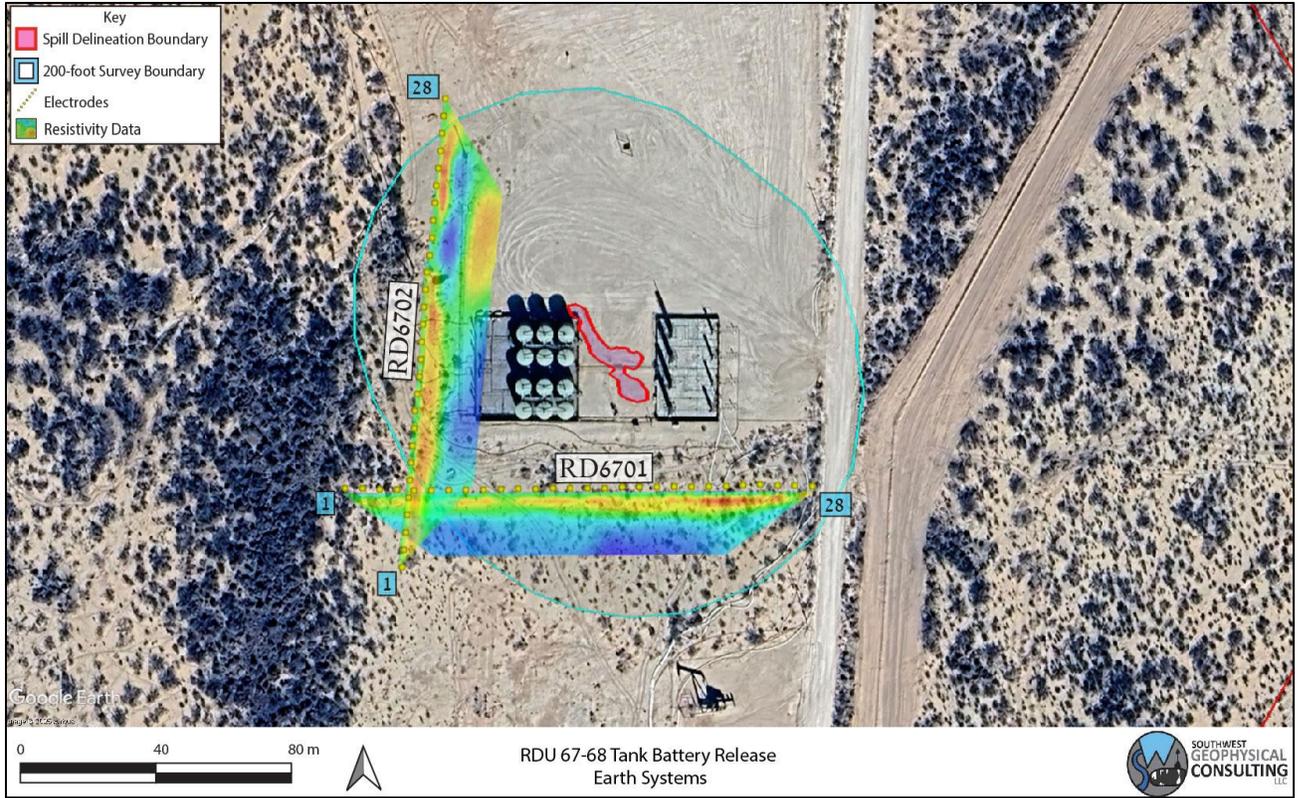
Figure 8: Interpretation. Colored trapezoids are 2D inverted resistivity lines. Background image credit: Google Earth. Image date: December 31, 2023.
