**Re: Closure Request
James Ranch Unit DI 7 Battery
Incident Number nAPP2525557554
Eddy County, New Mexico**

Ensolum, LLC (Ensolum) on behalf of XTO Energy, Inc. (XTO), has prepared this *Closure Request* to document site assessment, delineation, excavation, and soil sampling activities at the James Ranch Unit DI 7 Battery (Site). The purpose of the Site assessment, excavation, and soil sampling activities was to assess for the presence or absence of impacts to soil following a release of crude oil. Based on field observations, field screening activities, and soil sample laboratory analytical results, XTO is submitting this *Closure Request*, describing remedial activities that have occurred and requesting no further remediation for Incident Number nAPP2525557554.

**Environmental Karst Study Report
XTO JRU DI 7
Eddy County, New Mexico**

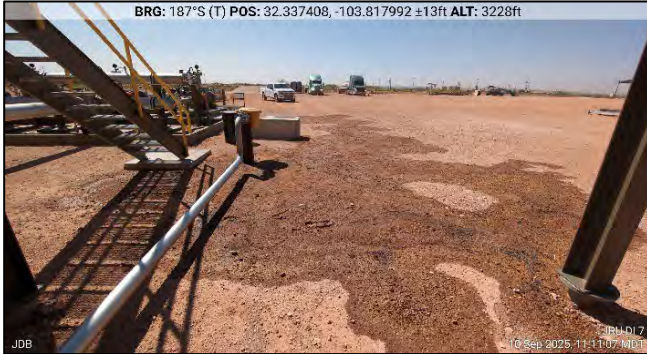
Photograph: 1 Date: 9/10/2025
Description: Initial release extent
View: South

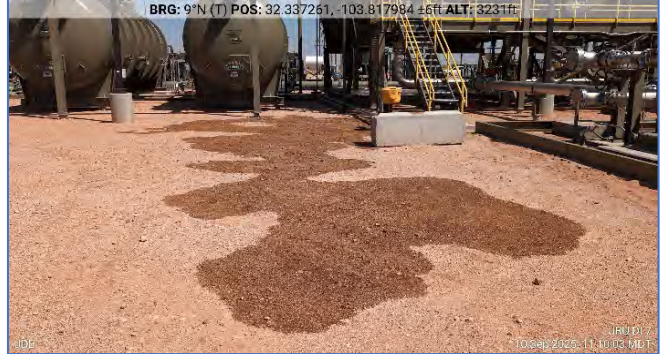
Photograph: 2 Date: 9/10/2025
Description: Initial release extent
View: North

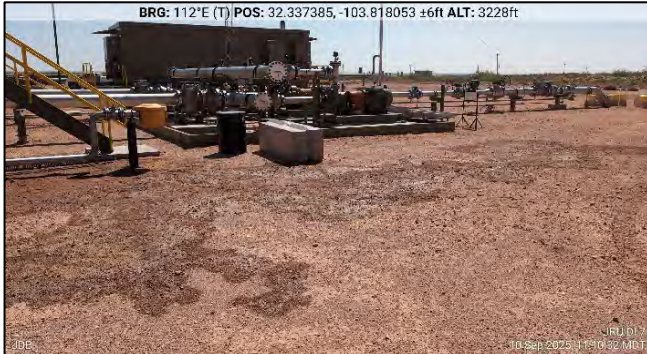
Photograph: 3 Date: 9/10/2025
Description: Initial release extent
View: East

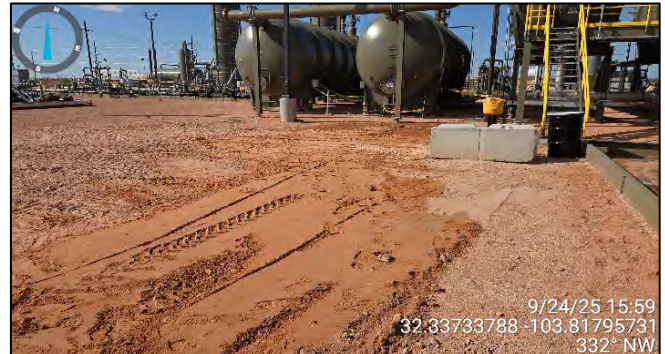
Photograph: 4 Date: 9/24/2025
Description: Delineation activities; near PH01
View: Northwest

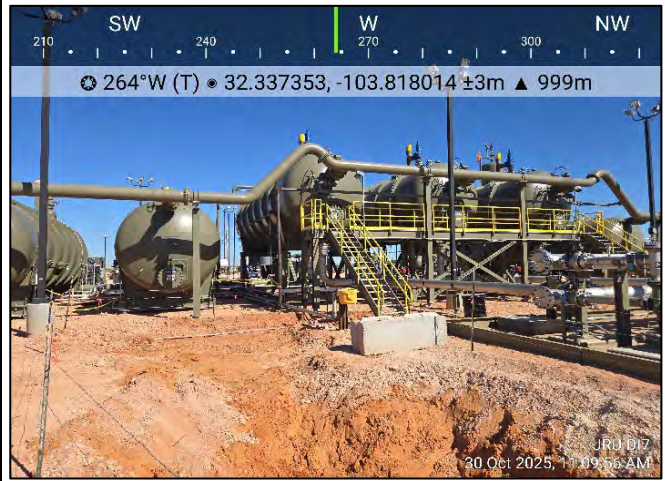
Photograph: 6 Date: 10/30/2025
Description: Excavation activities; near FS03
View: West

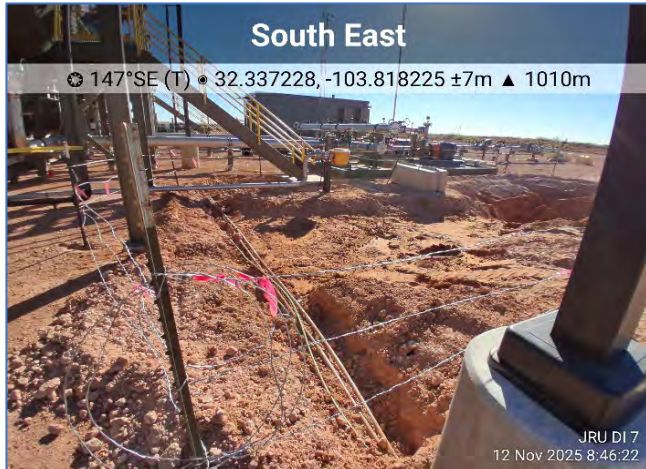
Photograph: 7 Date: 11/12/2025
Description: Excavation activities; facing FS04
View: Southeast

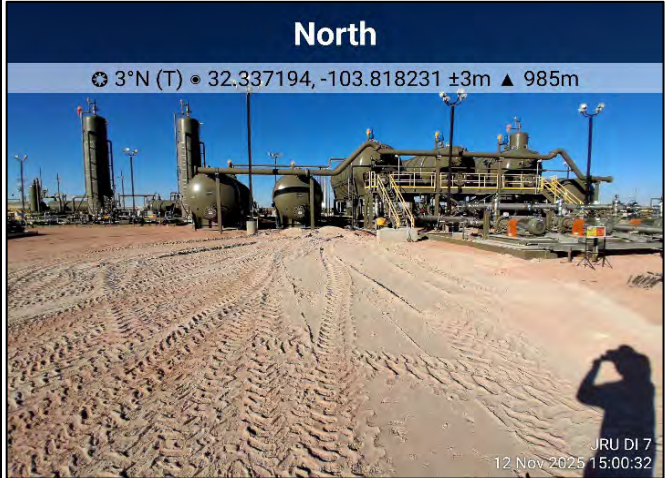
Photograph: 8 Date: 11/12/2025
Description: Backfill activities
View: North
