Closure Report
DL 10 3 Federal Com #407H (12.06.2025)
Incident ID: nAPP2534125945
Lea County, New Mexico
Unit M Sec 10 T22S R33E
32.399994°, -103.566222°

Condensate Release
Point of Release: Equipment failure resulting in flare fire
Release Date: 12.06.2025
Volume Released: 0 Barrels of Condensate
Volume Recovered: 0 Barrels of Condensate

Prepared for:
Chevron U.S.A., Inc.
6301 Deauville Blvd
Midland, Texas 79706

Prepared by:
Carmona Resources, LLC
310 West Wall Street
Suite 500
Midland, Texas 79701

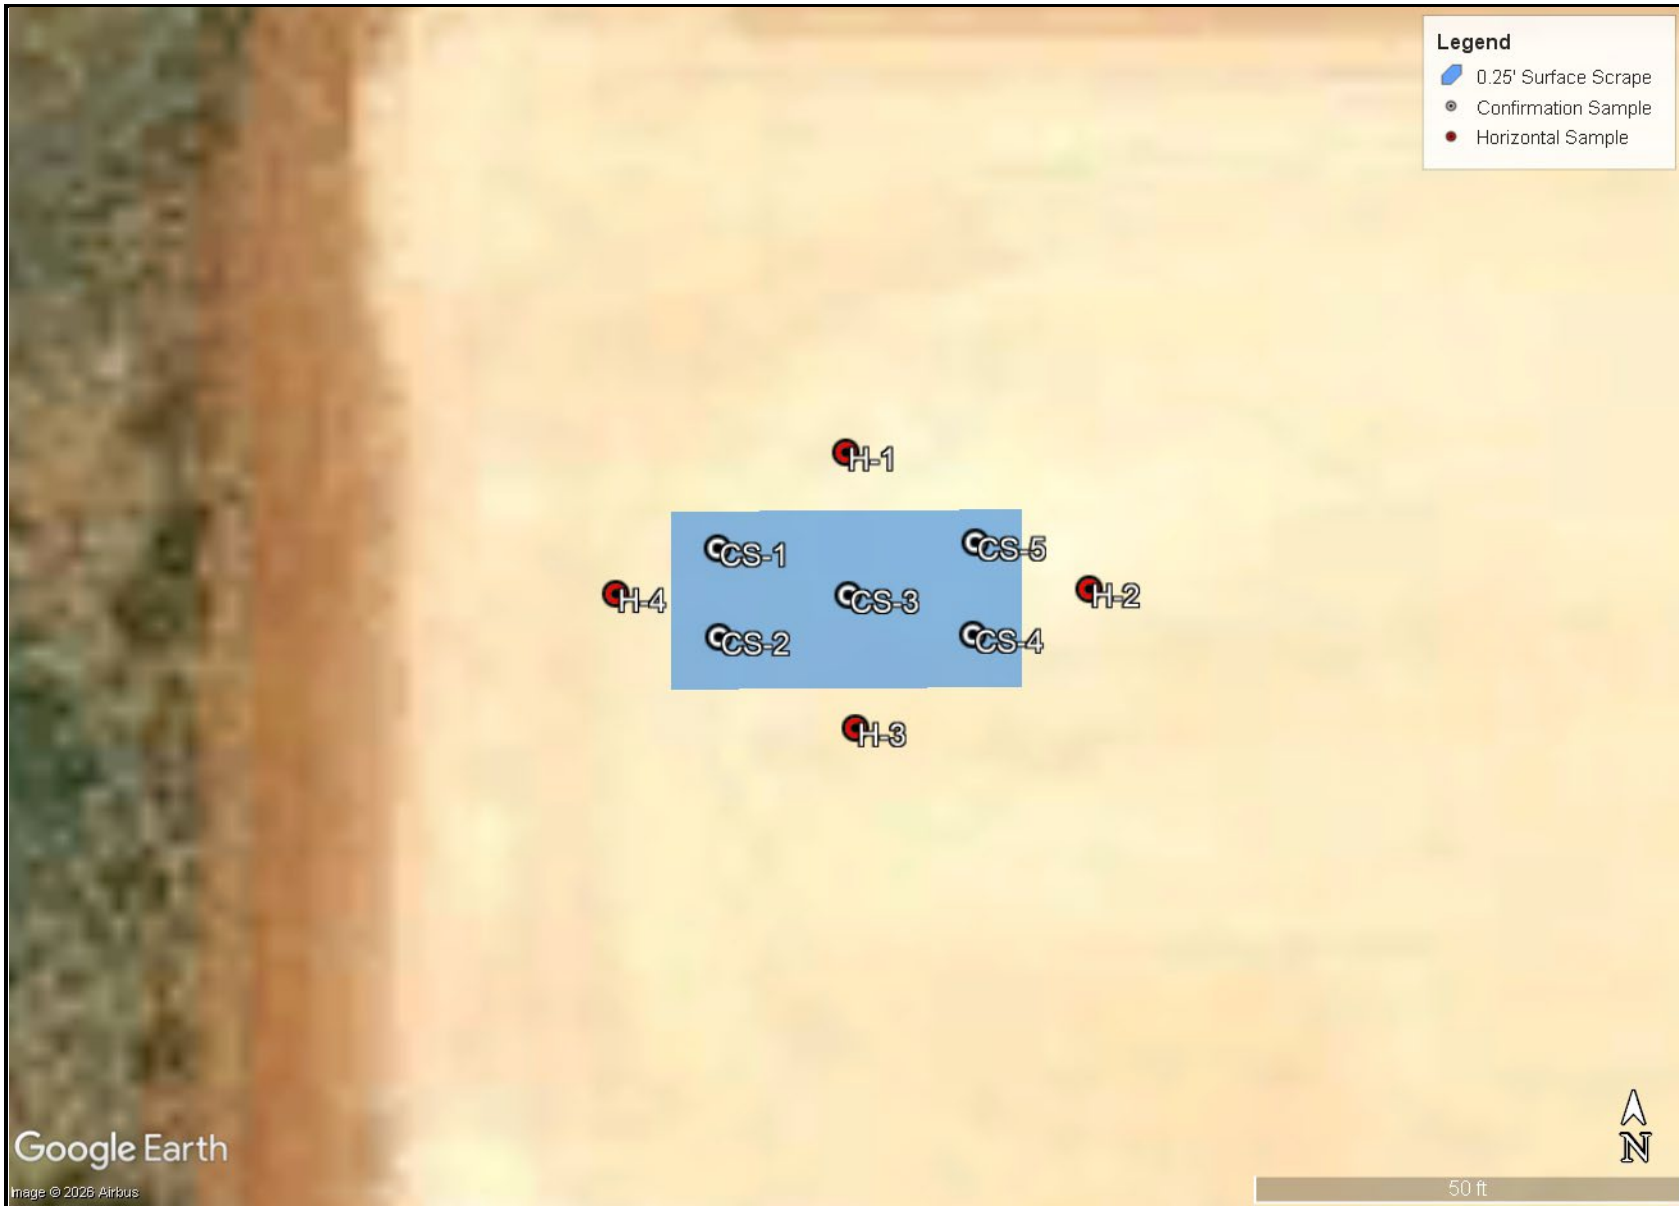
| <p>EXCAVATION DEPTH MAP CHEVRON U.S.A., INC. DL 10 3 FEDERAL COM #407H (12.06.2025) LEA COUNTY, NEW MEXICO 32.399994°, -103.566222°</p> | <p>CARMONA RESOURCES </p> | <p>FIGURE 3</p> |

All final confirmation samples were below the regulatory requirements for TPH, BTEX, and Chloride. Refer to Table 1. The excavation depth and confirmation sample locations are shown in Figure 3.

Approximately 850 square feet of area was remediated, resulting in 10 cubic yards of material excavated and transported off site for proper disposal.

Due to the excavation being less than 6 inches in depth, horizontal delineation samples were collected in place of composite confirmation sidewall samples. Additionally, due to the extremely shallow nature of the surface scrape of the remediation caused by a flare fire, a variance to NMAC 19.15.29.12.D.2 is requested in relation to backfilling the excavated (scraped) area. The area was not backfilled with any material since the scrape was minimal and did not cause any safety issues. Please see Figure 3 & Table 1 for sample locations and analytical results, respectively.

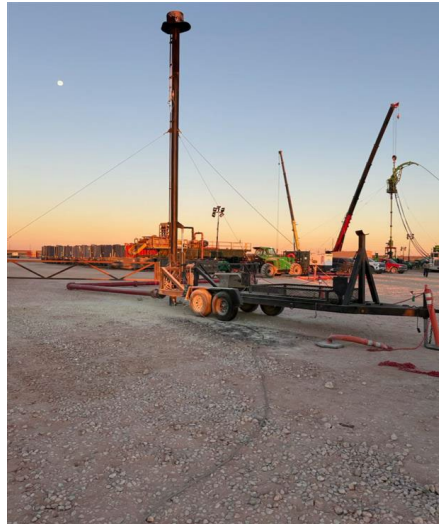
Photograph No. 1

View of the temporary flare trailer following the incident.

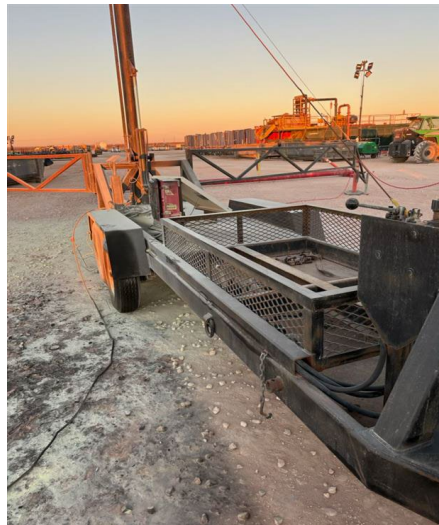
Photograph No. 2

View of the temporary flare trailer following the incident.

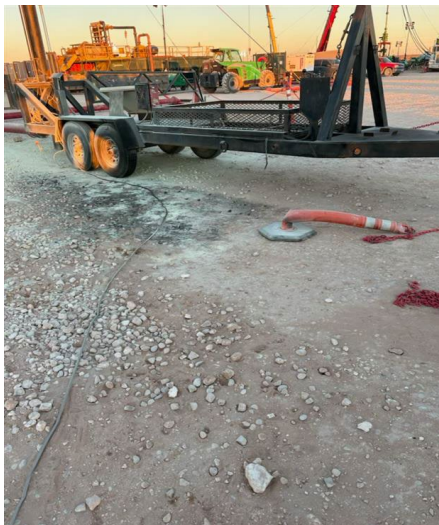
Photograph No. 3

View of the temporary flare trailer following the incident.

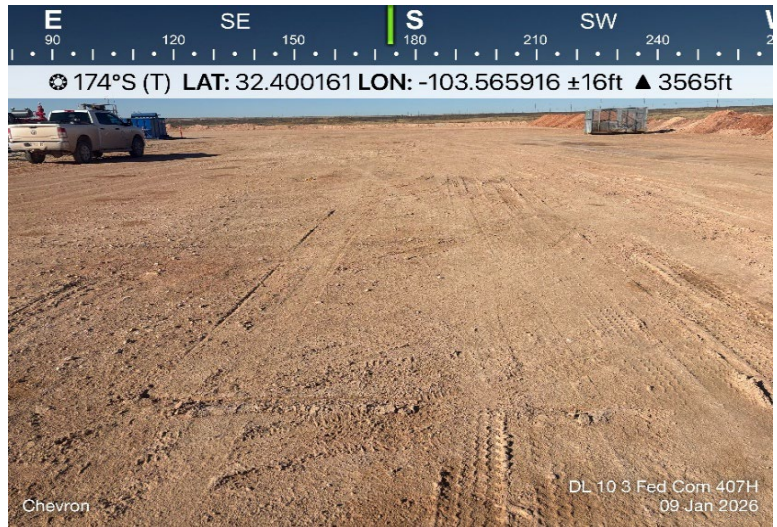
Photograph No. 4

Description:
View South, Area of CS-1 through CS-5 following the surface scrape.

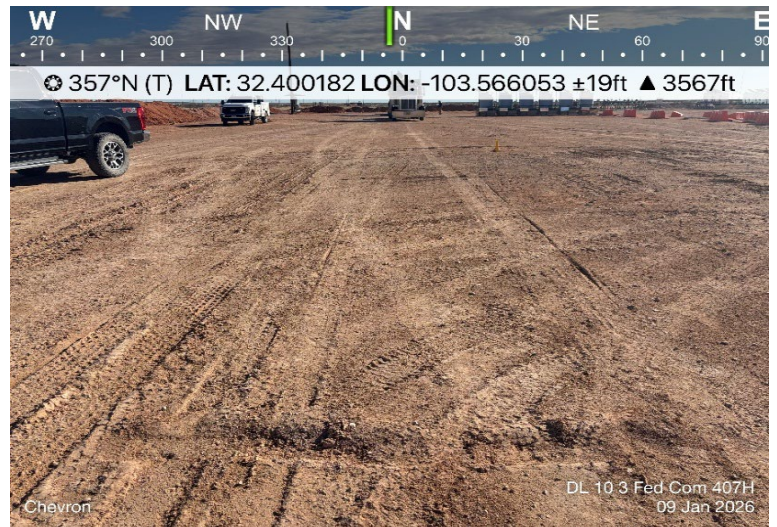
Photograph No. 5

Description:
View North, Area of CS-1 through CS-5 following the surface scrape.

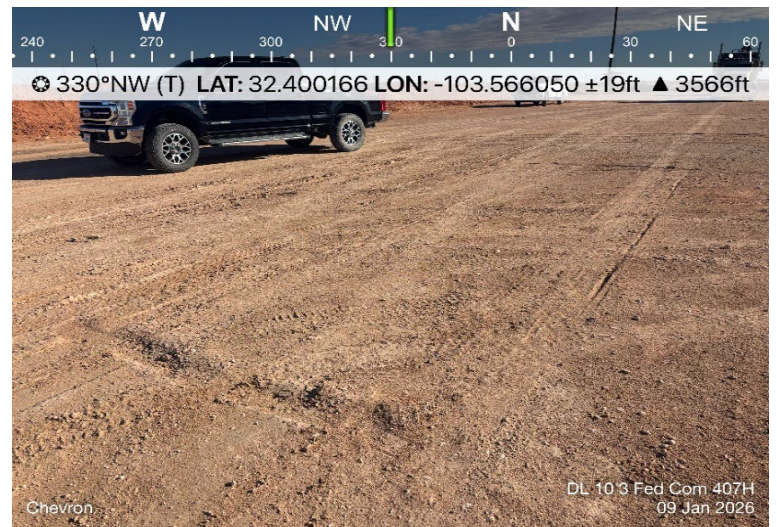
Photograph No. 6

Description:
View Northwest, Area of CS-1 through CS-5 following the surface scrape.
