**Closure Report**  
**Treble CTB (01.25.2026)**  
**Incident ID: nAPP2602661700**  
**Lea County, New Mexico**  
**Unit N, Sec 34, T19S, R35E**  
**32.61063°, -103.44936°**

**Crude Oil Release**  
**Point of Release: Flare Fire**  
**Release Date: 01.25.2026**  
**Volume Released: 0 Barrels of Crude Oil**  
**Volume Recovered: 0 Barrels of Crude Oil**

Re: **Closure Report**  
**Treble CTB (01.25.2026)**  
**Incident ID: nAPP2602661700**  
**Coterra Energy Operating Co.**  
**Site Location: Unit N, S34, T19S, R35E**  
**32.61063°, -103.44936°**  
**Lea County, New Mexico**

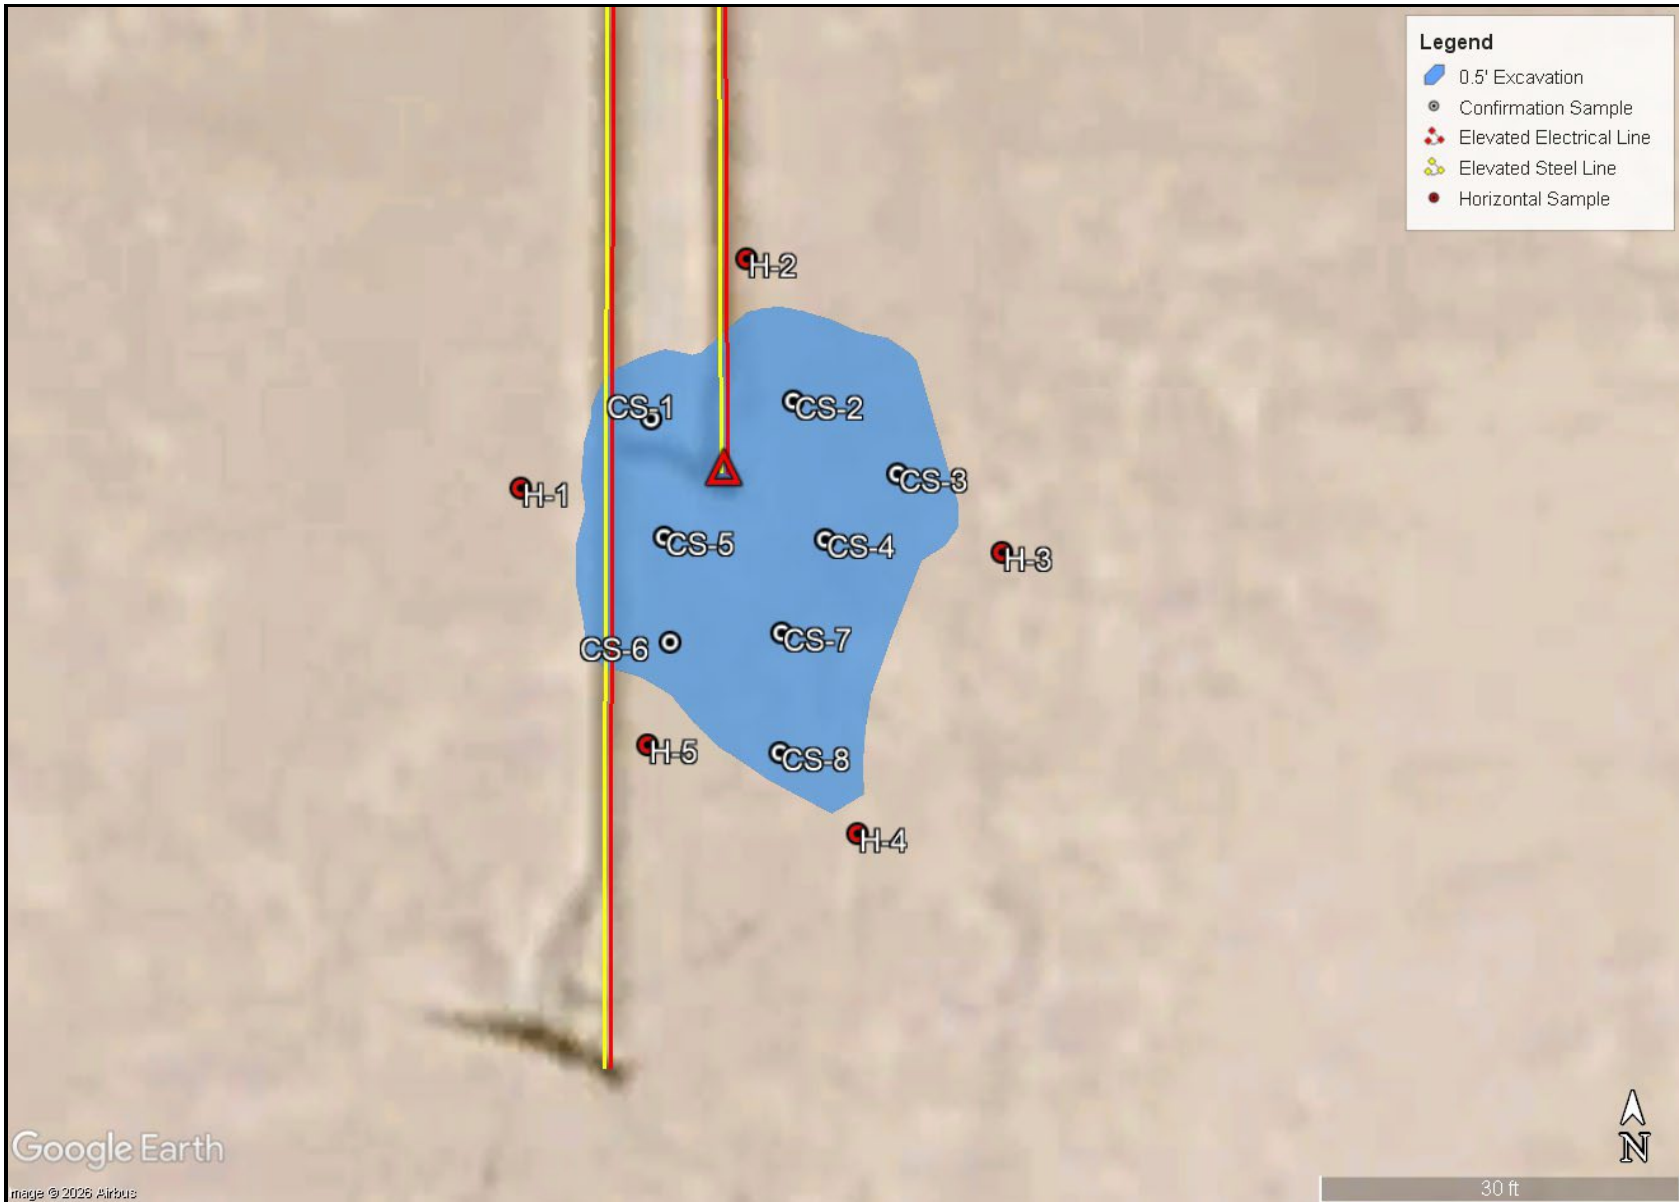
</p>	<p>FIGURE 3</p>
--	--	-----------------

All final confirmation samples were below the regulatory requirements for TPH, BTEX, and Chlorides. Refer to Table 1. The excavation depths and confirmation sample locations are shown in Figure 3.

<p>EXCAVATION DEPTH MAP COTERRA ENERGY OPERATING CO. TREBLE CTB (01.25.2026) LEA COUNTY, NEW MEXICO 32.61063°, -103.44936°</p>	<p>CARMONA RESOURCES

Approximately 920 square feet of impacted area was remediated, resulting in the removal of an estimated 15 cubic yards of soil, which was transported offsite for proper disposal at an approved facility. Due to the shallow nature of the surface scrape, the location was not backfilled with any material. Production managers onsite have determined that the caliche thickness remaining on the well pad is sufficient and does not pose any safety or stability risks for oil field operations. Once the wells on site have been plugged and abandoned, and all facility equipment has been removed, the entire well pad will be reclaimed per NMAC 19.15.29.13.

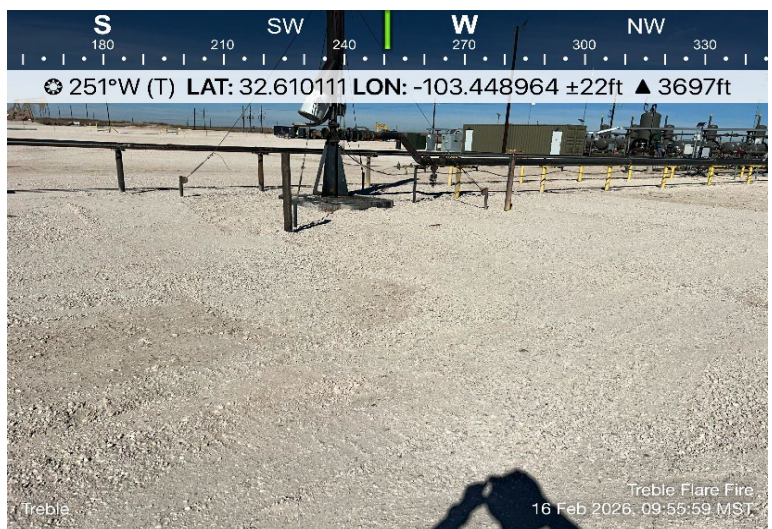
### Photograph No. 2

**Description:**  
View West, area of CS-1 through CS-8.

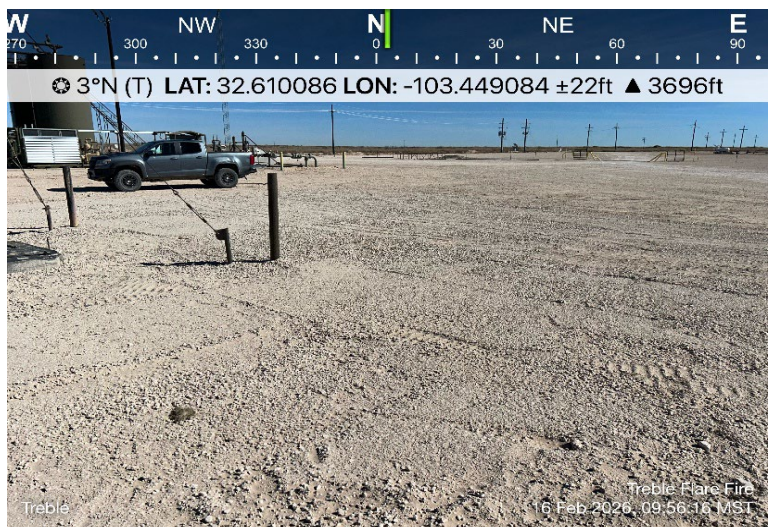
### Photograph No. 3

**Description:**  
View North, area of CS-1 through CS-8.
